Ngā Ūranga ki Pito-One Shared Path 30% Detailed Design

Prepared for Te Ara Tupua Alliance Prepared by Beca Ltd

5 September 2022

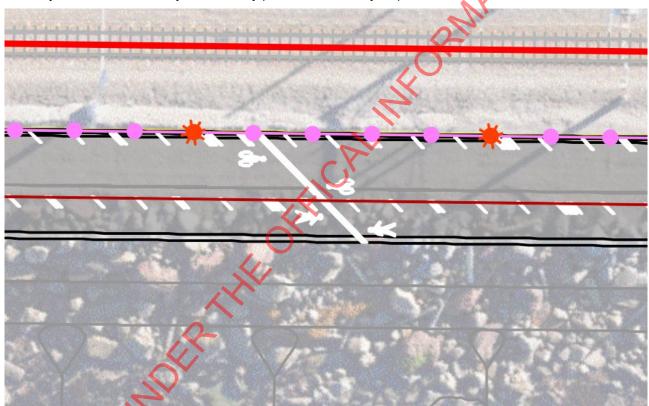
The preliminary drawings identify the pathway will be split with visual cues provided to demarcate separation between people walking and people cycling. During the project briefing the design team highlighted that a delineation strip was being provided to provide the visual separation, however, material choice has not yet been confirmed. It is conceptually shown as a directional tactile paver with painted hatching (or similar) which will provide a colour and texture difference.

The proposed pathway width could present risks of groups of walkers 3-4 abreast overlapping the cyclepath and may cause friction with cyclists as they protrude into the cycle path.

Figure 2: Example of the existing layout with visual delineation demarcating the pedestrian and cycle movements

It is recommended that an option to provide a full, shared path with no delineation along with behavioural influencing signage and marking to reduce friction between users.

It is also recommended that the disability sector is consulted about the use of tactile pavers along the length of the route.

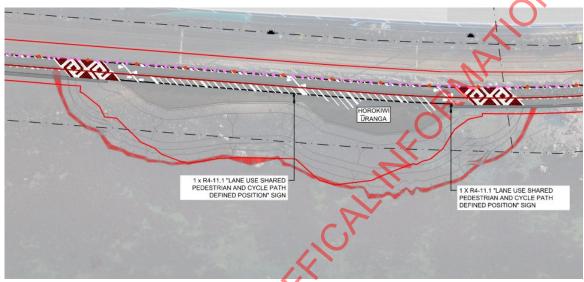
There are 6 proposed Uranga sites spread along the route which provide great amenity for path users. These areas provide seating, lookout and artwork which tell a story of the place. This will enhance the journey experience and enable people to stop, rest and gain knowledge before continuing along the route. Due to the length of the route the safety audit team questioned whether there were opportunities to integrate more secondary pause points (ie. Seating/ small stopping areas) to allow further opportunities for people to stop and rest along the journey. These sites will also be very popular destinations at the weekends for recreational users and require adequate space for movement as well as passive recreation.

Some Uranga sites are larger and have the ability to accommodate a walkway that is separate from the main shared path. This will provide relief from cyclists for pedestrians and enhance the separation of the modes.

Figure 3 Uranga layout requires further demarcation of movement vs. seating areas

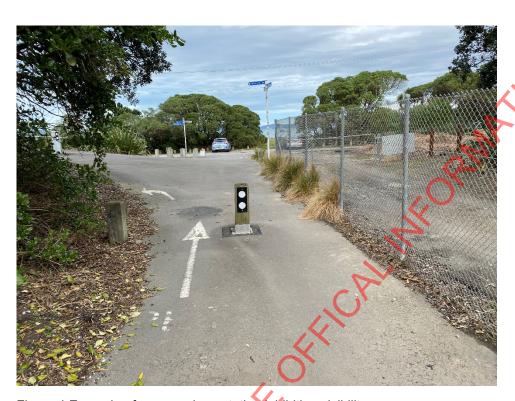
There are a number of areas that include landscaping adjacent to the path which could impede on the visibility of other shared path users approaching one another especially in areas where the path curves around obstacles including the underpass bridges and existing planted areas.

There are also existing areas of planting that create hiding opportunities and reduce path width through the existing pathway section adjacent to Hutt Road.

Figure 4 Example of unpruned vegetation inhibiting visibility.

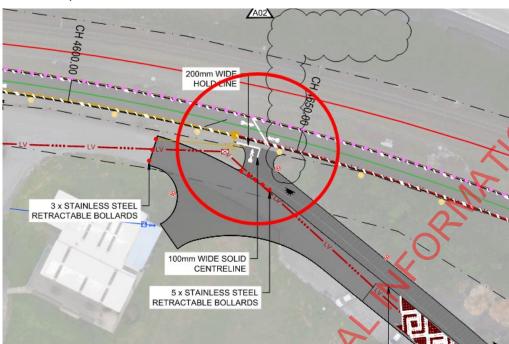
There is no wayfinding signage indicated on the plans. Consider providing wayfinding signage, map boards and signs highlighting distance to key destinations. A critical area for wayfinding includes at the Y junction in the shared path to both Hōniana Te Puni Reserve and Hutt Road.

Figure 5 Circled intersection for wayfinding required to enable clear directions for path users

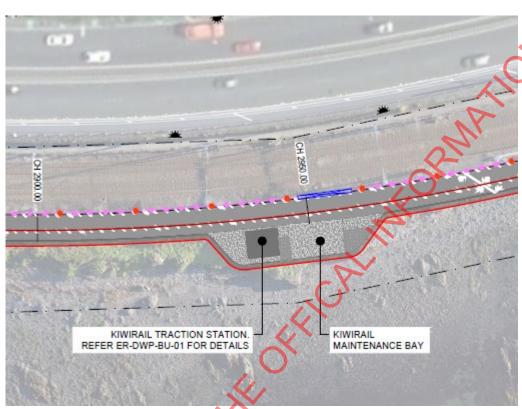
The existing KiwiRail Traction station shows a maintenance bay where vehicles are likely to park up during times of maintenance. This may cause conflict with shared path users.

Figure 6 KiwiRail Maintenance Bay located at CH2950m

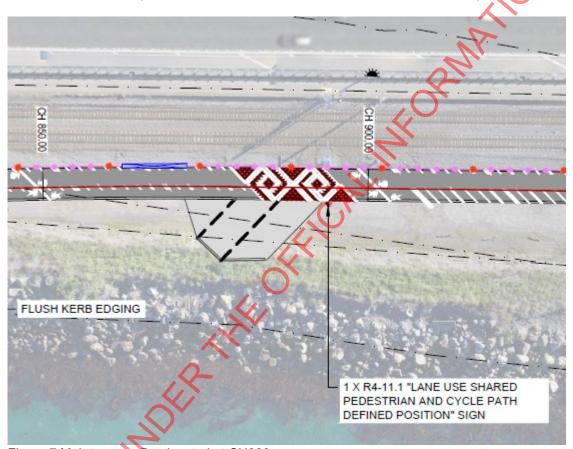
There are a number of maintenance bays for maintenance vehicles to park along the route. These areas have the potential to cause conflicts between vehicles and shared path users

Figure 7 Maintenance Bay located at CH880m

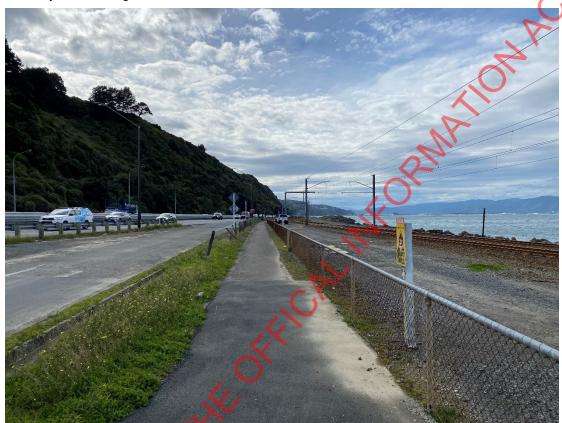
The existing path near Ngauranga Station shows evidence that gravel and construction debris have been spread across the pavement adjacent to the vehicle access within the KiwiRail yard. This causes a risk to cyclists getting punctures or sliding, particularly at corners. There is no evidence that sweeping had taken place recently to remove gravel.

Figure 8: Gravel and debris creeps on existing path near Kiwrail access track

Include appropriate mitigation to reduce the amount of gravel and debris that enters the shared path area from adjacent KiwiRail yard access roads. Consideration should be made for the maintenance and sweeping regime that is required to keep the pathway clear of debris and gravel. Or, better still, to seal the adjacent access lane which will remove the hazard completely or alternatively, construction a concrete nib to limit the amount of gravel.

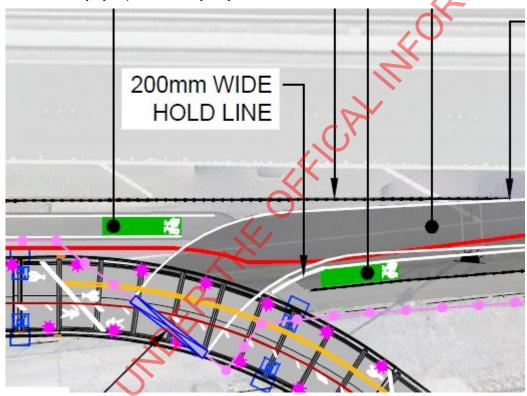
The access from the SH2 shows a formal cycleway with green markings which crosses the KiwiRail access lane. This may tend to encourage cyclists (especially the high speed cyclists) not to use the new shared path and to use the SH2 shoulder all the way from Petone to Ngauranga. We believe that this access should be a last resort only cyclepath and only if cyclists find themselves on SH2 and need to exit.

Figure 9: Cyclepath crossing over KiwiRail Access Lane.

- that this access from the shoulder be a subtle (i.e.) last resort) exit.
- Include appropriate signage installed at the Northern end of SH2 that encourages all cyclists to use the shared path and not SH2 as well as appropriate signage to indicate to any cyclists on SH2 that they must exit at this location before going onto the Thorndon Quay raised motorway.
- Include appropriate design elements to avoid conflict between KiwiRail users and cyclists such as giveway and warning signage and markings.
- It is recommended that the movement path for cyclists across the access lane should be at 90 degrees to the vehicle movements. An example of this layout is shown in Figure 9.

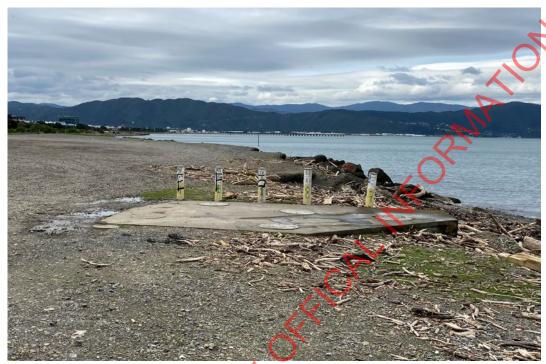
There are a number of water supply valve access manholes located at CH4370m. The current design does not indicate any formal access to these manholes. This is a potential conflict area during times of maintenance for the water supply service manholes and therefore specific formal access should be implemented.

Figure 11: Gravel and debris creeps on existing path near KiwRail access track

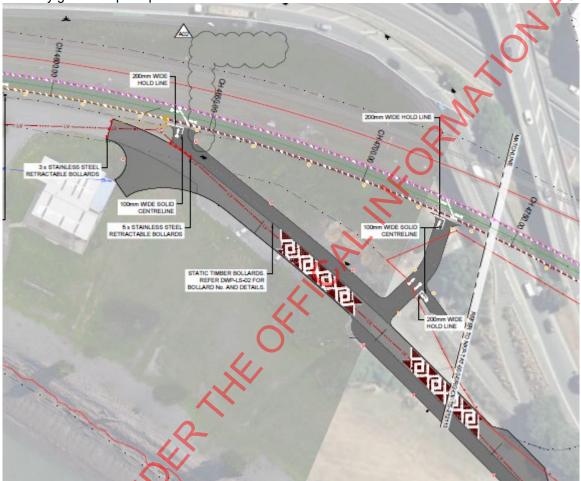
The shared path has been designed hard against the Access Road to the Water Ski club in the area to the west of the Korokoro bridge and South of the Water Ski Club Buildings. However, there is opportunity here to fully separate the shared path from the access road by creating a meandering path through the large currently grassed open space between the access road and the shore.

Figure 12: Area where there is opportunity to separate the shared path from the access lane.

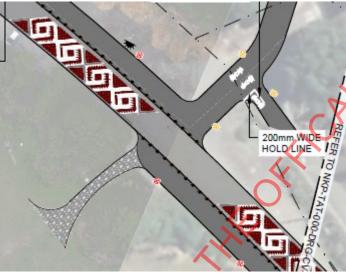
The shared path crosses the existing access lane in order to access the Petone foreshore path. This is a conflict point between vehicles using the access lane and shared path users. It is not clear in this design who has priority therefore will create confusion for users and thereby increasing the risk of collision between users.

Figure 13: Crossing point of Access lane by shared path

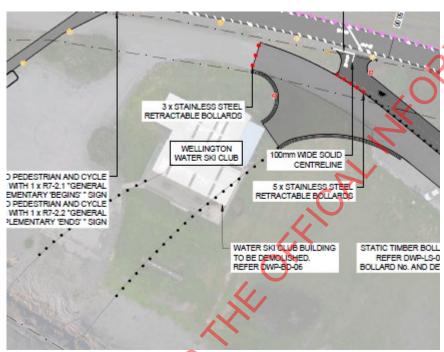
The proposed boat ramp access appears to have limited area for car and trailers to make turning and reversing manoeuvres. Vehicles with boat trailers (especially rowing skiffs) require large amounts of turning space to access the boat ramp. Providing a reduced area for manoeuvring could create issues with conflict with other vehicles and shared path users.

Figure 14: Boat Ramp area with very limited turning space.

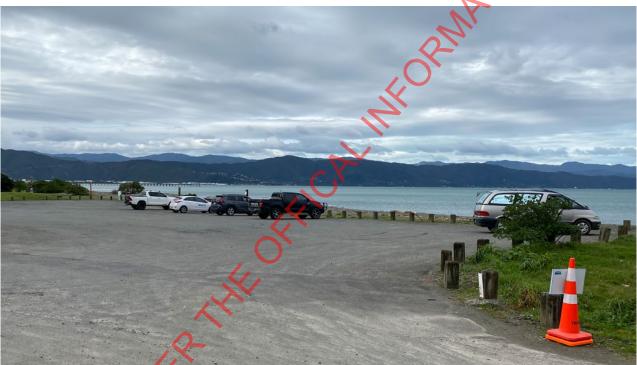
It was evident during our site visit that the Boat Club and Water Ski Club area is a popular destination for people walking their dogs and is likely to become even more popular for people accessing the new pathway. There is limited provision for parking in the reserve area which could result in parking non-compliance.

Figure 15: Foreshore Area around Boat Club is currently a popular location for public to park and walk.

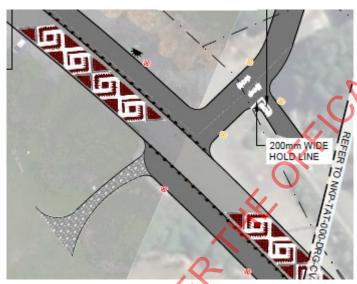
This area is a conflict zone with the different users including vehicles on the access lane, cyclists and walkers on the hazard path and other users within the park area itself. This area has potential to cause collisions between all the users.

Figure 16: Shared path crossing at boat access road

Provide traffic calming measures and bollard placement to enable a seamless journey for both pedestrians and cyclists. It is recommended that the option is explored to include a raised platform across the access road to retain the shared path at one level. A raised platform will also encourage slower speeds by car drivers.

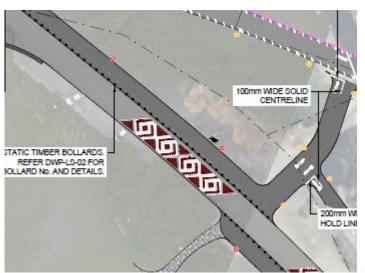
The cultural pattern on the boat ramp access lane is the same pattern that is used throughout the shared path route. This creates confusion for the users and could cause shared path users to think that they are on the shared path when in fact they are on the access road.

Figure 17: Cultural Marking on Access Lane (also used on shared path

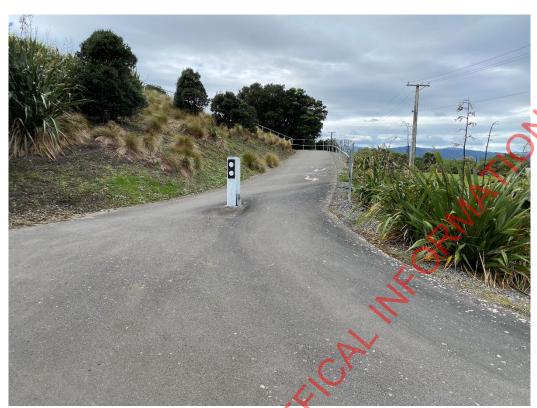
The connection pathway between Honiana Te Puni Reserve and the Hutt Road connection also provides a link to the Pito-One off ramp overbridge. There is a risk of people descending the ramp and approaching the pathway intersection at speed and crashing with other users.

Figure 18: Ramp from connecting pathway to Hutt Road with potential speed issue.

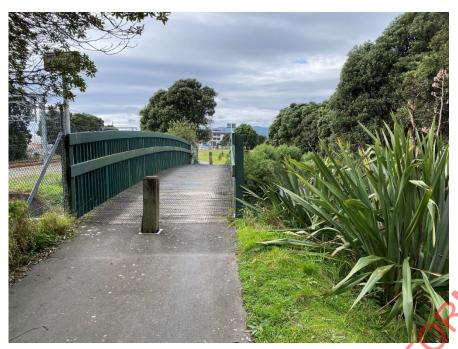
The safety audit team support the replacement and widening of the existing 2.1m wide bridge in Honiana Te Puni Reserve. While the existing bridge is in reasonably good condition, it is narrow and could cause conflict issues between users as the demand along the route increases.

Figure 19: Existing pedestrian bridge within Honiana Te Puni reserve

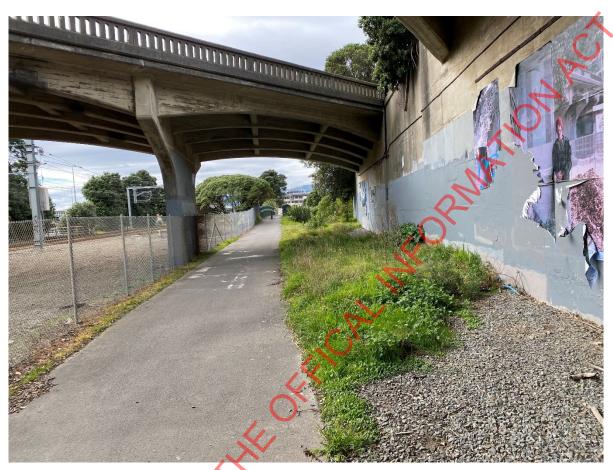
The existing path within the Honiana Te Puni reserve is an isolated area which has no passive surveillance, no lighting, no readily available escape routes, is a high noise area from nearby trains and traffic, has graffitiand torn posters, which all combine to create an intimidating environment for users, particularly after dark.

Figure 20: Existing intimidating environment below underpass

We recommend that there is design intervention through this area to provide a non-intimidating and well-lit environment.

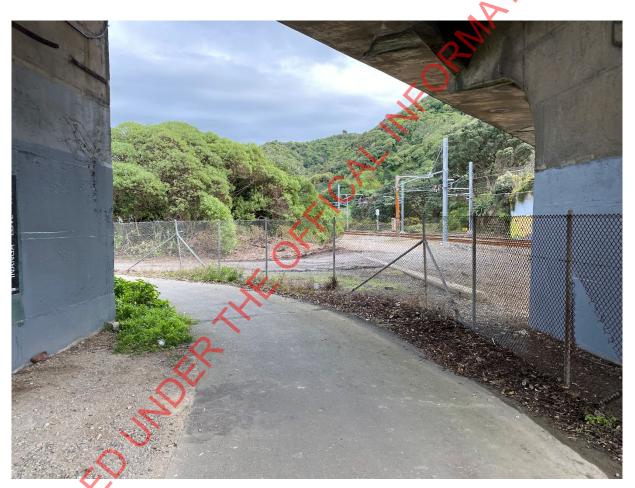
There is an existing tight corner with very limited visibility to oncoming path users. This has the potential to cause collisions between path users particularly with fast moving cyclists and other cyclists or pedestrians.

Figure 21: Existing tight corner below underpass

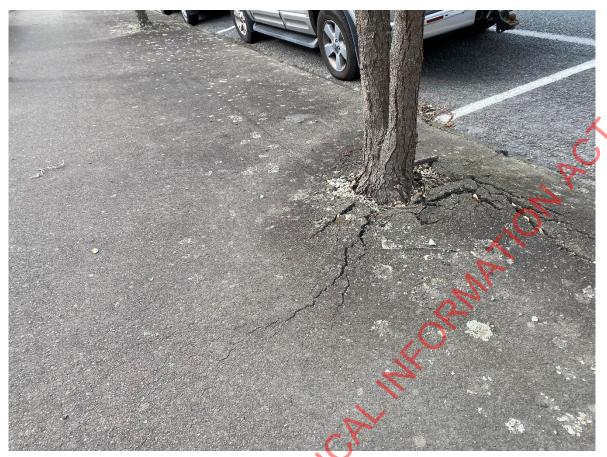
The existing trees near the connection point with the Melling Shared path (currently under construction) have caused an uneven path surface along the existing shared path adjacent to Hutt Road.

Figure 22: Existing uneven path adjacent to Hutt Road
