FIRE INVESTIGATION REPORT

50 Rawhiti Road, Manly, Auckland

F3756563

Suspicious Fire

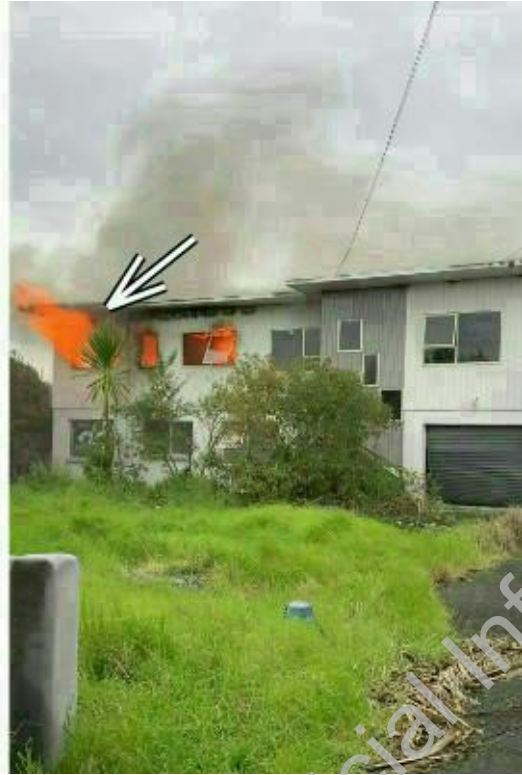
According to [REDACTED] observation, the fire had already gained significant intensity in a front bedroom upper level, with flames visibly emanating from the front windows of the dwelling. The strong winds further accelerated the spread of the fire throughout the upper levels, causing it to engulf the entire upper level.

Image 2: Photo at the time of arrival of Manly DCFO. Arrow indicating area of origin.

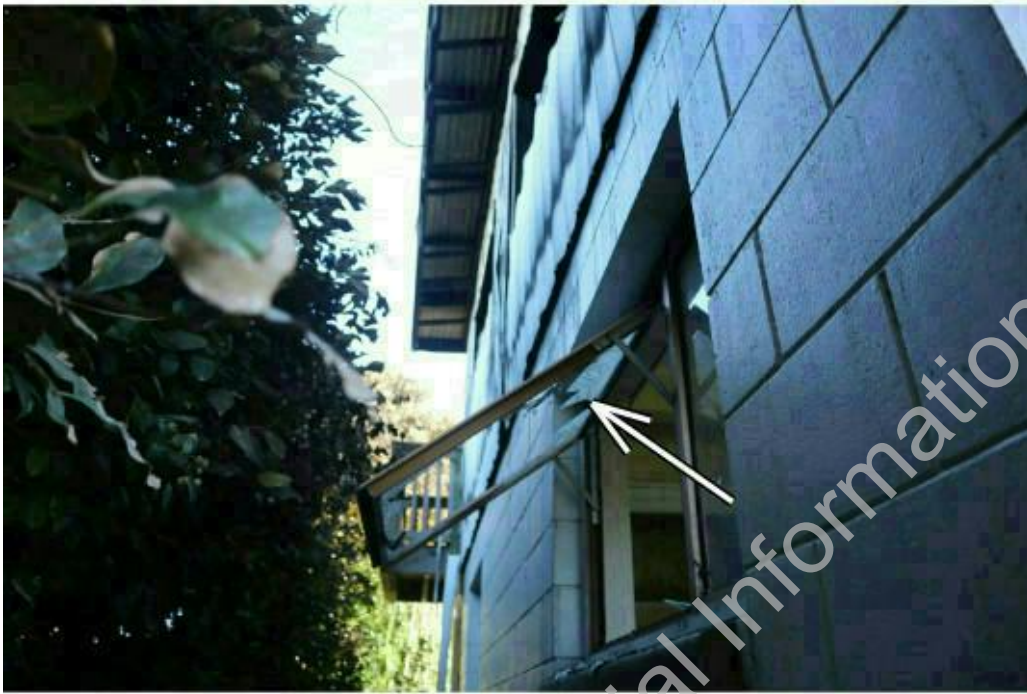
Lower level: No signs of fire damage were noted on the lower level of the dwelling. However, the presence of mechanically¹ broken windows suggests that these windows had been intentionally damaged, possibly as acts of vandalism.

Photograph 3: Mechanical window break on lower level.

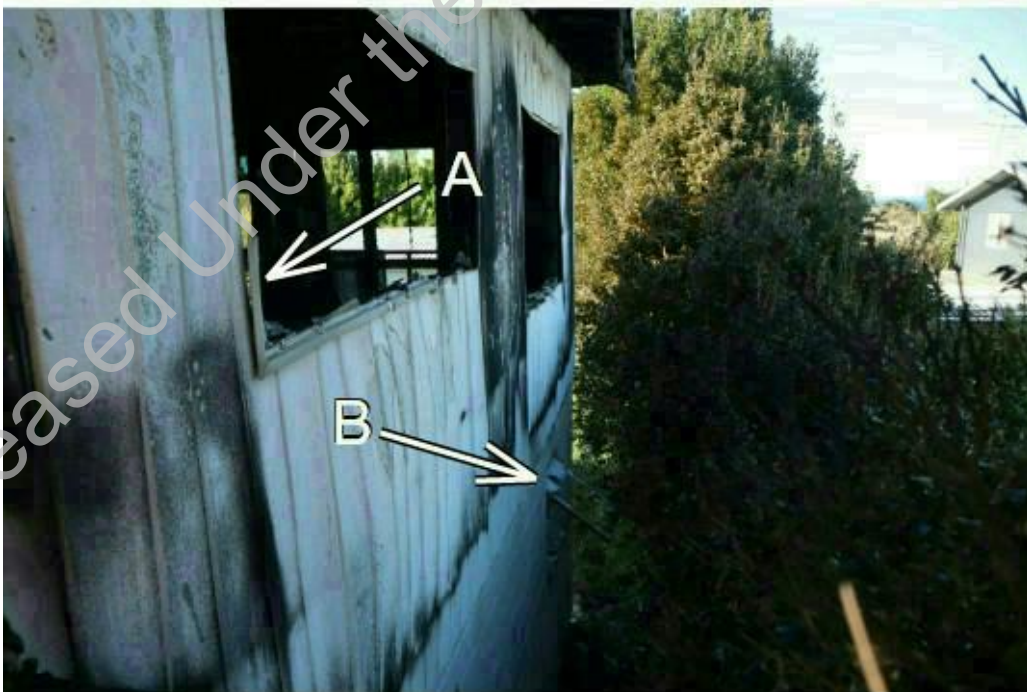
Upper level: Fire damage was observed on all parts of the walls and windows of the upper level, indicating that the fire spread throughout this area of the dwelling. The aluminium window frames had melted approximately 3/4 of the way down suggesting that the fire reached high temperatures, estimated to be at least 660 degrees Celsius. The extent of the fire damage on the upper level highlighted the intensity and rapid spread of the fire.

Photograph 4: Arrow A indicating aluminium window frame melted Arrow B indicating lower broken window from photograph 3.

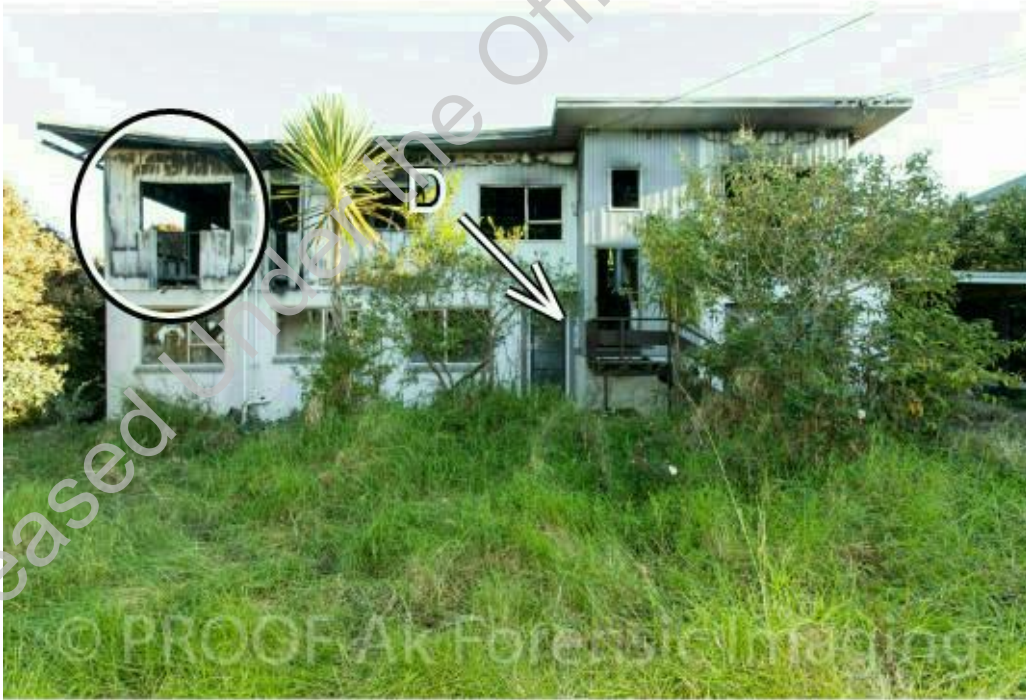
Upper Level: Fire damage was observed on all parts of the walls and windows of the upper level, indicating that the fire spread throughout this area of the dwelling. The greater extent of fire damage on the west profile suggested that the fire was more intense in that area. Clean burning² observed on metal wall panels suggested higher temperatures in those areas. The roof supporting beams were burnt away and the roof was slumping in the area of origin indicating significant fire involvement in this area. The melted PVC storm water pipe attached to the front of the dwelling had slumped down to the lower level further indicating higher temperatures experienced on the upper level during the fire.

Photograph 5: Circle indicating area of origin in upper-level bedroom 2. Arrow D indicating location of the mains power meter. (Courtesy of Police)

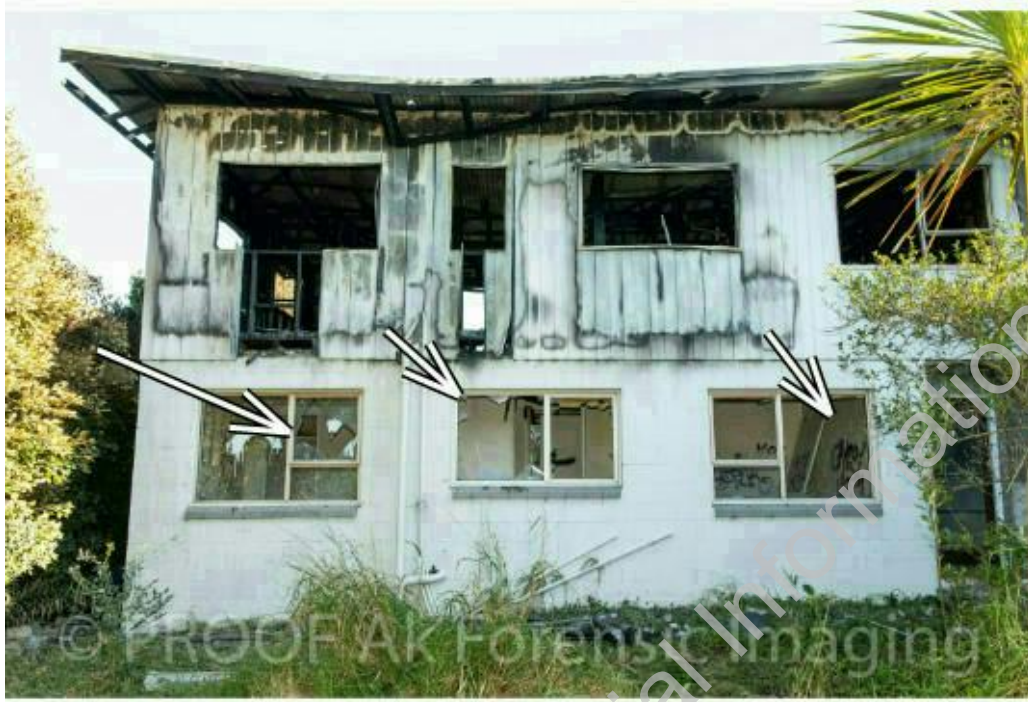
Lower Level: No signs of fire damage were noted on the lower level of the dwelling. The presence of mechanically broken windows suggested possible acts of vandalism. The mains power board located on the wall near the front door was examined and did not show any signs of damage related to the fire indicating that the fire did not originate or directly impact the power board.

Photograph 7: Arrows indicating mechanically windows broken on the lower levels. (Courtesy of Police)

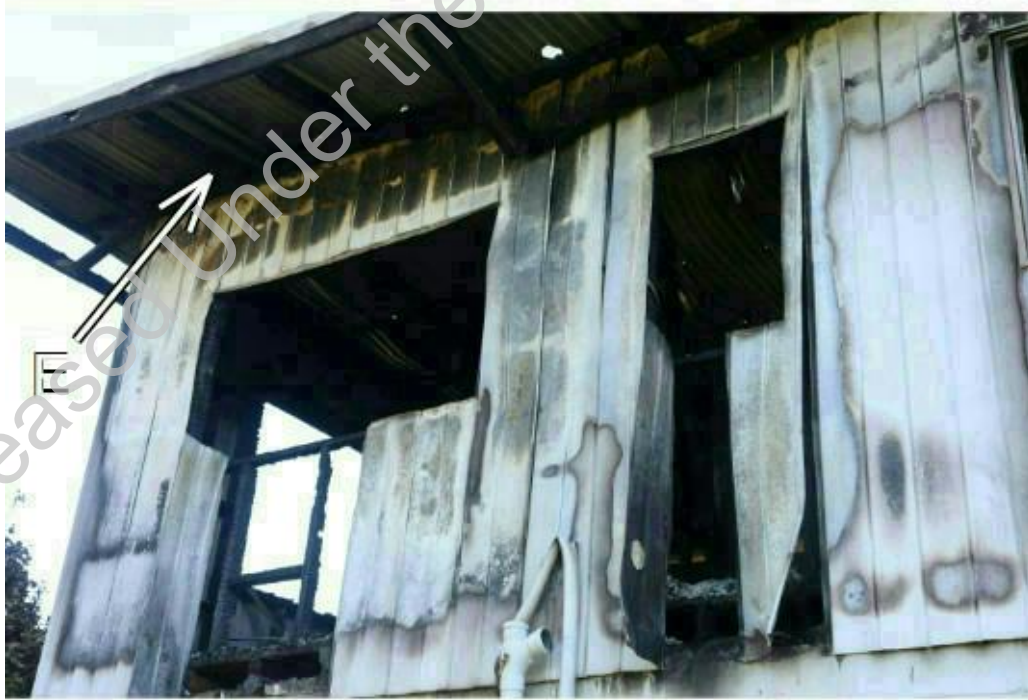
Photograph 7: Arrow E indicating soffit and timber support beams in the area of origin consumed by fire.

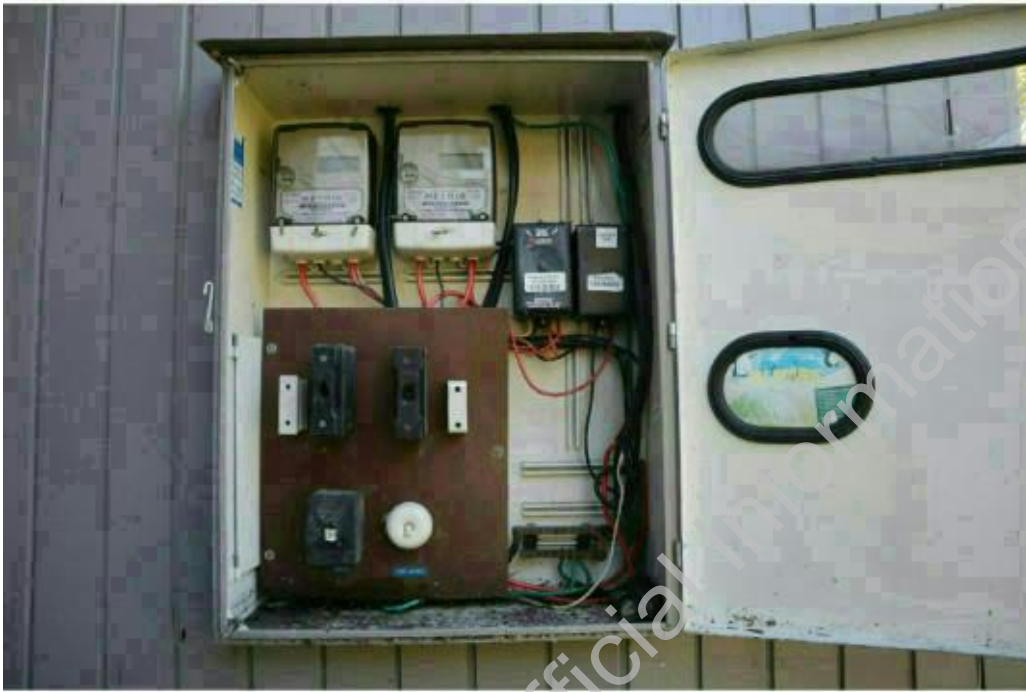
Photograph 8: Mains power meter undamaged.

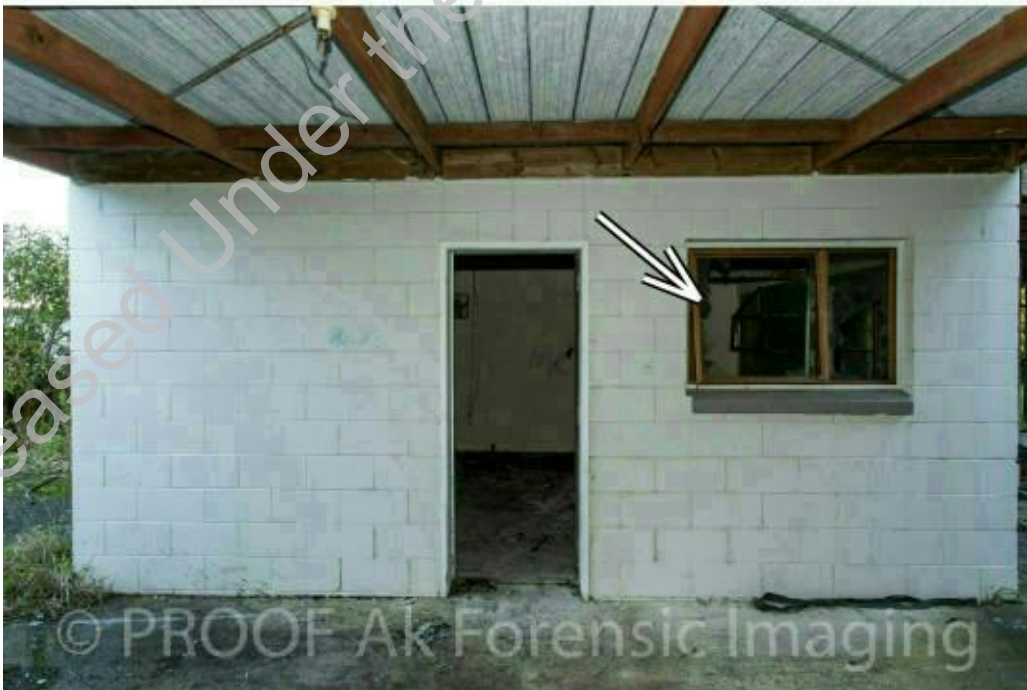
Lower Level: No signs of fire damage were noted on the lower level of the dwelling. The presence of mechanically broken windows in the garage area and graffiti suggested possible acts of vandalism. The OIC stated that the doors on the east profile were all open at the time of arrival and fire crews did not force entry.

Photograph 9: Mechanically windows broken on the lower levels. (Courtesy of Police)

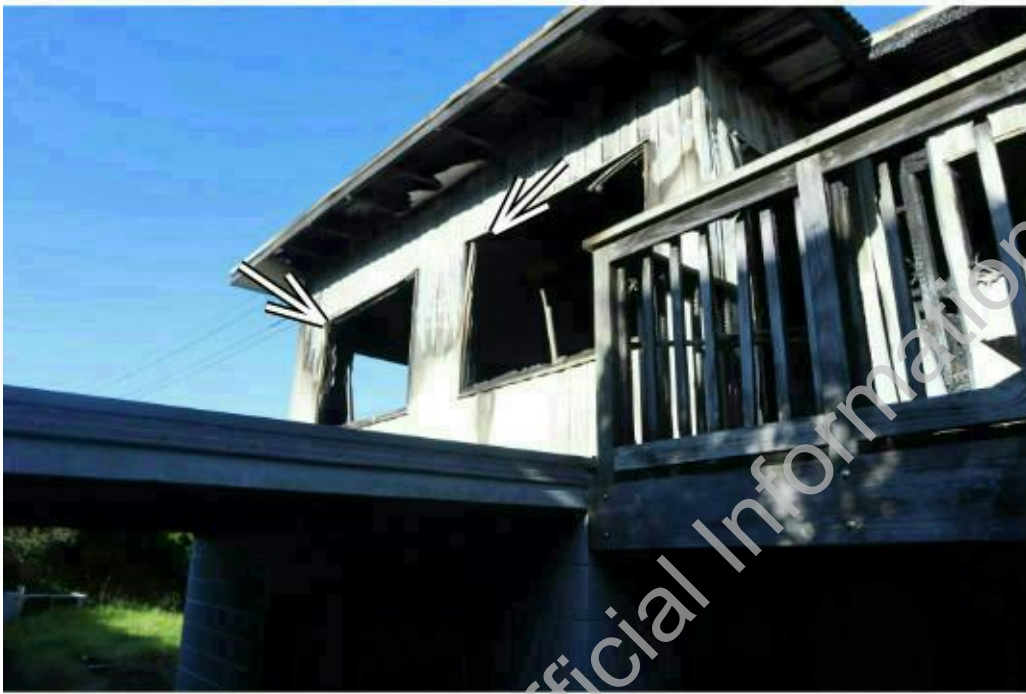
On the east profile of the dwelling, the aluminium window frames remained intact at the top of the windows, which indicated that the heat and fire intensity were greater on the west profile. Photograph 4 of the window on the west profile clearly shows the window frame melted approximately three-quarters of the way down, indicating the intense heat experienced in that area.

Photograph 10: Arrows indicating aluminium window frames on east profile.

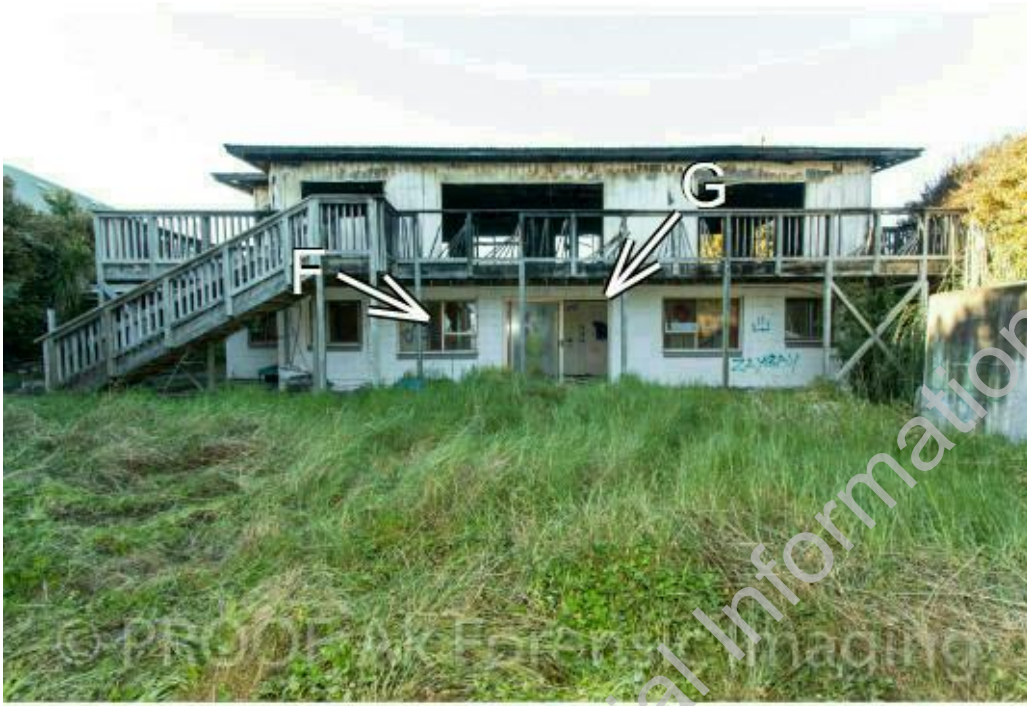
Lower Level: No signs of fire damage were noted on the lower level of the dwelling. The presence of mechanically broken windows in the garage area and graffiti suggested possible acts of vandalism.

Photograph 12: Arrow F indicating mechanically windows broken on the lower levels. Arrow G open sliding door. (Courtesy of Police)

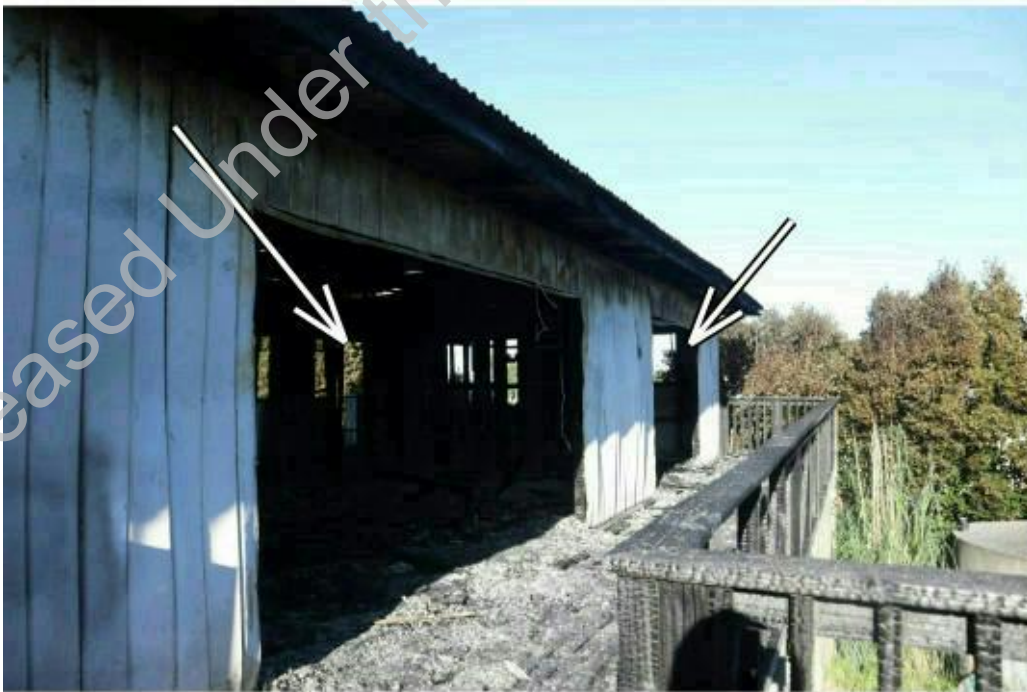
Upper Level: Fire damage was observed on all walls and windows on the upper level of the dwelling, indicating the widespread fire in this area. The presence of two large aluminium ranch sliding windows, once broken, would have provided a ventilation pathway for the fire, which would have contributed to the fire intensity.

Photograph 13: Location on the two large sliding windows.

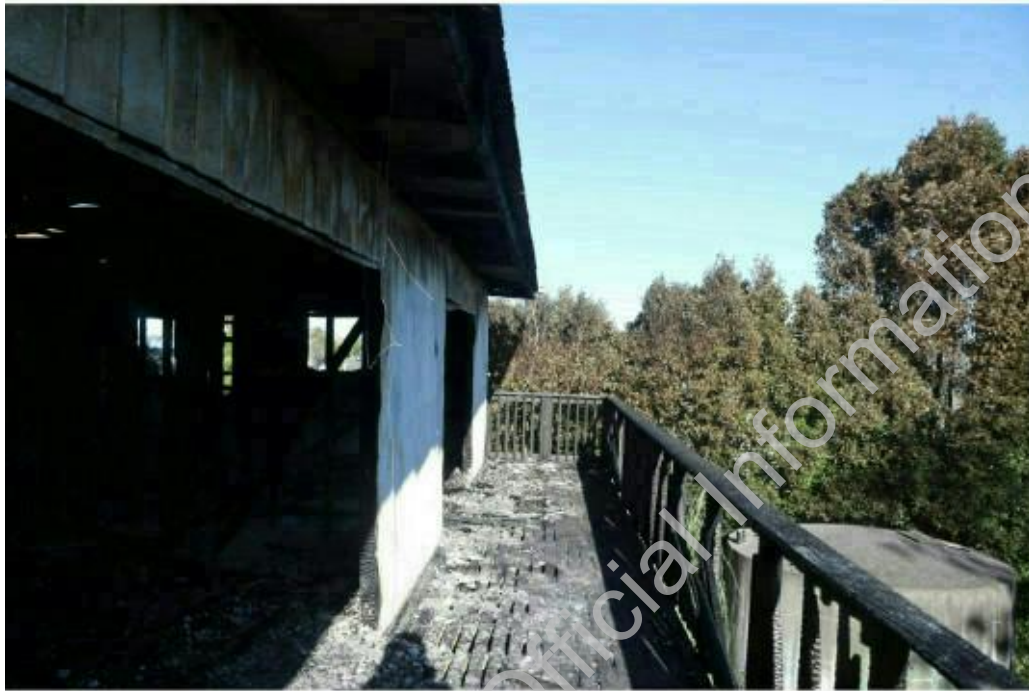
Additionally, a large wooden deck covering the entire length of the dwelling was located on the upper level of the north profile. This deck exhibited greater amounts of charring towards the west profile of the dwelling, indicating the path of the fire. Other than the charring the deck was still mostly intact.

Photograph 14: Deck located on the upper-level north profile.

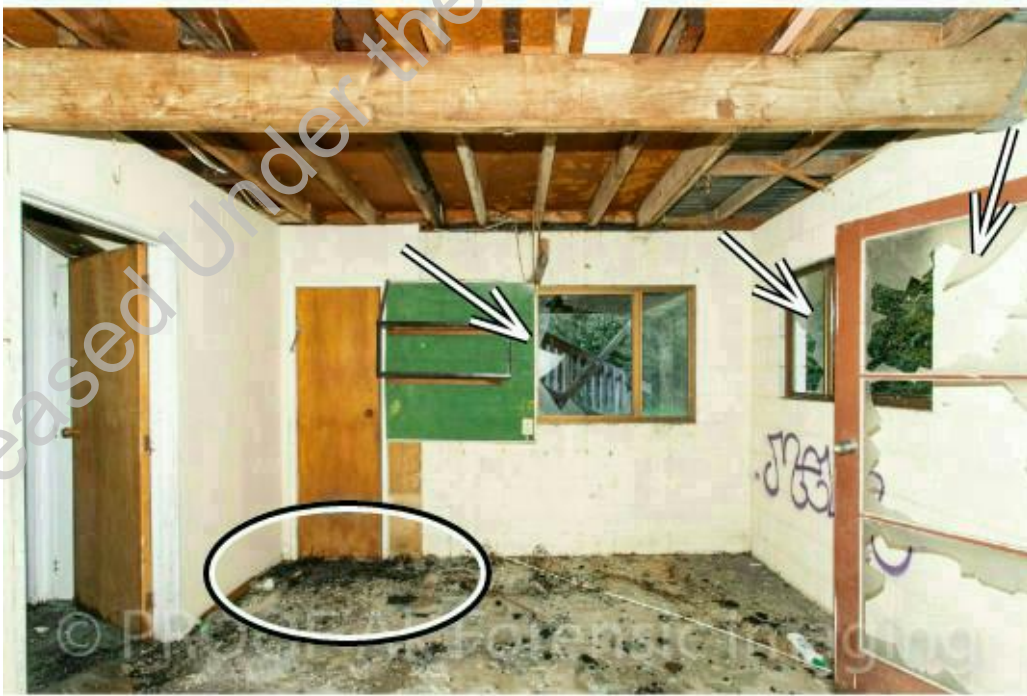
There was some fire debris observed in the garage, which likely fell from the upper level of the dwelling. This was due to the flooring of the upper level collapsing in several spots. The fallen debris indicated the extent of the fire's impact on the upper level and its subsequent effects on the lower areas, including the garage.

Photograph 17: Garage area of the dwelling. Circle indicating fire debris. Arrows indicating broken glass on doors. (Courtesy of Police)

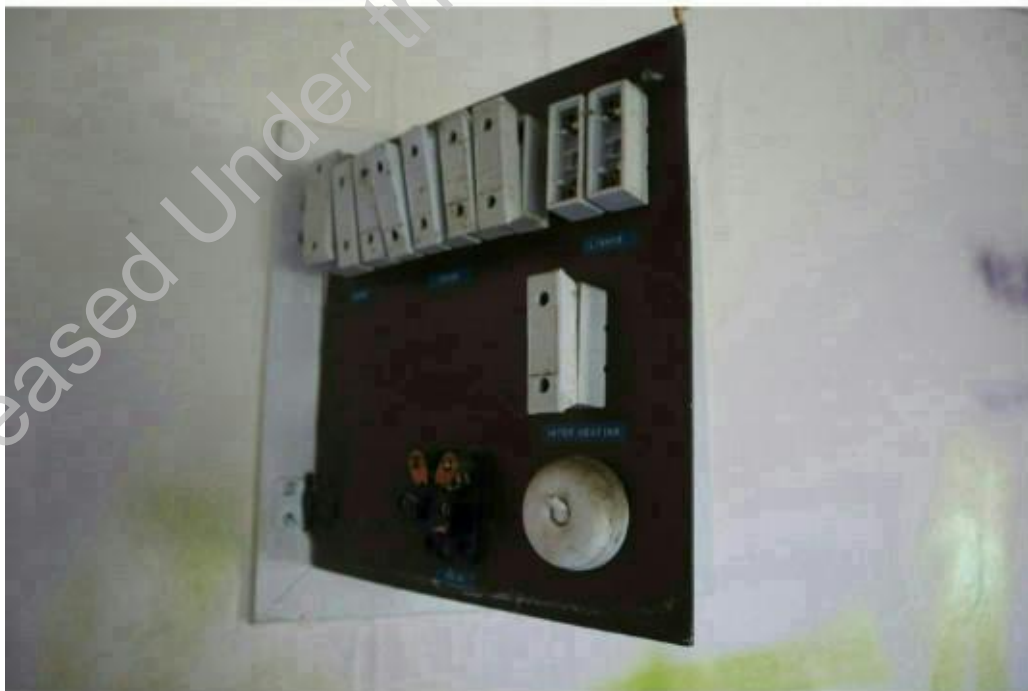
The main fuse board for the dwelling, located on the wall in the lower ground living area, was examined and showed no signs of fire damage.

Photograph 20: Fuse board

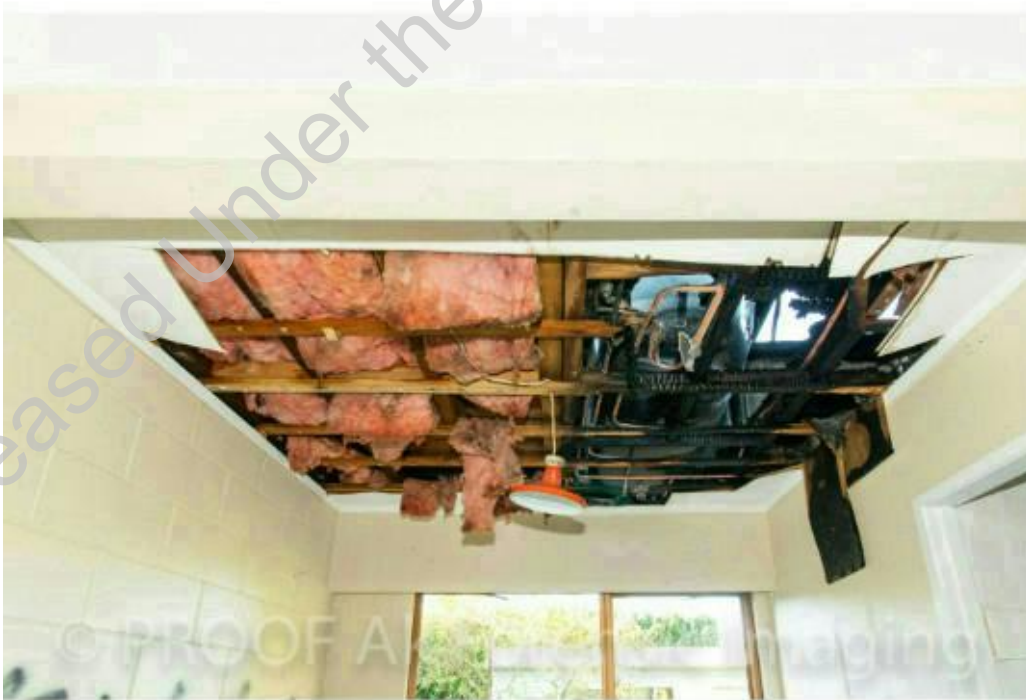
Located directly above bedroom 1 was the upper-level bathroom. Witness 2 stated that the flooring around the bath area was rotting away. Upon inspection, it was evident that the flooring in this area had failed and given way, creating a hole in the floor. The exposed timber joists were significantly charred indicating a fire burning above them in this area.

Photograph 23: Ceiling in bedroom 1 (Courtesy of Police)

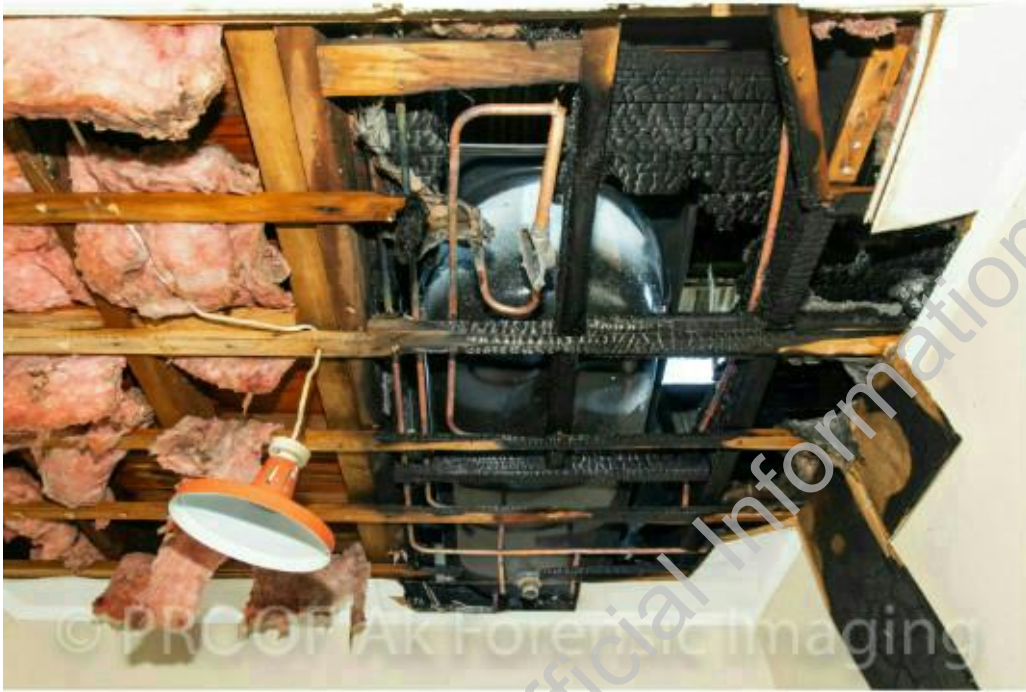
Photograph 24: Bathtub from above room. (Courtesy of Police)

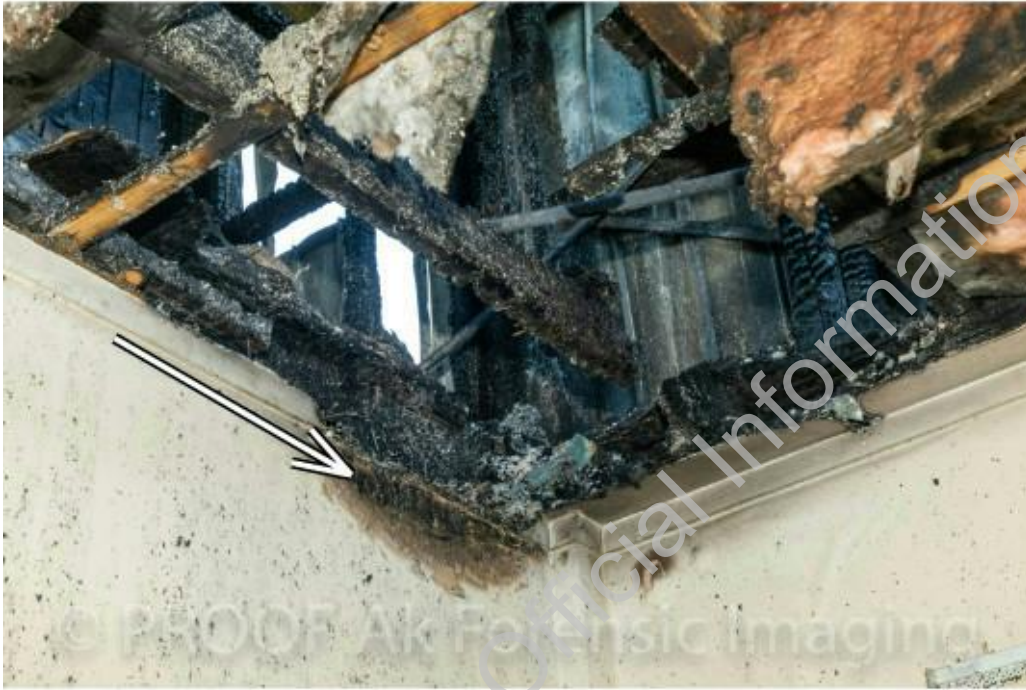
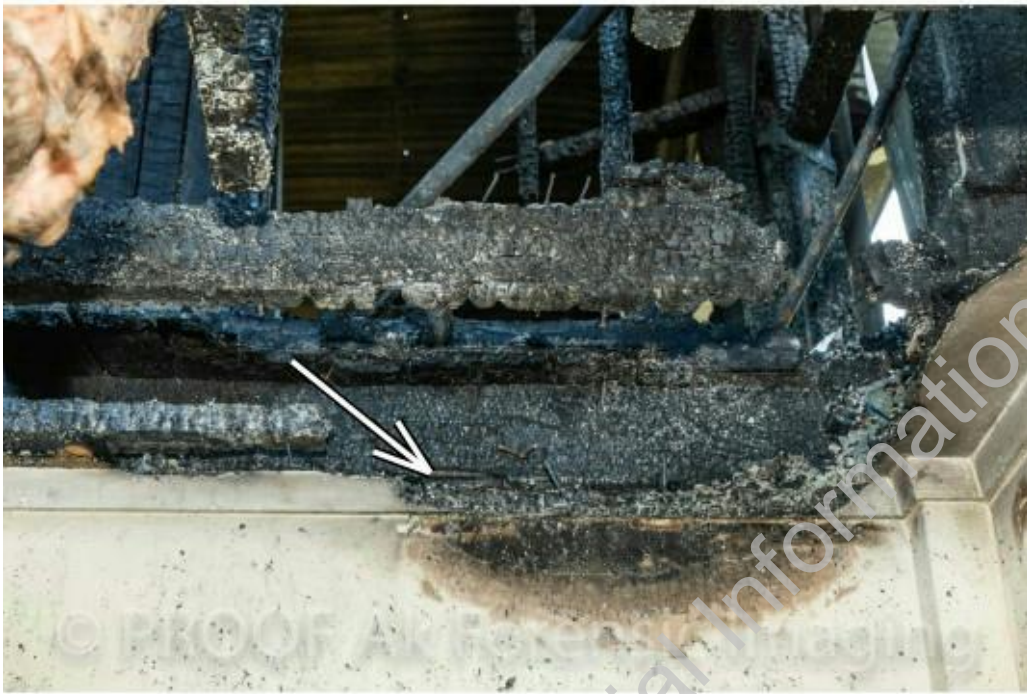
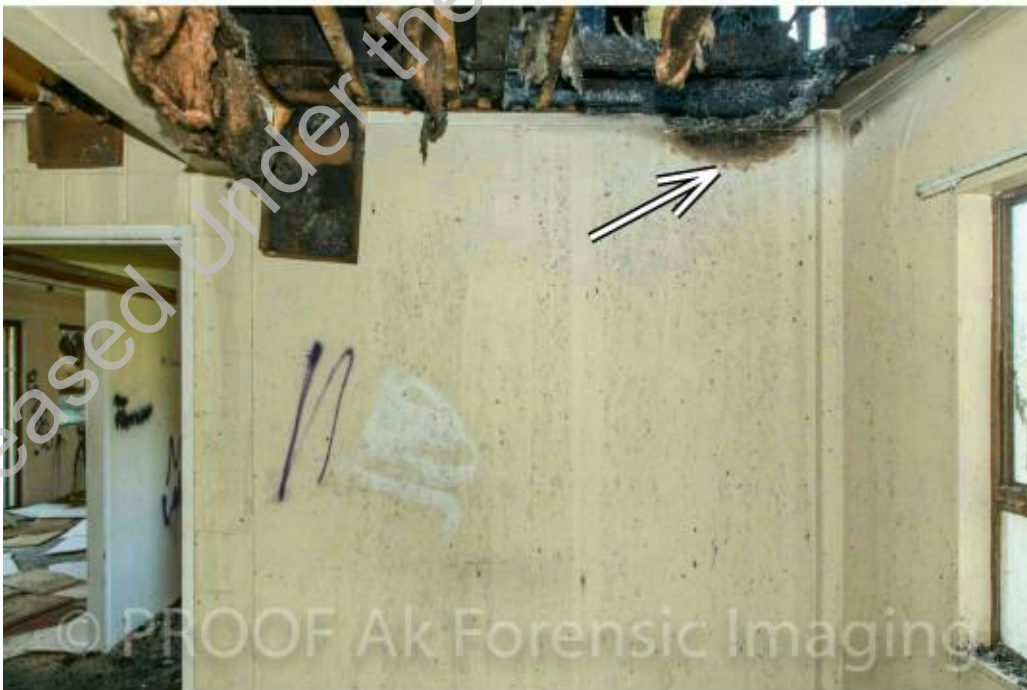
A ppb RAE 3000 photoionisation detector (PID) was used to test for the presence of volatile organic compounds (VOCs). The presence of VOCs may suggest a flammable liquid has been present at the time of a fire. The PID indicated elevated levels of VOCs around the corner of the bedroom in contrast to the surrounding areas, I recommended to the police that they remove samples in this area for forensic testing

There was an irregular burn pattern³ on the upper section of the wall corresponding with the corner of the above room below the eternal window. The surround burning on the timber joists was also more significant

in his area. This pattern was consistent with a possible flammable liquid seeping into this area and being ignited causing localised burning.

Photograph 25: Arrow indicating irregular burn patterns in bedroom 2. (Courtesy of Police)

Photograph 26: Arrow indicating irregular burn patterns. (Courtesy of Police)

Photograph 27: Arrow indicating irregular burn patterns. (Courtesy of Police)

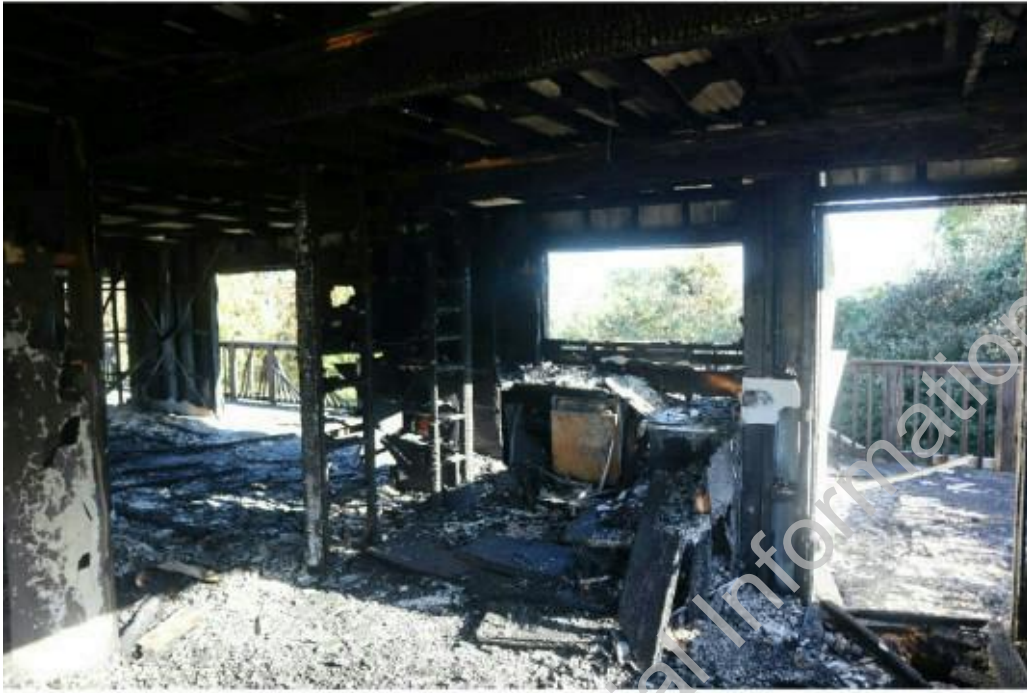
In comparison to the bedrooms and hallway, the kitchen area located on the east profile of the dwelling exhibited the least amount of fire damage. The fire intensity in this area was likely mitigated by factors such as the layout and materials present.

Photograph 28: Kitchen/Living area on upper level. Area of least damage.

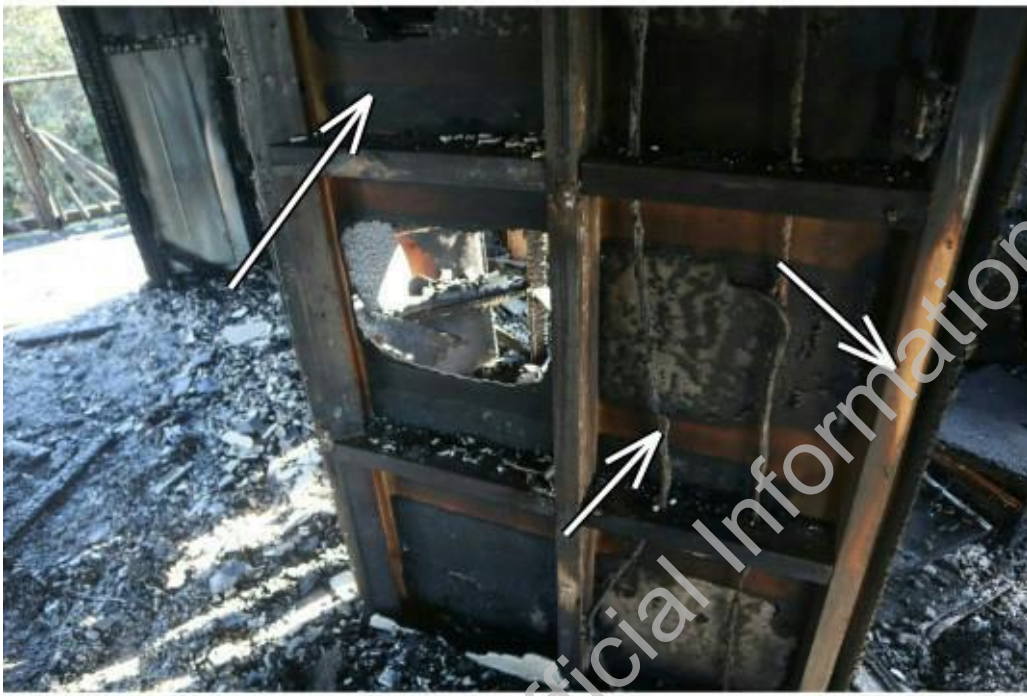
The electrical wiring in the kitchen area still retained its insulation, indicating that the fire did not reach temperatures high enough to cause significant damage to the wiring. However, in the bedroom area, the insulation has been burned away, leaving only the bare copper wire. This suggested that the fire in the bedroom area reached higher temperatures, leading to the destruction of the insulation on the electrical wiring.

Photograph 30: Unburnt timber wall framing in the kitchen and electrical cables that still have insulation present.

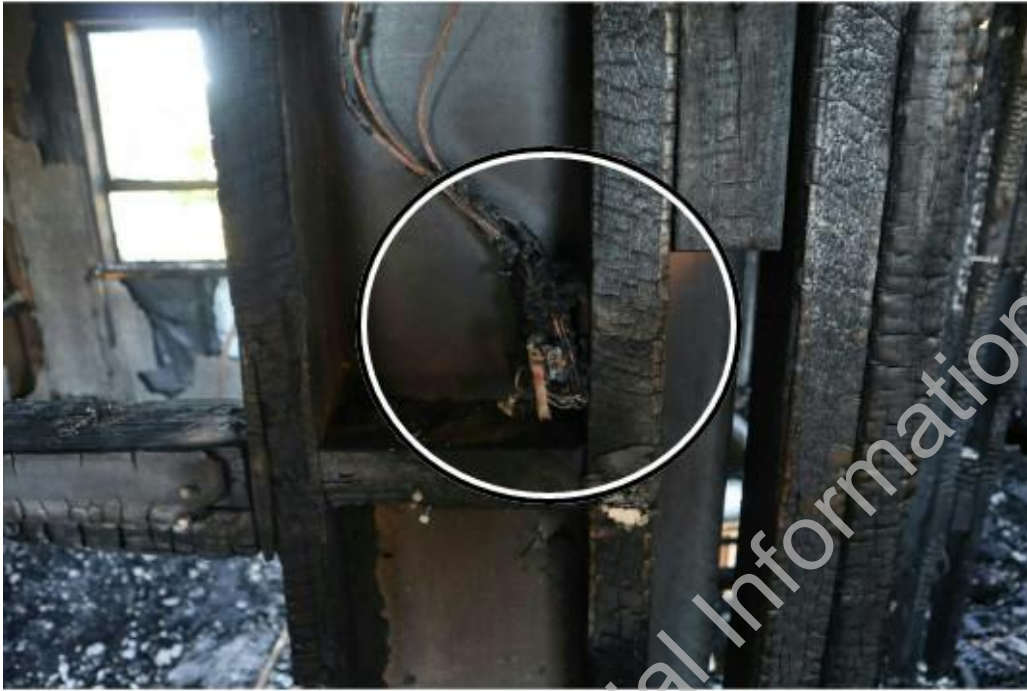
Photograph 31: Bedroom light switch in area of origin. Examined no signs of failure.

Upon further examination, it was determined that there was no damage to the wiring in the area of origin. As a result, an electrical cause was ruled out as the source of the fire. The fuse box and mains power meter were found to be undamaged, and Vector, the electricity provider, confirmed that the power had been disconnected for four years.

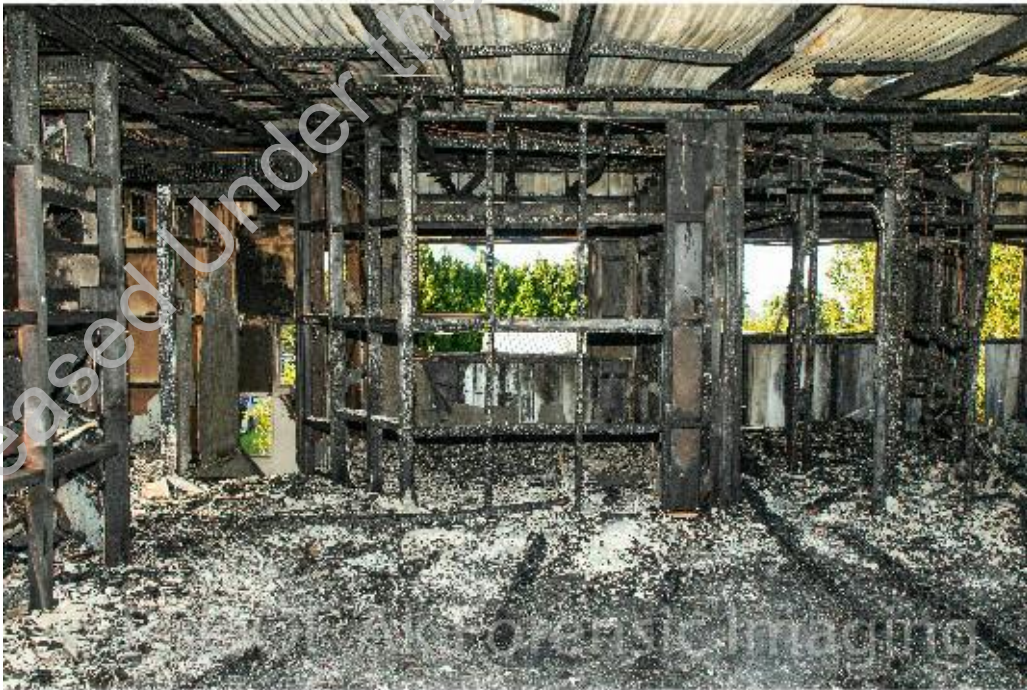
The lounge room area, on the other hand, showed significant fire damage. This can be attributed to the high winds and the ventilation pathway created by the two large ranch sliding windows. The fire dynamics in this area were influenced by the open windows, which allowed for increased air flow and the rapid spread of the fire.

Photograph 32: Lounge room area looking towards front of the dwelling. (Courtesy of Police)

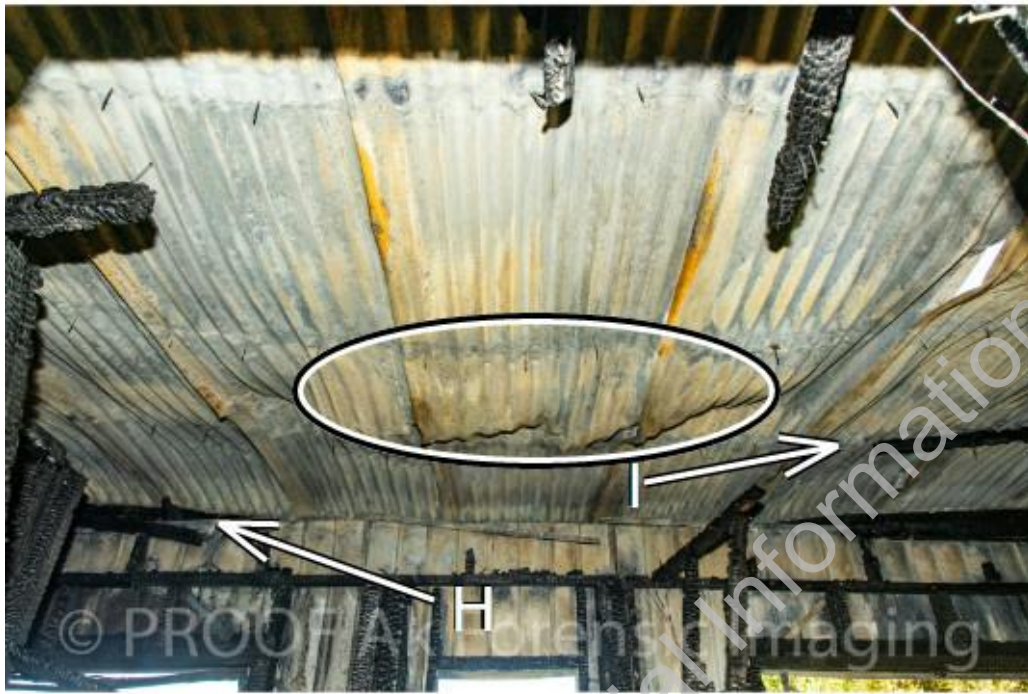
The area encompassing bedroom 1 and bedroom 2 experienced the most intense burning where the roof support joists were burnt away by the fire and the tin roof started to bow. A large hole had formed in the floor in this area as well, indicating the extensive damage caused by the fire. This damage corresponded to the photo taken upon the arrival of the Manly DCFO.

Photograph 34: Roof in the area of origin (Bedroom 2). Arrow I timber roof purlins consumed by fire. Circle indicating Roofing iron starting to bow. Arrow H Wall plates consumed by fire. (Courtesy of Police)

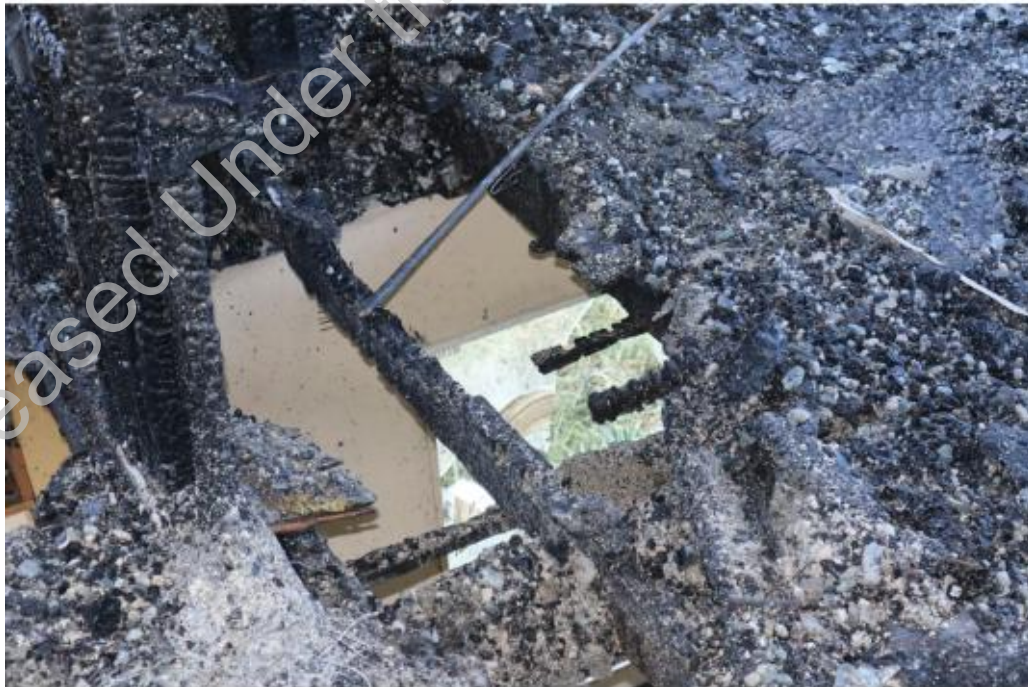
Photograph 35: Consumption of a large section of flooring in the corner of the bedroom at the point origin.

The point of origin of the fire was determined to be the corner of the wall beneath the window located in bedroom 2 in the area of the irregular burn pattern was exhibited. Upon investigation, it was found that the fire originated from this area and then spread to other parts of the room.

Based on the gathered evidence, it is believed that the cause of the fire was the deliberate ignition of an ignitable liquid. The liquid had been poured around the corner end of the bedroom and the surrounding floor area, leading to the rapid spread of the flames.
