South Waikato District Council  
Private Bag 7 (3444)  
Tokoroa 0738  
New Zealand

15 March 2019

**Initial Seismic Assessment Report – Former Countdown Building, Tokoroa**

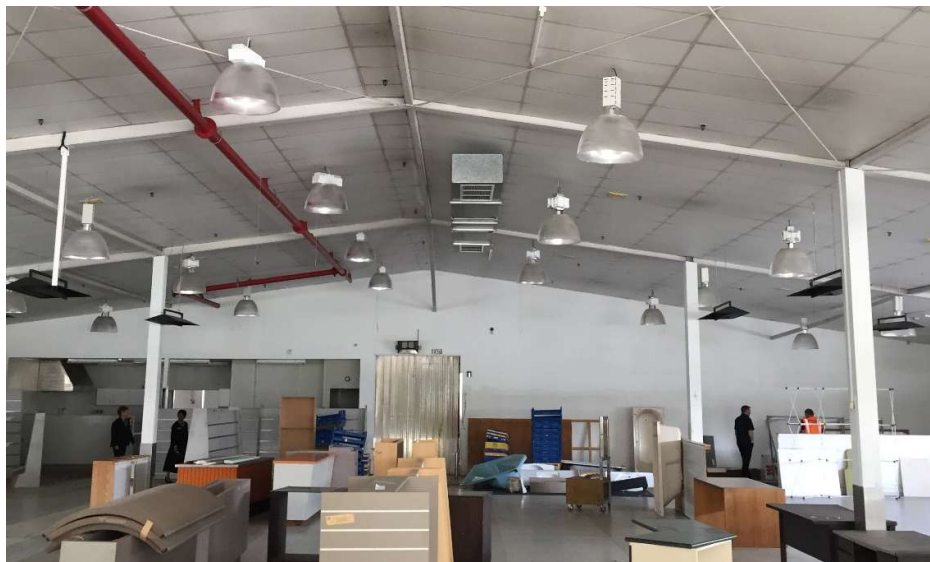
**Figure 3 Interior retail space of building**

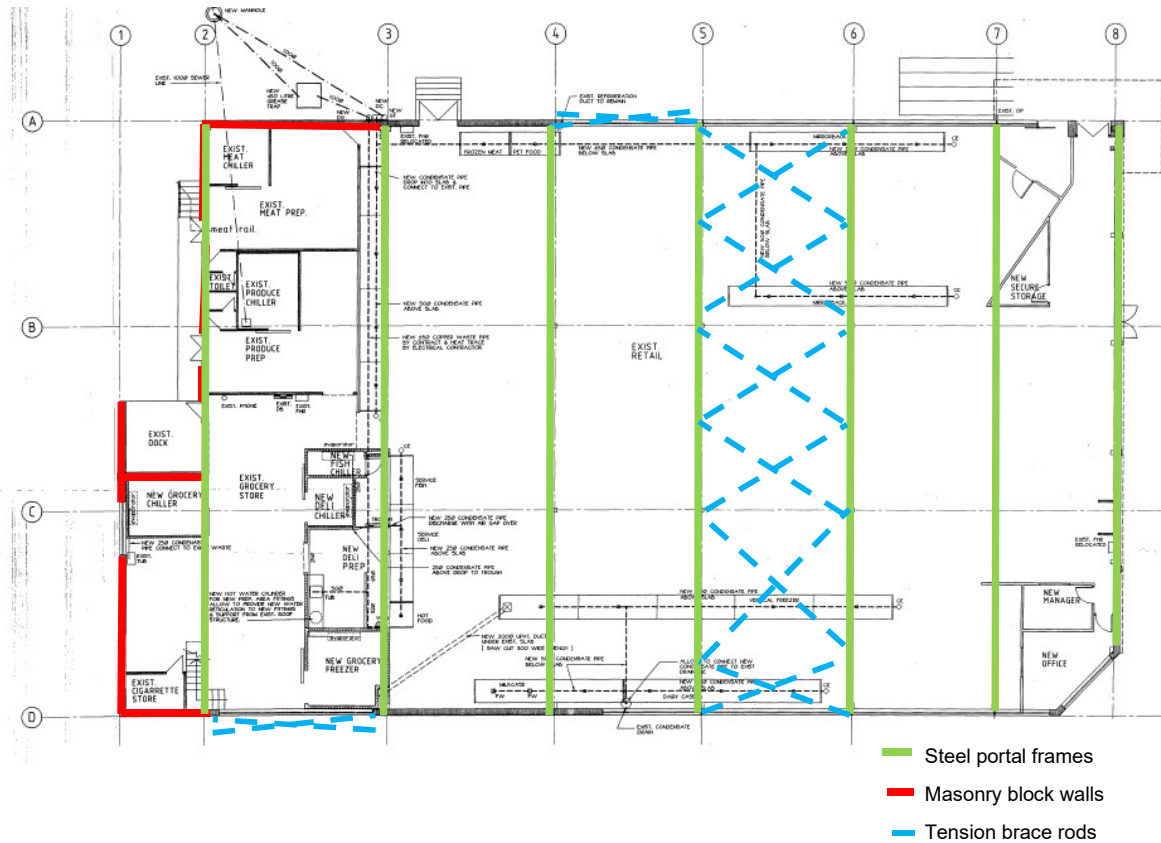
On Gridline A, it is evident that the egress double door, towards the western end of the building, has been relocated west by 2m, through a clear difference in the colour of the cladding. Cracking was observed in the external block walls and brick veneer, which is most likely moisture driven.
