Whanganui East Pool

Confidential Management Review – Part B

Condition Assessment

Prepared for: Whanganui District Council
July 2022

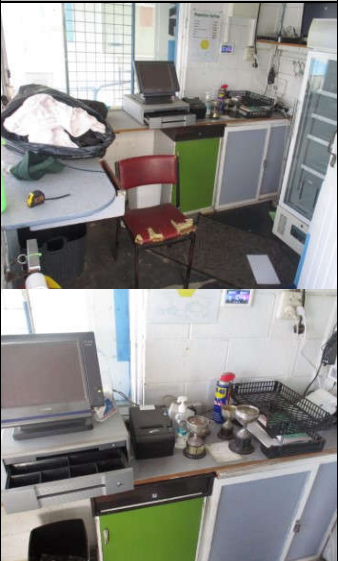
| Area | Watershed Comments | Ref. |
|--|--|---|
| | General view of the interior which is presented poorly and requires organising and tidying (Pay / Ticket Office) | 1 |

- The interior of the pay / ticket office was poorly presented and requires organising and tidying. Our initial impression of the area was that people just "locked up and walked away" at the end of the season with little regard for procedures being completed for the winter shutdown period.

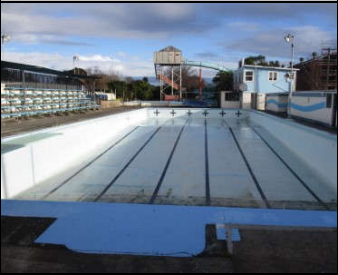
| Area | Watershed Comments | Ref. |
|---|---|---|
| | General view of the main pool | 1 |

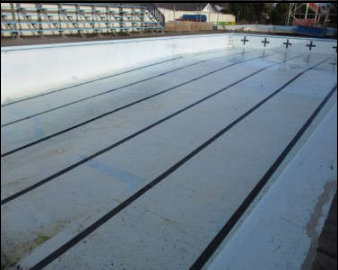
| Area | Watershed Comments | Ref. |
|---|---|---|
| | The refurbishment works from 2016 / 17 appear to have held up well; there were however minor cracks observed to the pool floor | 3 |

- The refurbishment works for the main pool undertaken in 2016 / 17 appear to have held up well. We did, however, observe that there were minor cracks to the pool floor that in our opinion, are likely to be superficial and not of concern.

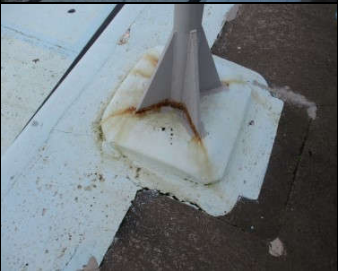
| Area | Watershed Comments | Ref. |
|---|---|---|
| | There is corrosion to the steel footing of the flood light that requires a rust treatment. This is indicative to all the steel footings of the flood lights | 4 |

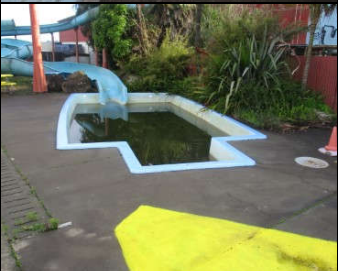
| Area | Watershed Comments | Ref. |
|---|---|---|
| | General view of the hydro slide exit chute pool | 5 |

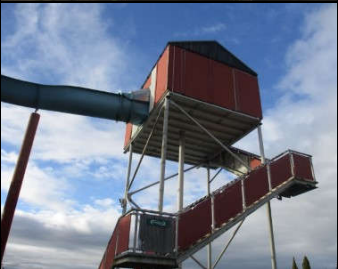
| Area | Watershed Comments | Ref. |
|---|---|---|
| | General view of the slide tower | 7 |

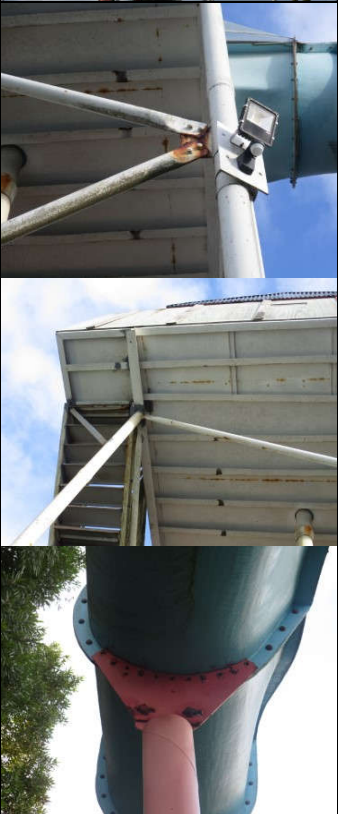
| Area | Watershed Comments | Ref. |
|---|---|---|
| | There is minor corrosion to the slide tower along with the slide brackets and fixings that require a rust treatment | 8 |

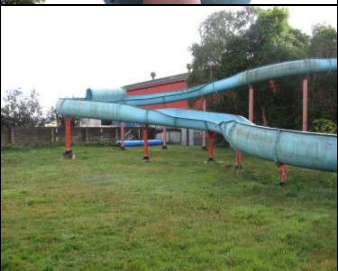
| Area | Watershed Comments | Ref. |
|---|---|---|
| | General view of the slide which has a build-up of slime / algae and is in need of a clean pre-season | 9 |

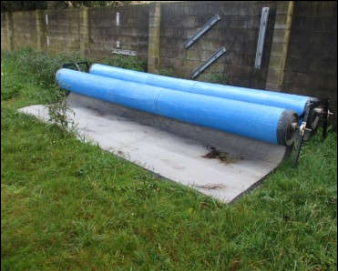
| Area | Watershed Comments | Ref. |
|---|--|---|
| | <p>We noted that these two pool covers were located nowhere near the pool, and we would suggest that they should be relocated closer to the pool where they can be used. They should also have a cover over them for protection during the winter and not in use</p> | 10 |

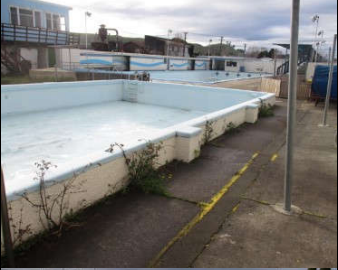
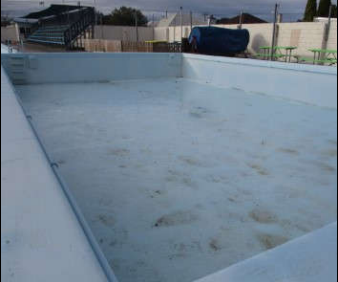
| Area | Watershed Comments | Ref. |
|---|--|---|
| | <p>General views of the learn-to-swim pool</p> | 11 |

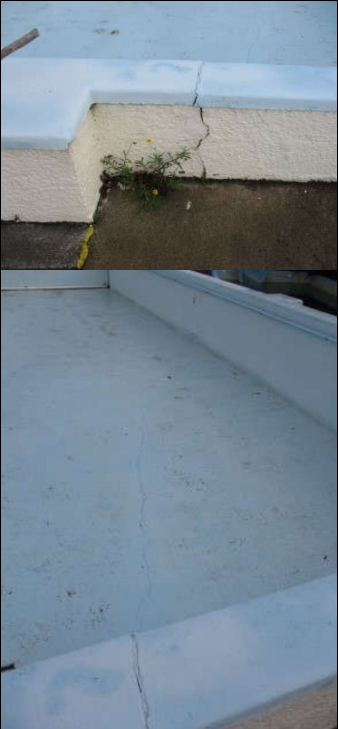
| Area | Watershed Comments | Ref. |
|---|---|---|
| | There are cracks that run over the head wall, down across the floor, and up the diagonally opposing wall of the learn-to-swim pool which require repair | 12 |

- The learn-to-swim pool has cracks that run over the head wall, down across the floor, and up the diagonally opposing wall. Based on our experience we would suggest that this could be related to minor slumping of the pool and while not a problem, should be monitored moving forward. We recommend that the cracks are repaired to give a better idea of any potential movement that is evident over the coming years.

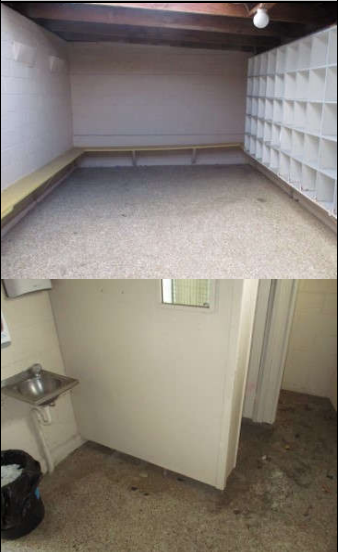
| Area | Watershed Comments | Ref. |
|---|--|---|
| | General views of the interior (Women's Changing Room / Toilets) | 1 |

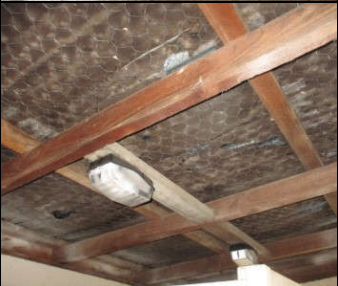
| Area | Watershed Comments | Ref. |
|---|--|---|
| | View of the building paper that is ripped and requires replacement (Women's Changing Room / Toilets) | 3 |

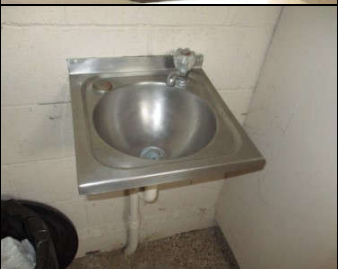
| Area | Watershed Comments | Ref. |
|---|--|---|
| | There is no hot water available at the hand basin (Women's Changing Room / Toilets) | 4 |

- While the change facilities are basic and generally in an acceptable condition, there are minor maintenance items required in areas as noted. We also noted that there is no hot water for hand washing. We recommend that hot water is provided to the hand basins for hygiene purposes.

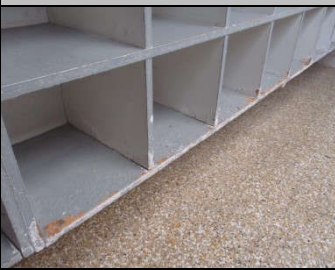
| Area | Watershed Comments | Ref. |
|---|---|---|
| | Close up view of the storage cubicles which are in poor condition and require replacement (Women's Changing Room / Toilets) | 5 |

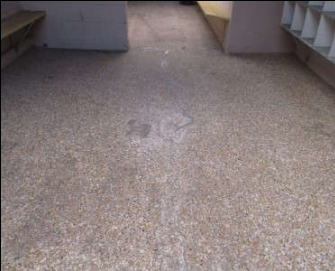
| Area | Watershed Comments | Ref. |
|---|---|---|
| | The epoxy resin floor surface is in reasonable condition (Women's Changing Room / Toilets) | 6 |

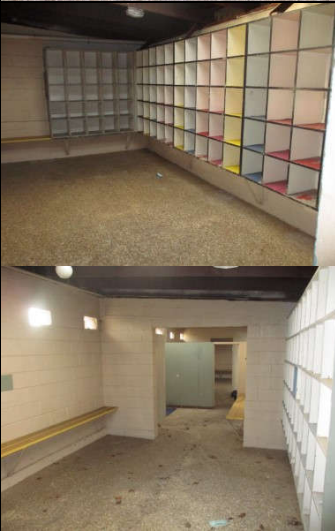
| Area | Watershed Comments | Ref. |
|---|---|---|
| | General views of the interior (Men's Changing Room / Toilets) | 7 |

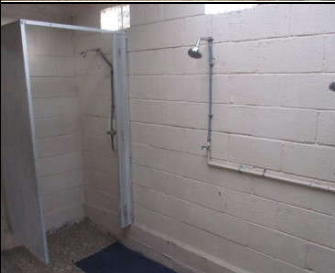
| Area | Watershed Comments | Ref. |
|---|---|---|
| | General view of the showers (Men's Changing Room / Toilets) | 8 |

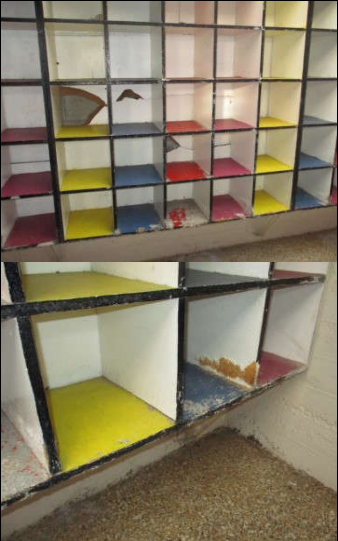
| Area | Watershed Comments | Ref. |
|---|---|---|
| | <p>Views of the storage cubicles which are in poor condition and require replacement. This is indicative to all the storage cubicles in this facility (Men's Changing Room / Toilets)</p> | 9 |

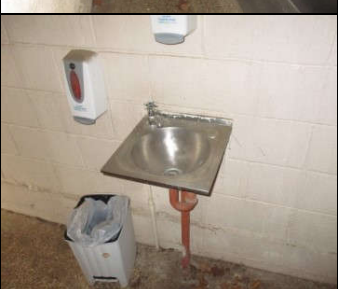
| Area | Watershed Comments | Ref. |
|---|---|---|
| | <p>There is no hot water available at the hand basin (Men's Changing Room / Toilets)</p> | 13 |

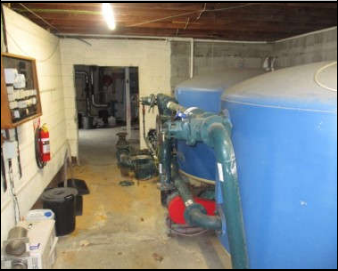
| Area | Watershed Comments | Ref. |
|---|---|---|
| | General view of the interior (Plant Room) | 1 |

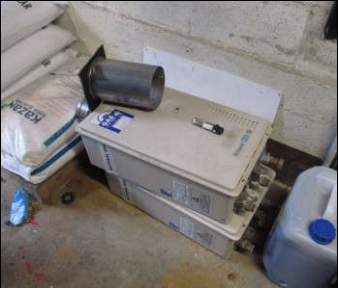
| Area | Watershed Comments | Ref. |
|---|---|---|
| | View of two older gas water heaters that were not in use (Plant Room) | 2 |

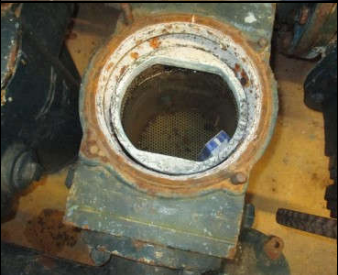
| Area | Watershed Comments | Ref. |
|---|---|---|
| | There was water still in the system, a clear indication of no winterisation of plant. This should be dry and free of water when not in operation (Plant Room) | 3 |

- There was still water evident in the pipework, pumps, and lint strainers even though the facility was closed for the winter. Our initial impression of the area was that people just “locked up and walked away” with little regard for procedures or winterisation being completed for the shutdown period. This will add time and potentially have cost implications pre-season due to a lack of clear procedures. This in turn will lead to accelerated deterioration of the plant and equipment and therefore a shorter lifespan.

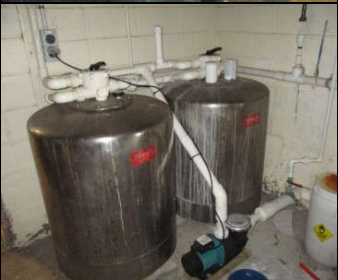
| Area | Watershed Comments | Ref. |
|---|---|---|
| | View of the filters for the hydro slides (Plant Room) | 4 |

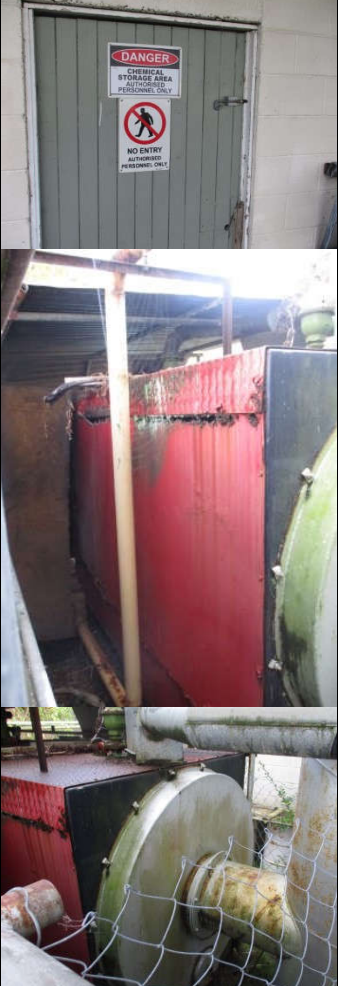
| Area | Watershed Comments | Ref. |
|--|--|---|
| | Views of the boiler system which appears to be at the end of its life | 8 |

- The boiler appeared to be end of life and while we were unable to access the area where the boiler is located, what we observed of the unit over the fence supported that the boiler needs to be replaced if it is used. If the boiler is not in use, nor intended to be replaced, it would make sense to dispose of the boiler and cap all of the services.

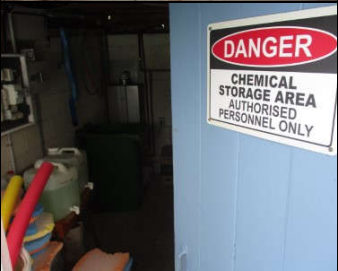
| Area | Watershed Comments | Ref. |
|---|--|---|
| | View of the interior (Chemical Storage Room) | 11 |

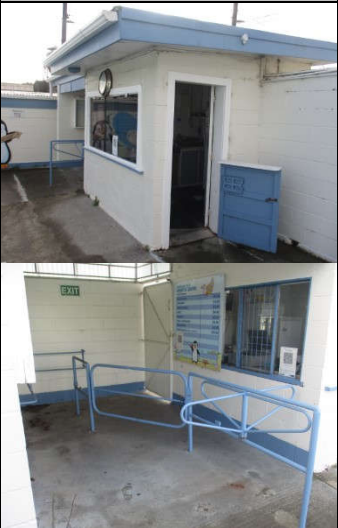
| Area | Watershed Comments | Ref. |
|---|---|---|
| | General views of the building exterior (Pay Office) | 1 |

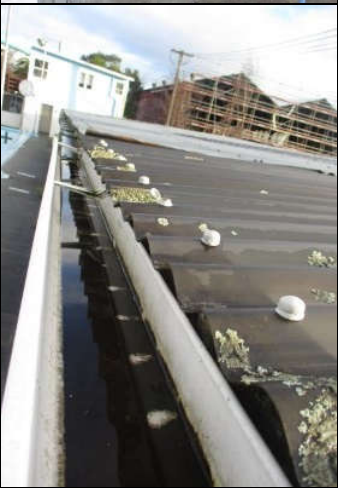
| Area | Watershed Comments | Ref. |
|---|---|---|
| | The roof has lichen growth which will require chemical treatment to remove followed by a wash. The gutters need clearing to remove a build-up of dirt and grime | 2 |

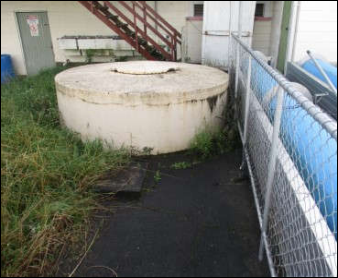
| Area | Watershed Comments | Ref. |
|---|---|---|
| | View of the balance tank | 4 |

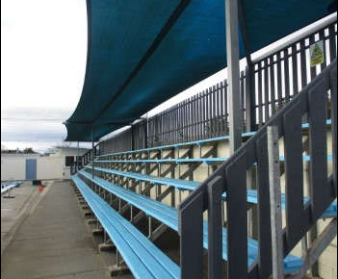
| Area | Watershed Comments | Ref. |
|---|---|---|
| | The bleacher seating is in good condition | 5 |

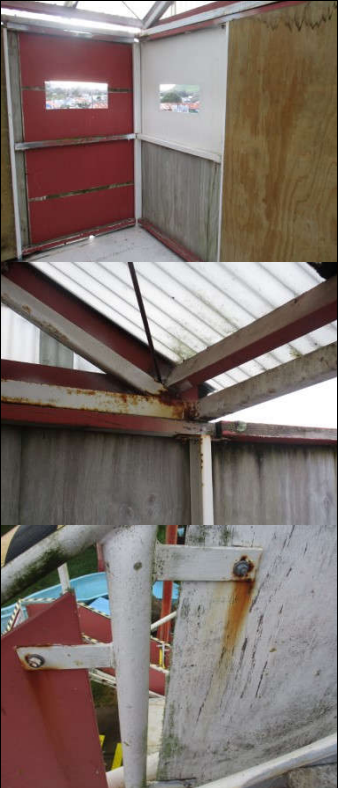
| Area | Watershed Comments | Ref. |
|---|--|---|
| | <p>There is rust and corrosion in a number of areas across the tower, stairs, balustrades, and landing that all require a rust treatment</p> | <p>9</p> |

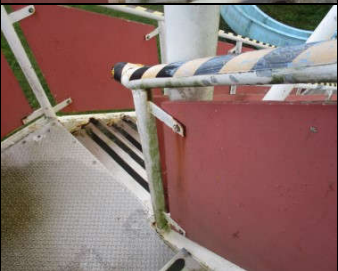
| Area | Watershed Comments | Ref. |
|---|--|---|
| | <p>The stairs were very slippery with slime and required cleaning</p> | <p>10</p> |

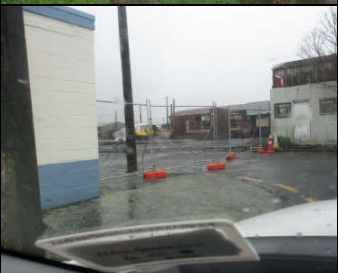
| Area | Watershed Comments | Ref. |
|---|--|---|
| | <p>The right-of-way (R.O.W) was fenced off due to works at the neighbouring property and we were unable to access and assess the exterior of the facility down the R.O.W</p> | <p>12</p> |

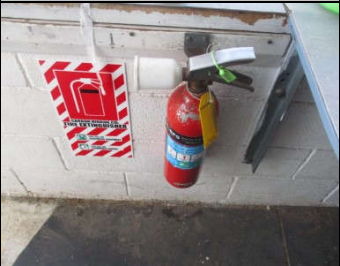
| Area | Watershed Comments | Ref. |
|---|---|---|
| | The fire extinguisher's test date is current (Pay Office) | 1 |

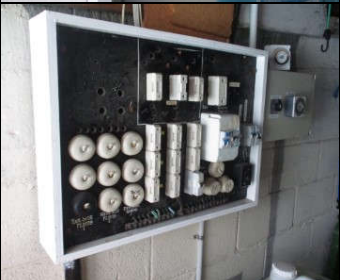
| Area | Watershed Comments | Ref. |
|---|---|---|
| | Based on the age and the visual characteristics of this distribution board, we suspected this to be an asbestos containing material (Chemical Room) | 4 |

- Does the facility have an asbestos management plan? Given the likelihood of asbestos or asbestos containing material due to the age of the facility, there should be asbestos management plan and any identified asbestos noted and included in the hazard register.
- Chemical storage and labelling are generally poorly managed. This includes open containers, poor separation, unidentified items and a lack of safety data sheets which would be required in the event of an emergency. Again, it appears that staff up and left without following any clear procedures post season. We would expect at the least for all open containers and/or bags of chemicals to have been sealed, and in some cases disposed of compliantly as they will have a shelf life.

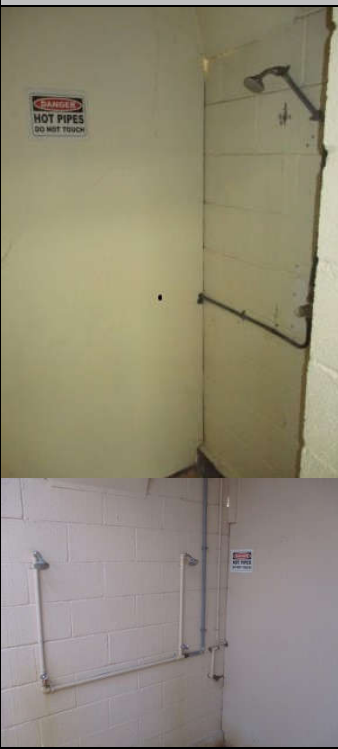
| Area | Watershed Comments | Ref. |
|---|--|---|
| | The exposed hot water pipes are a hazard and require covering (Womens Changing Room) | 5 |

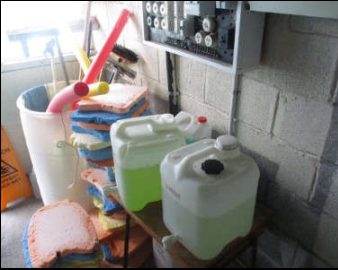
| Area | Watershed Comments | Ref. |
|---|--|---|
| | There are no Safety Data Sheets displayed by the chemicals. The chemicals were not stored correctly as the lids were off | 6 |

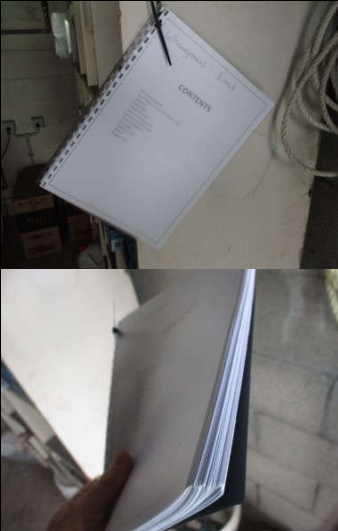
| Area | Watershed Comments | Ref. |
|---|--|---|
| | There is no quick reference guide with the booklet. This is not compliant to HSN regulations | 7 |

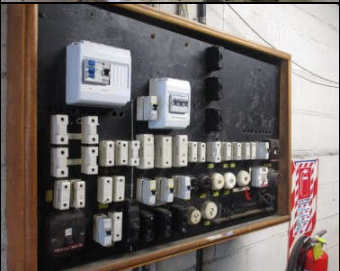
| Area | Watershed Comments | Ref. |
|---|---|---|
| | <p>Based on the age and the visual characteristics of this distribution board, we suspected this to be an asbestos containing material (Plant Room)</p> | <p>10</p> |

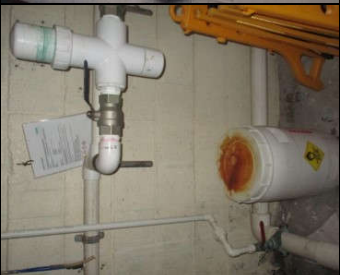
| Area | Watershed Comments | Ref. |
|---|---|---|
| | <p>The corresponding Safety Data Sheets are available with the calcium hypochlorite (Plant Room)</p> | <p>13</p> |

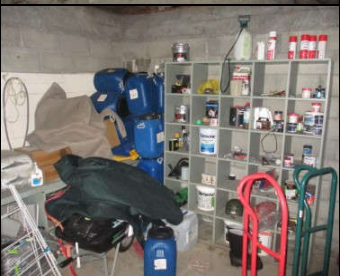
| Area | Watershed Comments | Ref. |
|---|---|---|
| | <p>There are "every day" chemicals stored throughout which should be in another room (Plant Room)</p> | 15 |

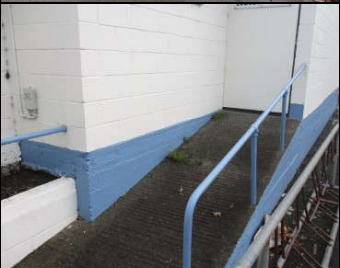
| Area | Watershed Comments | Ref. |
|---|---|---|
| | <p>The entrance ramp appears too steep; making it difficult for wheelchair users, therefore it is most likely non-compliant</p> | 17 |
