Shirley Road / Marshland Road Raised Safety Platform

Scheme design safety audit

Report prepared for
Christchurch City Council

January 2023

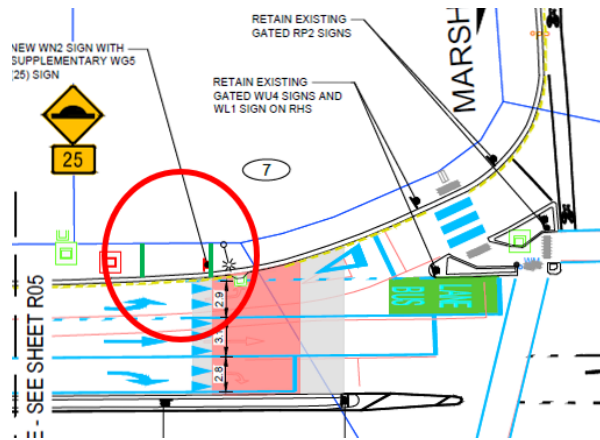
Figure 2-1: indicative driveway location

The driveway into 7 Marshland Road (Z – Shirley) is located within the raised safety platform approach ramp. The ramp proximity is not expected to result in loss of control crashes due to the levels required to raise to the platform height

Probability of crash occurring	N/A
Expected crash severity	N/A
Primary treatment recommendations:	
2.1.3.1	Consider relocating the platform away from the driveway
Supporting treatment recommendations:	
2.1.3.2	N/a

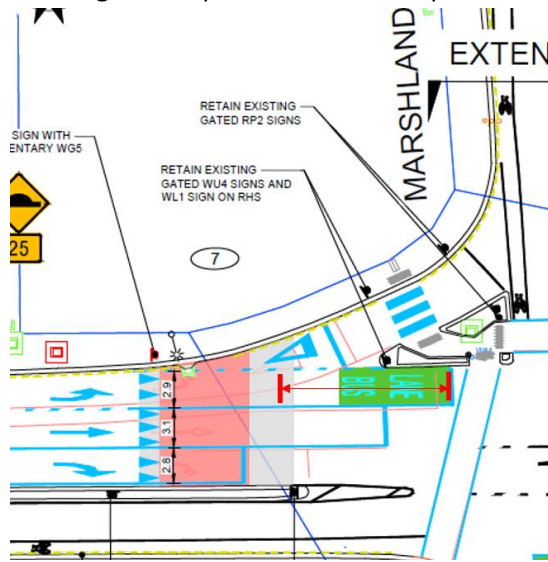
Figure 2-2: Extents of bus blocking slip lane

The left turning slip lane from Shirley Road into Marshland Road will be blocked everytime a bus stops in the allocated space at the traffic lights. If the bus stops with the front wheels at the limit line, the front of the bus will encroach the pedestrian crosswalk.

The crash type/s expected rear end crashes between stopped buses and motor vehicles trying to access the turning lane.

- Regular volume of buses (11 per hour)
- High volume of turning vehicles using the slip lane (123 am, 189 noon, and 305 pm peak hour)
- There is roughly a two metre gap between kerb and rear of bus that some drivers may not mistake as being wide enough.
- The downhill platform gradient prior to the bus stop.

Probability of crash occurring	Unlikely
Expected crash severity	Minor injury
Primary treatment recommendations:	
2.2.1.1	Remove the slip lane

2.2.1.2 Re align crosswalk to push the limit line and bus stop back, which would completely block the sliplane.

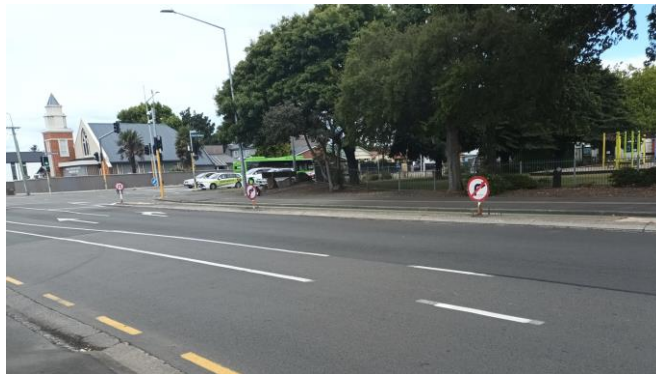
Figure 2-3: The current signs on the median island

The safety concern is drivers may drive over the median island to preform a right turn out of the Z Service Station because the new RSP puts them at the same height as the raised median that was put there to restrict this movement.

Probability of crash occurring	N/A
Expected crash severity	N/A
Primary treatment recommendations:	
2.2.2.1	As the RSP is not a crossing, consider providing a physical deterrent to stop people driving across the RSP and median island.
Supporting treatment recommendations:	
2.2.2.2	Ensure the No Right Turn sign is correctly oriented and maintained to remind drivers not to right turn.

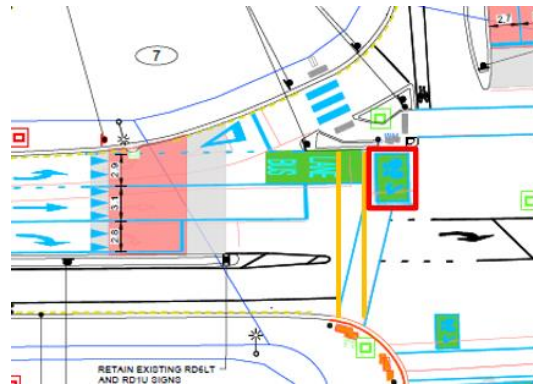
Figure 2-4: Straight crosswalk option

Pedestrians are required to walk on an angle across the western pedestrian crosswalk. This is believed to be a legacy issue from the existing layout.

Due to the legacy layout no hook turn box is possible, users walk further across the road, and some pedestrians go through or around the island and approaching drivers aren't sure if the pedestrians are continuing to the zebra crossing or crossing to the palms.

Probability of crash occurring	N/A
Expected crash severity	N/A
Primary treatment recommendations:	
2.3.1.1	Realign the crosswalk to be straight as shown in Figure 2-4.
Supporting treatment recommendations:	
2.3.1.2	N/a

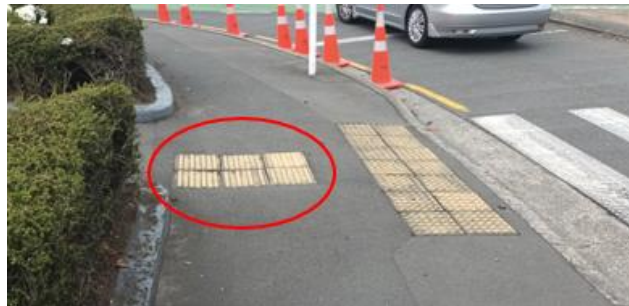
Figure 2-5: Incorrectly installed directional paving

The safety issue is that the existing directional ground tactile paving are guiding usings to continue along the footpath not directing them to the crossing point or traffic signal pole. The relevant standards are [Waka Kotahi RTS 14](#)

Probability of crash occurring	N/A
Expected crash severity	N/A
Primary treatment recommendations:	
2.3.4.1	Reorientate directional paving shown in Figure 2-5
Supporting treatment recommendations:	
2.3.4.2	Check existing paving and confirm compliance as per RTS 14

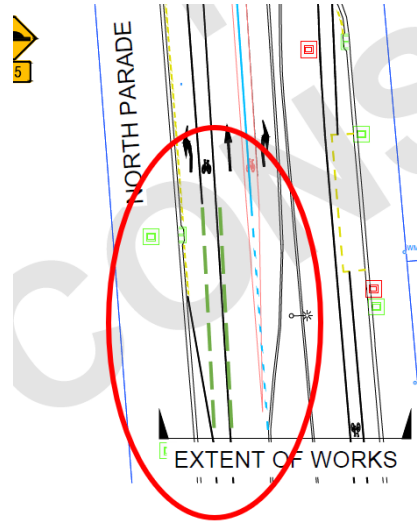
Figure 2-6: Location of missing continuity lines

The safety issue is that no continuity lines are shown in the scheme design through the conflict area of vehicles wanting to turn left from the through lane and across the cycle lane, out of North Parade. This can result in drivers crossing in locations that are not anticipated or expected by cyclists.

The crash type/s expected motor vehicles cutting off and striking cyclists

- Low volume of left turning motor vehicles (53 am, 24 noon, 34 pm peak hour)
- Low volume of through cyclists (1 am, 16 noon, 2 pm peak hour)

Probability of crash occurring	Unlikely
Expected crash severity	Minor injury
Primary treatment recommendations:	
2.4.2.1	Provide continuity lines across cycle lanes to indicate where vehicles should travel across the cycle lane.

2.4.2.2	Provide green road marking to highlight the conflict area
---------	---

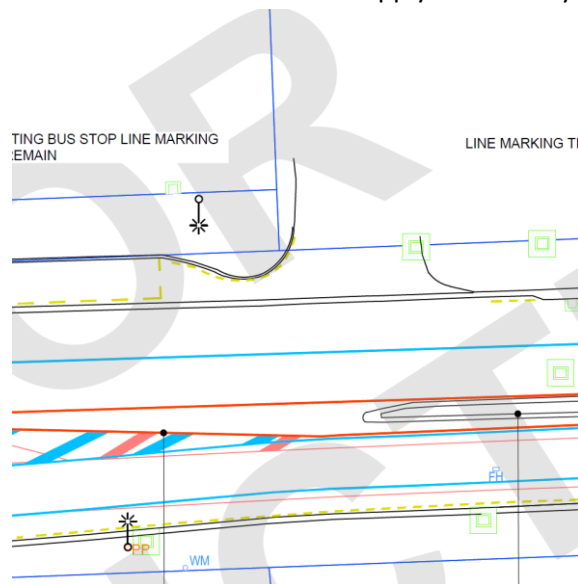
Figure 2-7: The Palms driveway on New Brighton Road

The safety issue is the New Brighton Road entry into The Palms car park will be left-in left-out only. This will cause some drivers to find new routes from what they have previously

done. Drivers can become frustrated with changes that they don't know about or understand the rationale behind the change.

The crash type/s expected is drivers making their previous turns and colliding with through vehicles on New Brighton Road or impacting the mountable median island.

2.4.3.1	Provide no turning signs and arrow road markings from existing palms entry / exit
---------	---

2.4.3.2	Target the consultation information to inform drivers that may have previously used this entry exit to turn right in or out of the Palms driveway on New Brighton Road
---------	--
