Official Information Act request: Taieri Mouth boating incidents

Summary of Maritime New Zealand investigation into the Taieri river mouth recreational fatality on 3 April 2021 (INV-748)

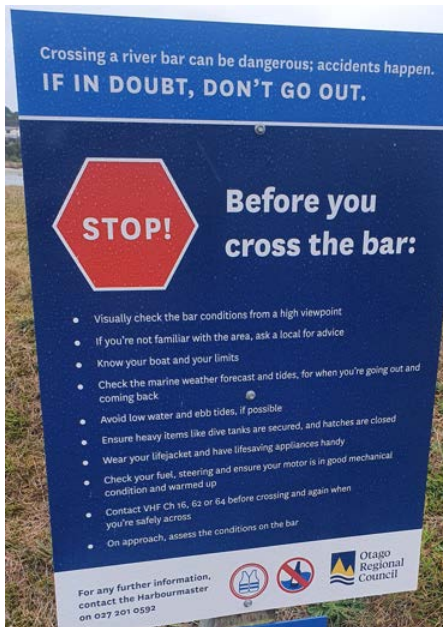
The investigation indicated that, while the owner/skipper took some preparations prior to crossing the bar (checked vessel and weather, ensured life jackets were worn and tried to follow previously obtained local knowledge) other preparations were lacking, namely he did not research the effects of tides on the bar and did not read the advisory signs (which were highly visible).

Sign erected at each boat ramp
