Re: Gordon Wilson Flats - Structural Condition of the Façade

SITE INSPECTION REPORT

JOB:	320 The Terrace - Gordon Wilson Flats Structural Report	JOB NO:	210090
TO:	HCNZ	ATTENTION:	Mr R Hopkins
INSPECTOR:	Ray Patton		
INSPECTION DATE:	29/04/2010

Detailed Seismic Assessment
Gordon Wilson Building
320 The Terrace
Wellington

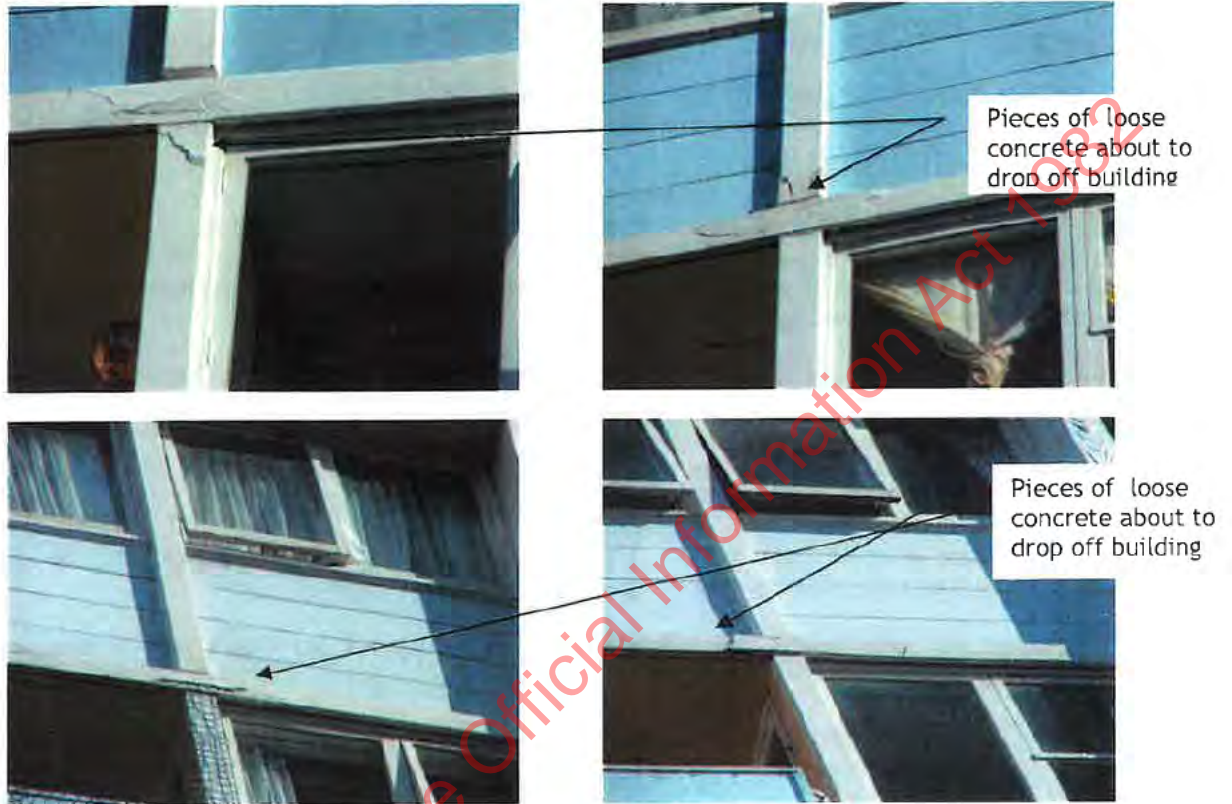
The building is generally suffering from significant deferred maintenance. The most notable example of this are areas where concrete has or is about to spall as a result of corrosion of the reinforcement .

Front Façade - Concrete About to Spall

This process which in time affects most concrete buildings is a generally a result of chlorides penetrating the concrete and forming acid when combined with water. Eventually the acid will penetrate deep enough to react with the steel reinforcement. The resultant ferrous oxide (rust) is approximately five times the volume of the original steel and as it expands it causes the cover concrete to spall.

Immediate steps should be taken to ensure that people are kept from congregating in the front or rear of the building for a minimum distance of five metres until the facades have been inspected and any loose concrete removed. This can be achieved by either scaffolding the building (which could be done in conjunction with re-painting which is referred to further on) or by suspending a swinging stage and working progressively over each façade.

More involved permanent repair work would then be required to ensure the ongoing integrity of the exposed concrete on each façade.

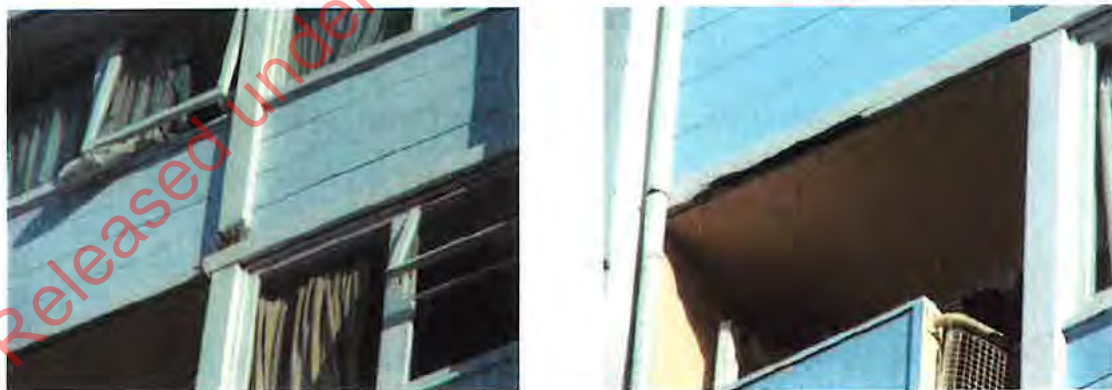
Front Façade - Concrete has Spalled

There is the potential for pieces of concrete to fall from the building at any time. This poses a threat to both tenants and visitors to the building. Pieces are large enough and when falling from a significant height could cause severe injury or possible death to someone who is hit on the head. We note that there is an access path running along the front of the building and although the chances of being hit are low persons using this path are potentially at risk from falling debris. We note however that the areas of the building we concrete pieces have previously been dislodged are not generally located over the building entrances

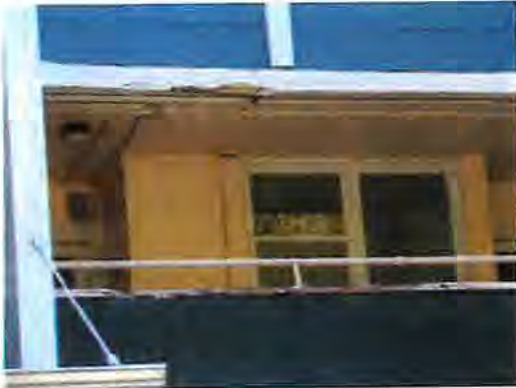
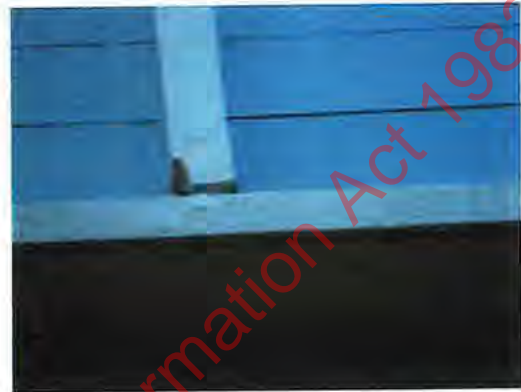
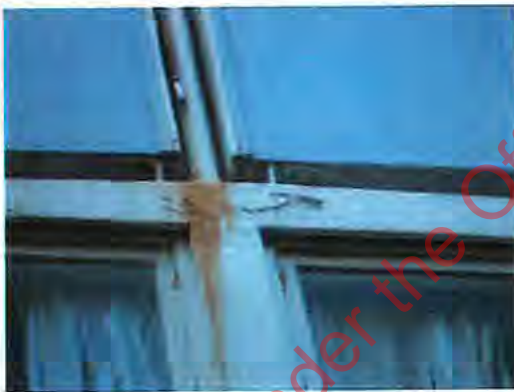
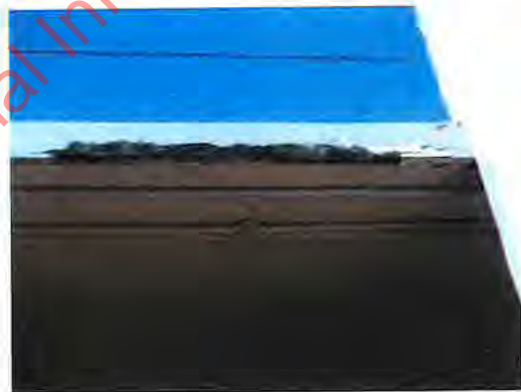
Rear Façade - Examples of Spalling Concrete

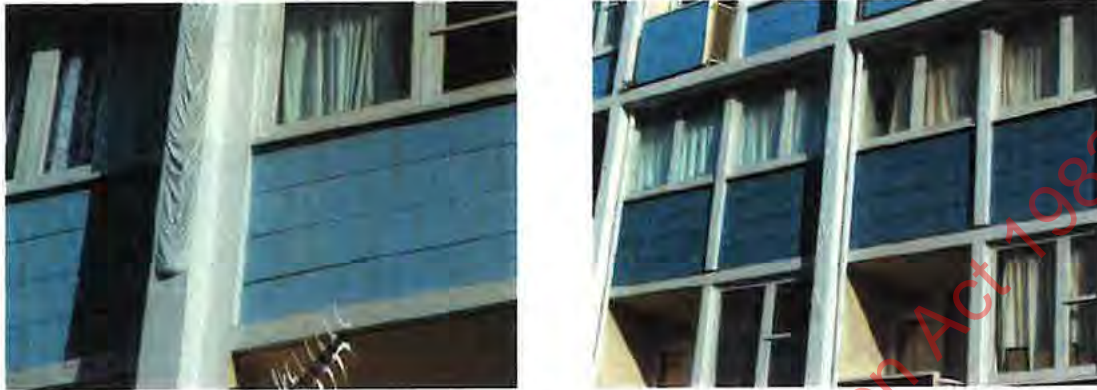
As mentioned above one way of slowing the onset of reinforcement corrosion is to ensure the paint system is well maintained. Inspection of each building face shows the paint system has failed. It is interesting to note that in many places the paint layer has delaminated from the building but is still largely intact.

Failure of Paint System (Delaminating).

Although unable to inspect the paint work close up, from a distance it appears to be retaining water in some of the large bubbles. The most likely cause of this failure is inadequate preparation of the sub-base resulting in lack of cohesion between the concrete and the paint film. Before new paint is applied the problem of the deteriorating concrete needs to be addressed.

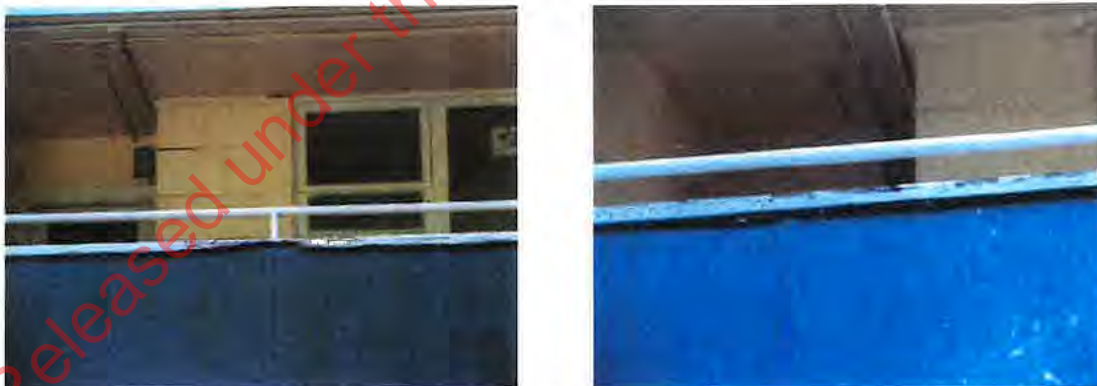
Rotting Top Timber Railing to Balustrade

The top timber railing to the balustrades on the rear walkways have rotted away in many places. This railing trims the top of the balustrade and also supports a pipe handrail which is fixed to the top of it at regular centres. This pipe hand rail also provides the means by which the hose reels on each level are supplied with water. Should the handrail fixings become free as a result of timber railing rotting away it is possible that the pipes could be fractured resulting in loss of water supply.

The rotting top rail also calls into question of whether or not the timber framing to the balustrades has started to rot where it is fixed at its base to the concrete slab. As replacement top timber rail is well overdue due it would be prudent to remove the balustrade covering panels to check the frame base fixings at the same time.

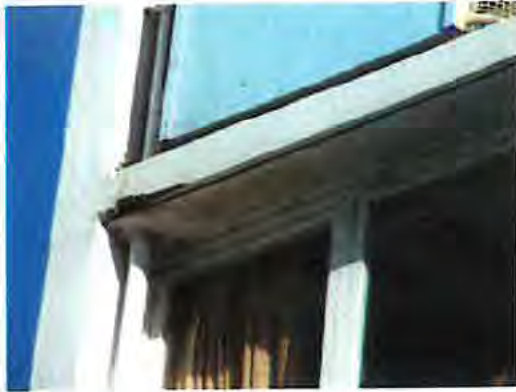
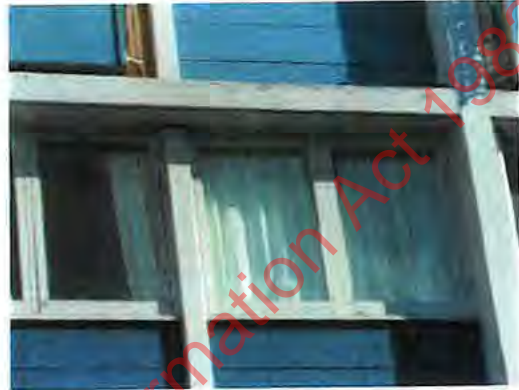
During our visual inspection of the front façade we observed that many of the opening windows are top hung sashes fixed with two hinges. Many of these hinges showed signs of rusting albeit relatively minor in many cases.

Minor rusting to Window Hinges.

All windows should be inspected from inside the flats to confirm the level of corrosion to the hinges and their fixing screws. Any showing evidence of corrosion should be replaced. If left to badly corrode the action of opening the window could cause it to come of its hinges dropping to the ground below.

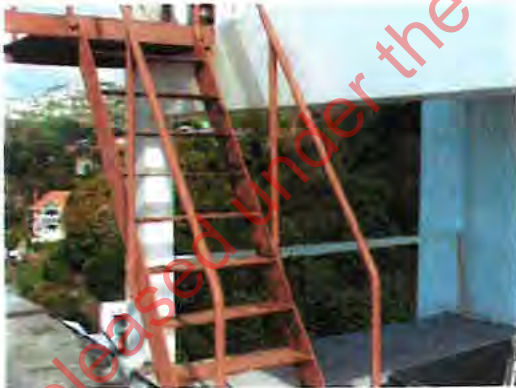
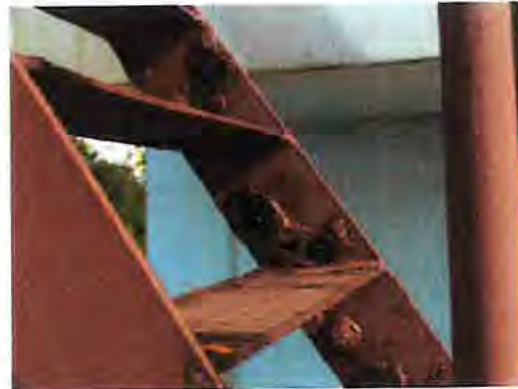
Access Stair to Lift Machine Room Badly Corroded

The access stair is badly corroded with parts of the stringer completely rusted through. This should be replaced at the earliest opportunity and workman using advised of the risk especially if more than one person is on the stair or a heavy load is being carried up it.

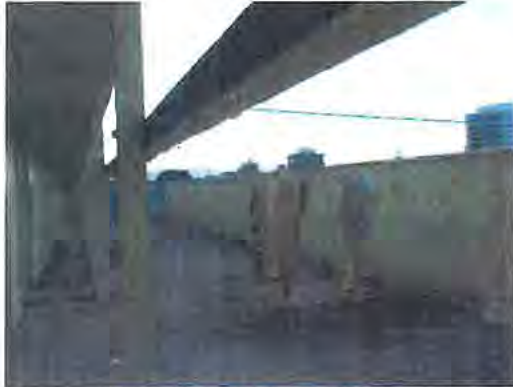
The lower roof appears to be in good repair having a reinforced membrane to sustain the foot traffic and appears to have been well maintained over the life of the building. The upper roof however appears to be the original and has reached the end of its useful life.

Lower Roof is Satisfactory

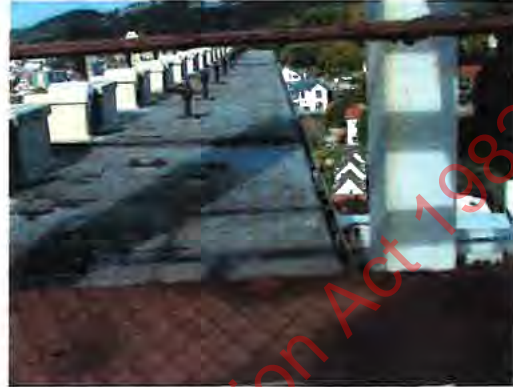
Upper Roof Needs Replacement

Note The beer bottles in the gutter in the right hand picture which implies access to this dangerous area of the roof is not secure.

When the stair towers at each end of the building are being refurbished it is recommended that this roof be replaced.

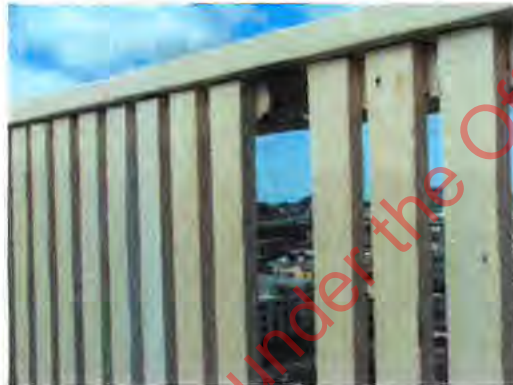
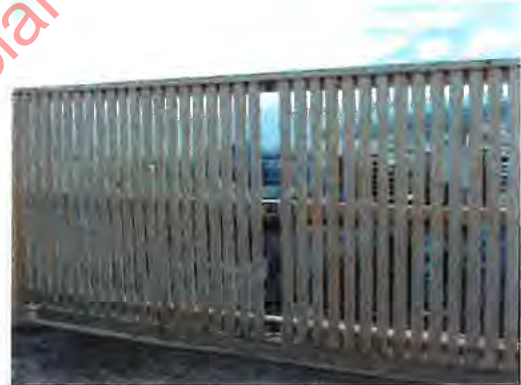
Palings missing from Security Fence

This fence provides the only protection from falling off the laundry drying roof area. While generally in good condition there are some palings missing. It is unclear what has caused their removal. However it is possible they have rotted out. The whole fence should be carefully inspected and all unsatisfactory palings replaced.

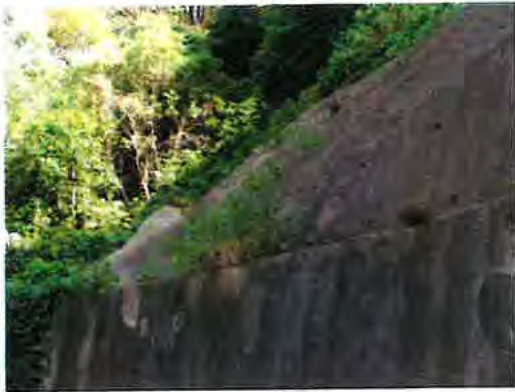
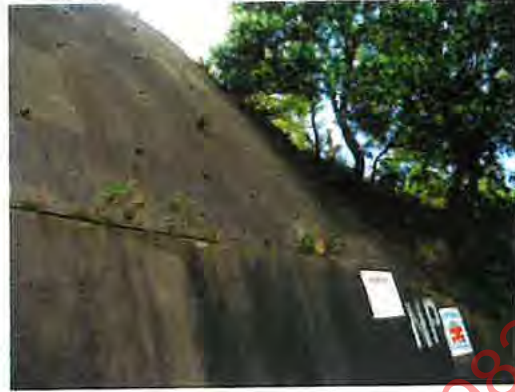
Many weep holes placed over the plane of the wall to drain any water that may seep out of the bank. It is important that these are maintained by periodic cleaning out including the removal of any live plants. Also it was observed that there are some cracks in the concrete out of which various plants including small pohutukawa trees. These should be removed and areas treated to inhibit future re-growth.

Sprayed Concrete Bank
Greenery to be removed and Weep holes Cleaned

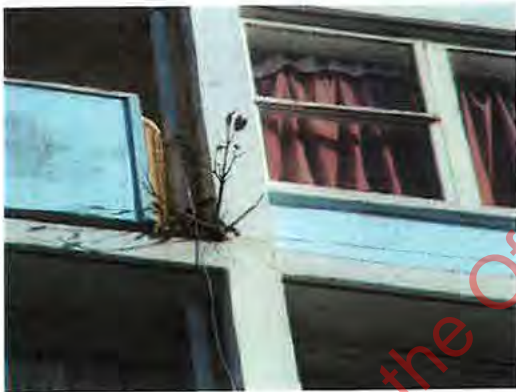
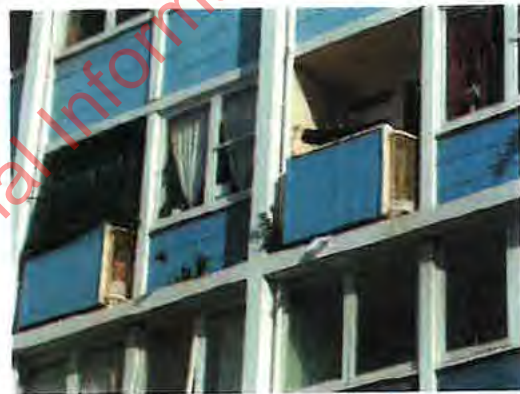
During our inspections we noted that small young trees were growing in various crevices on the building. These should be removed as soon as possible as their expanding root systems will eventually cause damage to the concrete causing splitting and spalling.

Examples of Greenery growing in Building Crevices
