Damage Assessment (Gisborne Heavy Rainfall) - Construction Observation

Ngaeikura Toma / Riverdale School (Gisborne),
2667 / 26 Jun 2023 / Medium Damage

Actions	0
Site conducted	Riverdale School (Gisborne), 2667, Cyclone Gabrielle
School Name	Riverdale school
School ID Number	2667
Report prepared by	Ngaeikura Toma
Conducted on	26.06.2023 03:00 UTC
School Ministry Contact	Robyn Burns
School Contact Person	Principal Julie McGlochlan
Level of overall damage	Medium Damage

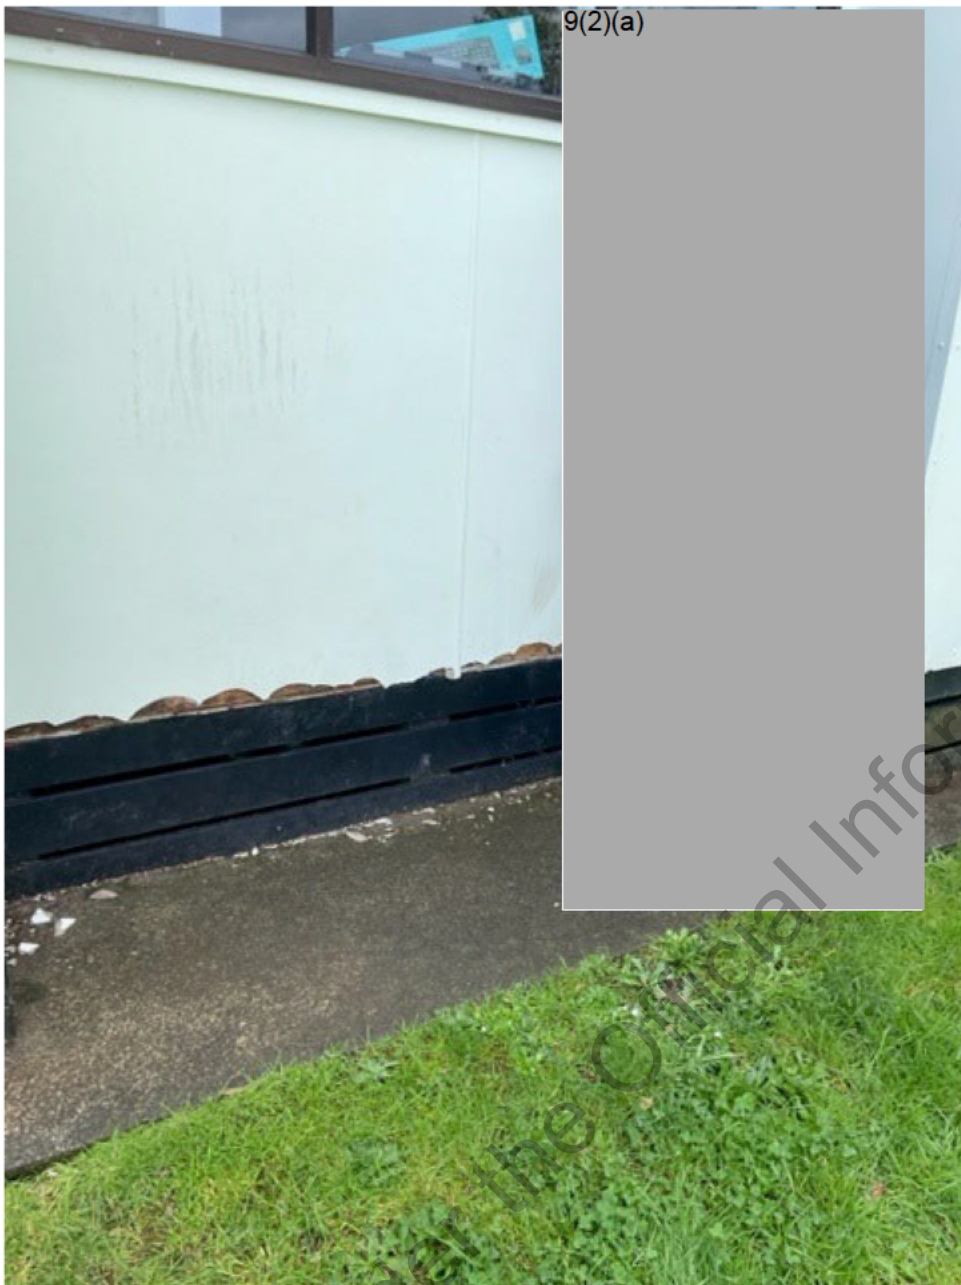
Gutters are rusted away and down pipes either rusted away or detached from the gutter. Combination of the 2 recent events have accelerated damages to an historic issue

Block I This used to be guttering

Gutters and down pipes to be remediated/replaced

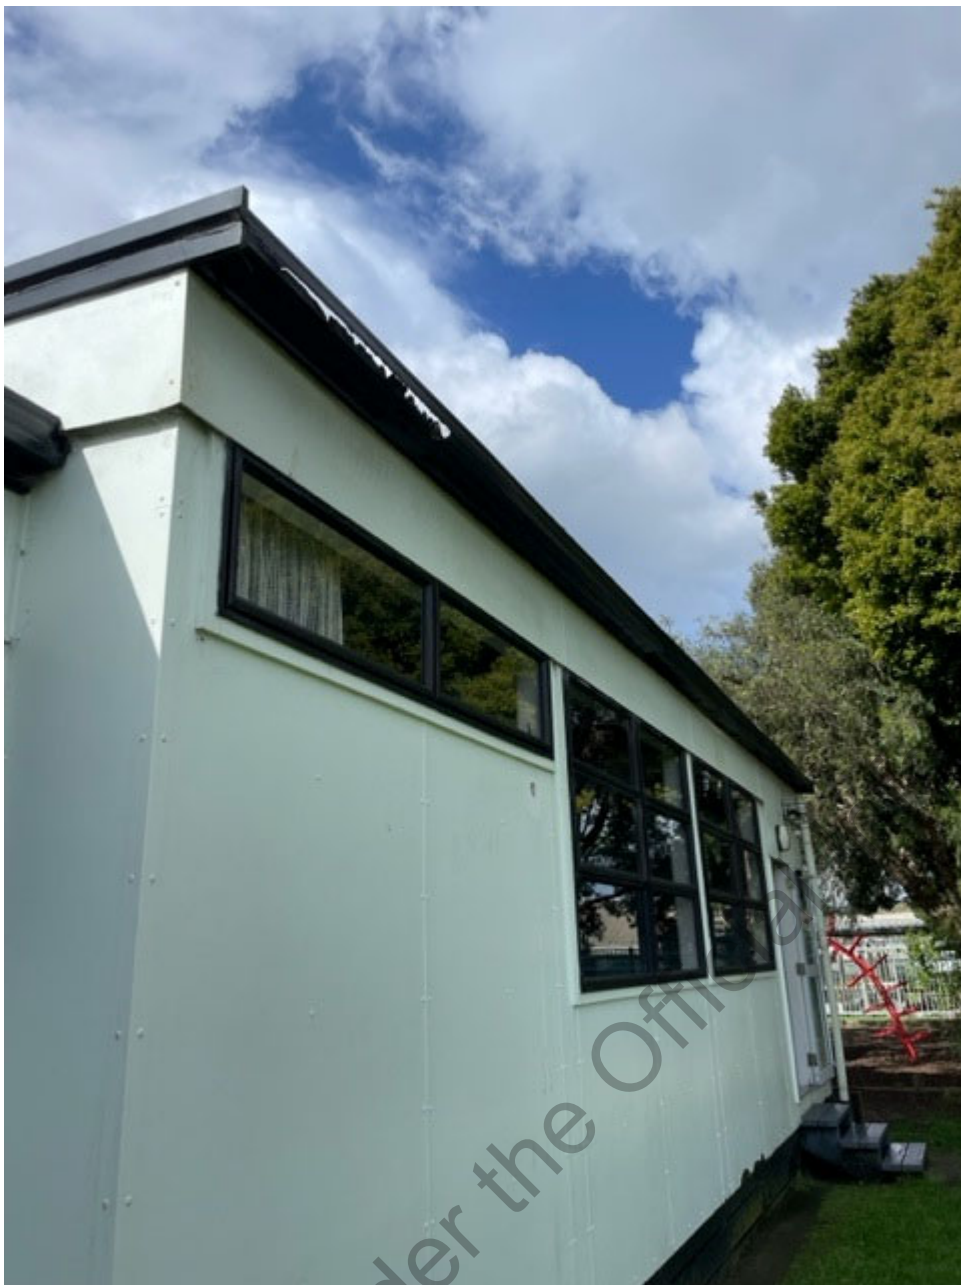
Block I - Downpipes used to connect to guttering

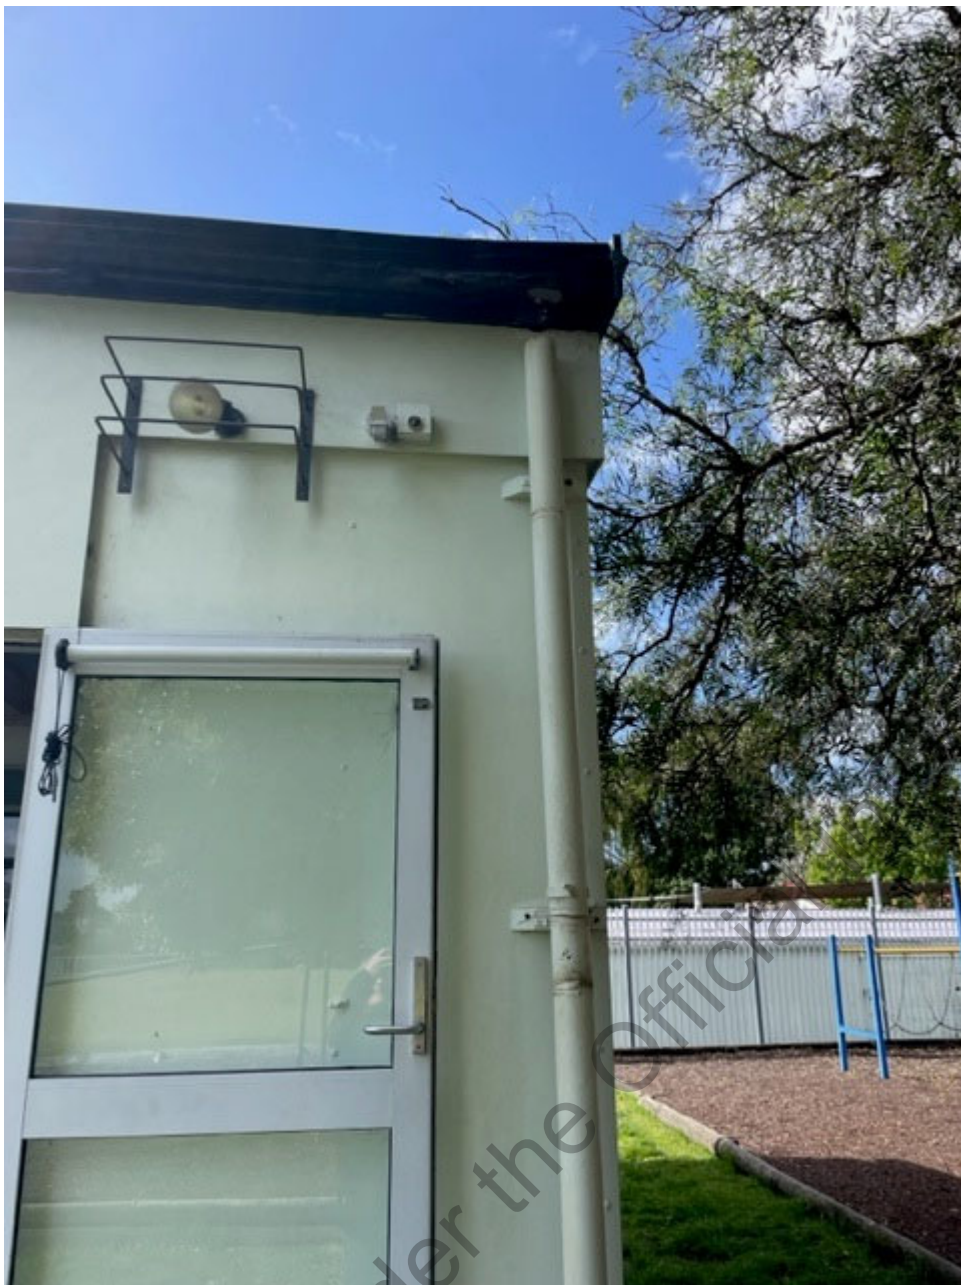
Block I Guttering and Asbestos issue

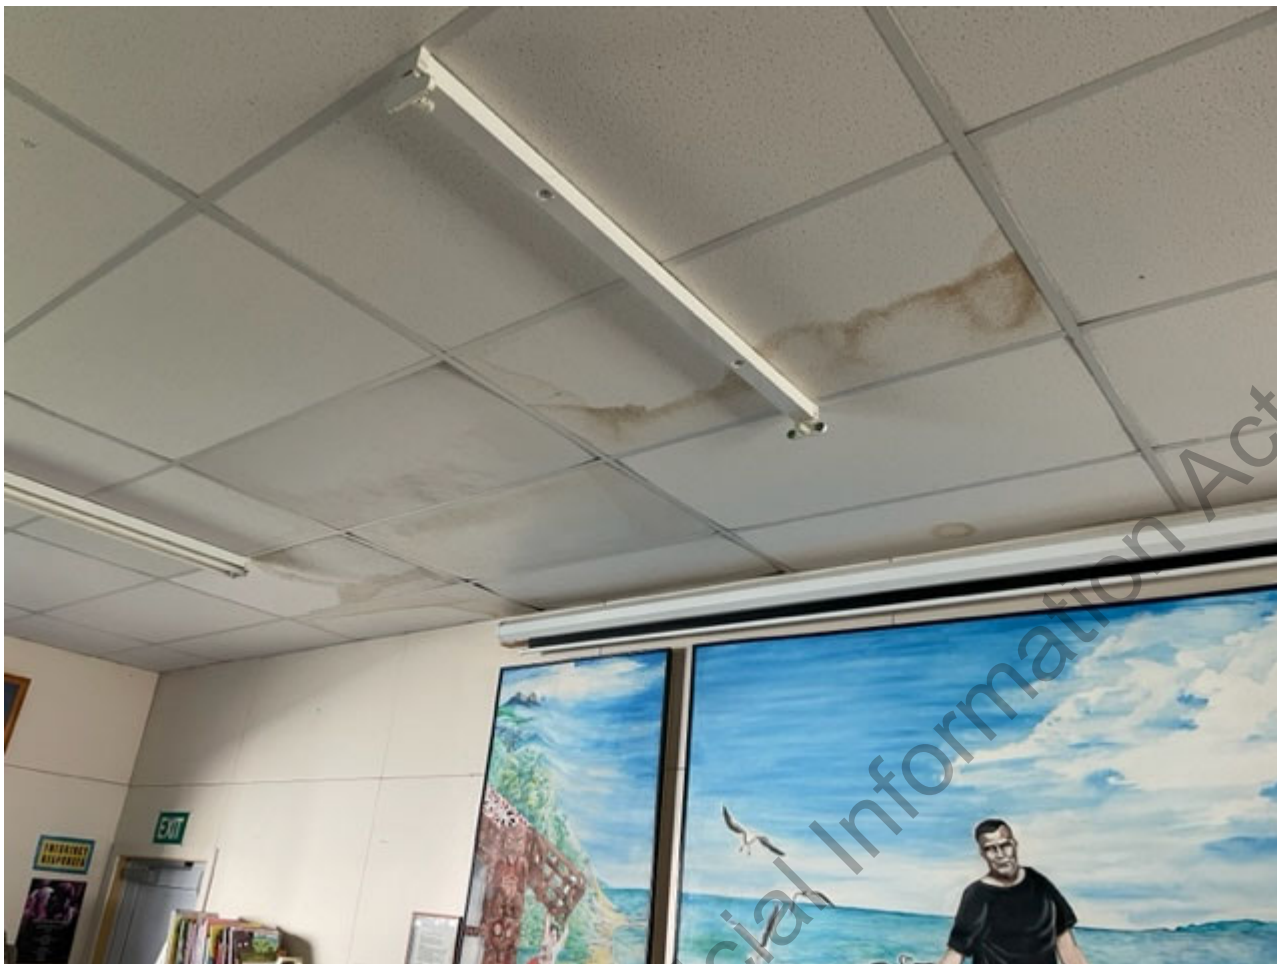
Block E Ceiling issues

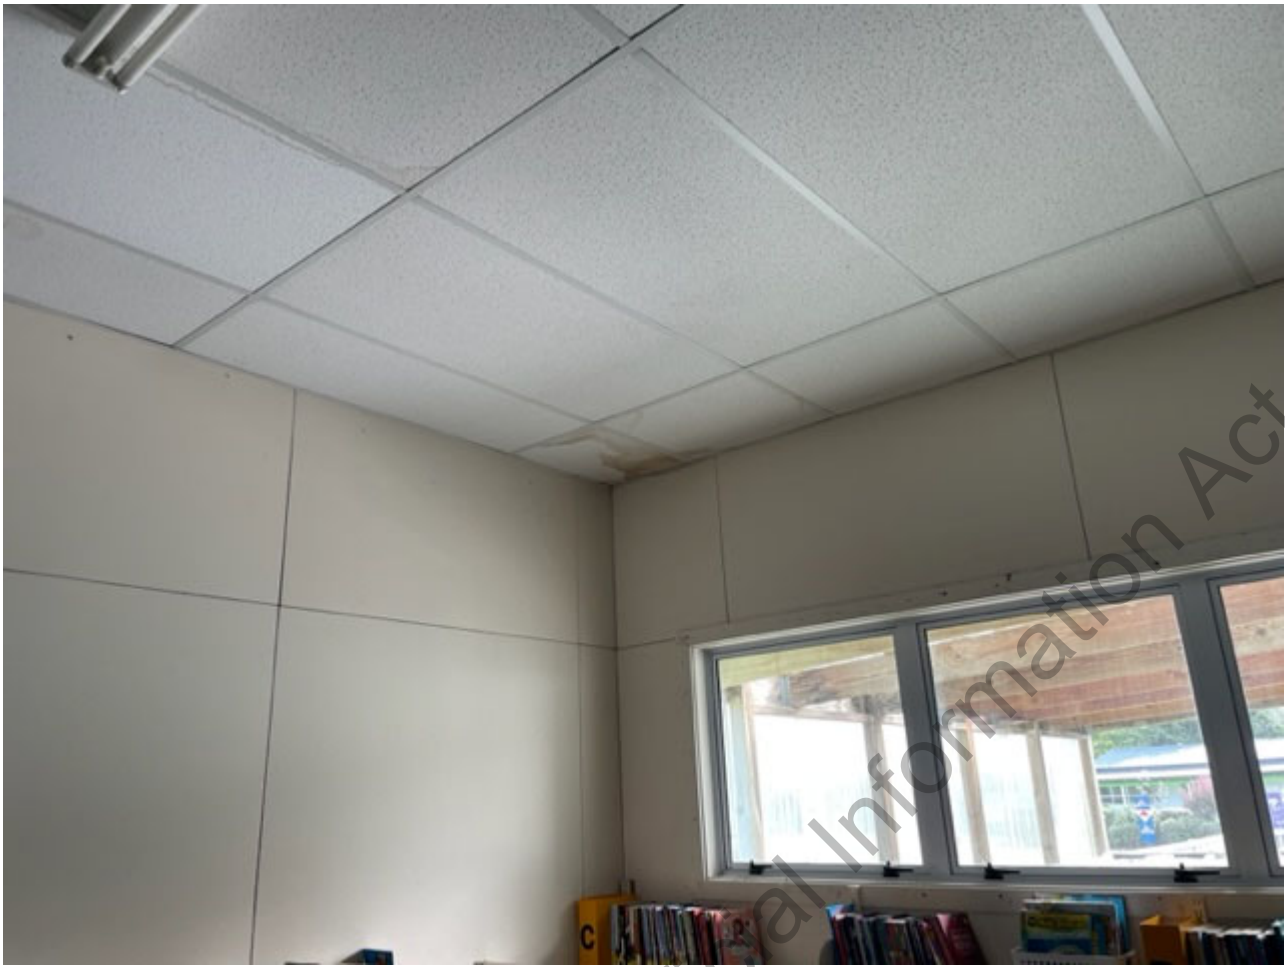
Block E Ceiling issues

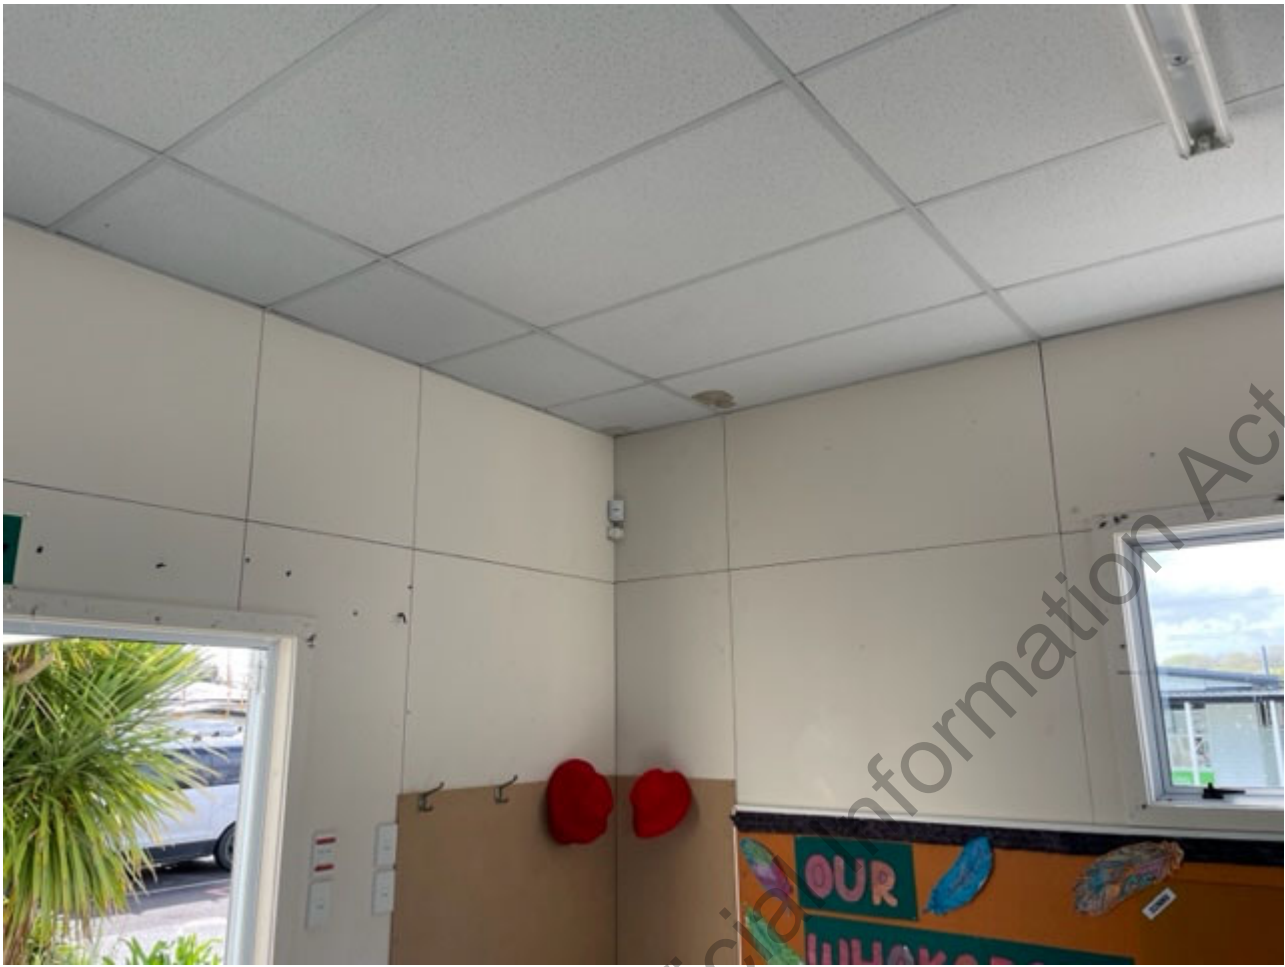
Block E Ceiling issues

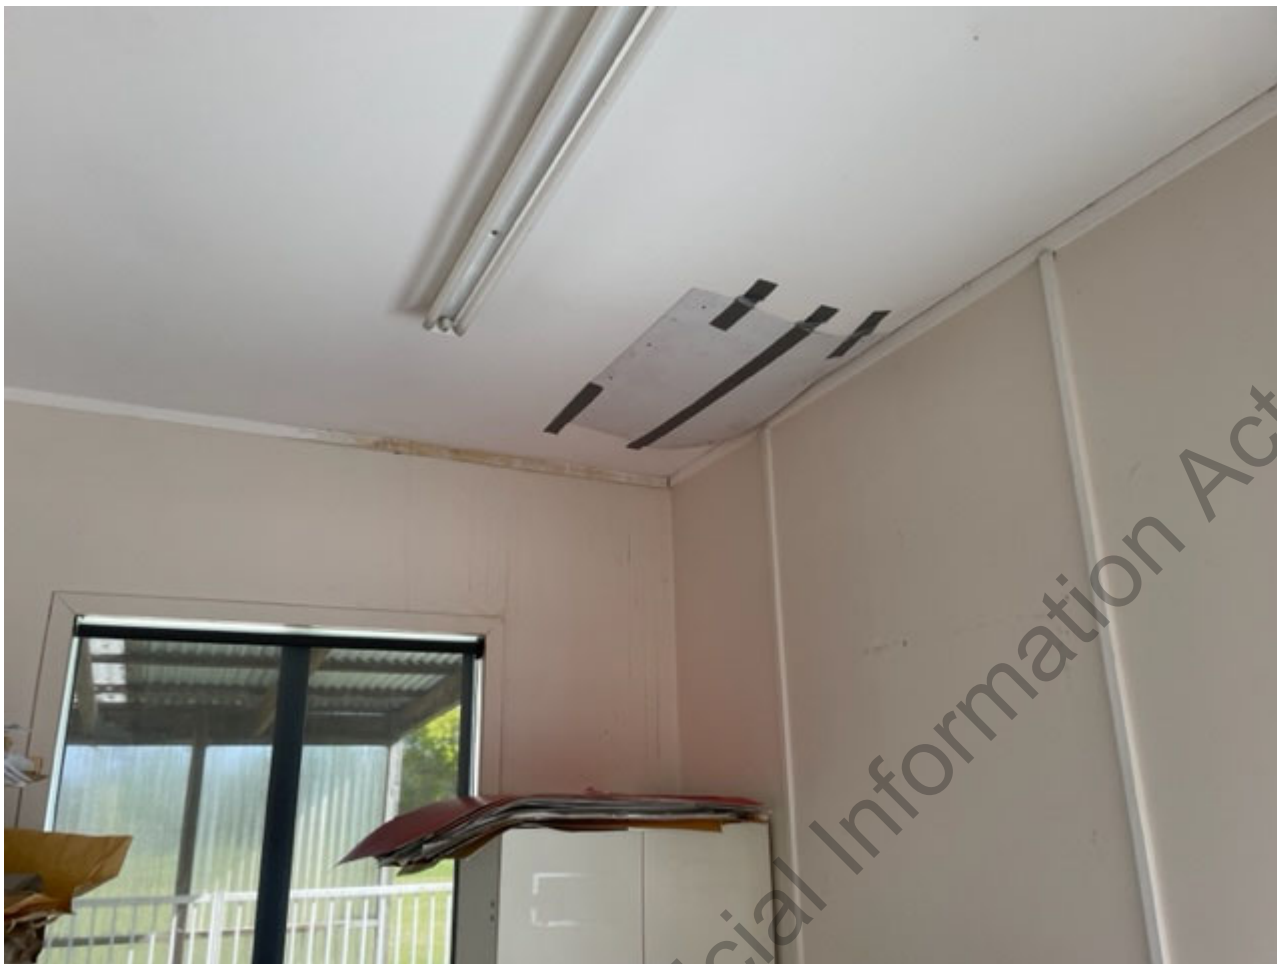
Block E Special needs Ablutions Ceiling issues

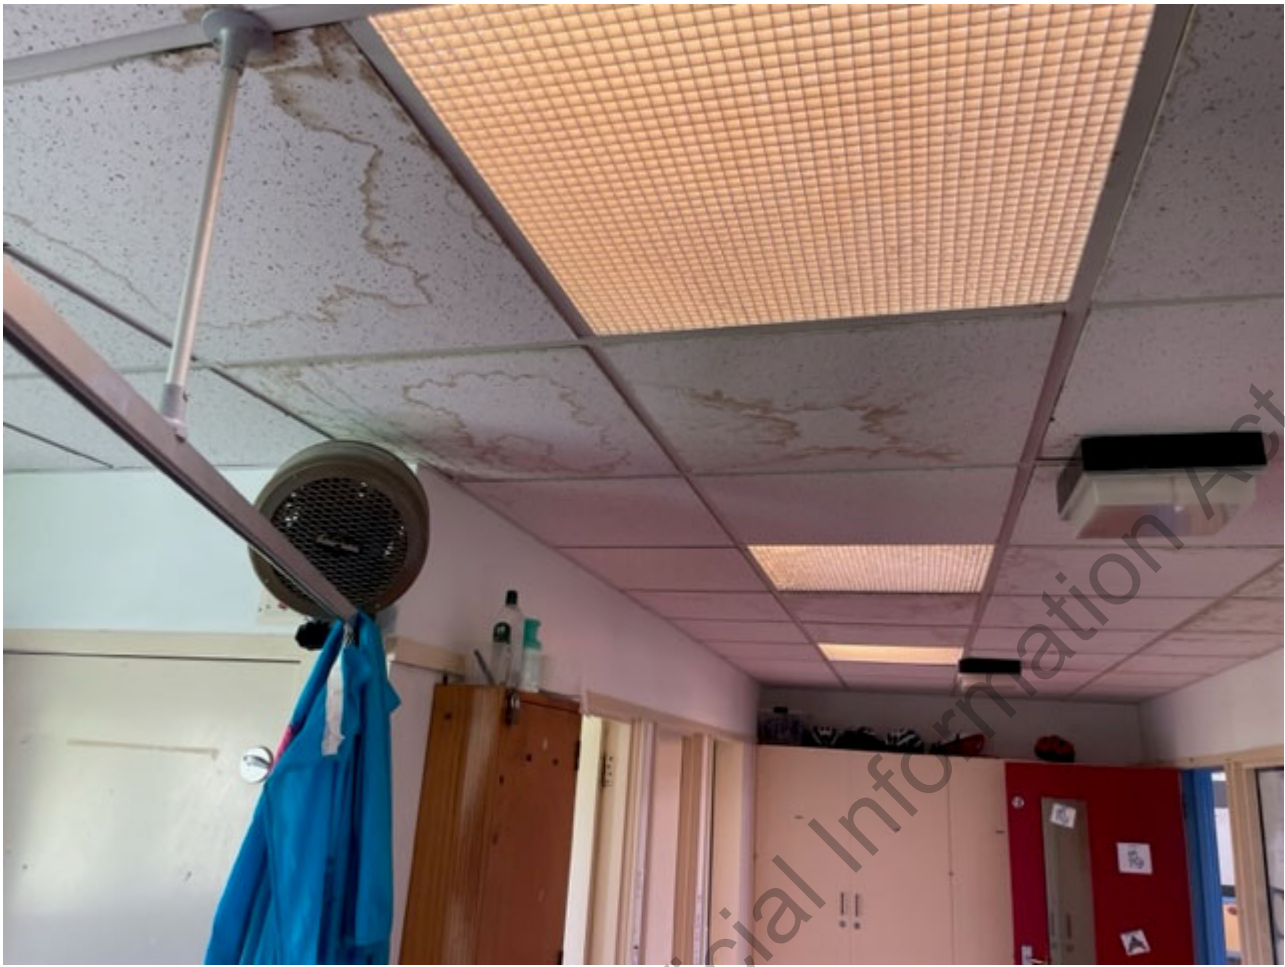
Block E Special needs Ablutions Ceiling issues

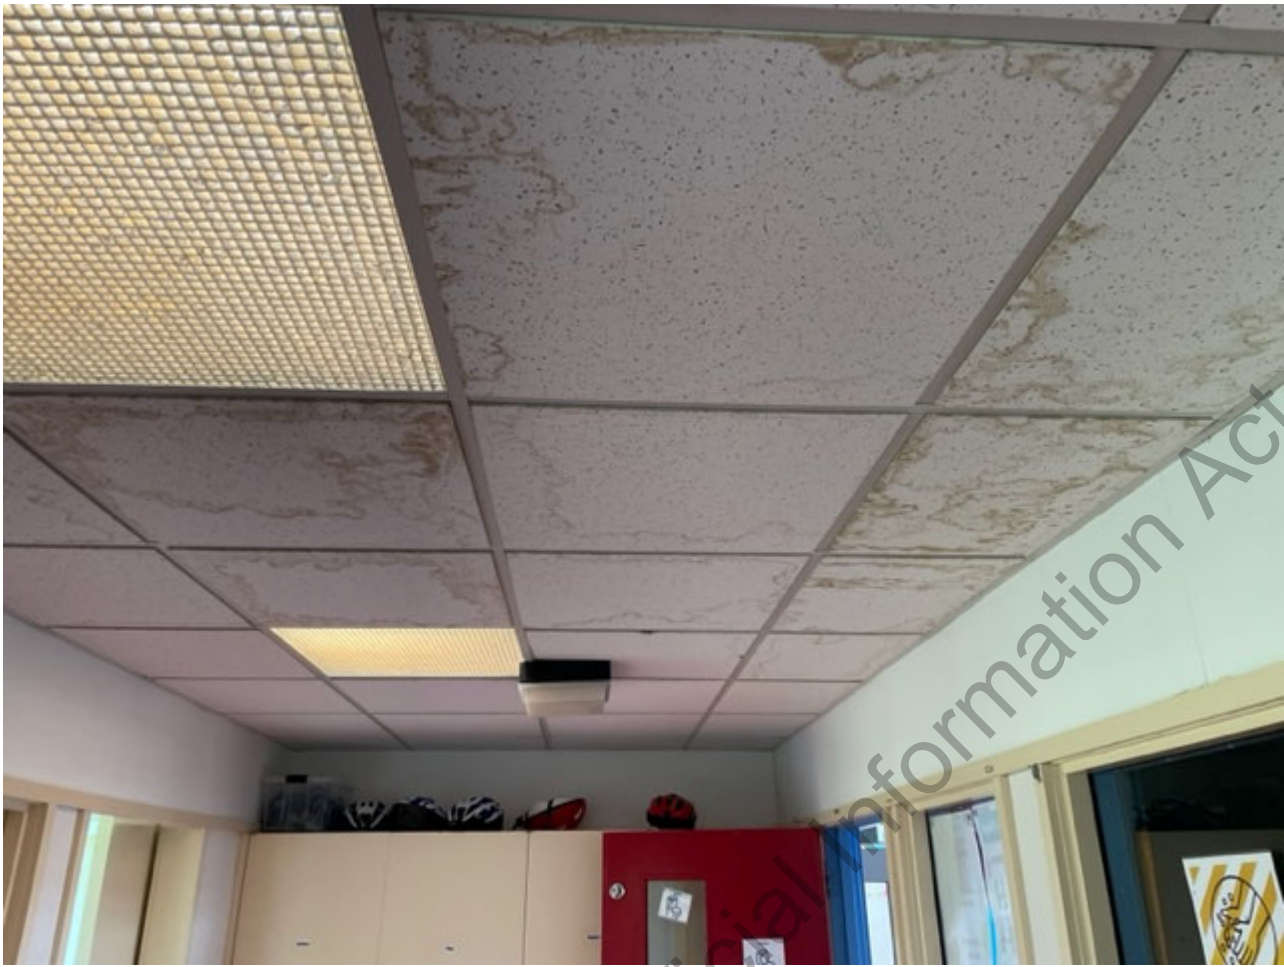
Block E Special needs Ablutions Ceiling issues
