**WEGC Block 4**

**Structural Condition  
Survey**

MINISTRY OF EDUCATION

December 2016

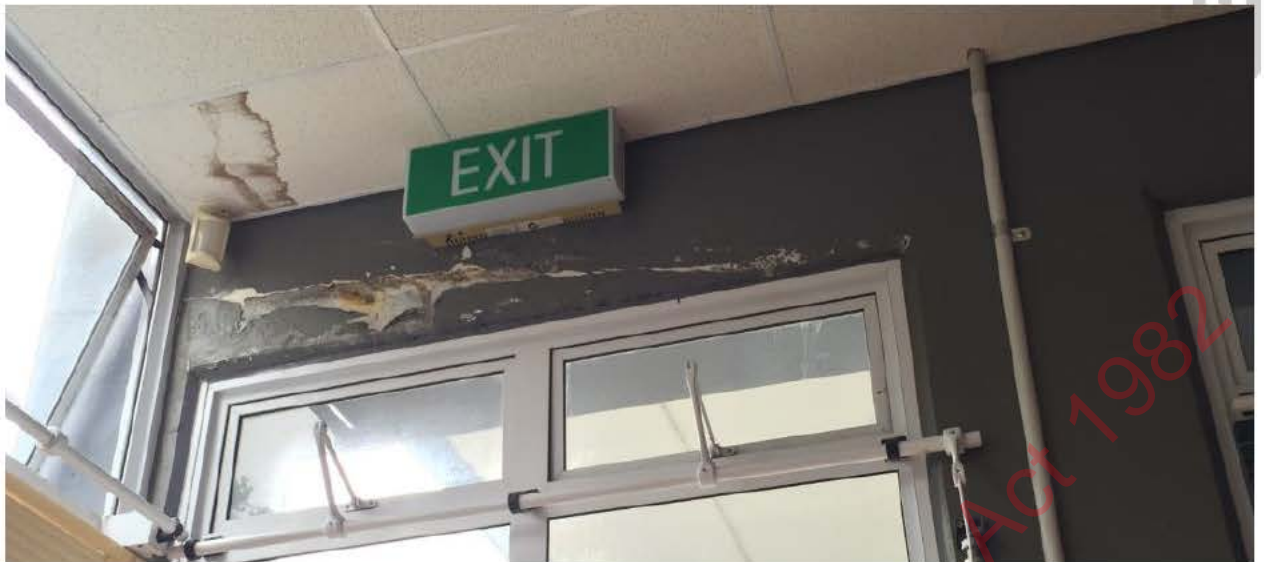
A-Build sheet S4 notes a new soffit has been cast against the original concrete at grids 1, 5 and 11. However, from review on-site it appears that this detail was installed at Grids 1, 4, 5 and 11. At each of these locations, there are signs of moisture ingress at the concrete cold-joint and cracking of the concrete and rust staining are evident. Moisture ingress is evident at all of these locations and it appears that moisture has been tracking into the building along this joint detail. It appears that these areas have been cleaned and painted a number of times so the extent of the underlying damage is difficult to determine. However, as long as no concrete has spalled and there are no cracks greater than 5mm, the repair methodology will not change.

Additionally, even where no new soffit has been installed, the joint between the new column and the underside of the original beam/column is showing similar signs of moisture ingress at all locations where this detail occurs. Less severe corrosion and staining than at the soffits is evident but it is possible defects have been hidden under new coatings. Sealing of this joint is required.

Picture 1 - Typical example of damage at junction between new/original concrete.

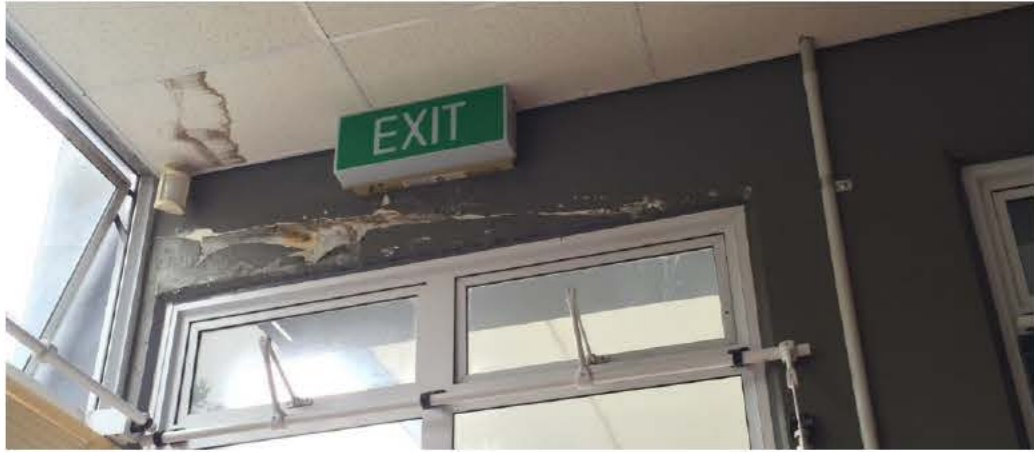
DEFECT NO.	DESCRIPTION	REPAIR/REMEDIATION
1 to 4	Deterioration of the new to original concrete joint at the underside of the original cantilever beam. Moisture ingress through this <b>“cold-joint”</b> has tracked moisture inside the building, damage finishes and caused deterioration of the reinforcing across the joint and has caused efflorescence and minor spalling at the face of the joint.	Concrete in this area should be cleaned of all finishes to both internal and external faces. Assess condition of concrete once exposed. Assuming no major spalling and cracks less than 5mm, pressure grout and seal the joint from both sides. Refer to Appendix B for detailed specification for repair.
5	Deterioration of the new to original concrete joint at the interface of the top of the new concrete column and the underside of the original cantilever beam. Moisture ingress <b>through this “cold-joint”</b> has caused efflorescence. There is potential for there to be rust staining and deterioration of the reinforcing across this joint but re-painting of the surface will have obscured this.	As per Defects 1 to 4.

Defect 1 to 4 - Deteriorated new to original concrete joints that require sealing (underside of original cantilever beam)

Defect 5 - Deteriorated new to original concrete joints that require sealing (joint between new column and END of original cantilever beam)
