FIRE INVESTIGATION REPORT

1 Balmoral Drive, Tokoroa, South Waikato District

F3860442

Suspicious Fire

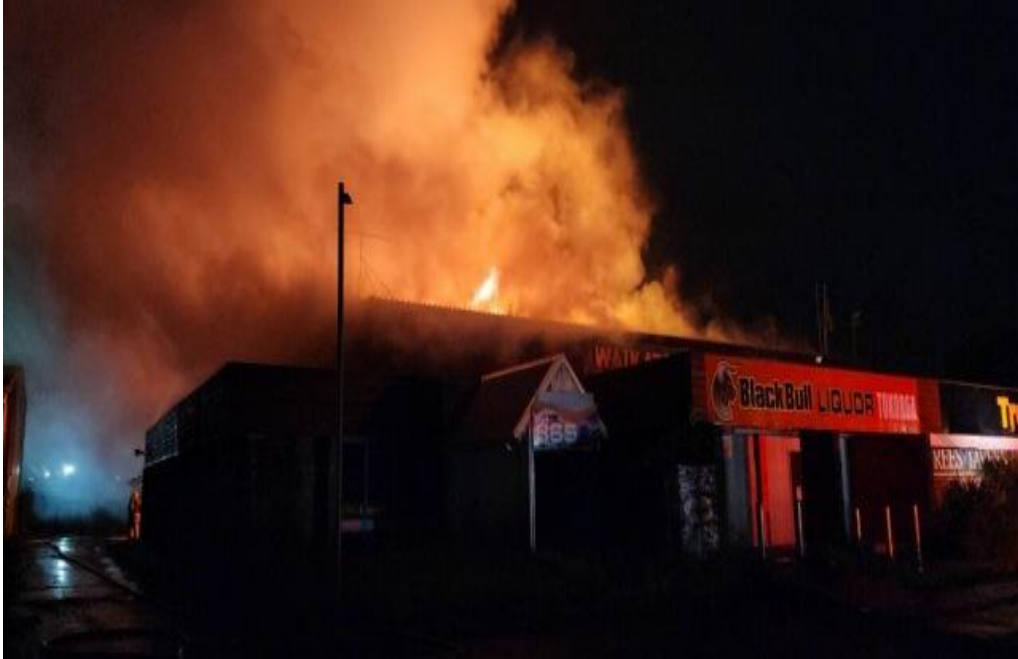
Photo 1: Showing fire inside the southwest corner of the tavern on arrival of firefighters. (Photo courtesy of Police.)

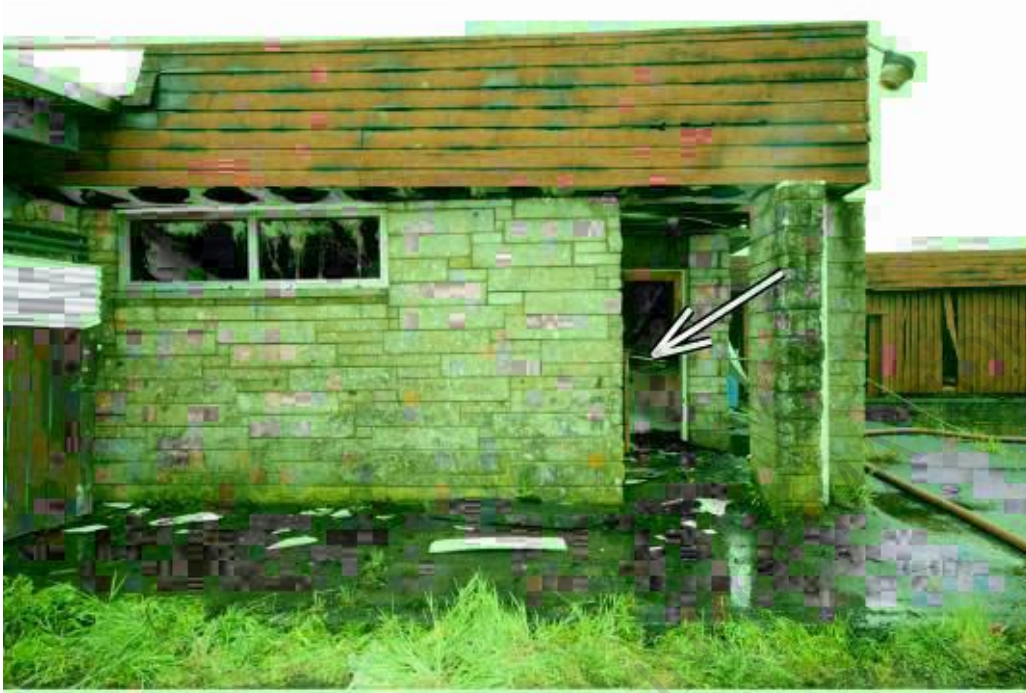
I moved to the northwest corner of the tavern adjacent the smoking area and noted a single damaged door that opened into the kitchen area. Reviewing the damage, it appeared to have happened post fire which was clarified as fire fighters forcing this door open on their arrival.

Photo 8: Single door forced opened by firefighters. Arrow depicting damaged door. (Photo courtesy of Police.)

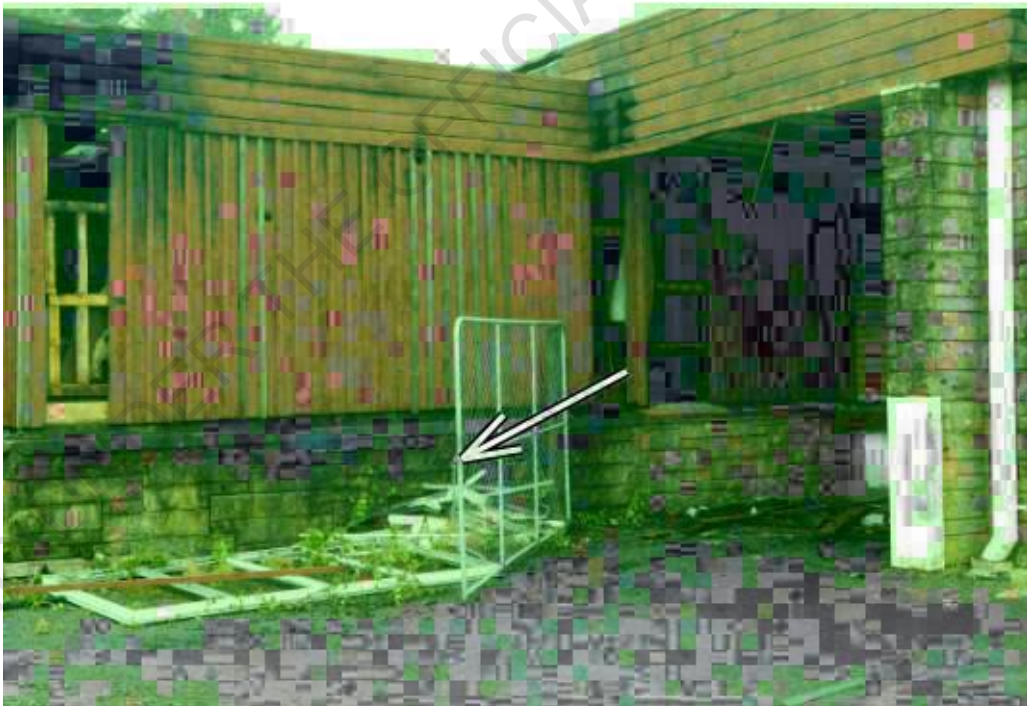
There was a steel gate was in a partially opened position. I examined the gate, chain, and padlock. I noted that a chain link that was attached to the timber post that was against the building had been cut. I checked with the firefighters who were working within this area, and they confirmed that they did not cut the chain to the gate.

Photo 13: The gate chain was cut prior to fire fighters arrival. Northwest corner of the tavern. (Photo courtesy of Police.)

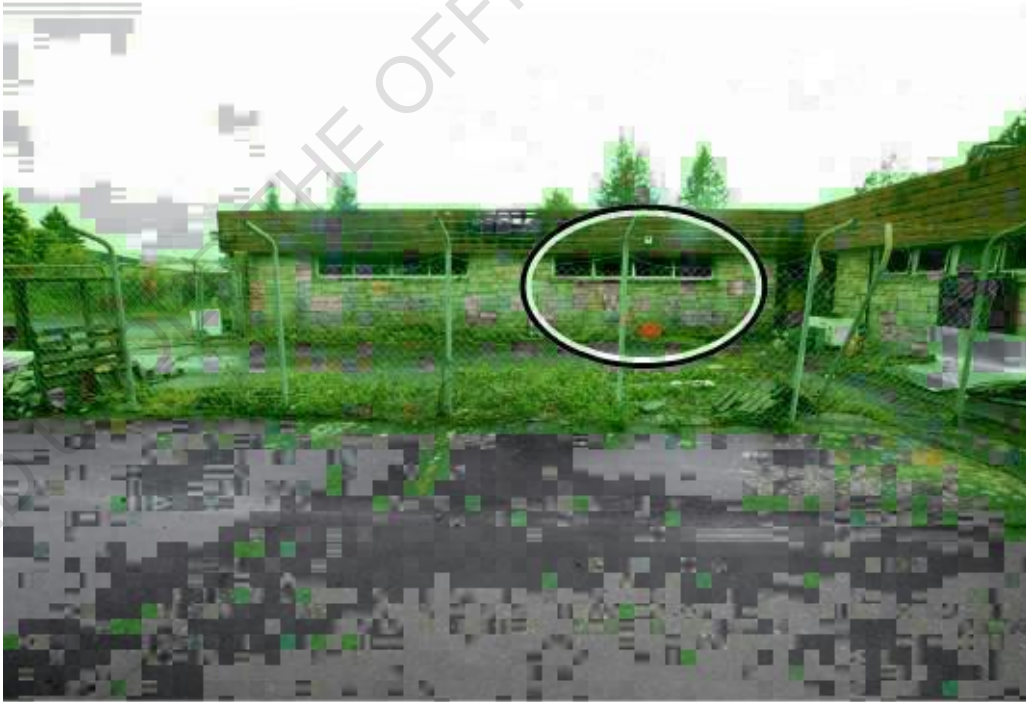
In the rear of the Southwest corner of the tavern, I noted a set of four windows in the opened position, and the right-side window aluminium joinery sash showed damage consistent to having been forced open.

I examined windowpane glass on the ground below the four windows, and I did not locate any evidence of clean broken glass that could indicate there was broken glass before the fire.

Photo 14: Four opened windows southwest corner of tavern. (Photo courtesy of Police).

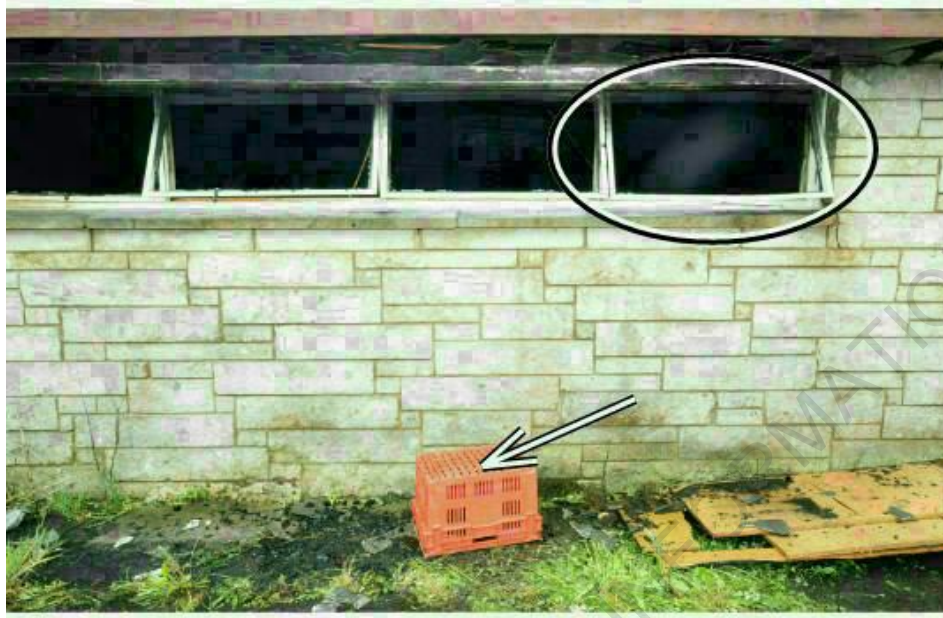
Under the four windows, I noted a red plastic crate. Further investigation confirmed that this crate was likely to have been placed under the windows by firefighters.

Photo 15: Right damaged aluminium window sash. The arrow depicts a red plastic crate. (Photo courtesy of Police).

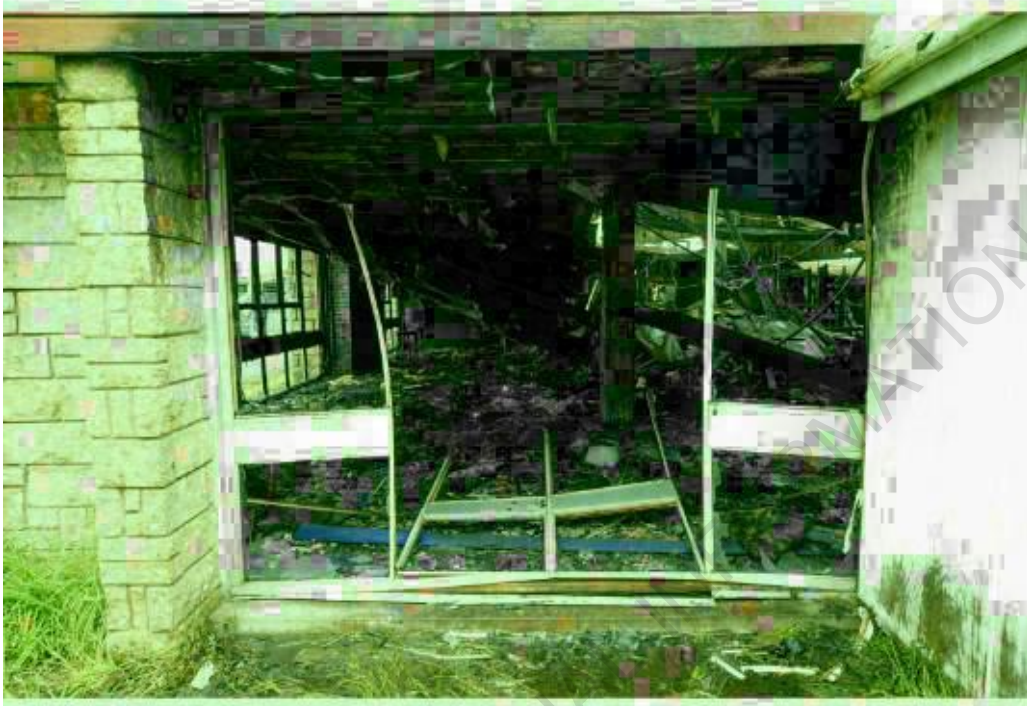
I viewed the interior of the club from the windows and doors. While the interior damage was extensive, I confirmed that the fire had spread to the club and had not originated inside. Witness 1 confirmed that the fire was not visible inside the club on their arrival.

Photo 18: View of the aluminium window and interior of Club 865. (Photo courtesy of Police).

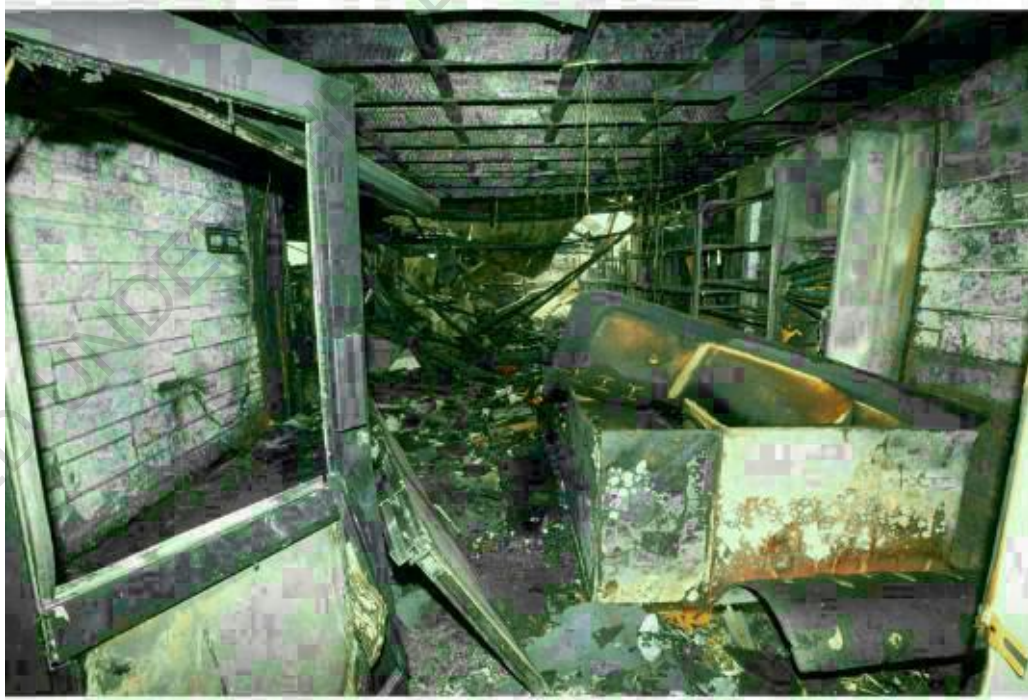
Reviewing the fire damage within the outlet, I believe the fire had spread to the liquor shop and had not originated inside.

I noted there were electrical appliances, including freezers, inside the outlet. Given the electricity was not operating inside the tavern beyond the electrical cabinet, I ruled out an electrical event inside the Black Bull Liquor store.

The Back Bull Liquor outlet was eliminated as an area of origin.

Photo 21: Interior of Black Bull Liquor store. (Photo courtesy of Police).

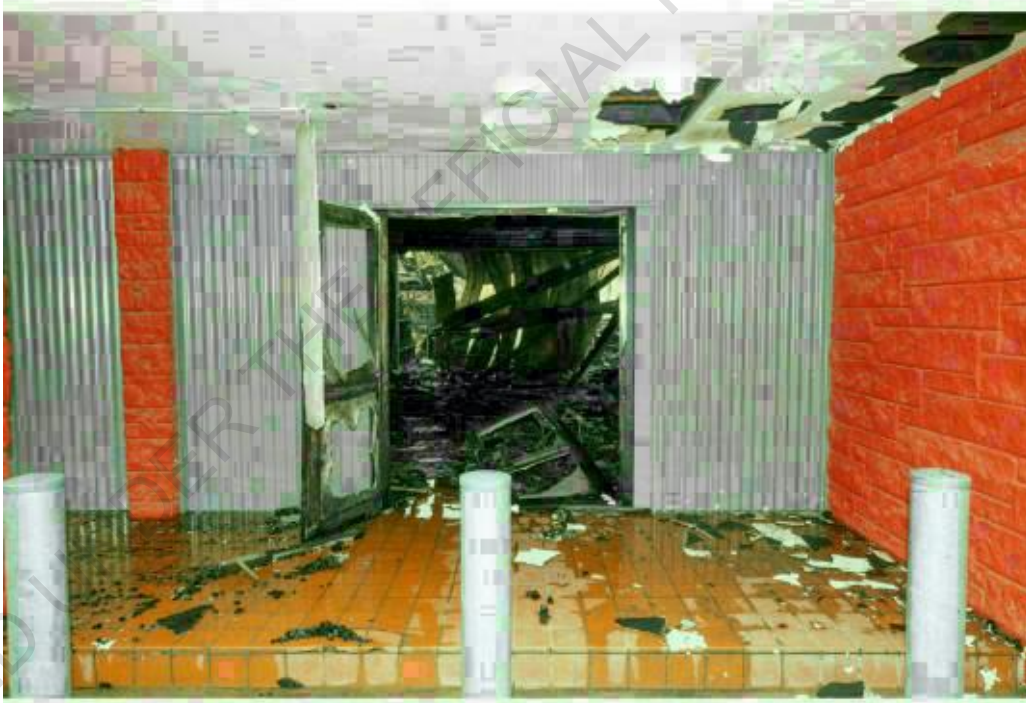
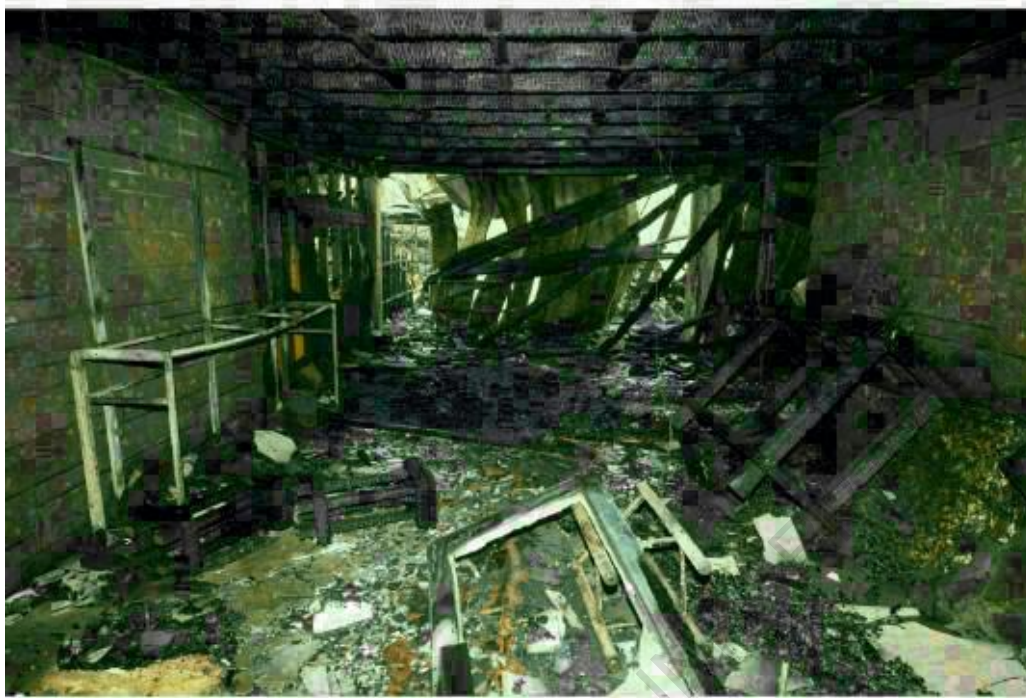
Reviewing fire patterns inside the entrance to the tavern, I was of the opinion that the fire had spread from the west side of the tavern and had not originated inside the entrance.

The south end entrance to the tavern has been eliminated as an area of origin.

Photo 22: Southeast entrance door to tavern. (Photo courtesy of Police).

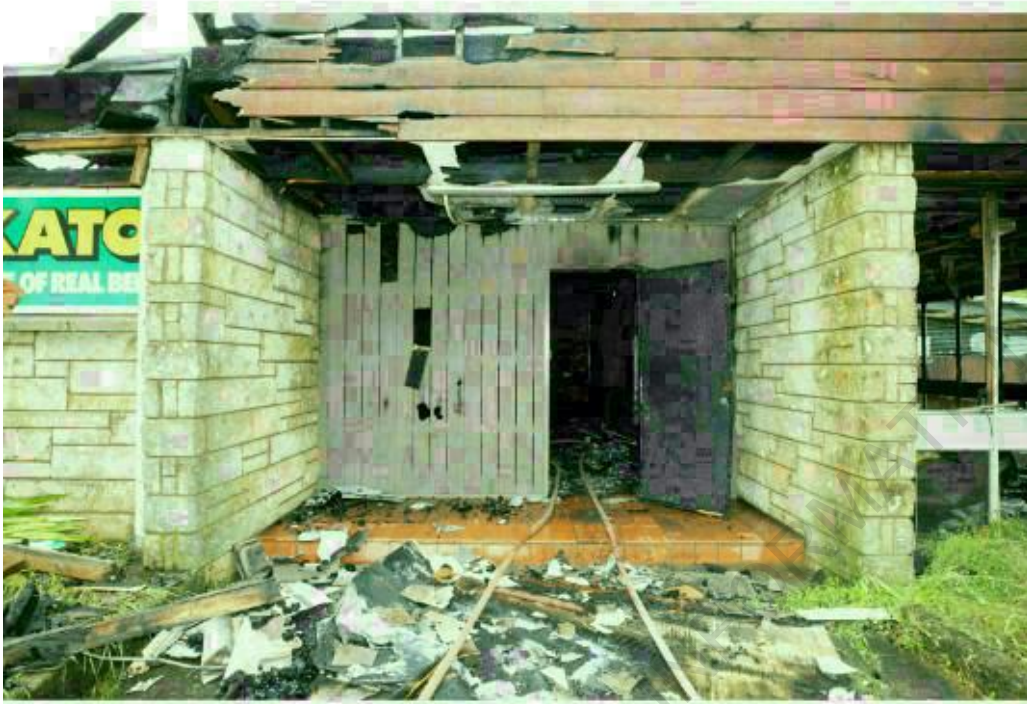
Reviewing fire patterns inside the entrance to the tavern, I was of the opinion that the fire had spread from the west side of the tavern and had not originated inside the entrance.

The north end entrance to the tavern has been eliminated as an area of origin.

Photo 24: Northeast entrance to tavern. (Photo courtesy of Police).

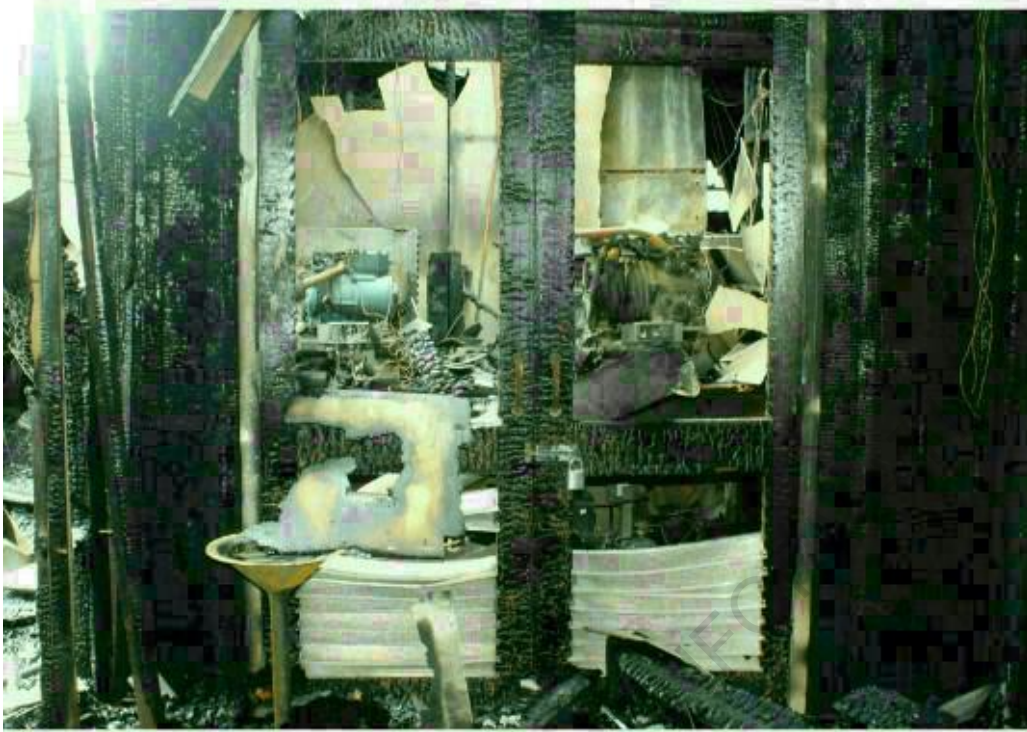
I examined the refrigeration room at the end of the passage. Examining the electrical components and wiring of the refrigeration units inside the room confirmed the damage was an external source of fire, and no evidence would support an issue with the plant equipment.

I eliminated the refrigeration room as an area of origin.

Photo 27: Refrigeration room.

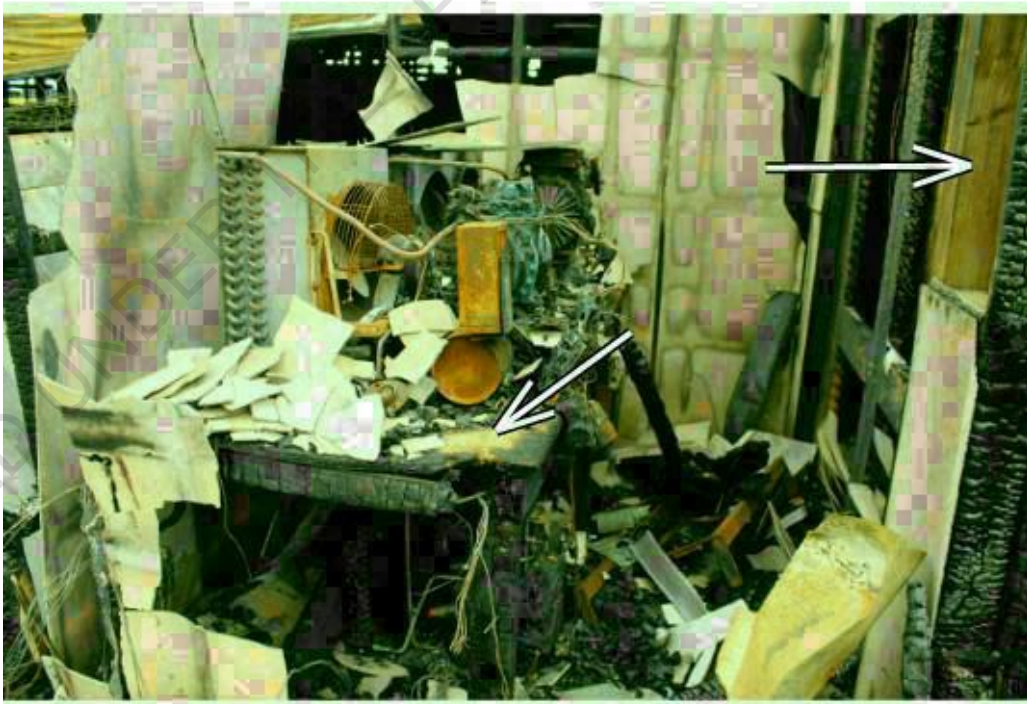
I examined the timber framing in the room and confirmed that there was still timber framing present that showed timber that had not been exposed to fire or smoke damage.

Photo 28: Arrows depicting timber and shelving that was not fire damaged.

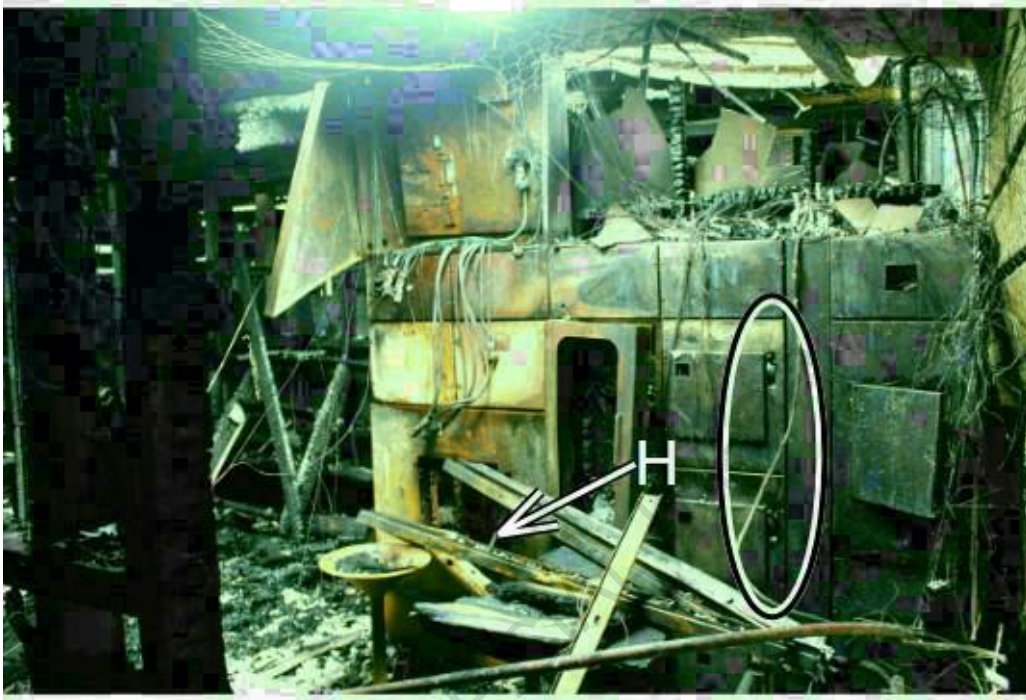
I noted a 2nd set of two levers on the cabinet's right side. The levers were in the "on" position (lever up is in the "On" position). The two right levers were subsidiary. 9(2)(ba)(i) [REDACTED]

Photo 31: Tavern electrical distribution cabinet. "H" is the leading electrical on/off lever. The oval depicts the two subsidiary levers in the "On" position.

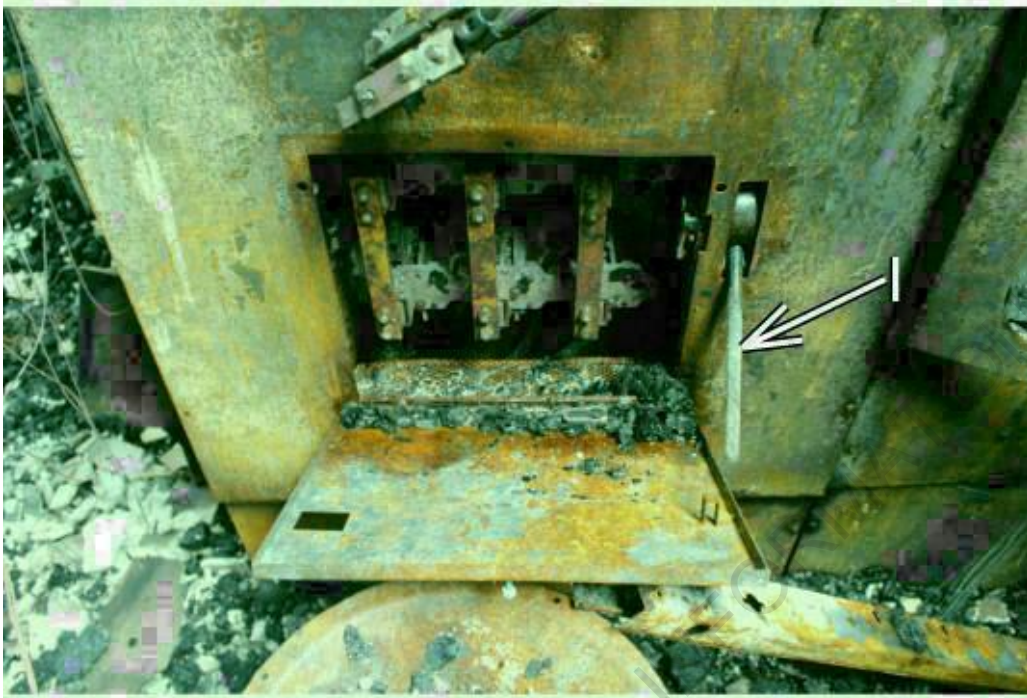
I examined the distribution cabinet inside the room and noted there was one large lever on the left side in the "Off" position (the lever down is "Off"). 9(2)(ba)(i) [REDACTED]

Corporate Risks (Contracted Insurance Investigators) engaged an electrical engineer to survey the electrical cabinet, and they confirmed that the power was isolated at the cabinet; therefore, there was no electricity beyond the cabinet to the tavern before the fire.

Photo 32. "I" Main electrical distribution cabinet lever was in the "Off" position.

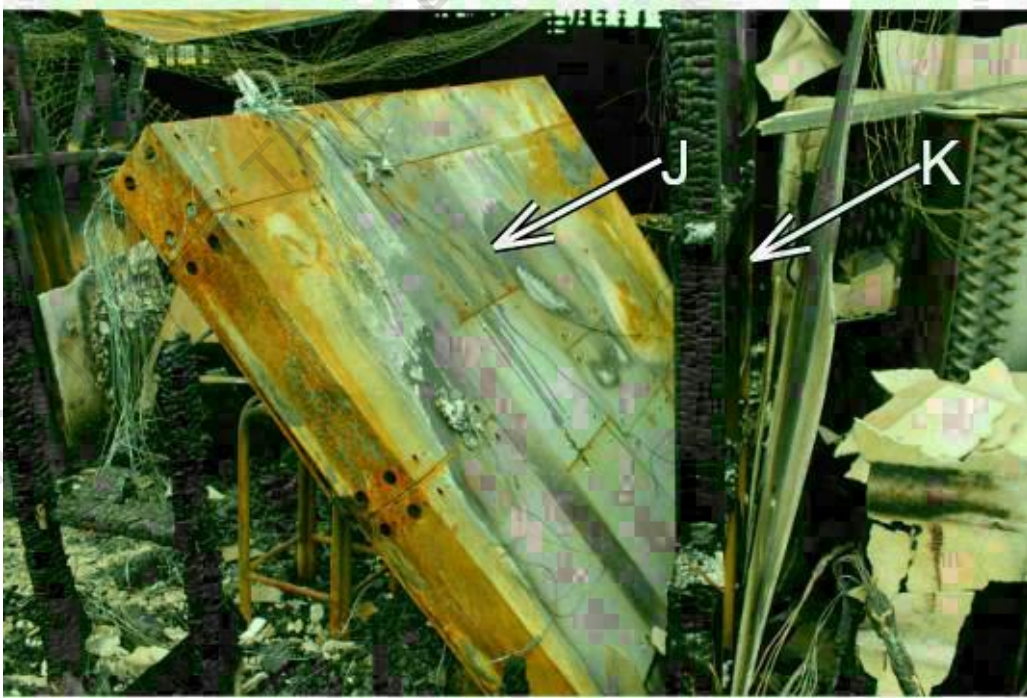
I examined the electrical cabinet, electrical components, and the area surrounding the cabinet. There were no fire patterns to support a fire originating from the electrical cabinet.

The electrical distribution cabinet was eliminated from the scene examination.

Photo 33: "J" Rear of electrical cabinet. "K" Timber framing behind cabinet still intact.

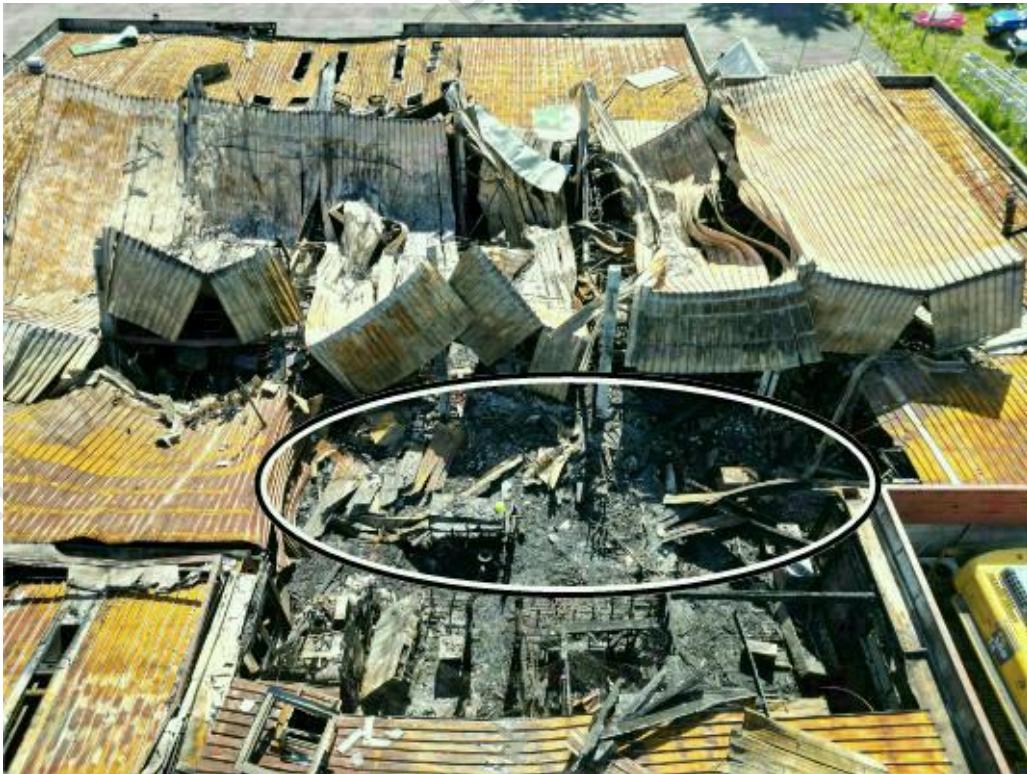
Photo 36: Enlarged area of origin. (Photo courtesy of Police).

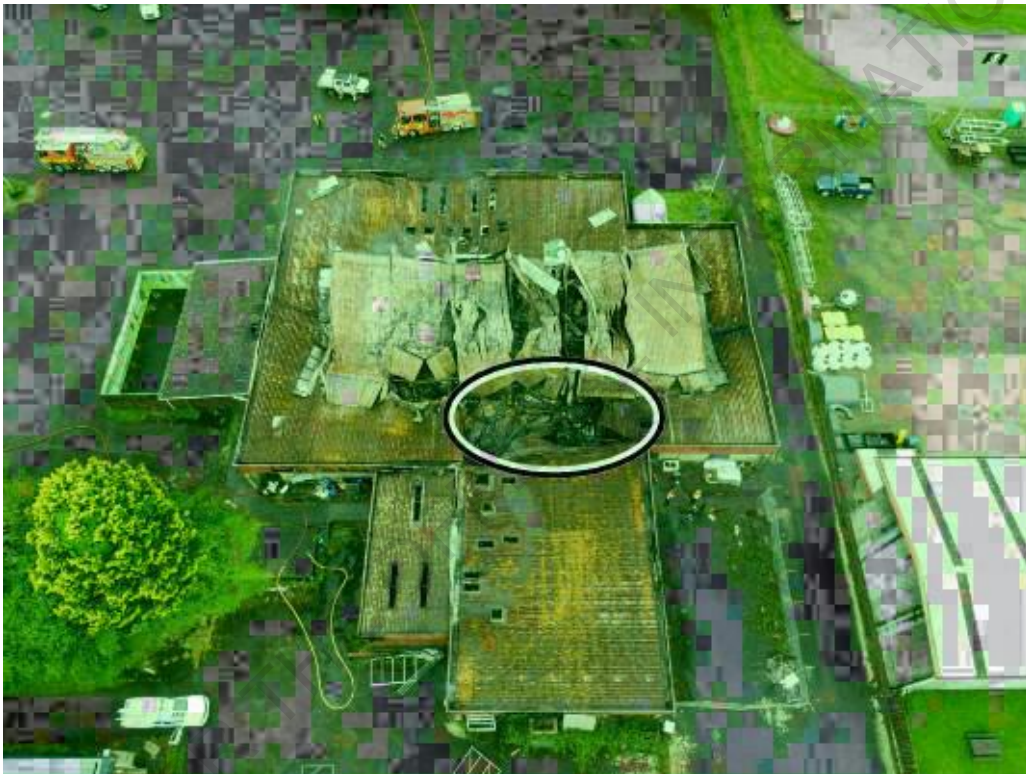
I determined that the southwest corner of the tavern was area of origin.

Due to the extensive fire damage throughout the tavern, I could not rule out that there was also other areas of origin to an acceptable level.

Photo 37: Area of origin in the southwest corner of the Tavern. (Photo courtesy of Police).

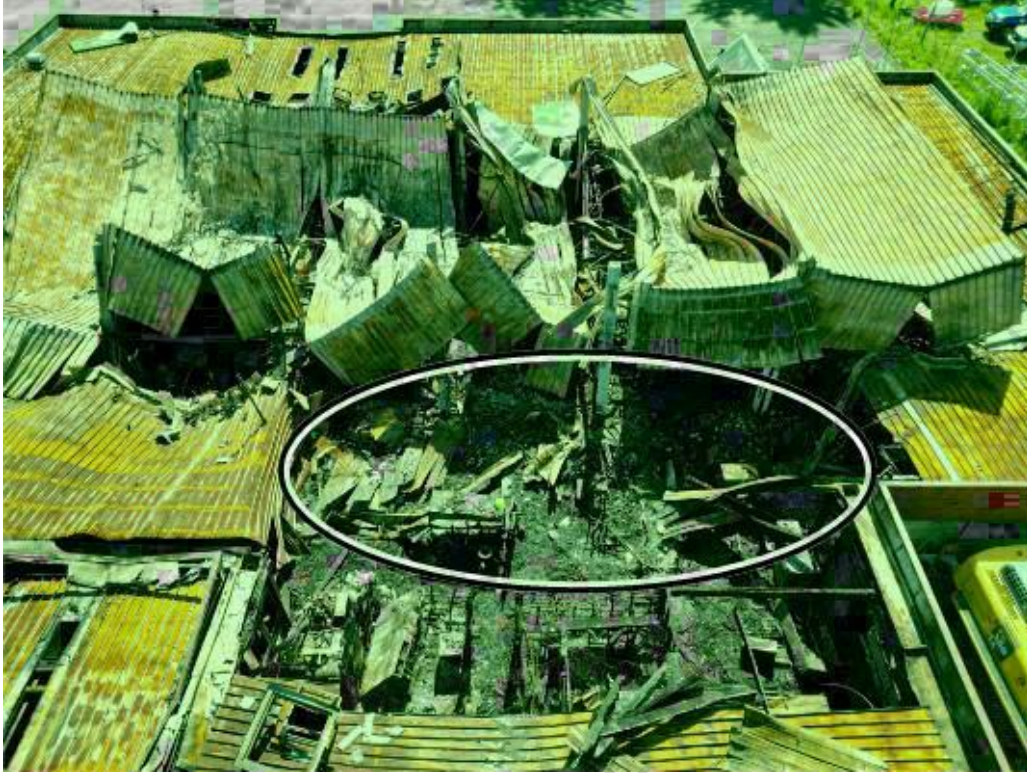
Photo 38: Area of origin after the removal of the roofing iron. (Photo courtesy of Corporate Risks).

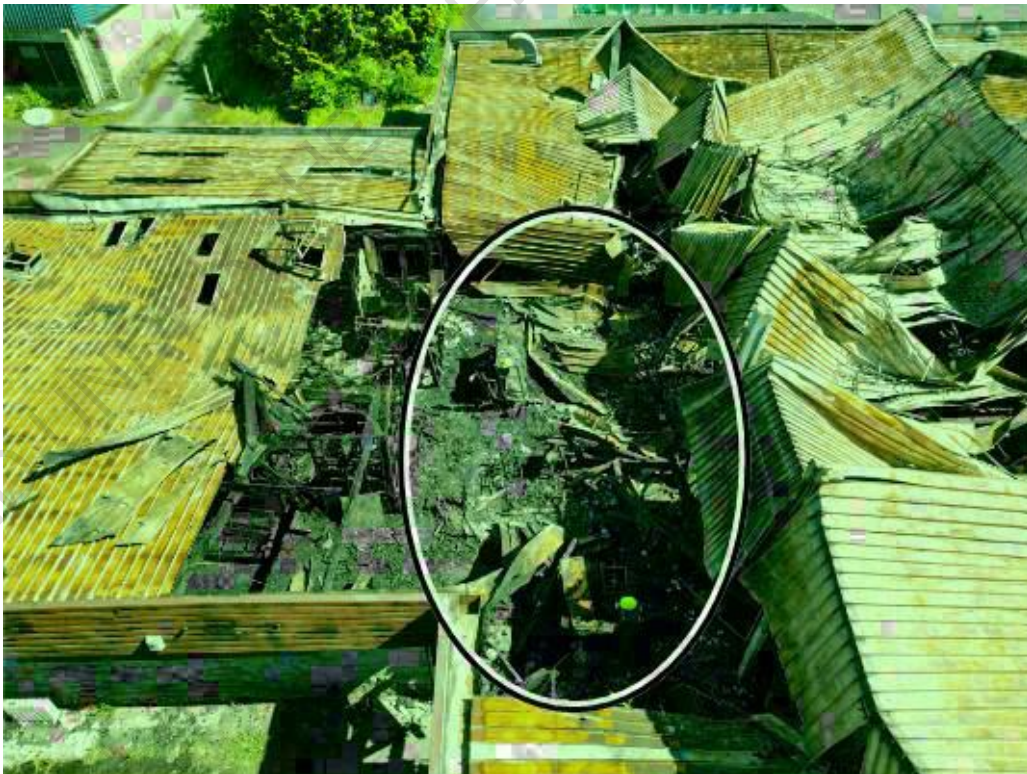
Photo 39: Area of origin looking from South towards the North of the Tavern. (Photo courtesy of Corporate Risks).
