Inspection Details

Type: Annual Inspection Inspector: Philippa Boland (RPI Annual Inspector)

Inspected: 16/02/2024 Start Time: 18:00 End Time: 18:05

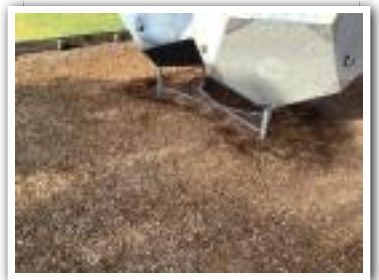
Manufacturer:	Not Identified	Surface:	Woodchip
Item Complies:	N/A	Surface Complies:	Yes
Finding	The level of loose fill surfacing has fallen significantly below the minimum 300mm recommended by NZS 5828:2015 Part 1		
Remedial Action	Top up loose fill surfacing to recommended levels.		
Risk Assessment	Low Risk (10)		
Type	Maintenance		
Defect Tracking			
Highlighted	No
