CASH SETTLED CLAIM(S)

Statement of Claim Checklist / Repair Strategy

CLM/2010/102220

RG Bull
 28 MALTA CRESCENT
 SOUTH NEW BRIGHTON
 CHRISTCHURCH

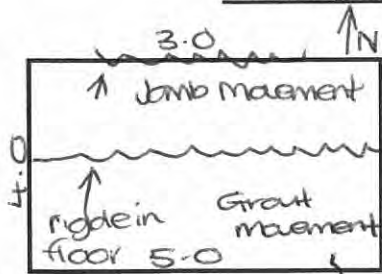
Lounge 1.0 x 1.0

| Room | Earthquake Damage | Walls | Ceiling | Floor | Repair Strategy |
|---|---|---|---|---|---|
| Lounge 2W GSD | Y | ✓ | ✓ | ✓ | REPAIR WATER DAMAGE AT GLASS SLIDING DOOR TO CEILING, WALL + PAINT. REPAIR GROUT IN DECORATIVE FIRE SURROUND. UPLIFT CARPET + PLANE RIDGE IN FLOOR. |

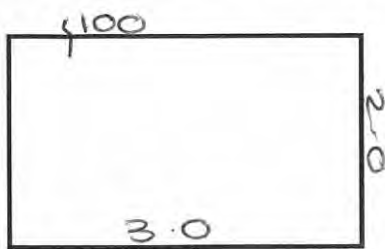
| Room | Earthquake Damage | Walls | Ceiling | Floor | Repair Strategy |
|---|---|---|---|---|---|
| Dining Room 1W C | Y | ✓ | | | REPAIR + PAINT CRACK IN WALL. CRACK 1.000 m |

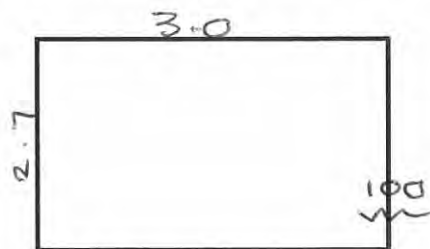
| Room | Earthquake Damage | Walls | Ceiling | Floor | Repair Strategy |
|---|---|---|---|---|---|
| Kitchen 1W J | Y | ✓ | | | REPAIR CRACKS IN WALL + PAINT. CRACK 1.000 m |

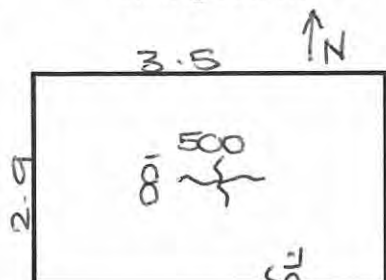
Bed 1

| Room | Earthquake Damage | Walls | Ceiling | Floor | Repair Strategy |
|---|---|---|---|---|---|
| Bedroom 1 | Y | ✓ | ✓ | | REPAIR + PAINT CRACKS IN WALL + CEILING. WALLS - 700 CEILING: 500 + 100 |

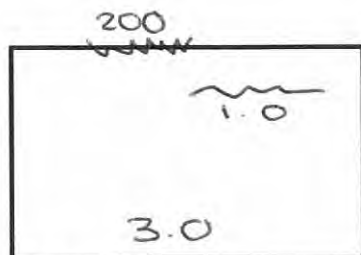
Bed 2

| Room | Earthquake Damage | Walls | Ceiling | Floor | Repair Strategy |
|---|---|---|---|---|---|
| Bedroom 2 1W C | Y | ✓ | ✓ | | REPAIR + PAINT CRACKS IN STIPPLE CEILING REPAIR + PAINT WALL CEILING JOINT. |

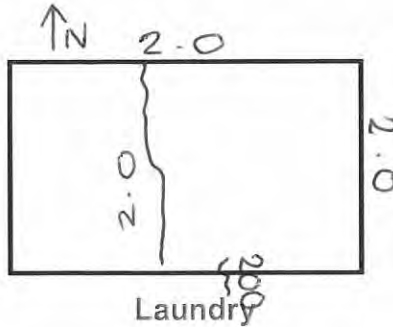
| Room | Earthquake Damage | Walls | Ceiling | Floor | Repair Strategy |
|---|---|---|---|---|--|
| Laundry 1WV | Y | ✓ | ✓ | | REPAIR + PAINT CRACK IN STIPPLE CEILING REPAIR + PAINT SEPARATED ARCHITRAVE |

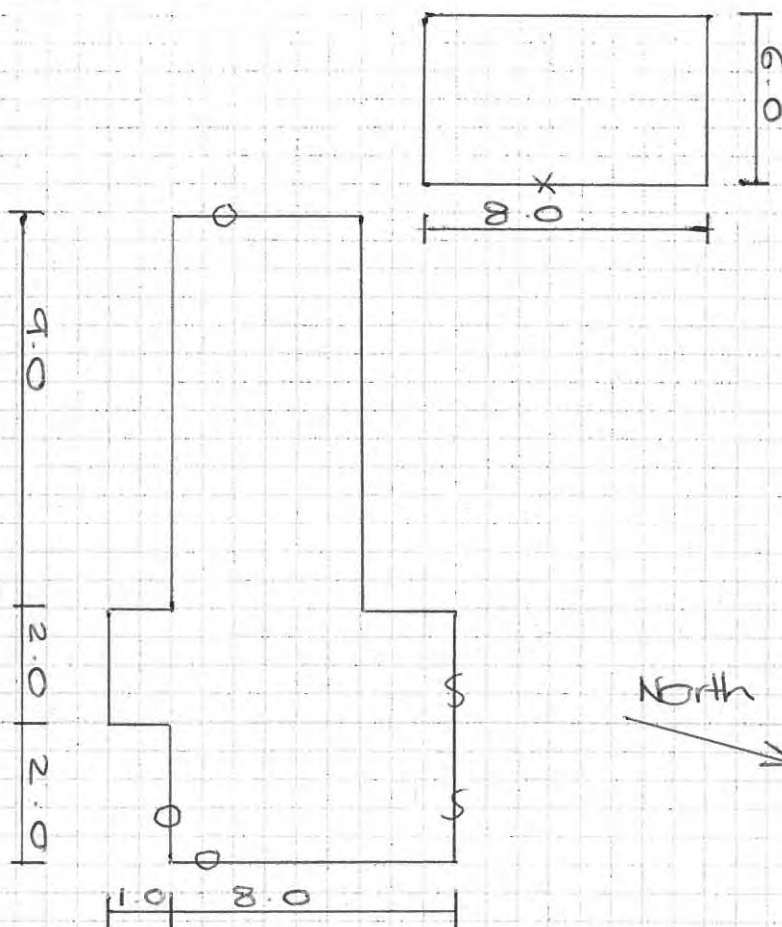
O Ring wall crack
 S movement in pergola
 X garage door pillar
 movement

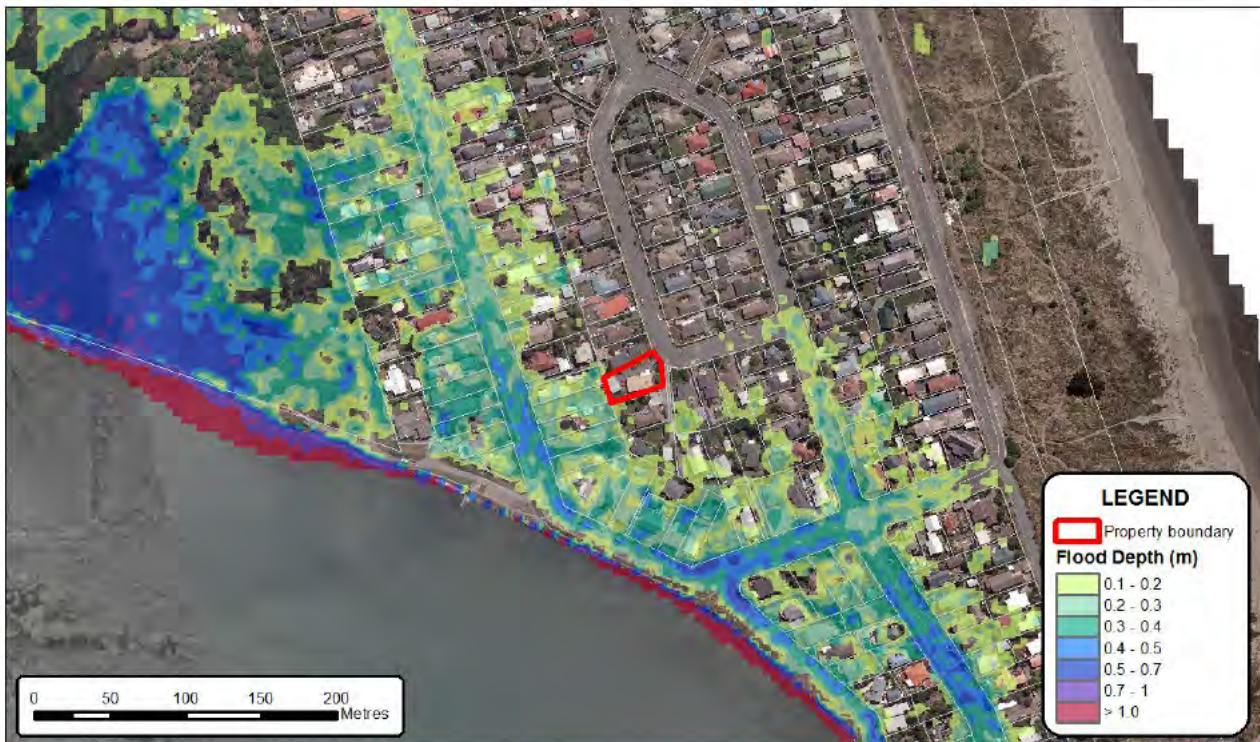
Map 2: Modelled flood depths for a 1 in 100 year flood event before Canterbury earthquake sequence

Map 2 shows flooding for the 1 in 100 year flood event before the Canterbury earthquake sequence.

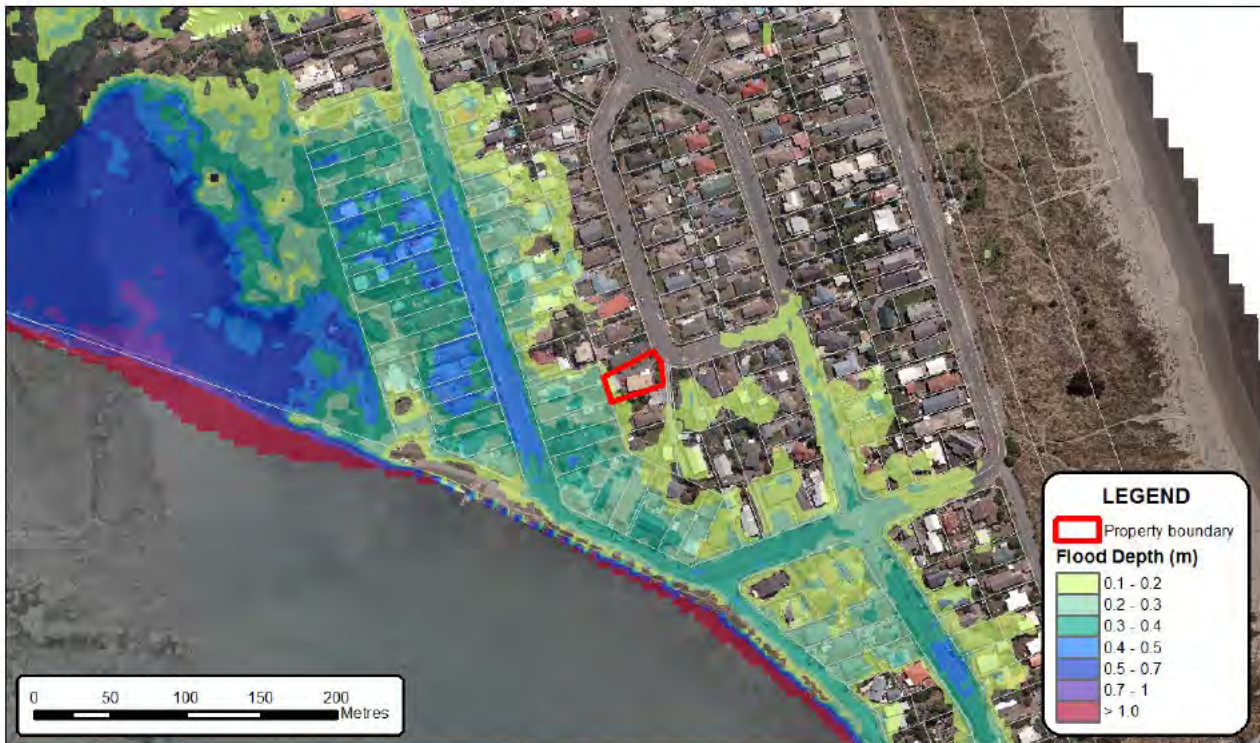
Map 3: Modelled flood depths for a 1 in 100 year flood event after the Canterbury earthquake sequence

Map 3 shows flooding for the 1 in 100 year flood event after the Canterbury earthquake sequence. EQC's flood model maps are available to technical professionals on the Canterbury Geotechnical Database.

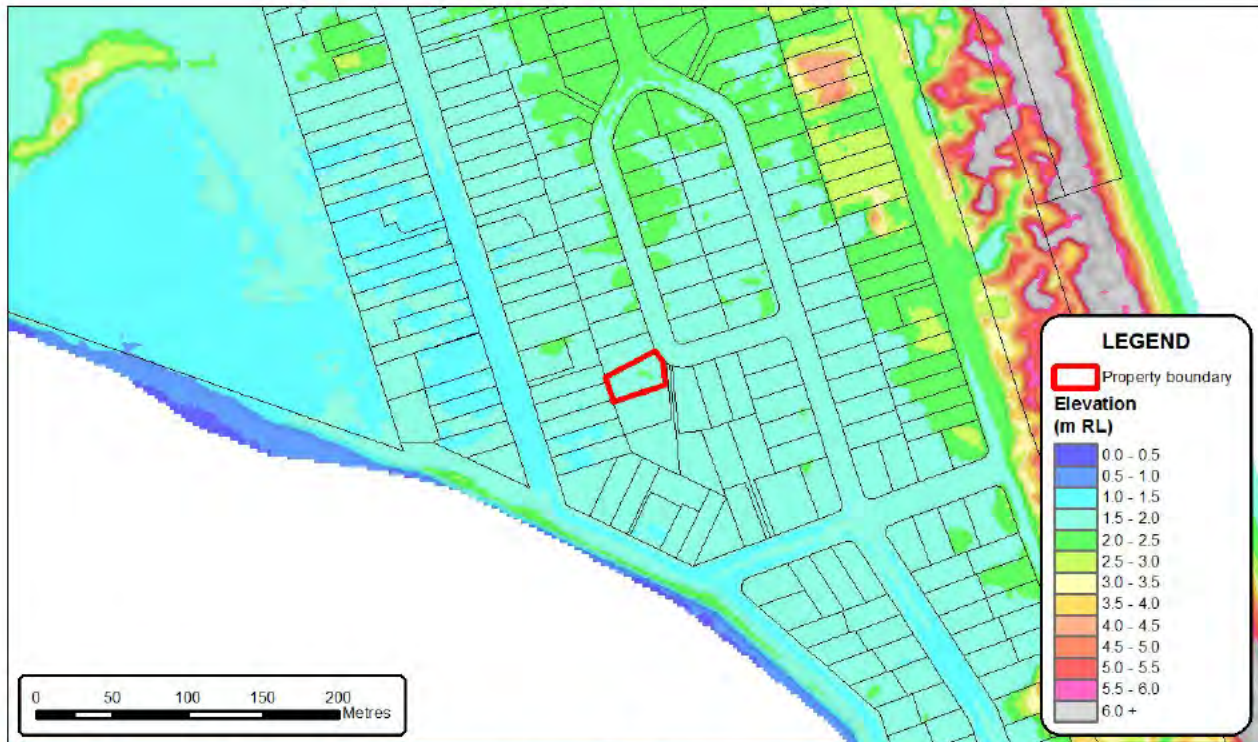
Map 4: Ground surface elevation post December 2011

Map 4 shows the ground elevation (i.e. the height of the land) following the Canterbury earthquake sequence. The ground surface elevation was measured using an aerial LiDAR survey (which involved scanning the ground surface

from an aircraft). This post-earthquake ground elevation survey is a key input into the modelling of the post-earthquake flood depth. Similar surveys were used as an input into the modelling of pre-earthquake flood depths.
