**KOROKORO, WOOLLEN MILLS AND
BIRCHVILLE DAMS**

SAFETY REVIEW

March 2013

Greater Wellington Regional Council (Parks)

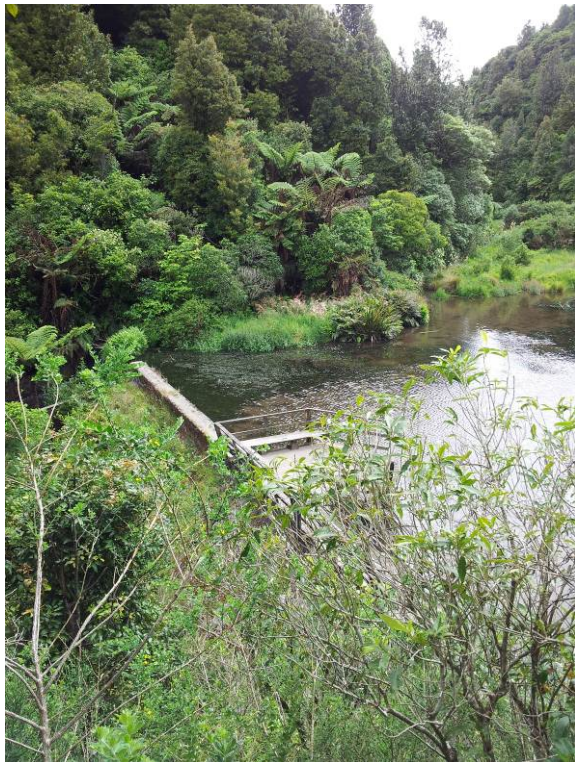
Both left and right abutments are heavily vegetated with no signs of instability (photos 1 and 2). There is no sign of erosion at the upstream contact of dam to abutment on either abutment. The downstream left groin is vegetated right to the dam contact (photos 2 and 9). *It is recommended that a 2m clear width be provided to allow ongoing inspection of this key area.* The downstream right abutment is vegetated right to the contact with the spillway chute (photos 3, 4 and 11). *It is recommended that selective trimming of overhanging vegetation be undertaken to allow ongoing inspection of this key area.*

Photo 1: Korokoro Dam looking upstream to head of reservoir. Spillway entrance in middle left.

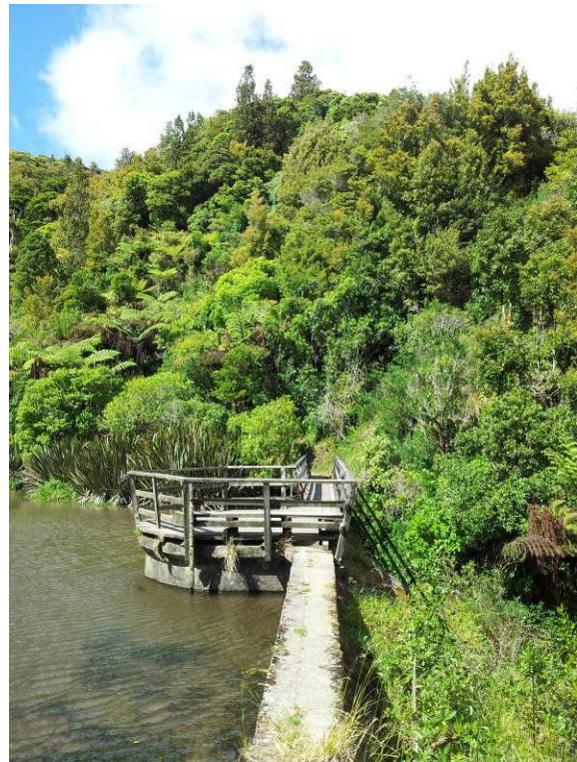
Photo 2: Korokoro Dam crest and left abutment. Note vegetation on dam downstream face and groin.

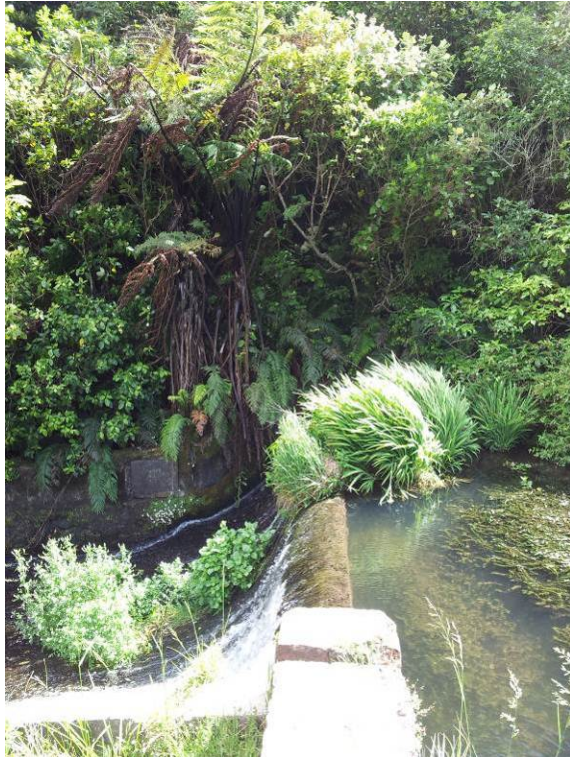
Photo 3: Korokoro Dam spillway crest and right abutment. Note vegetation in spillway chute and on abutment.

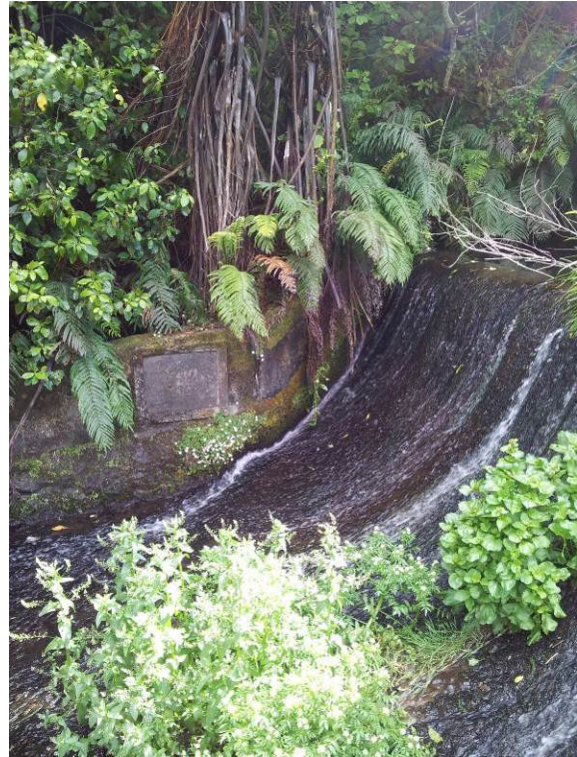
Photo 4: Spillway crest and right abutment contact.

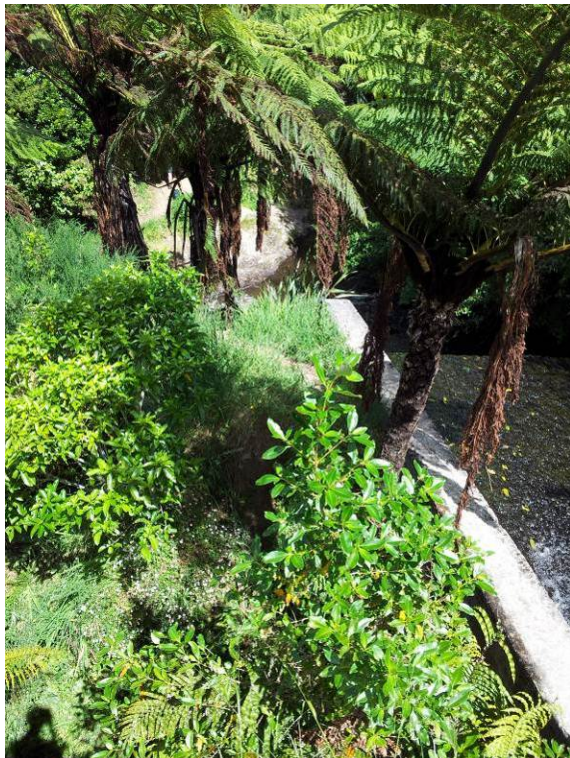
Photo 5: Looking down spillway chute and adjacent to left wall.

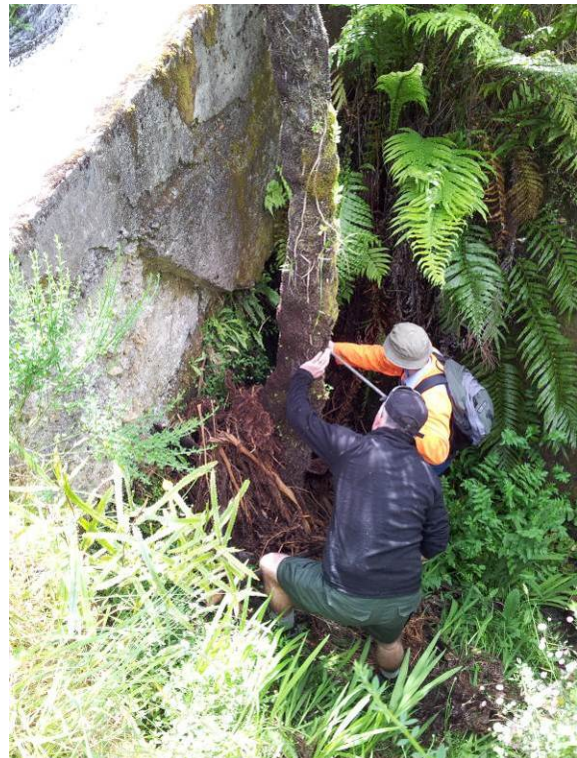
The dam is performing well except for significant seepage at the toe near to the spillway. It appears that the rate of seepage has increased with time and may be suggestive of erosion of the dam's foundation. Whilst this would likely not deteriorate rapidly nor lead to a rapid failure, a recommendation has been made to undertake regular monitoring of the seepage rate to characterise its behaviour with time and serve as an early warning of foundation piping.

Photo 6: Seepage emerging from poor quality concrete beneath spillway chute.

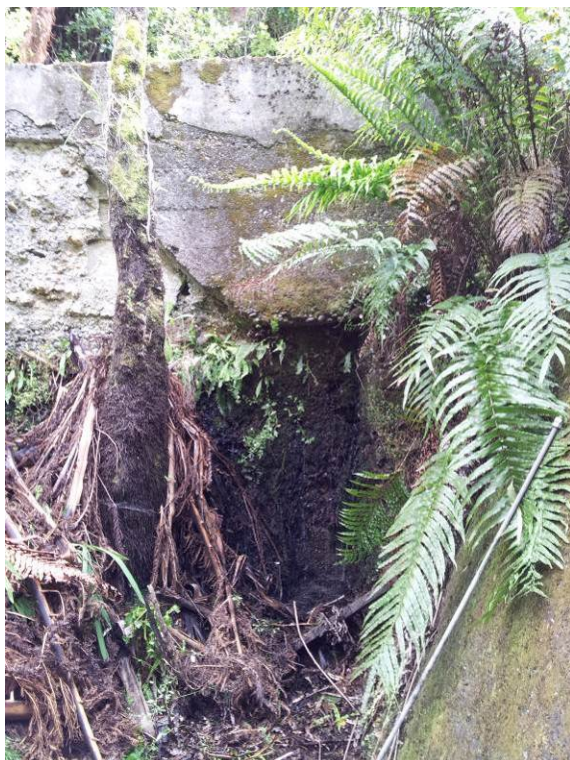
Photo 7: Seepage emerging from poor quality concrete beneath spillway chute.

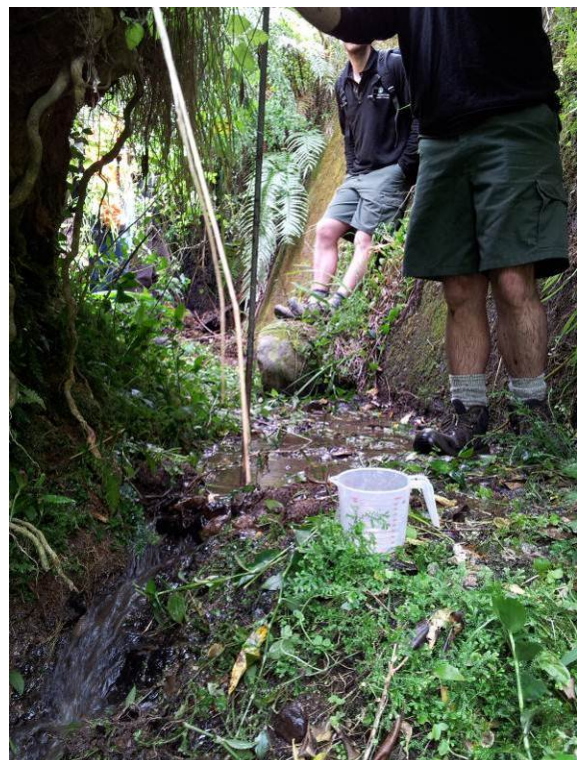
Photo 8: Seepage flow from beneath spillway chute and dam toe approximately 12 litres per min.

| Recommendation | Report ref. | Timeframe to address |
|--|---|---|
| <i>The downstream toe should be monitored during and after flood events and if undermining of the toe develops, remediation will be required. In the meantime it should remain uncovered so that toe seepage can be observed and measured.</i> | 5.2.2 | During and after floods |

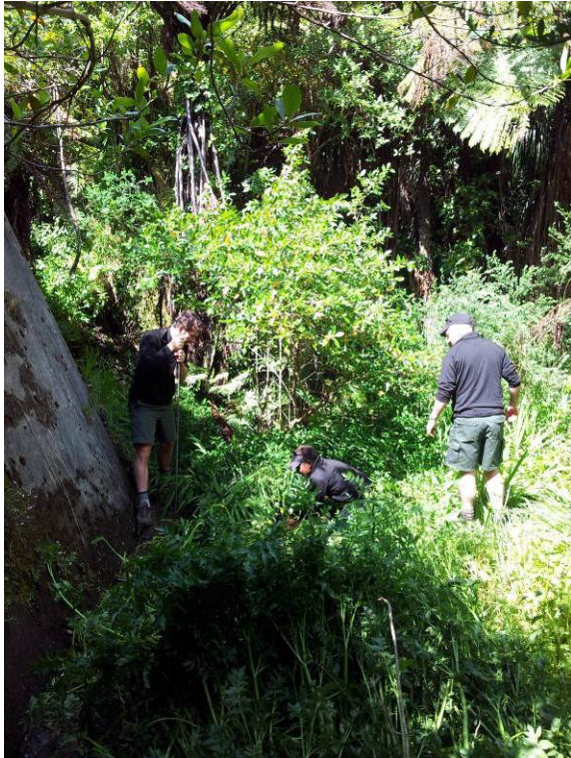
Photo 9: Vegetation cover on dam toe looking toward left abutment.

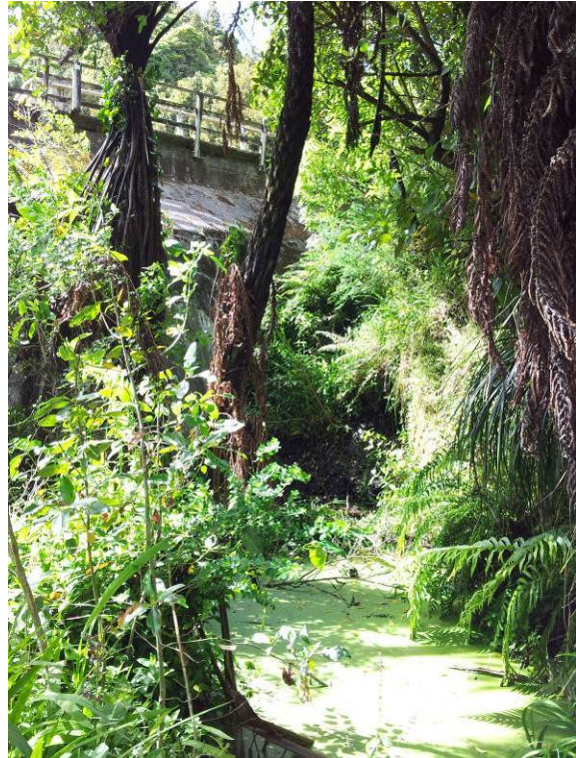
Photo 10: Water ponded at left side toe.

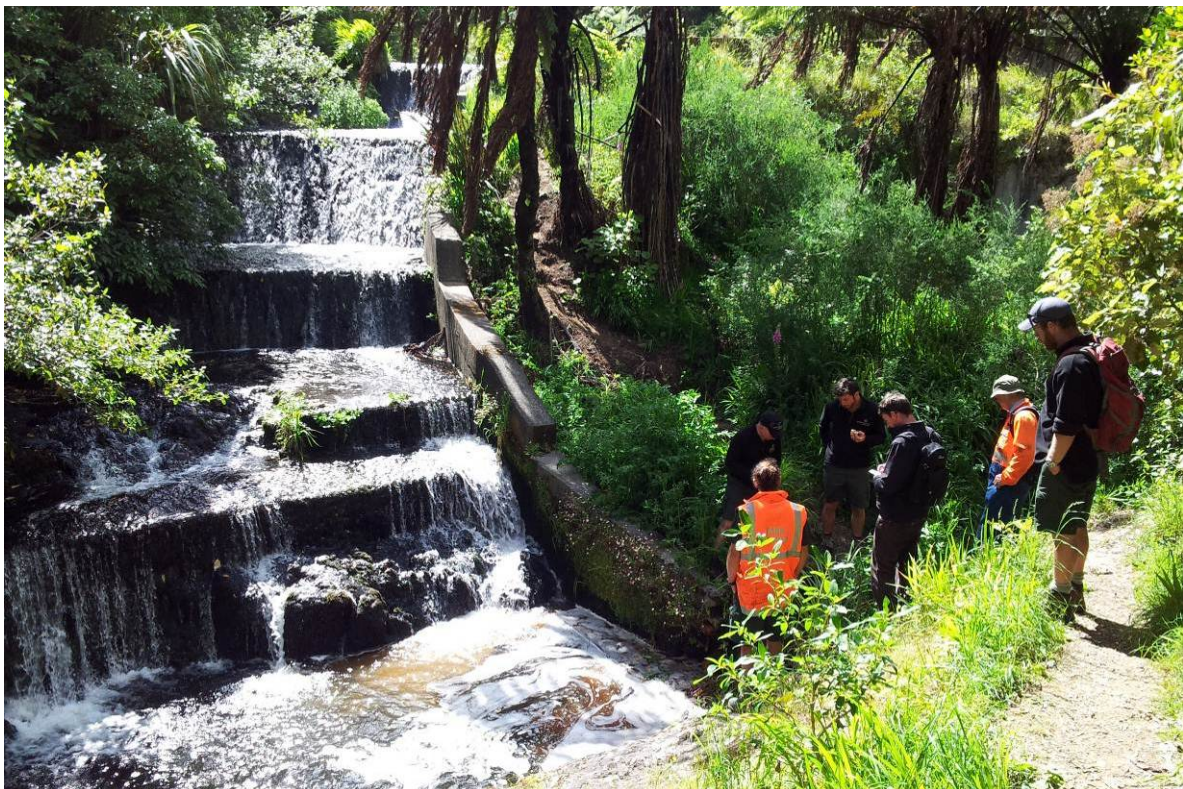
Photo 11: Spillway chute, plunge pool and downstream toe. Outlet pipe amongst people standing right of middle.

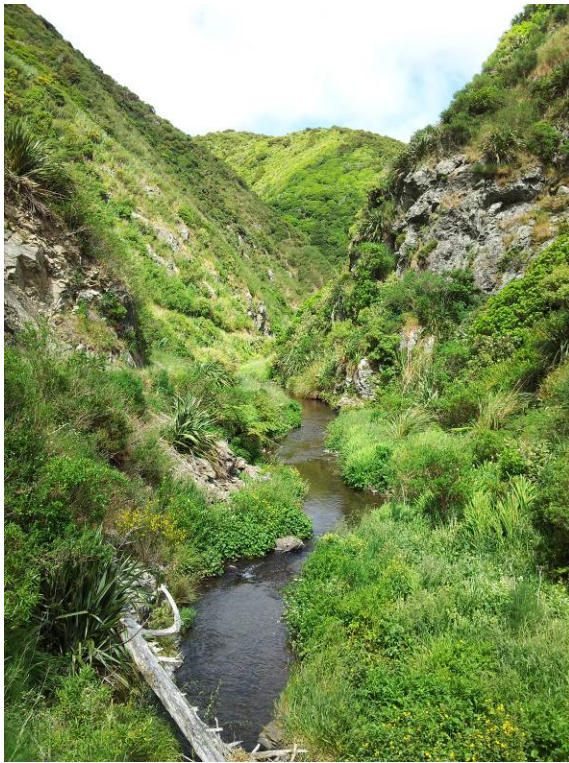
Photo 12: Typical valley profile downstream of Korokoro Dam and upstream of Woollen Mills Dam. Photo taken in downstream direction.

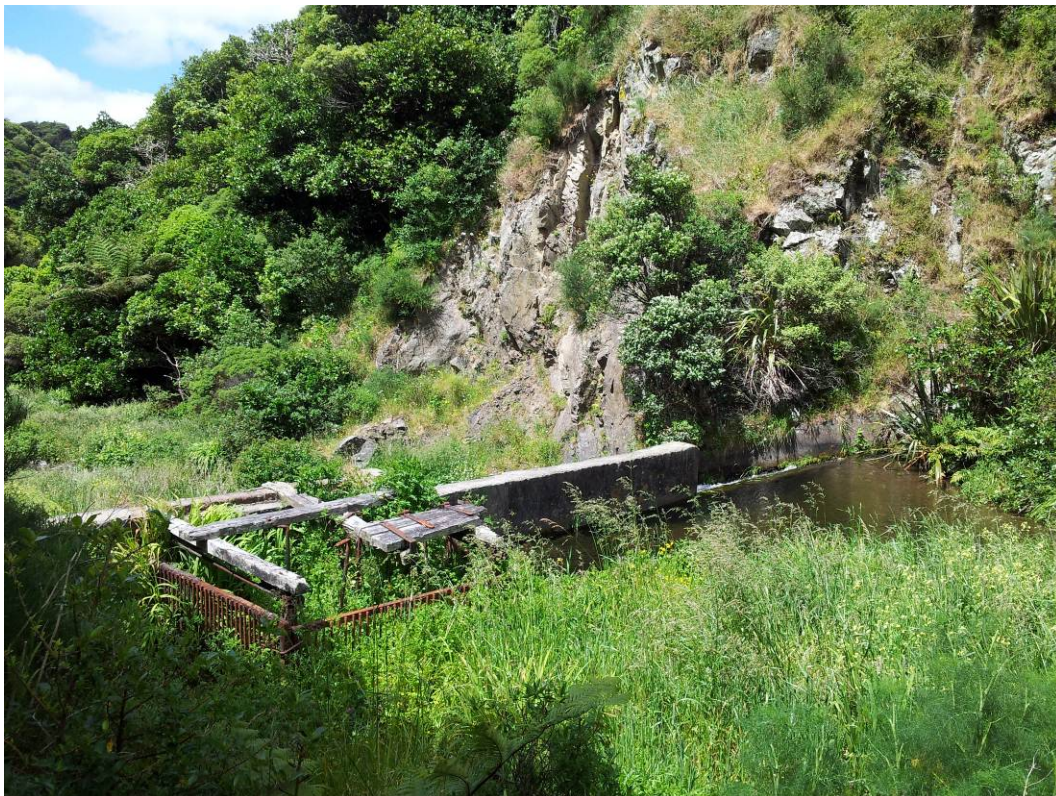
Photo 13: Woollen Mills dam and reservoir looking from upstream left abutment toward downstream right abutment. Note that the impounded reservoir is very small.

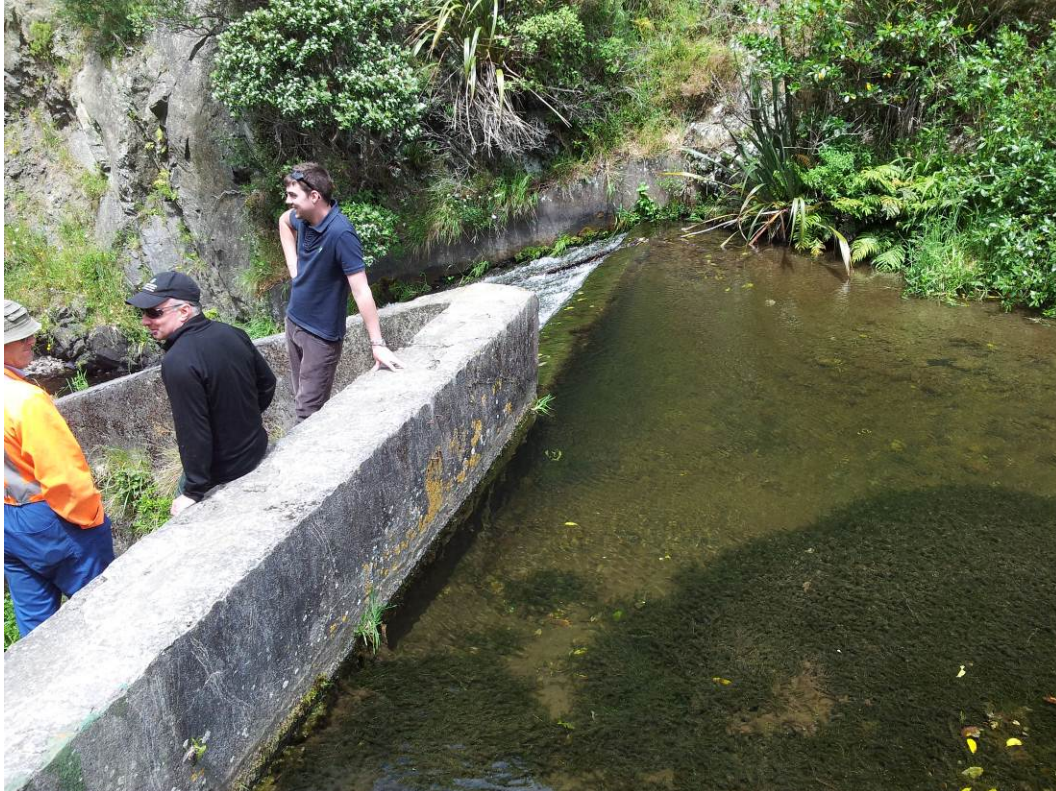
Photo 14: Woollen Mills dam upstream face, spillway crest, and right abutment. Note shallow depth to impounded gravels (less than 0.5m).

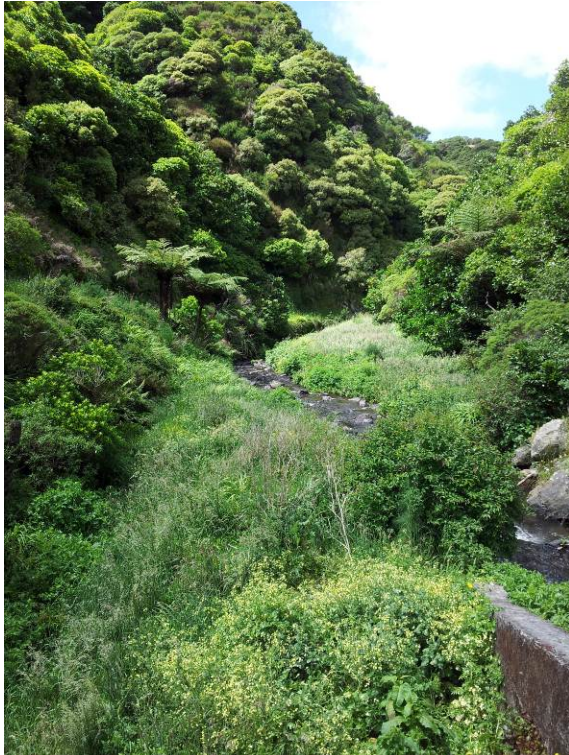
Photo 15: Looking downstream between left abutment and spillway chute wall.

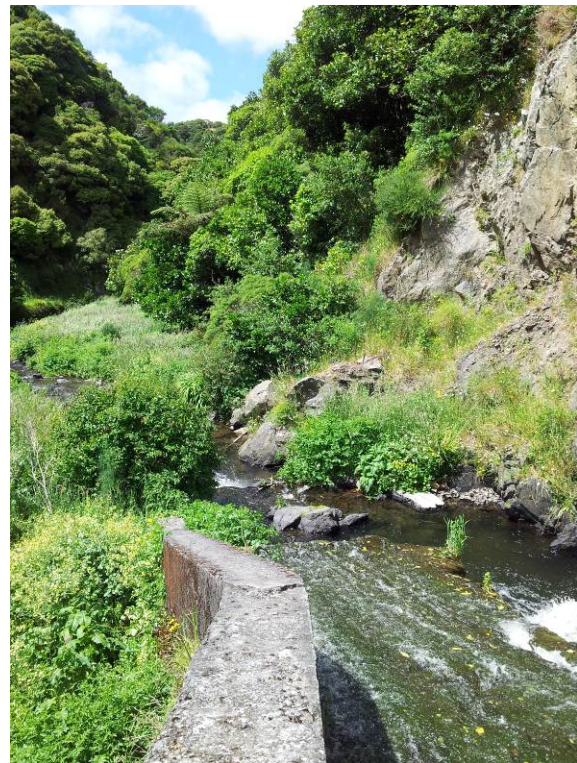
Photo 16: Woollen Mills spillway chute and wall looking downstream. Note rock-fall upper right in photo.

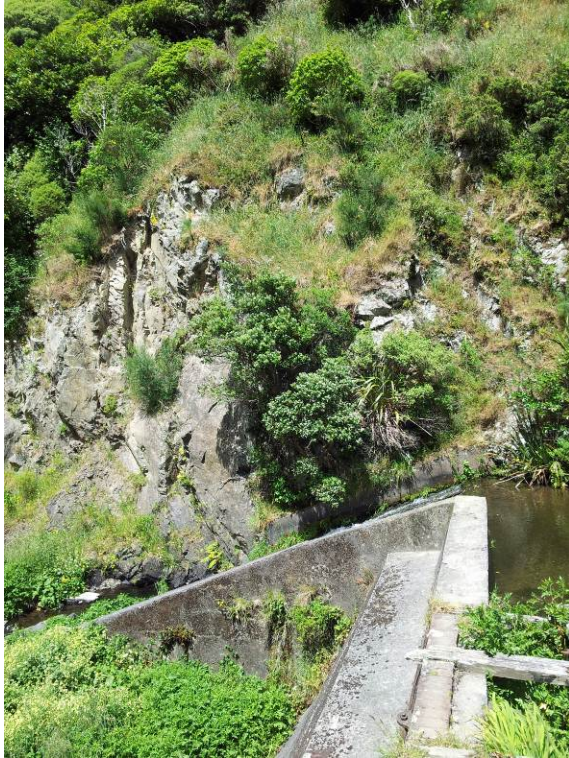
Photo 17: Woollen Mills dam crest, spillway chute wall and right abutment. Note rock-fall middle left in photo.

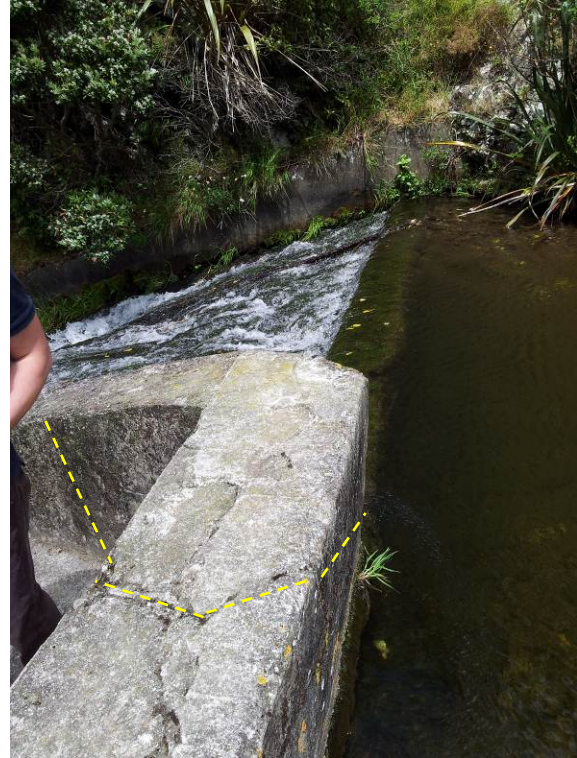
Photo 18: Woollen Mills spillway crest and chute. Crack extends down spillway wall, across dam crest wall and down upstream face toward spillway crest.

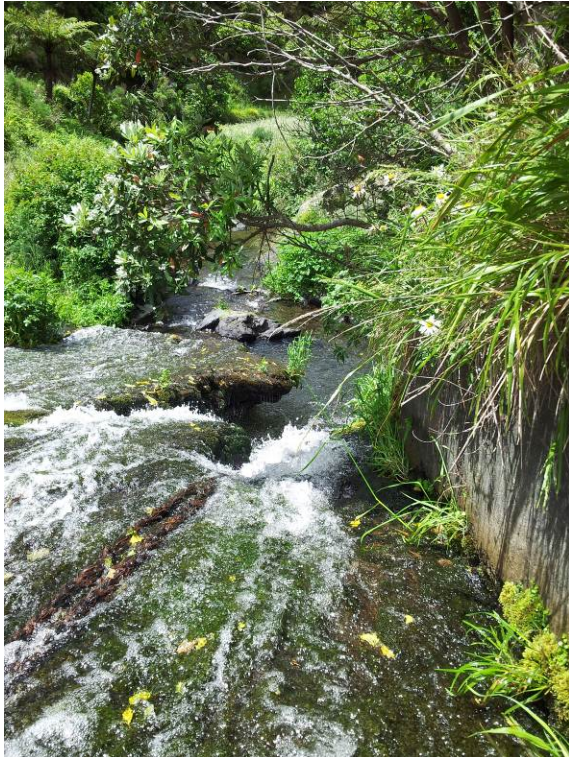
Photo 19: Spillway chute looking toward plunge pool. Note chute damage and overhanging vegetation.

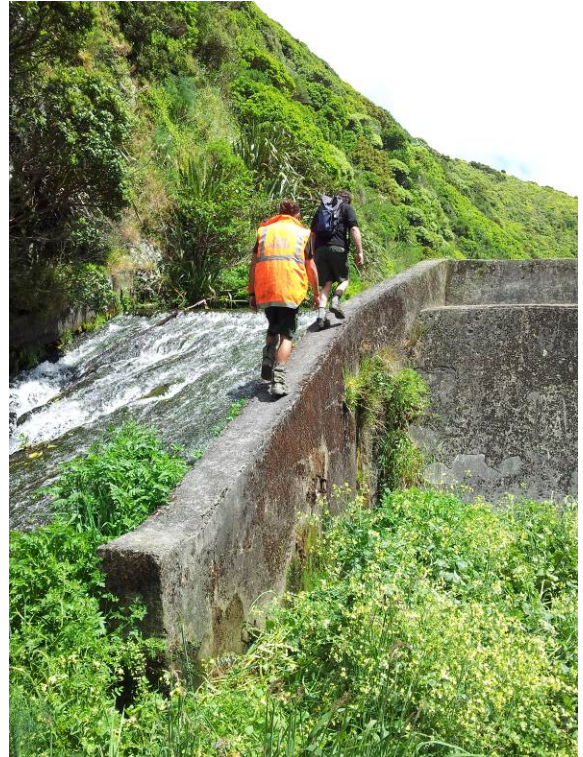
Photo 20: Spillway chute and chute wall. Dam toe obscured by vegetation.

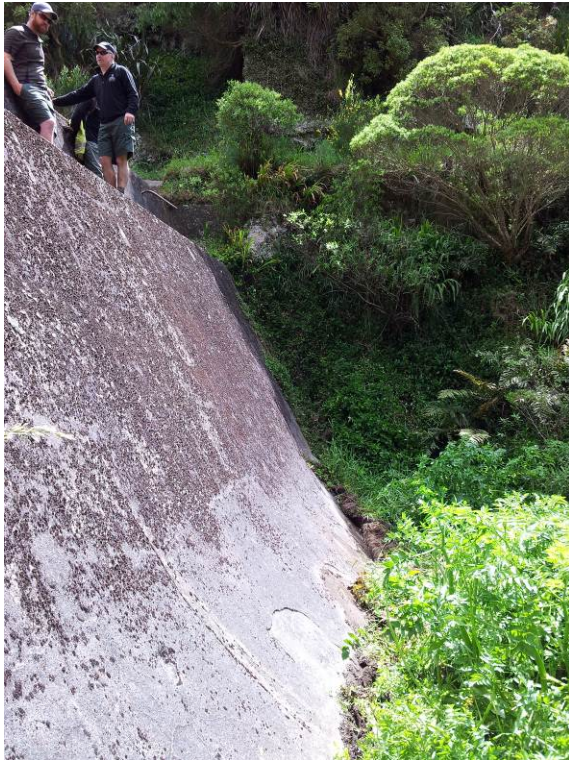
Photo 21: Dam downstream face and left abutment contact.

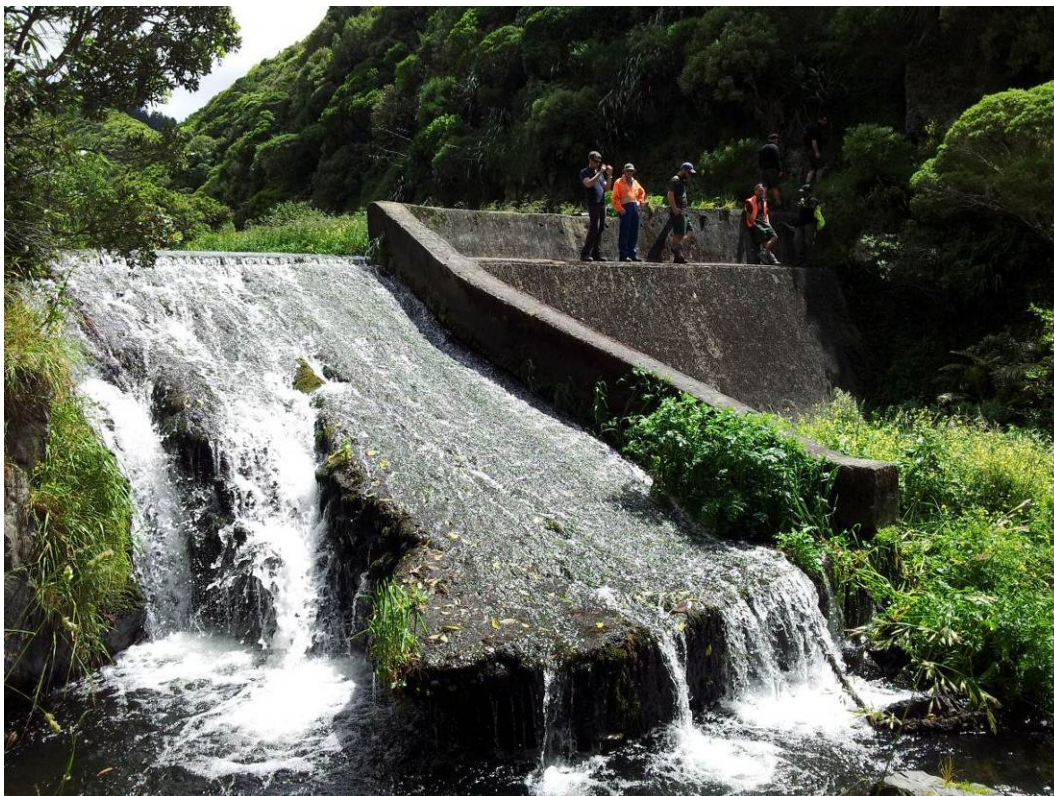
The dam is performing well except for major erosion beneath and at the toe of the spillway. This appears to have been initiated by rock-fall damage to the spillway chute and subsequent undermining by normal and flood flows. The extent of undermining has worsened significantly over the last six years and if it continues will eventually lead to the dam's integrity being compromised through removal of base and toe support. A recommendation has been made to

Photo 22: Woollen Mills spillway and dam looking upstream from toe of rock-fall. Note damaged spillway chute and major undermining. Probing with a long stick indicated a very large cavity under the remaining chute slab in centre photo. Cavity horizontal extent approx. 1.5m and depth approx. 2m.

| Recommendation | Report ref. | Timeframe to address |
|--|---|---|
| <i>The spillway toe undermining has worsened in the last six years and will need to be remediated before erosion removes material supporting the dam resulting in dam failure. In the meantime the extent of undermining should be regularly monitored, particularly after significant rainfall events.</i> | 5.3.2 | Remediate in next 12 months |

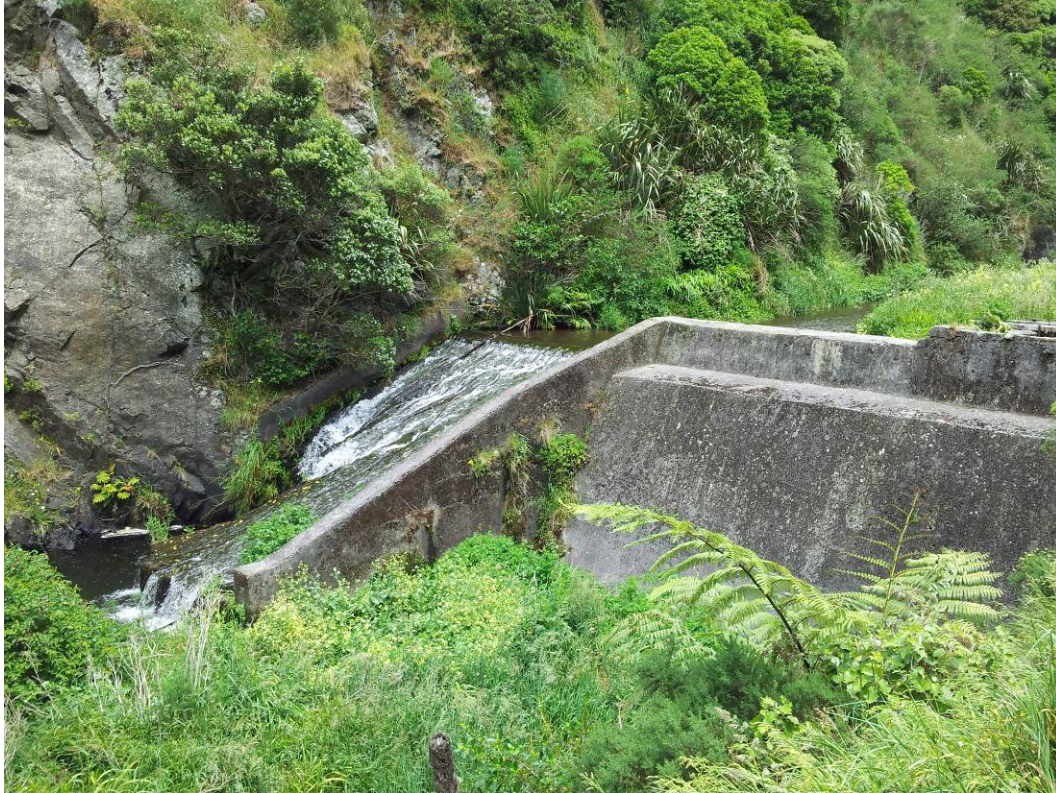
Photo 23: *Woollen Mills spillway and dam looking upstream from downstream left abutment. Note damaged spillway chute and visible extent of upstream regression.*

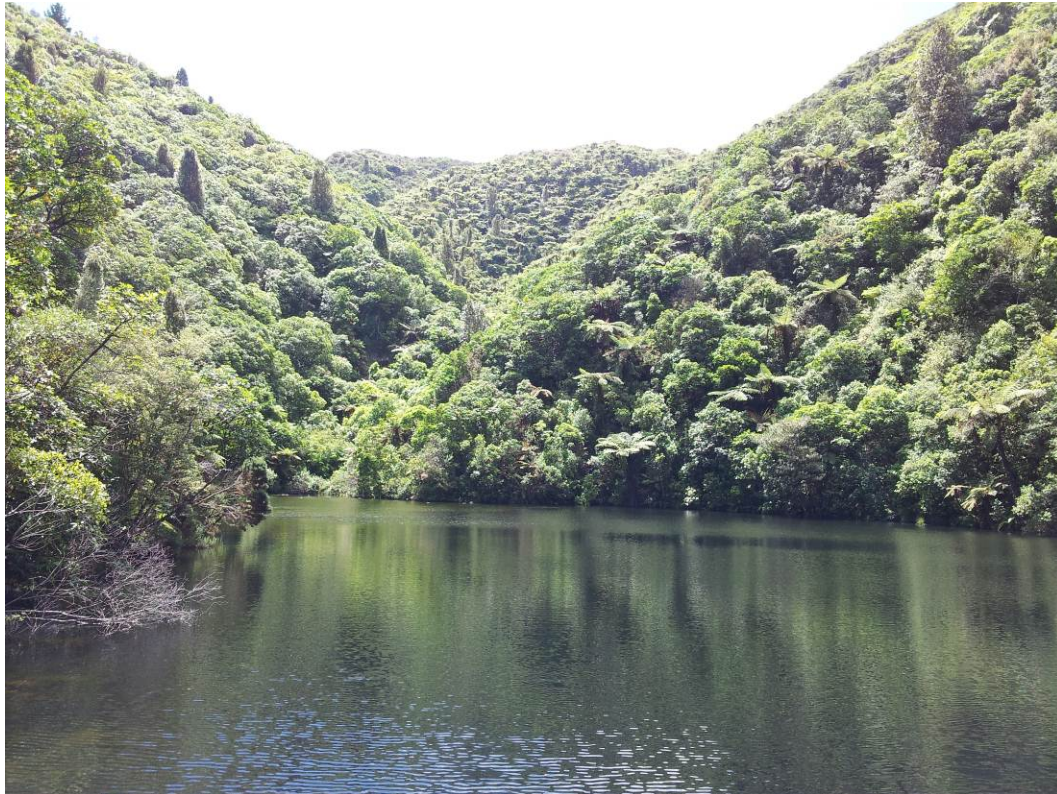
Photo 24: Birchville Dam reservoir

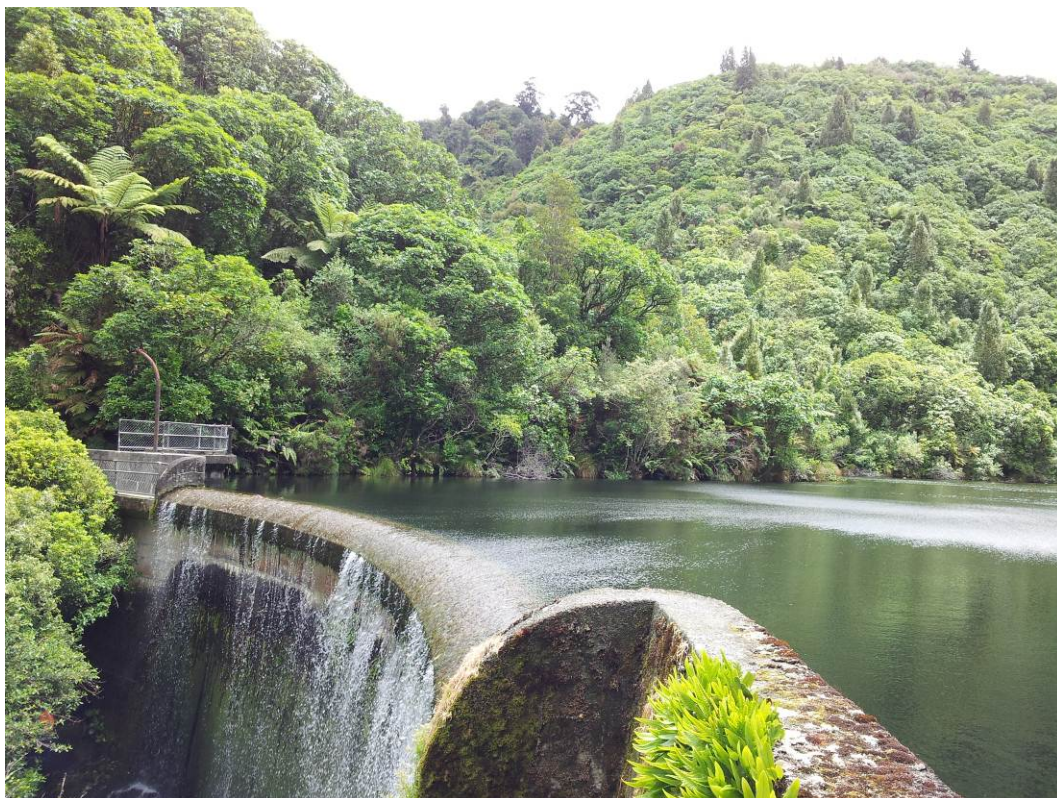
Photo 25: Birchville Dam spillway crest and right bank reservoir

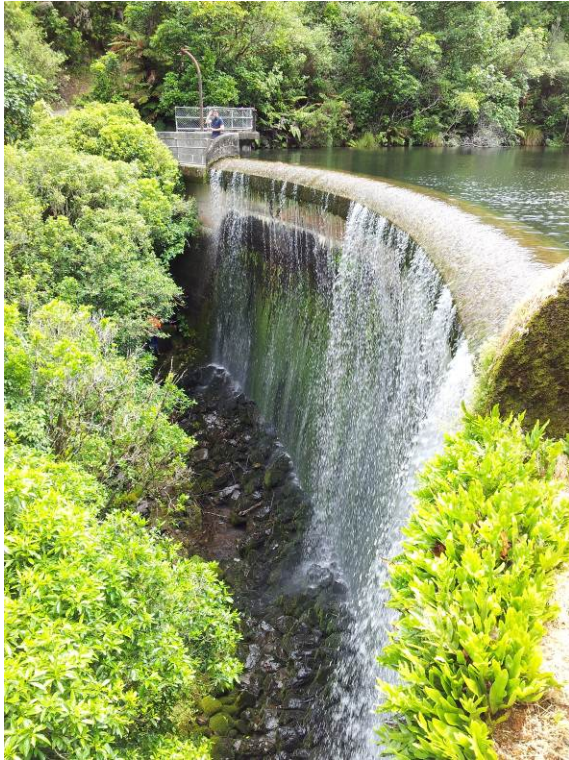
Photo 26: Birchville Dam spillway crest and toe from left abutment.

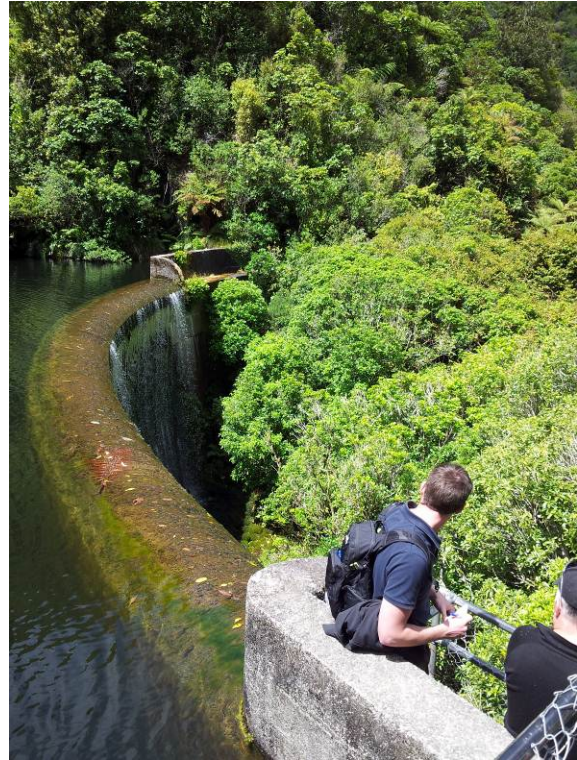
Photo 27: Spillway crest and downstream left abutment.

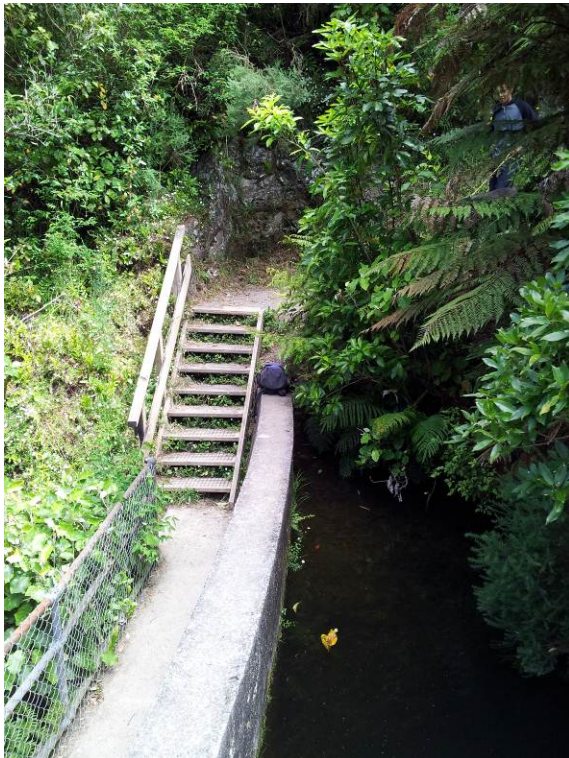
Photo 28: Dam contact with right abutment

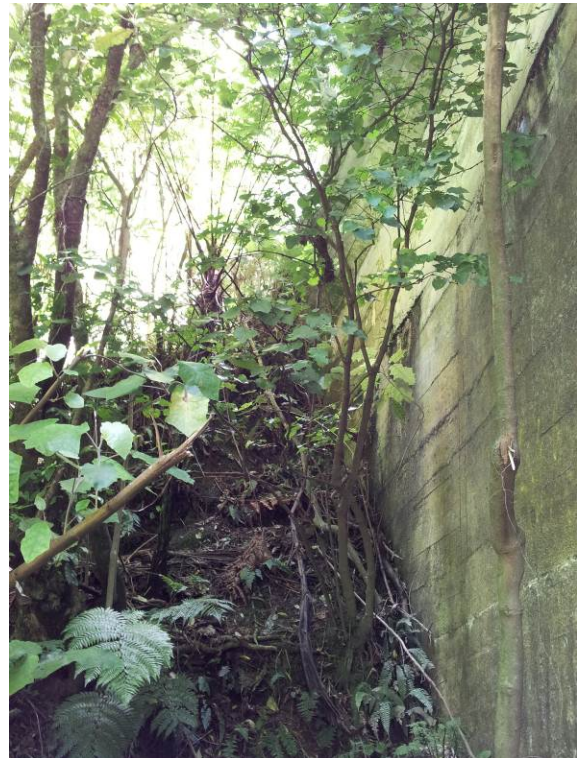
Photo 29: Downstream contact with right abutment.

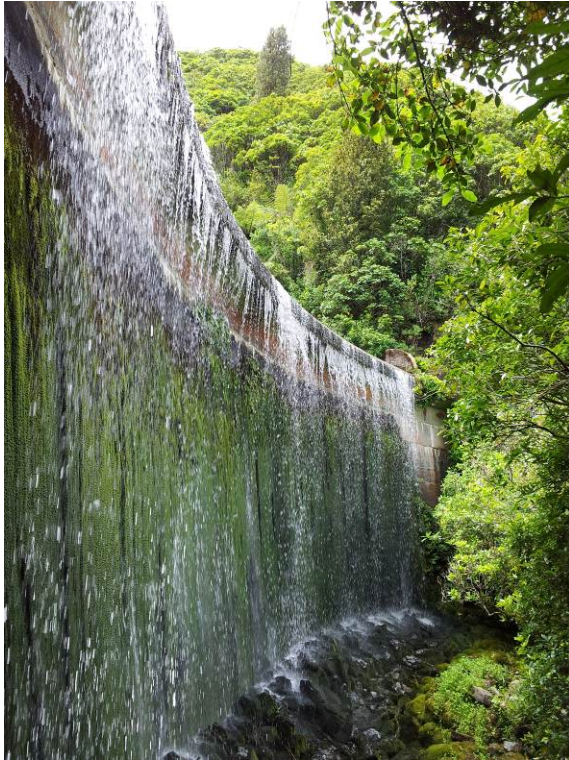
Photo 30: Downstream toe looking towards left abutment.

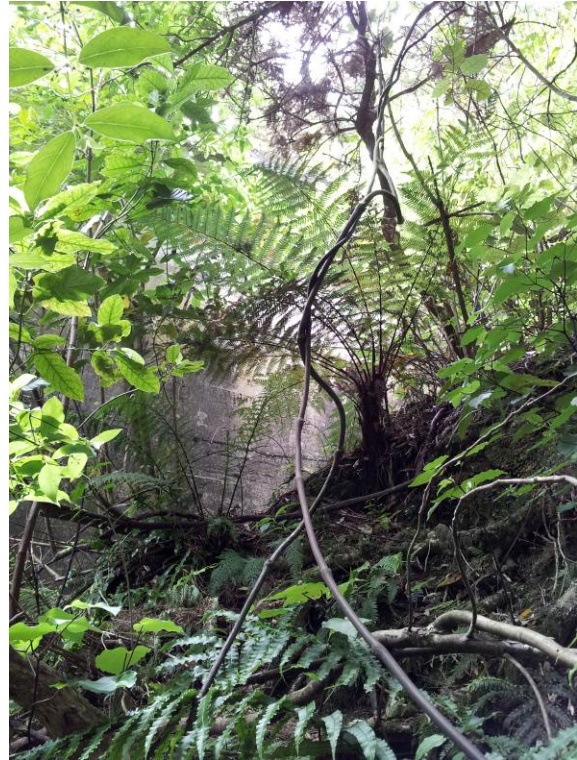
Photo 31: Downstream contact with left abutment.
