**Upper Hutt City Council Water Reservoirs
Seismic Assessment**

*Report for Capacity Infrastructure Services
March 2010*

Date: 17 June 2010
Reference: 5C1754.00
Status: Final Issue

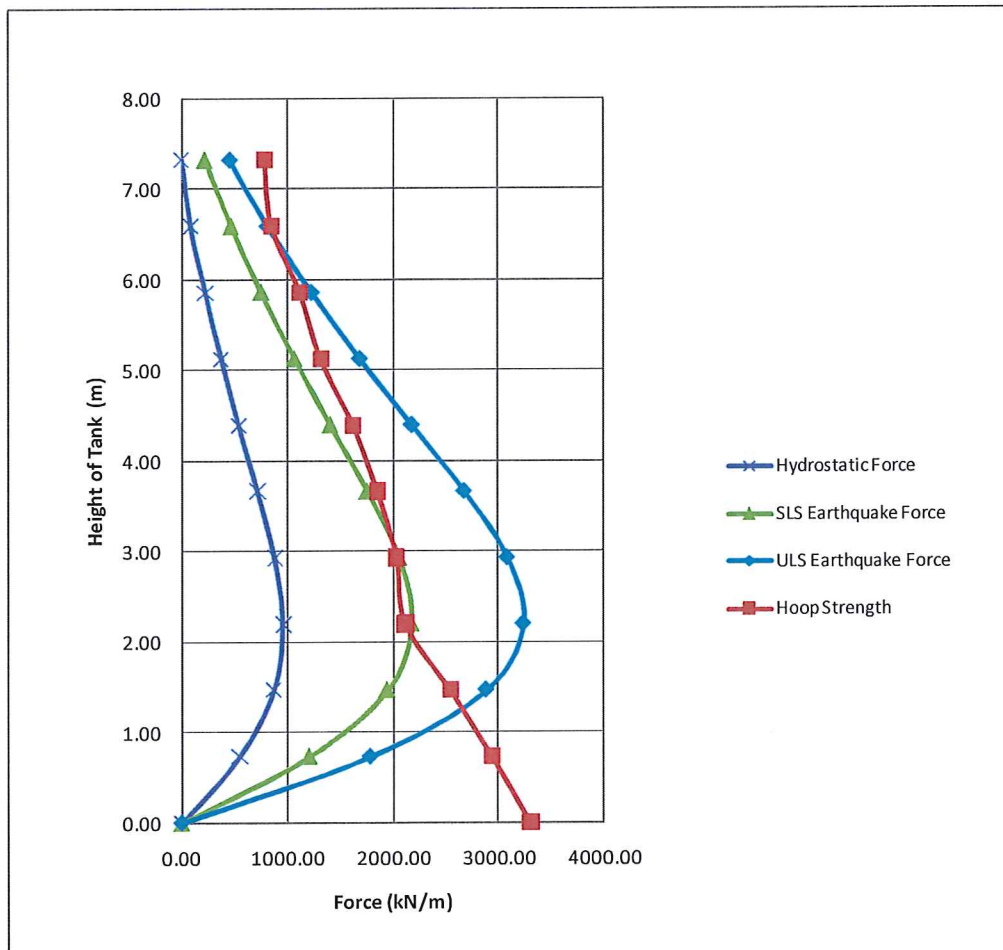
7.3 Trentham 2

Hoop force ratio = 1.0 SLS, 0.65 ULS.

Shear Action	Shear Capacity	Capacity/Action
42223 kN	32673 kN	<1

Wave height	Clearance Height	
0.61 m	0.487 m	OK

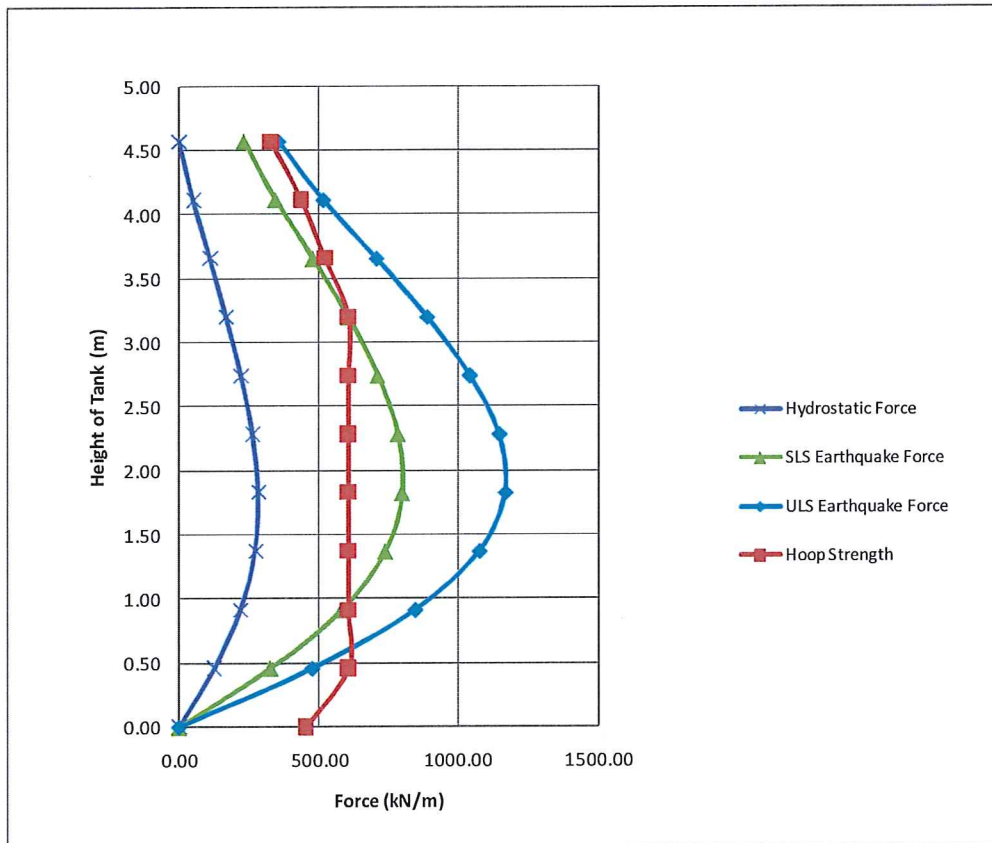
7.10 Trentham 1

Hoop force ratio = 0.75 SLS, 0.52 ULS.

Required	Provided	Minimum Requirement
0.00603	0.00148	NG

Shear Action	Shear Capacity	Capacity/Action
14670 kN	11287 kN	<1

Structural connection between floor and foundation NG

Trentham 1 is an older cast-in-situ reinforced concrete tank. Unsurprisingly given its age, the hoop reinforcement falls short of current seismic design standards. The hoop reinforcing is expected to yield in strong earthquake shaking resulting in permanent outward hoop displacements and permanent vertical cracking with rapid loss of contents. The floor is also not connected to the wall foundation, which could result opening of and leakage from, the floor joint.

It is possible to improve the reservoir's earthquake performance significantly by adding hoop reinforcement to the walls and connecting the wall footings to the floor slab.

One approach to adding hoop reinforcement is to construct a steel shell around the tank and fill the gap with grout. This approach was adopted for the Gracefield and Maungaraki reservoirs in Lower Hutt, although in those cases the remedial work was required to deal with severely corroded prestressing steel as well as insufficient hoop reinforcement. It would be relatively straight-forward to connect the wall footings to the floor slab with drilled and epoxied dowels. The rough order estimate of cost for the upgrading using the steel shell option is \$430,000. A less costly option of adding external, possibly prestressed, reinforcement might also be feasible.

Another remedial option would be to add a flexible, internal liner to the tank wall to prevent water flowing through the cracks. The rough order cost of this option is \$80,000.

The SLS hoop force ratio will increase to 1.0 if the water depth is reduced from 4.5m to 3.5m.
