## BRIDGE INSPECTION FORM

Road Name: <b>Bridge</b>		Bridge Name: <b>Andrew's</b>		Bridge No: <b>B8/1</b>	RP: <b>50</b>	District: <b>UHCC</b>	
Bridge Type: Prestressed Concrete				Report Type: <b>General / Principal / Posted</b>			
<b>Marking code</b> 0 = Not inspected 1 = Satisfactory 2 = Monitor next inspection R = Routine maintenance (provide comment) S = Structural maintenance (provide comment) N = Not applicable		Overall Condition Category:	Deck width: 3.70	Posting:			
		Condition: <b>Good</b>	Total Bridge length: 42.60	Axles:			
		Expected Life: <b>20 - 40</b>	No of Spans: 2	Gross:			
			Span: of	Speed:			
			Span length:	Design Loading: <b>H20-S16</b>			
			Construction Date: 1954	Bridge Rating:			
<b>Element</b>			Inspector: <b>N. Moon</b>	Next Inspection Type:			
			Date: <b>29/7/15</b>	Date (mth/yr)			
Set	No	Description	Mark	Brief description of fault and comments			
Superstructure Elements	1	Primary load carrying element	2	Minor spall to LH span B2 bottom flange

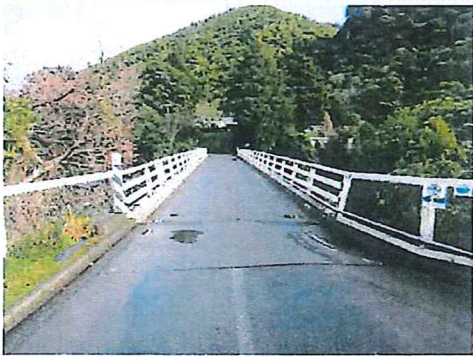
Left hand approach - Note settlement and ponding.			Right hand approach - Note ponding of deck - Drainage to be improved.

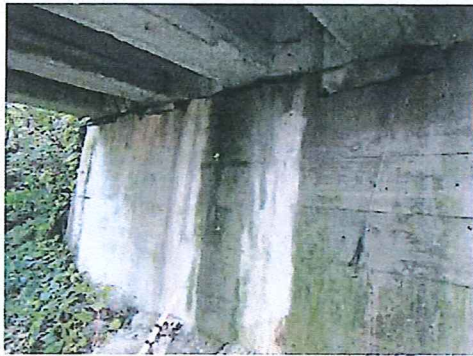
Left hand abutment - Note deck joint leaking.

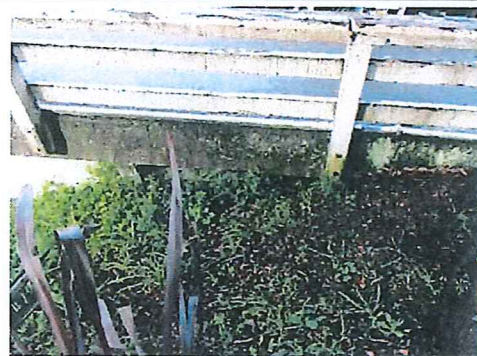
Right hand abutment - Very limited access.

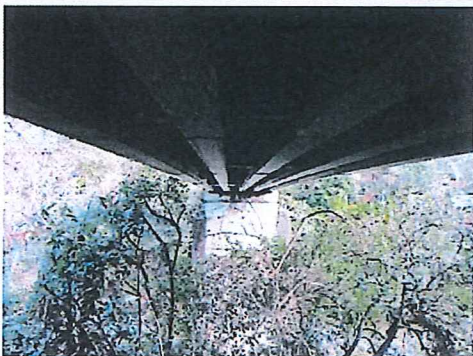
Centre pier - Note clearing of flood debris ideally should be carried out. - Review if scour resulting from the flood debris is exposing the piles of the original bridge's pier.

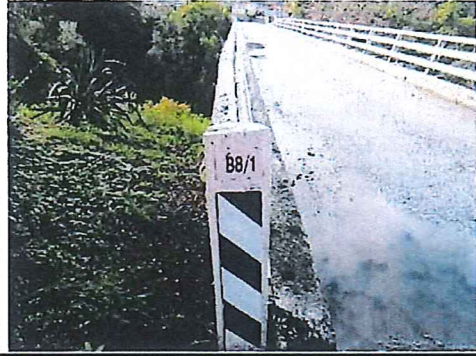
Ponding to right hand upstream approach.

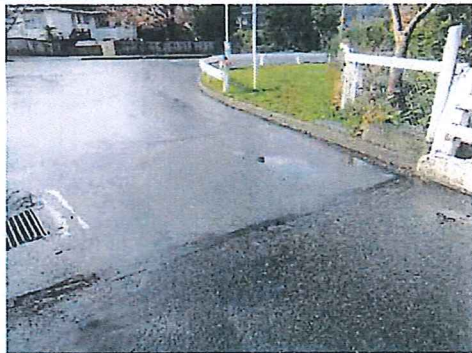
Monitor settlement of left hand approach.

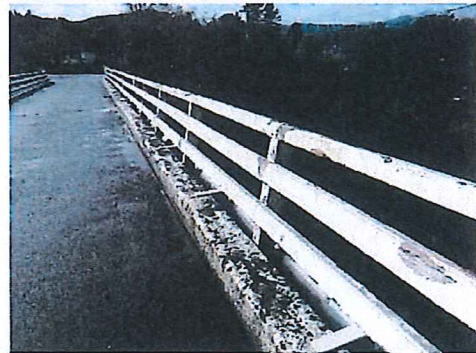
Repainting of timber kerbs and handrails required - No decay detected to the rails.

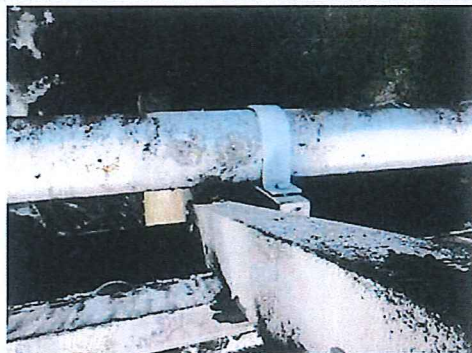
Monitor corrosion of handrail fixings - Note nut failed, no movement detected.

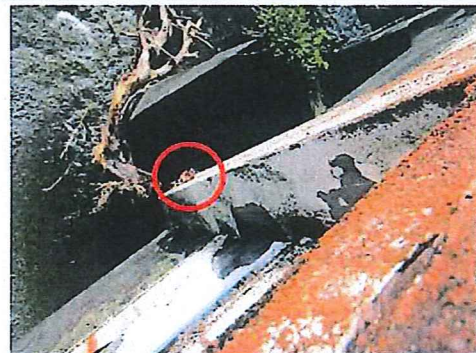
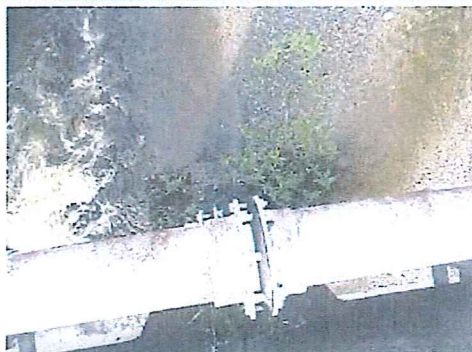
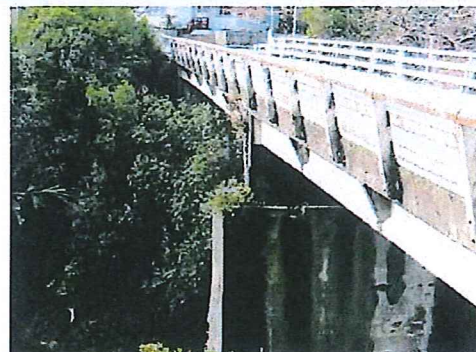
Clearing of vegetation from pier caps is an outstanding action.

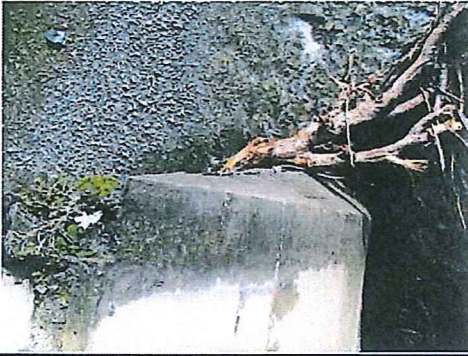
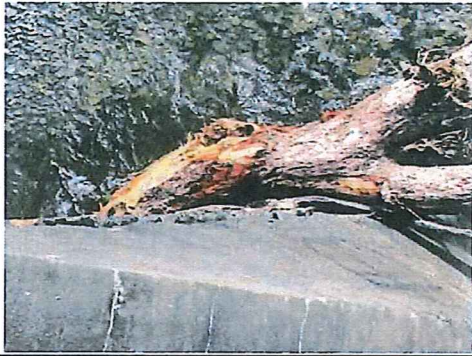
<p>Flood debris at pier - Note cracking of solid plaster.</p>	<p>Close up of pier nosing - Appears that a timber nosing was in place which has failed.</p>

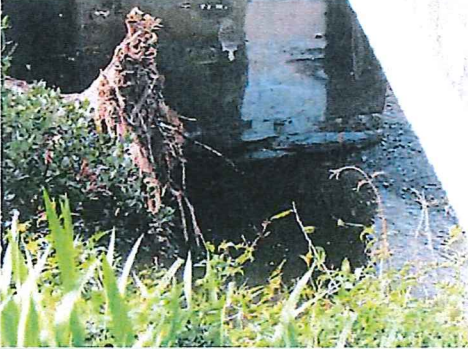
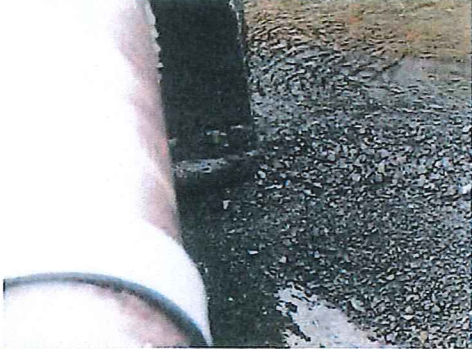
<p>Monitor minor scour to downstream of the central pier - Note beach area which would allow access to the pier from a boat/kayak.</p>

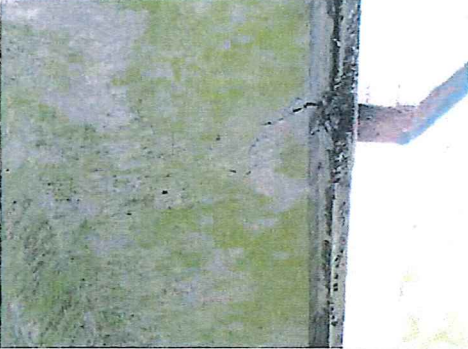
<p>Monitor minor spalling to edge of left hand span upstream deck soffit.</p>	<p>Left hand abutment beam detail.</p>

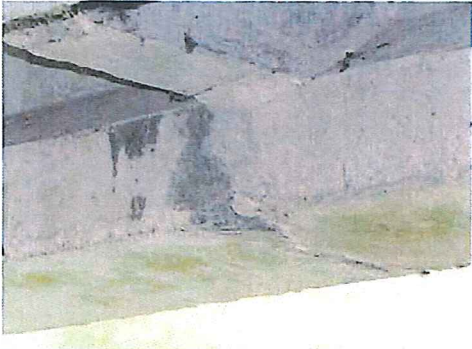
<p>Diaphragm infill detail.</p>	<p>Poor construction of LH span B2 main beam bottom flange, reinforcing steel exposed.</p>
