Waikaraka Park - Grandstand Concrete Inspection Review

Prepared for Downer NZ Ltd (Client)

By Mannco Consulting Ltd (MCL)

10 October 2014

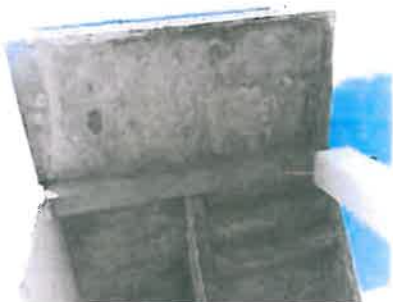
3. Location of cracks from upper South landing support beam

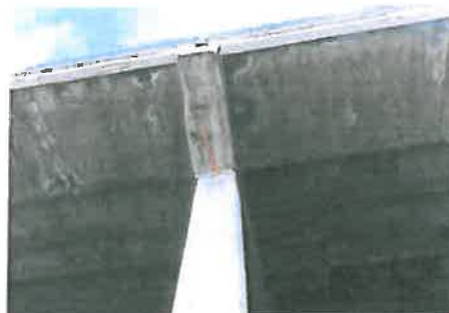
4. Location of cracks in cantilever beam

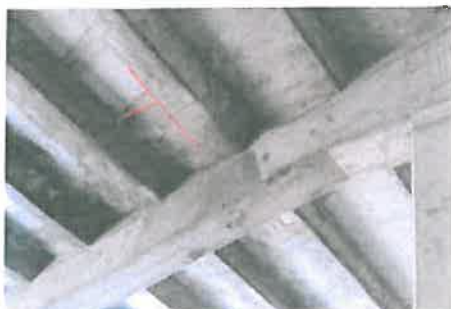
5. Location of cracks in upperside of upper terrace seating

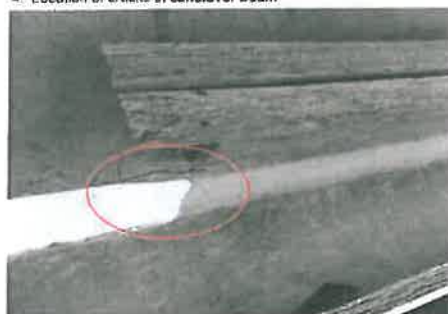
6. Location of cracks in lower terrace seating

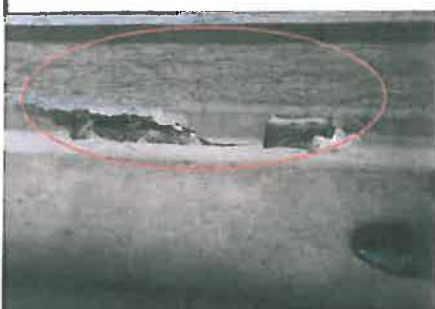
7. Location of spalling concrete in lower terrace seating

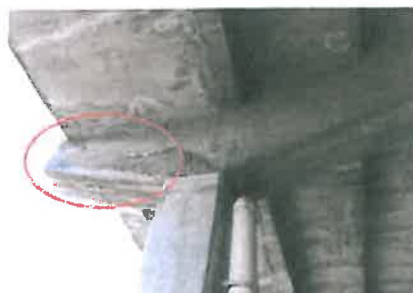
8. Location of cracks in patching of upper terrace beam

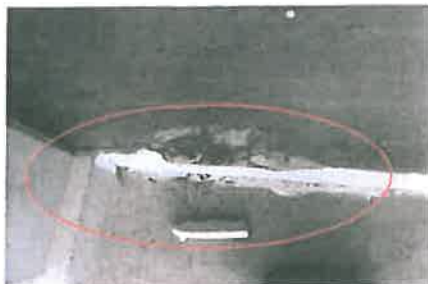
9. Location chipped off corner concrete in terrace aisle walkway

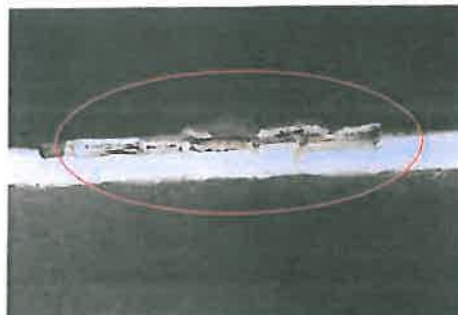
10. Location blown off cover concrete and rusting reinforcement

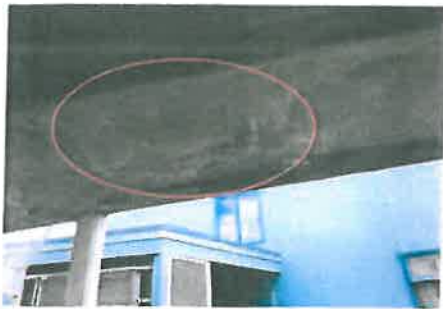
21. Location of cracks in patches in main beam under upper terrace

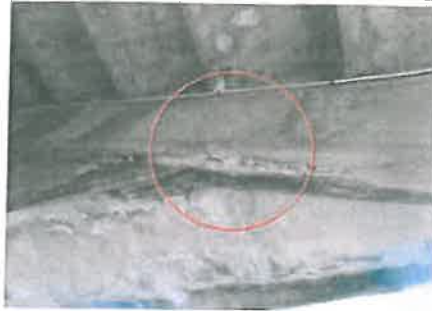
22. Location of cracks in main beam under upper terrace

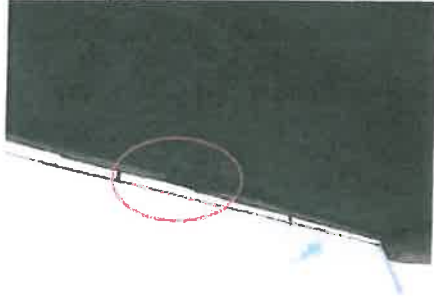
23. Location of failure of trim beam across front of upper terrace

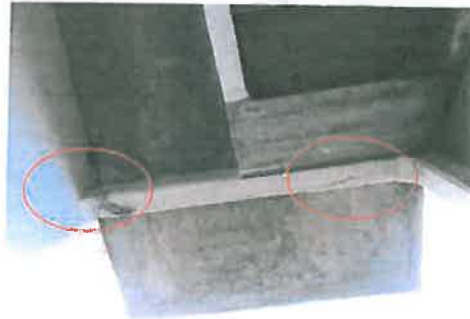
24. Location of failure cracks in upper Nth landing stair beam

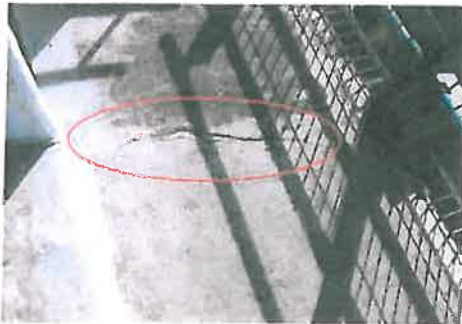
25. Location of cracks in upper deck

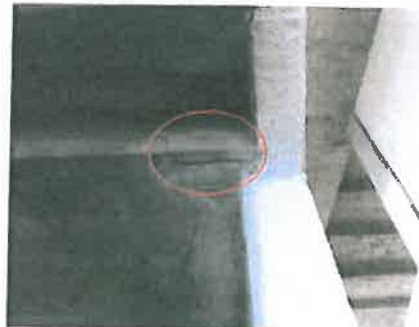
26. Location of cracks in exterior concrete stairs

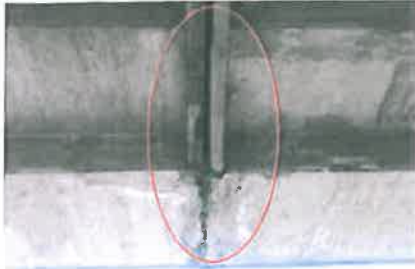
13. Location of cracks in upper dividing joint patches support beam

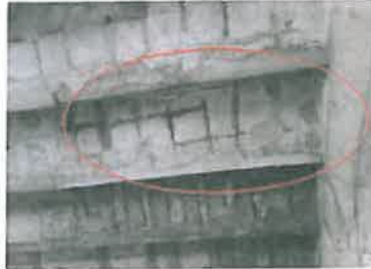
14. Location of cracks surrounding previous patches in underside of upper seating

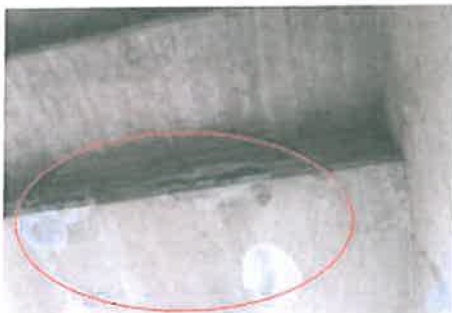
15. Location of concrete efflorescence in upperside of upper terrace seating

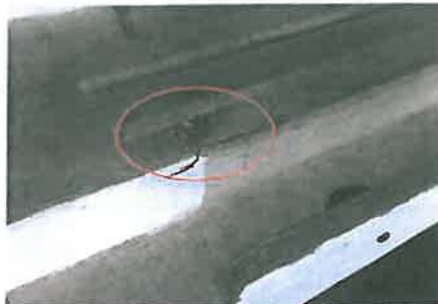
16. Location of cracks in patches of lower terrace seating

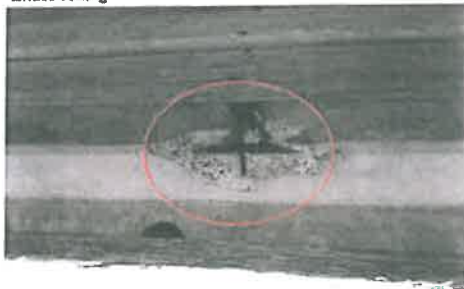
17. Location of brusing reinforcement in lower terrace seating

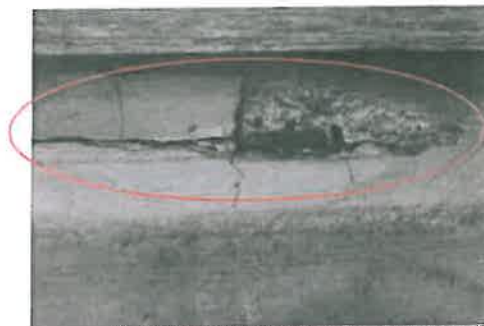
18. Location of rusted through reinforcement in lower terrace seating

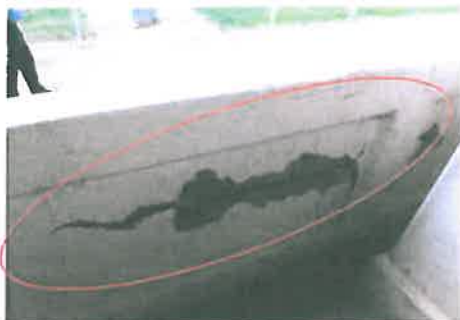
19. Location fallen off cover to rebar in lower seating front wall

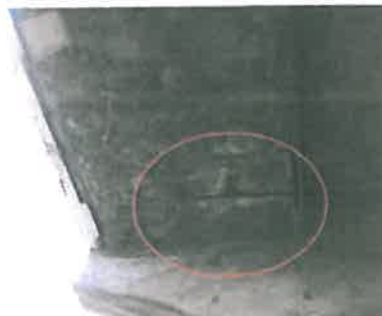
20. Location blown off cover concrete and rusting reinforcement in underside of upper terrace seating
