20 December 2014

WAIKARAKA PARK GRANDSTAND – STRUCTURAL CONDITION AND IMMEDIATE PUBLIC SAFETY ISSUES

Appendix - Reference Photos:

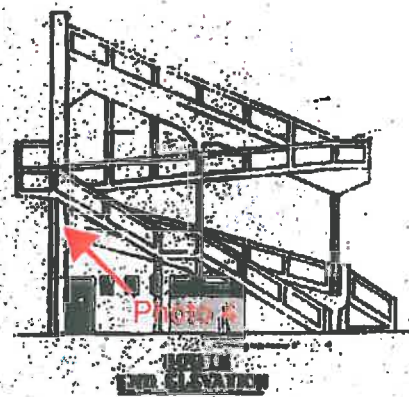
South Stair

1. The underside of the two concrete stair structures at the North and South ends:
= Areas of cracked concrete that represent an over-head hazard if they dislodge.
We recommend;

- For immediate, on-going use, install 9mm minimum plywood linings across the underside of these two structures, packed off battens and framing, to support any patches of concrete that may come loose. This would need to be applied to the underside of the upper-ramp on the Northern stair as well (as this sits over a public-access route).

- Install a new 75x6 SHS strut between the top of the main stair column and the main structure adjacent, with 2xM12 concrete fixings each end.
 - If the intention is to continue to use the structure past April 2015: Breakout all loose concrete, clean back all exposed reinforcing steel, treat the exposed reinforcing steel with a rust-inhibitor paint, grout/mortar patch these areas, and apply a suitable paint or protection coating.
