**386 – 388 FERGUSON DRIVE
UPPER HUTT
DETAILED SEISMIC ASSESSMENT**

Kevin O'Connor & Associates Ltd Reference: 113400

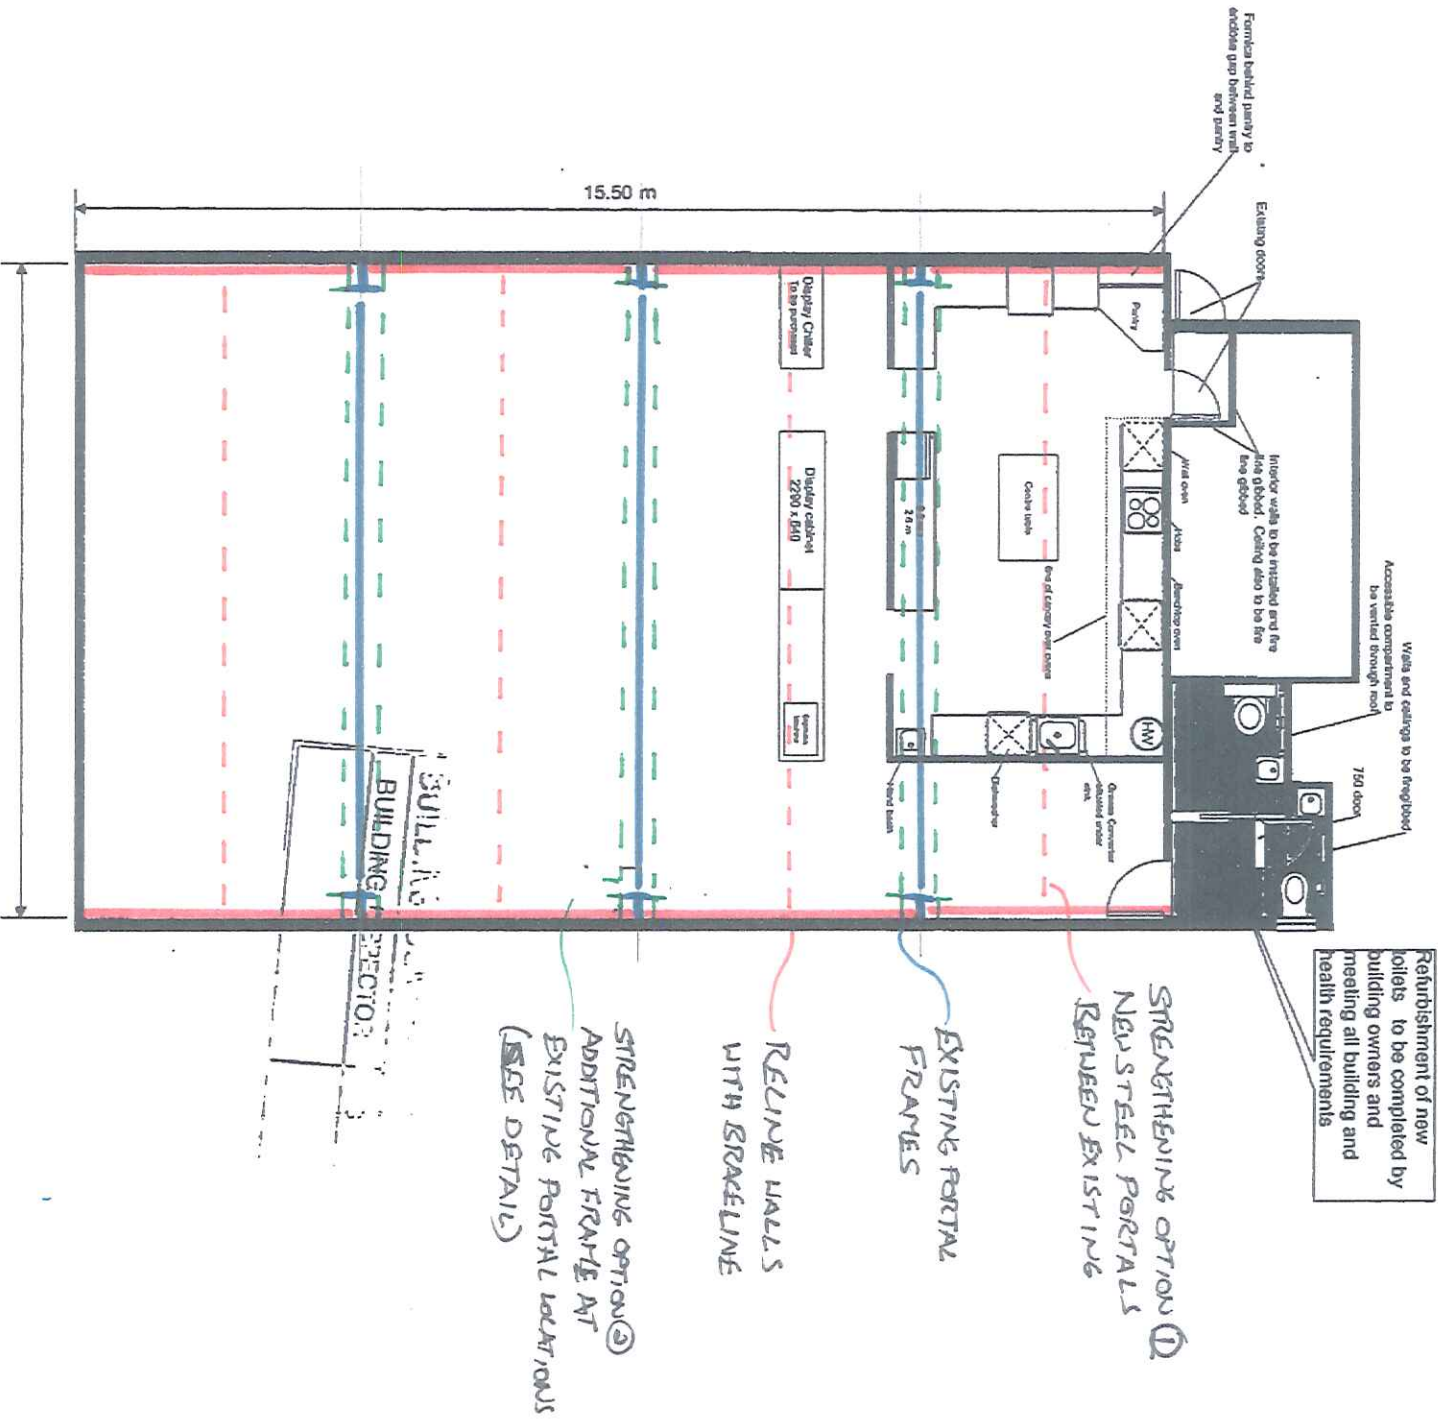
113400 - FRONT HALL.

Element	Aspect	%NBS	Comments
<u>Front Hall</u>	Across	Portal Frames	~40%	New portal frames or additional steel to existing frames
		Floor Diaphragm	~70%	Deemed acceptable risk
	Along	Walls	~40%	Re line walls with bracing (88%)
<u>Rear Hall</u>	Across	Portal Frames	66%	Deemed acceptable risk
		Partially Filled Block Walls	60%	Deemed acceptable risk
	Along	In Plane	Out of Plane	Acceptable

Based on the results shown in the tables above, the front building is considered Medium Risk in both directions with a seismic strength of approximately 40% NBS. This corresponds to the building having around 9 times the risk of its strength being exceeded due to earthquake actions than an equivalent fully compliant new building.

- NEW GIB BRACE LINE WALL LINING
 - OPTION 1 - NEW PORTALS BETWEEN EXISTING
 - OPTION 2 - NEW FRP PORTAL EITHER SIDE OF EXISTING
- SEE DETAIL.

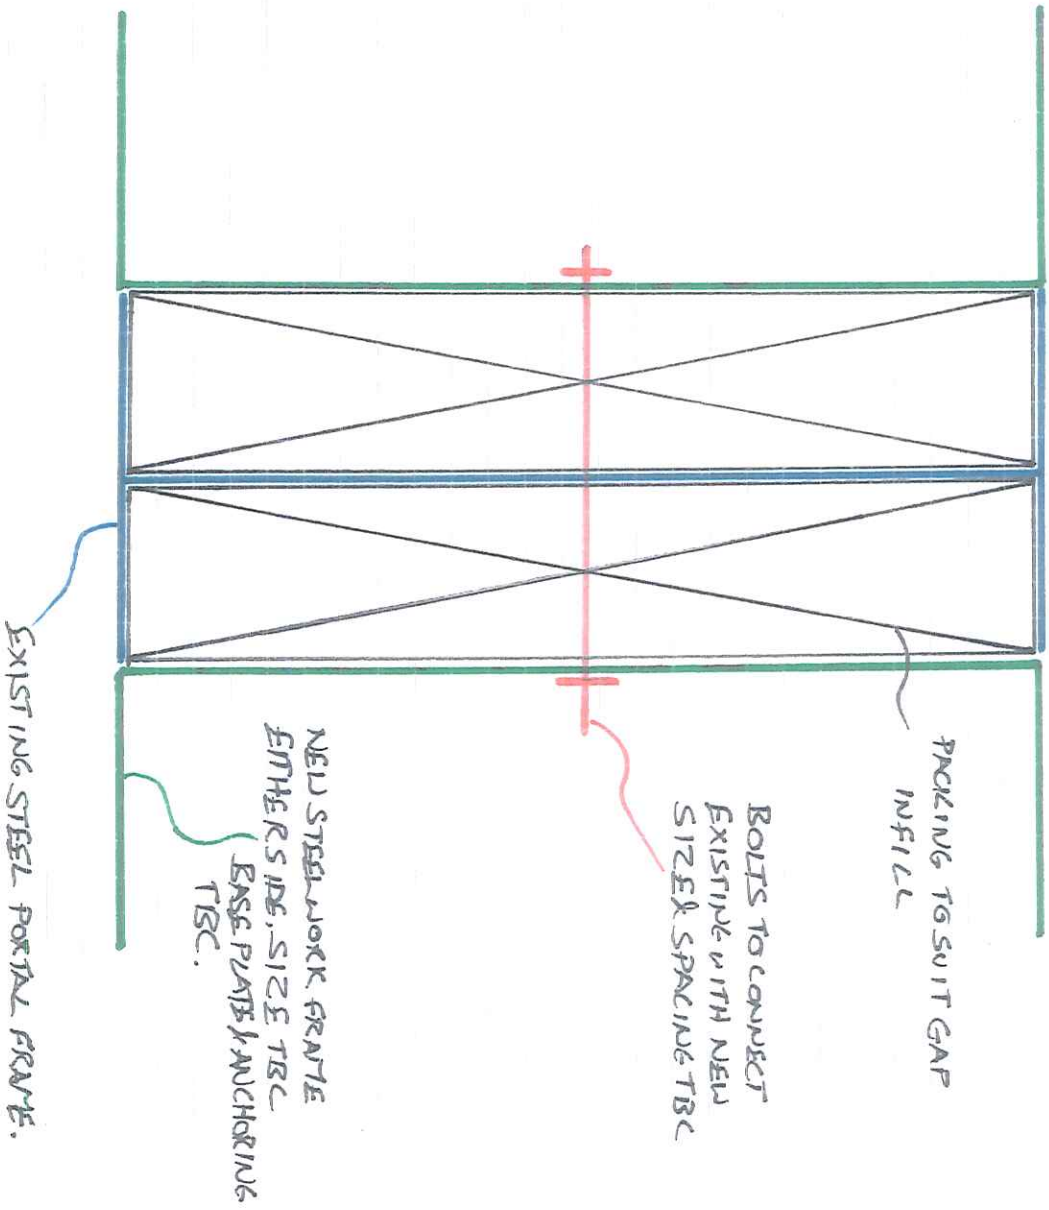
STRENGTHENING OPTION 2 - DETAIL 1-1

In the event of earthquake the steel portal frames will deflect and dissipate the forces. Assessment of the existing portal frames returned a result of approximately 40% NBS. It should be noted that the probable deflection of the portal frames under the assessed loadings was also carried out, although the results returned were in excess of the limits for new construction, excessive deflection was not deemed to be critical as it would not lead to catastrophic failure of the structure.
