ROYAL NEW ZEALAND NAVY
PHILOMEL
MINUTE

ACCIDENT REPORT (OP POSEIDON - 06 APR 13)

ACCIDENT INVESTIGATION REPORT

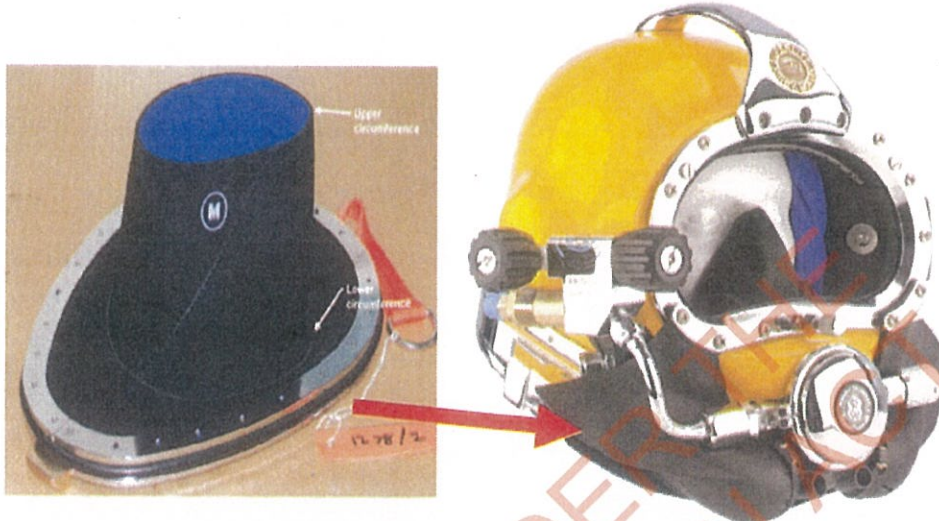
Figure 3: KMB SL 27 Deck Dam and Helmet

- b. If the neck dam is too loose gas will burp out the back of the neck whenever the diver looks down and may also leak water into the bottom of the helmet during inhalation.

39. In summary a photo of the ADR wearing a medium neck dam shows a good fit and the 20mm difference detected by DTA appears within stated KMB tolerances.

43. **Recommendation # 2** – Fit SL 27 helmets individually

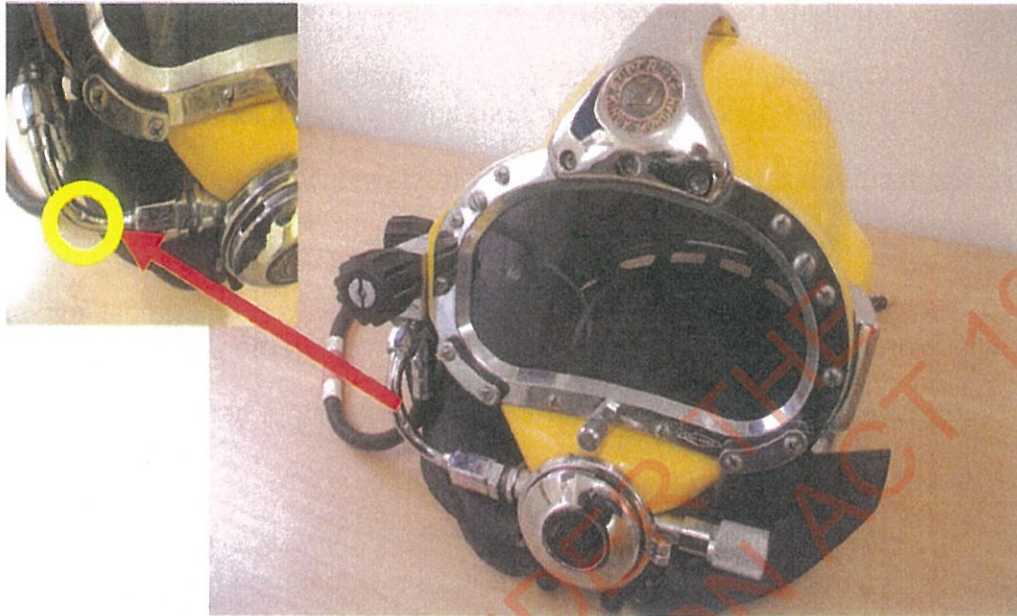
Figure 4: Bent Tube damage

48. A witness mark on the bent tube assembly was found and suggests metallic contact although entanglement or rapid surfacing may have contributed. See Fig 4.

49. A further inspection was therefore completed and no defects were identified.

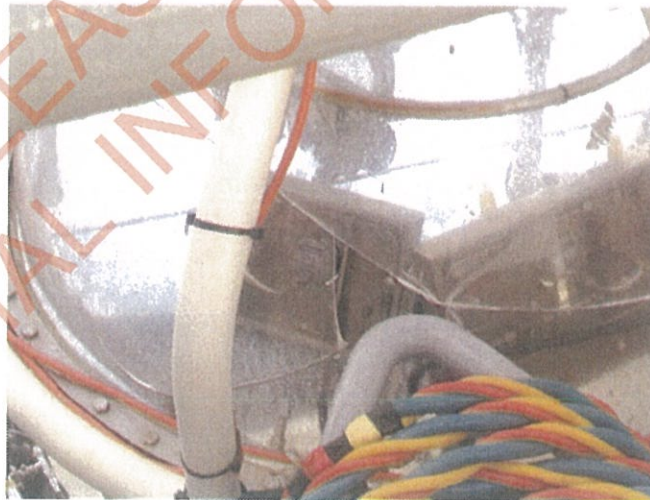
Figure 5: MAN Dive Bell damage

64. The perplex dome had been damaged during the passage to Raglan and the Perspex dome holed. See Fig 5. This was a concern as the dive umbilical could get snagged. The dome was therefore removed and prior to the ADR's accident.

65. Post accident it was found removing the dome led to the communication system becoming damaged and the dive bell gauges had become salt encrusted.

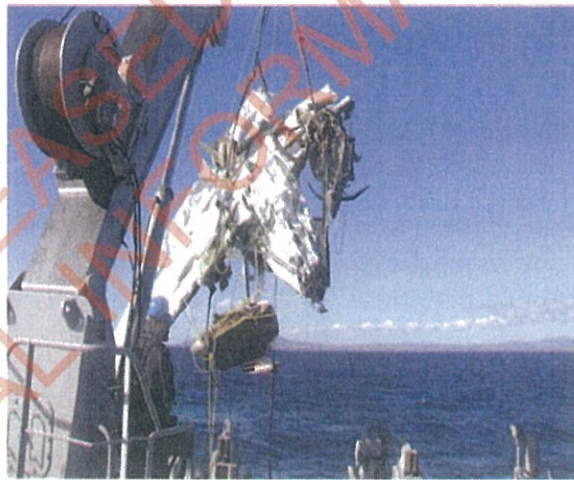
Figure 6: photo of recovered plane³⁸ debris

- c. The Wing was hard up against the seabed hence the need to push the strop under with a boat hook.
- d. The PODR was to push a boathook under the wing which was hard up against the seabed and the ADR task was to place the strop on the hook.

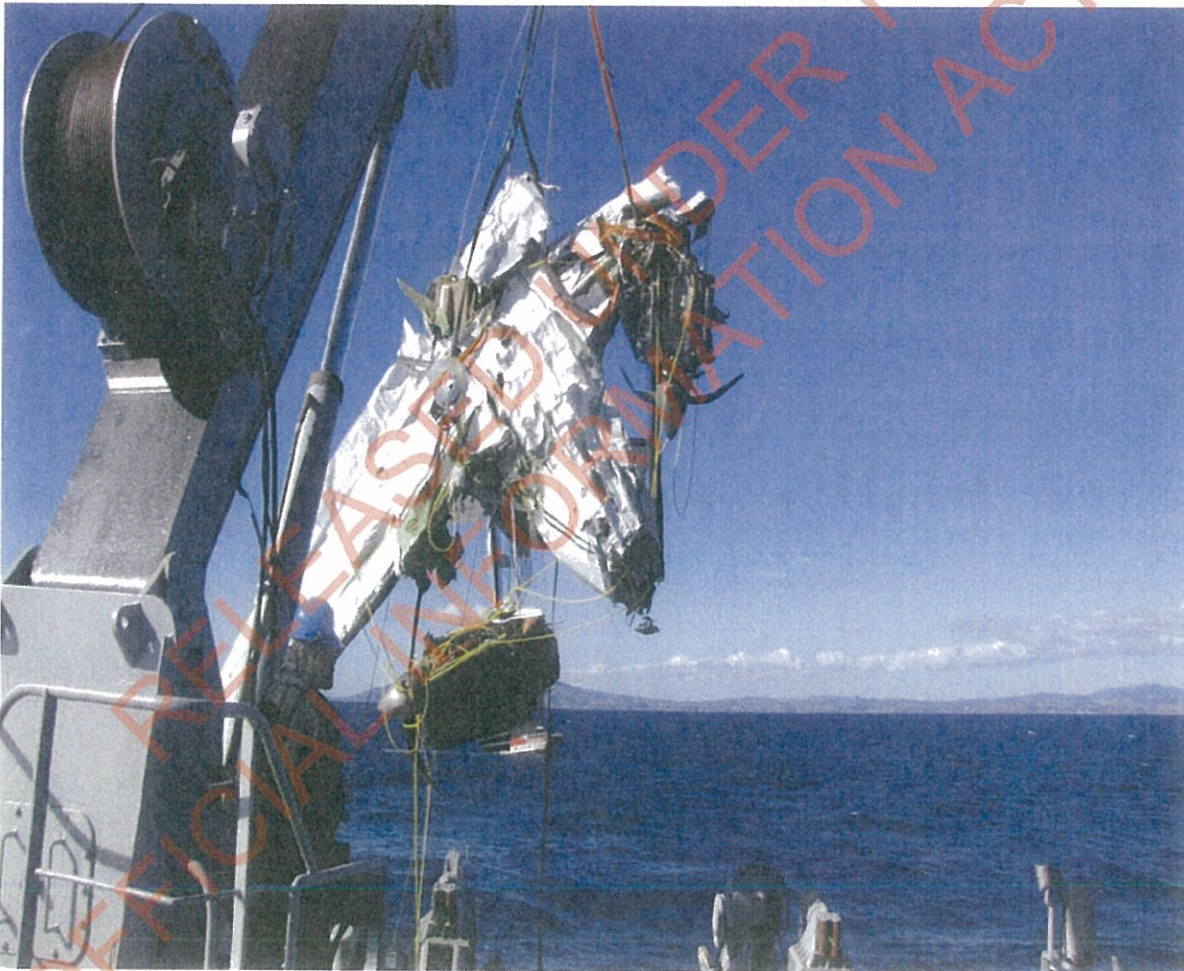
Figure 1: photo of recovered plane¹ debris

There is no useful diagram available for the scene at 56m. However Fig 1 does show the state of the damaged plane after it had been recovered.

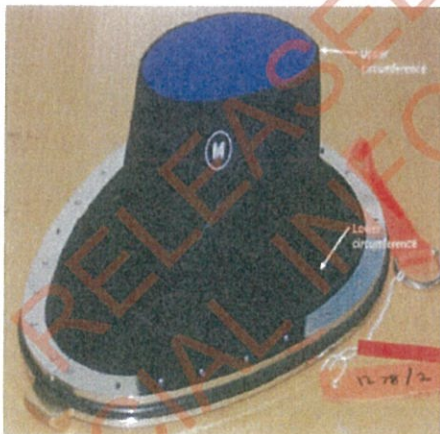
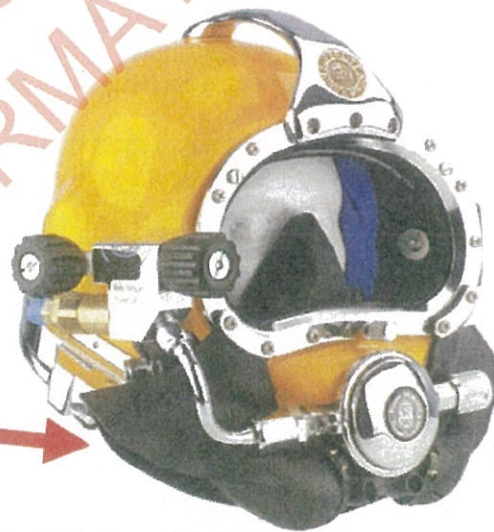
Figure 3: KMB SL 27 Deck Dam and Helmet

Fig 2 shows the RNZN dive platform used, HMNZS Manawanui. Fig 3 shows the helmet worn and the neck dams examined as part of a detailed accident investigation. The position of the oral nasal mask and the dive helmet head cushion can also be seen in the photo.
