MEMORANDUM

UND-02-Memo-014

| Subject | Underpass – Historic Lateral Spreading Cracks – Geological Observations |

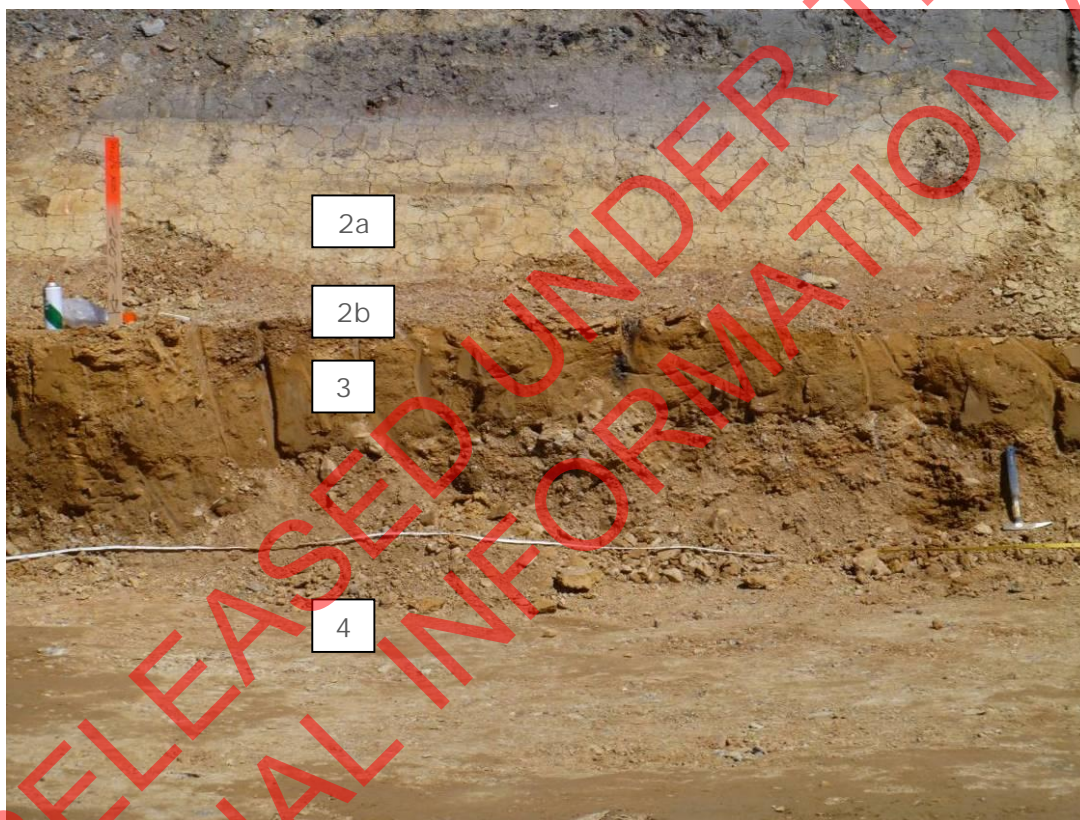
Photograph 1: Alluvium and marginal marine deposits in site excavation

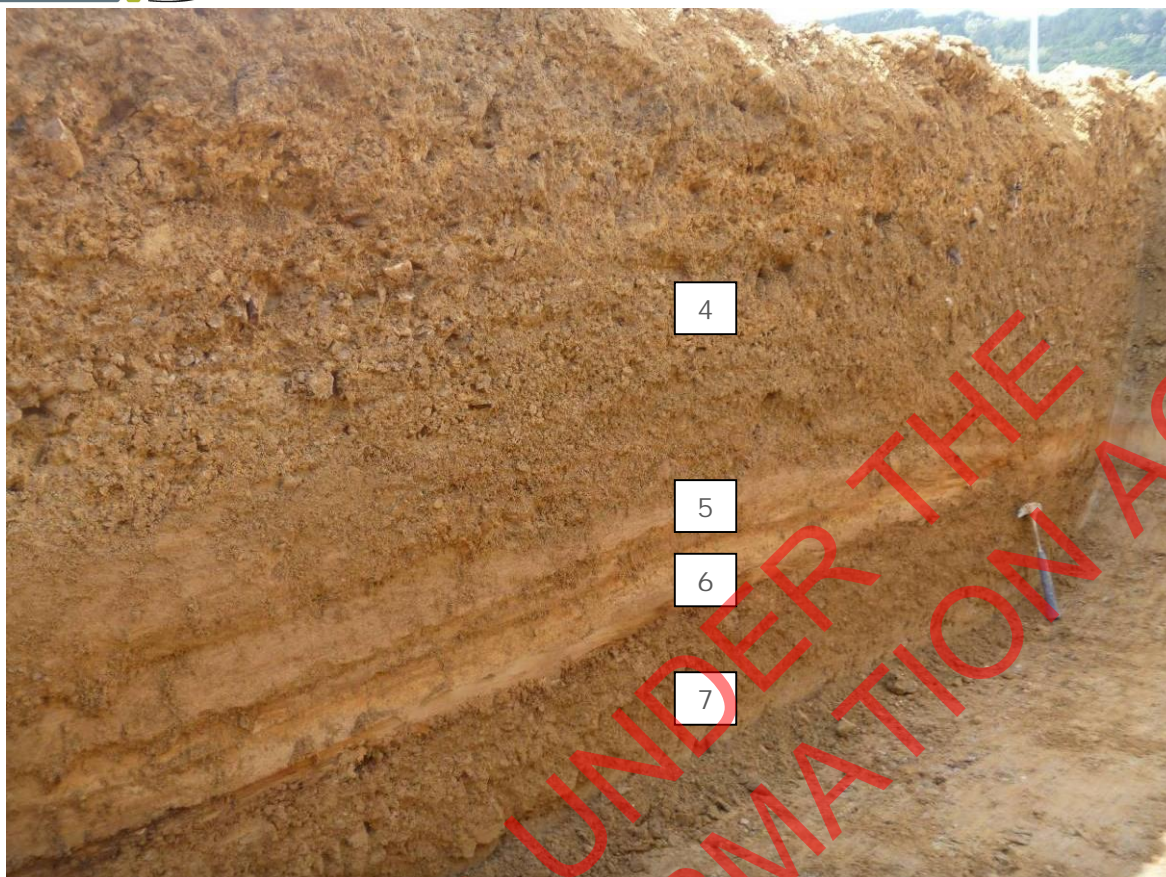
Photograph 2: Alluvium and marginal marine deposits in TPTT8

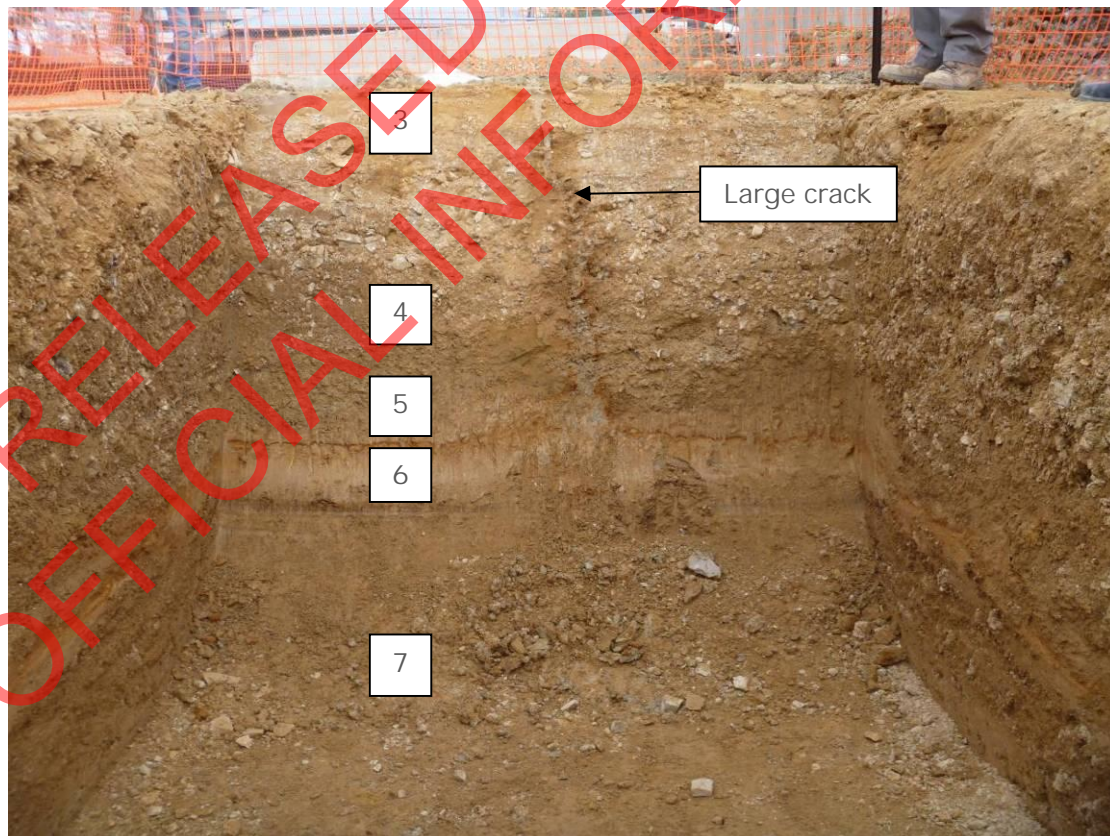
Photograph 4: Geological sequence in TPTT8 with large crack through middle of face

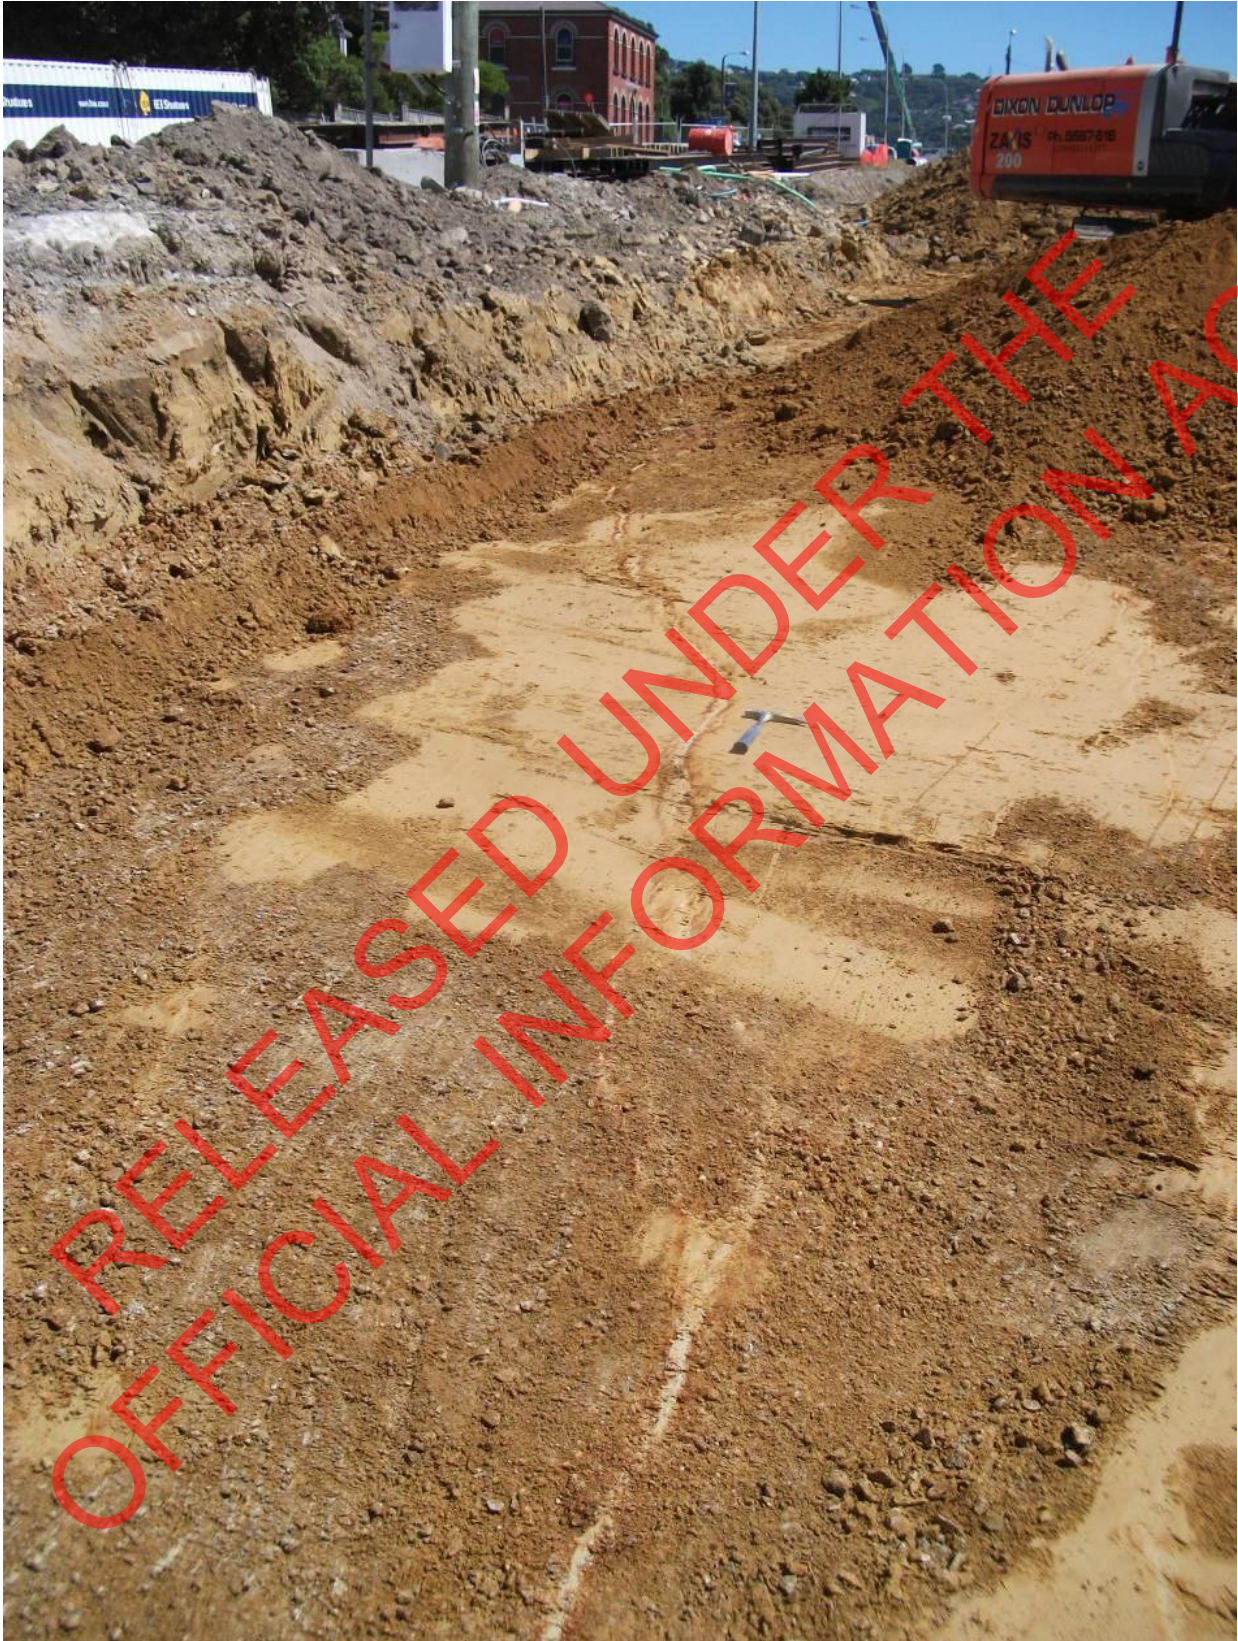
Photograph 5: Large bifurcating crack passing through Layer 2b (gravel) and 3 (sand)

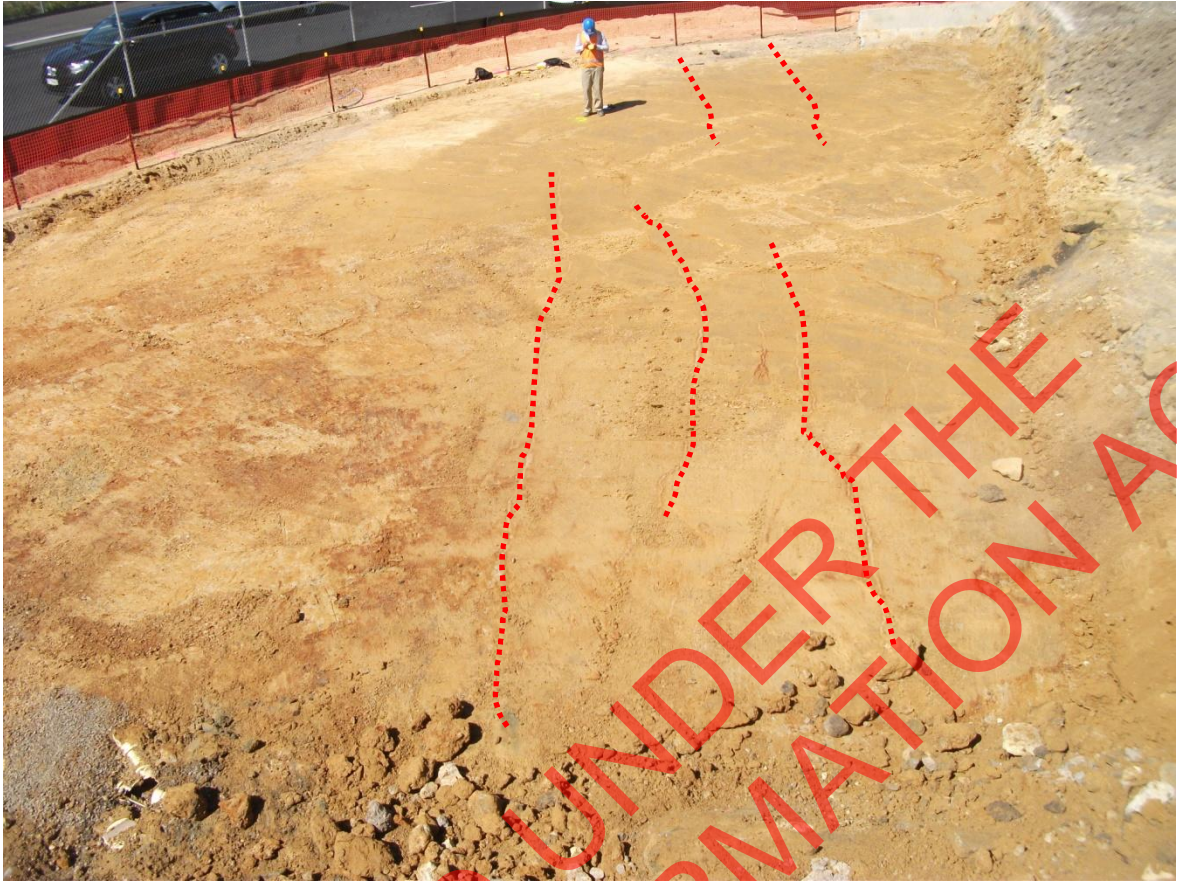
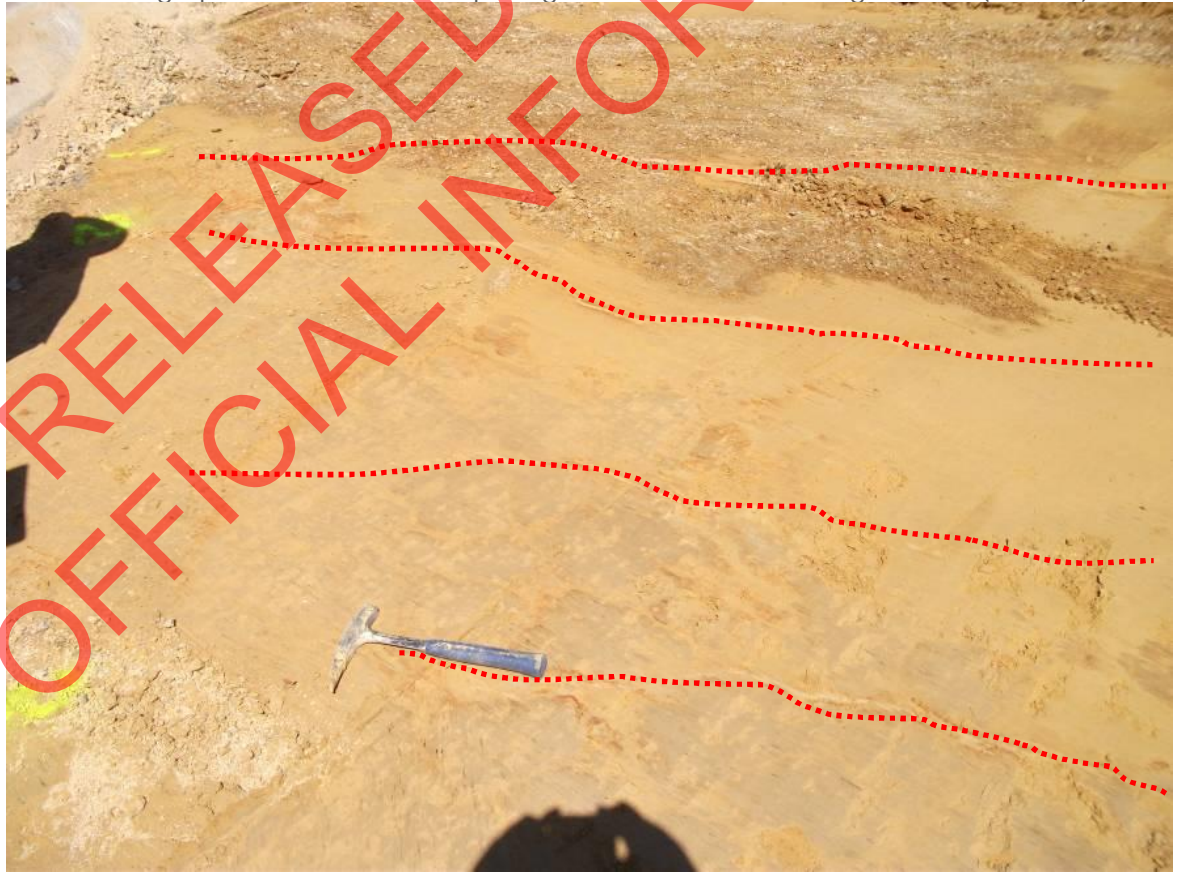
| Spacing | Smaller cracks are approximately 300-500mm spaced. Larger cracks are approximately 1.5-2m spaced. |

Photograph 6 & 7: Indicative spacing and distribution of large cracks (1.5-2m)

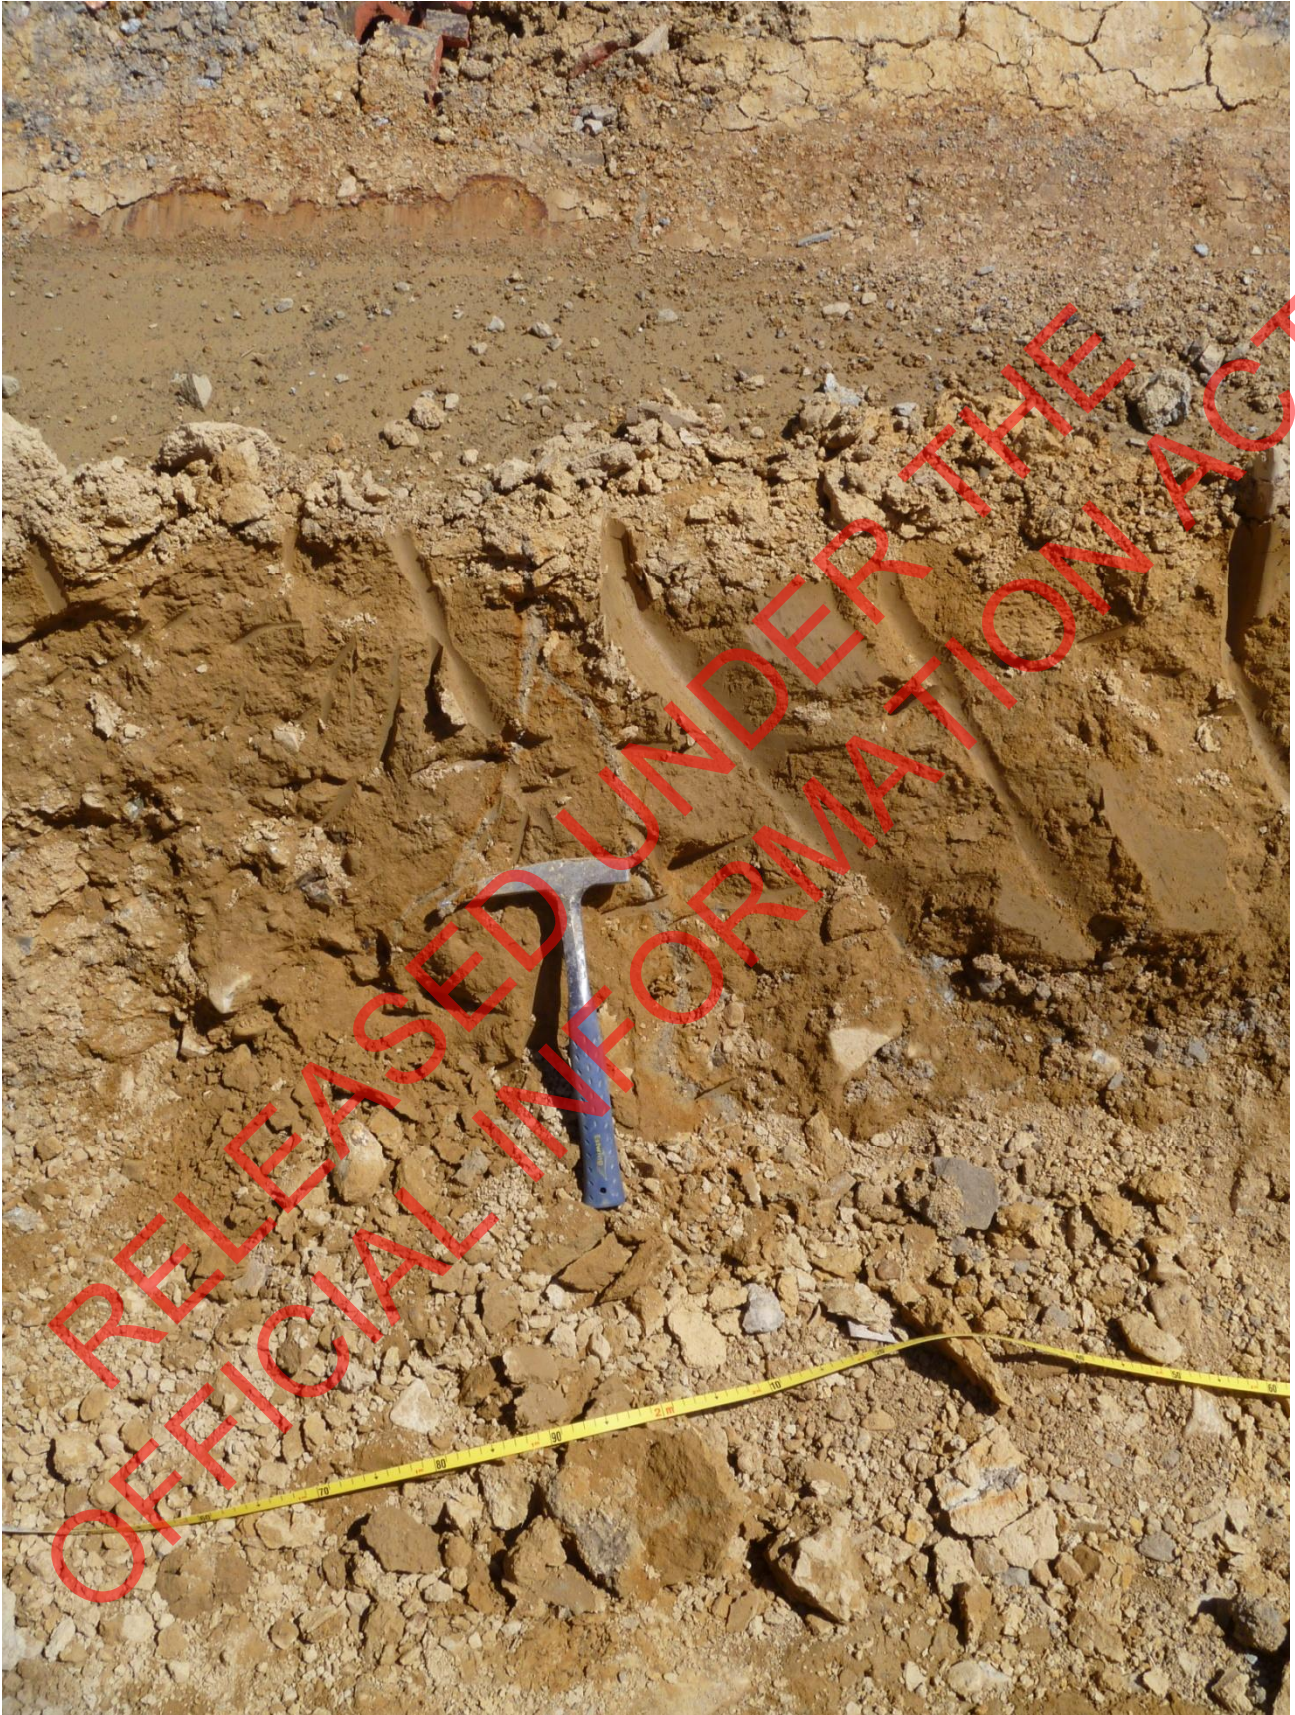
Photograph 8: Vertical bifurcation of cracks in Layer 3

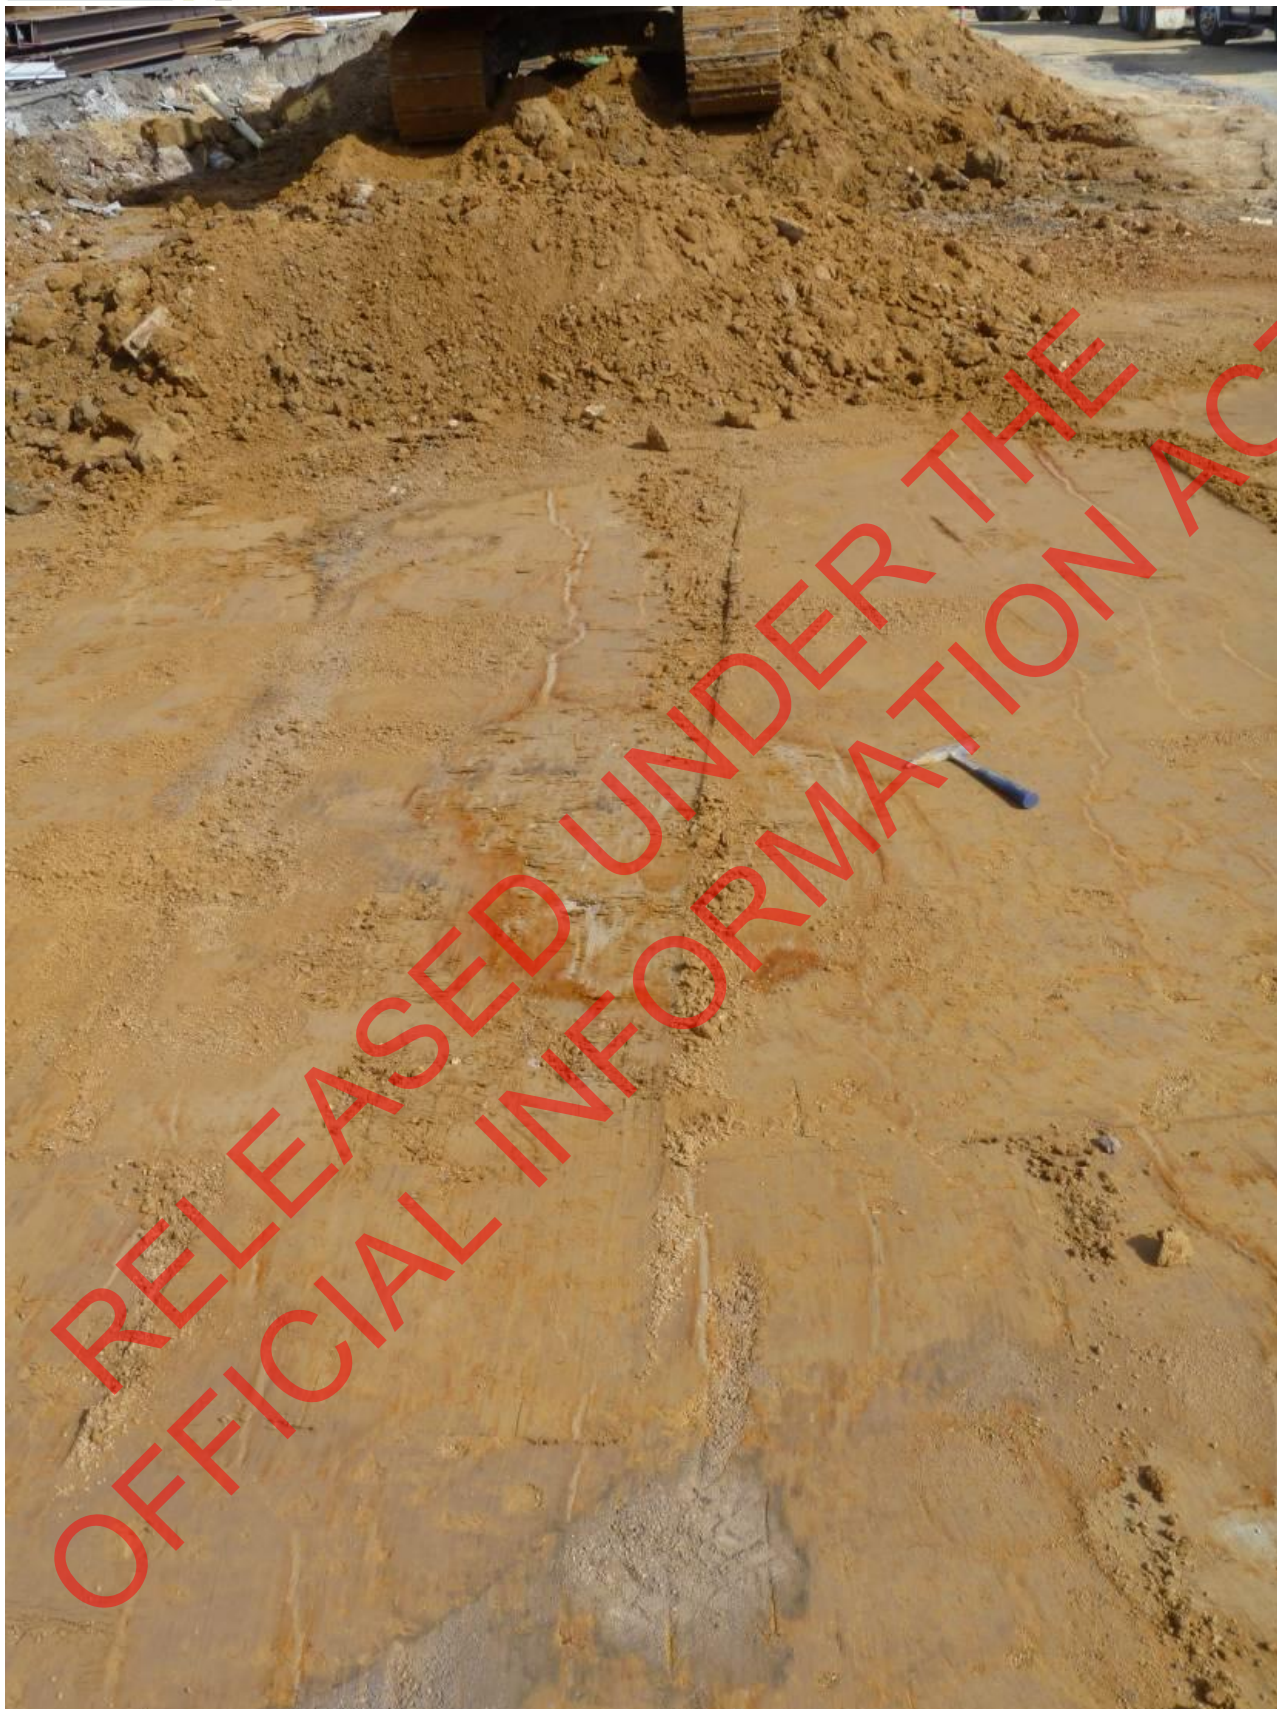
Photograph 9: Crack infill also infilling low spots in top of Layer 3

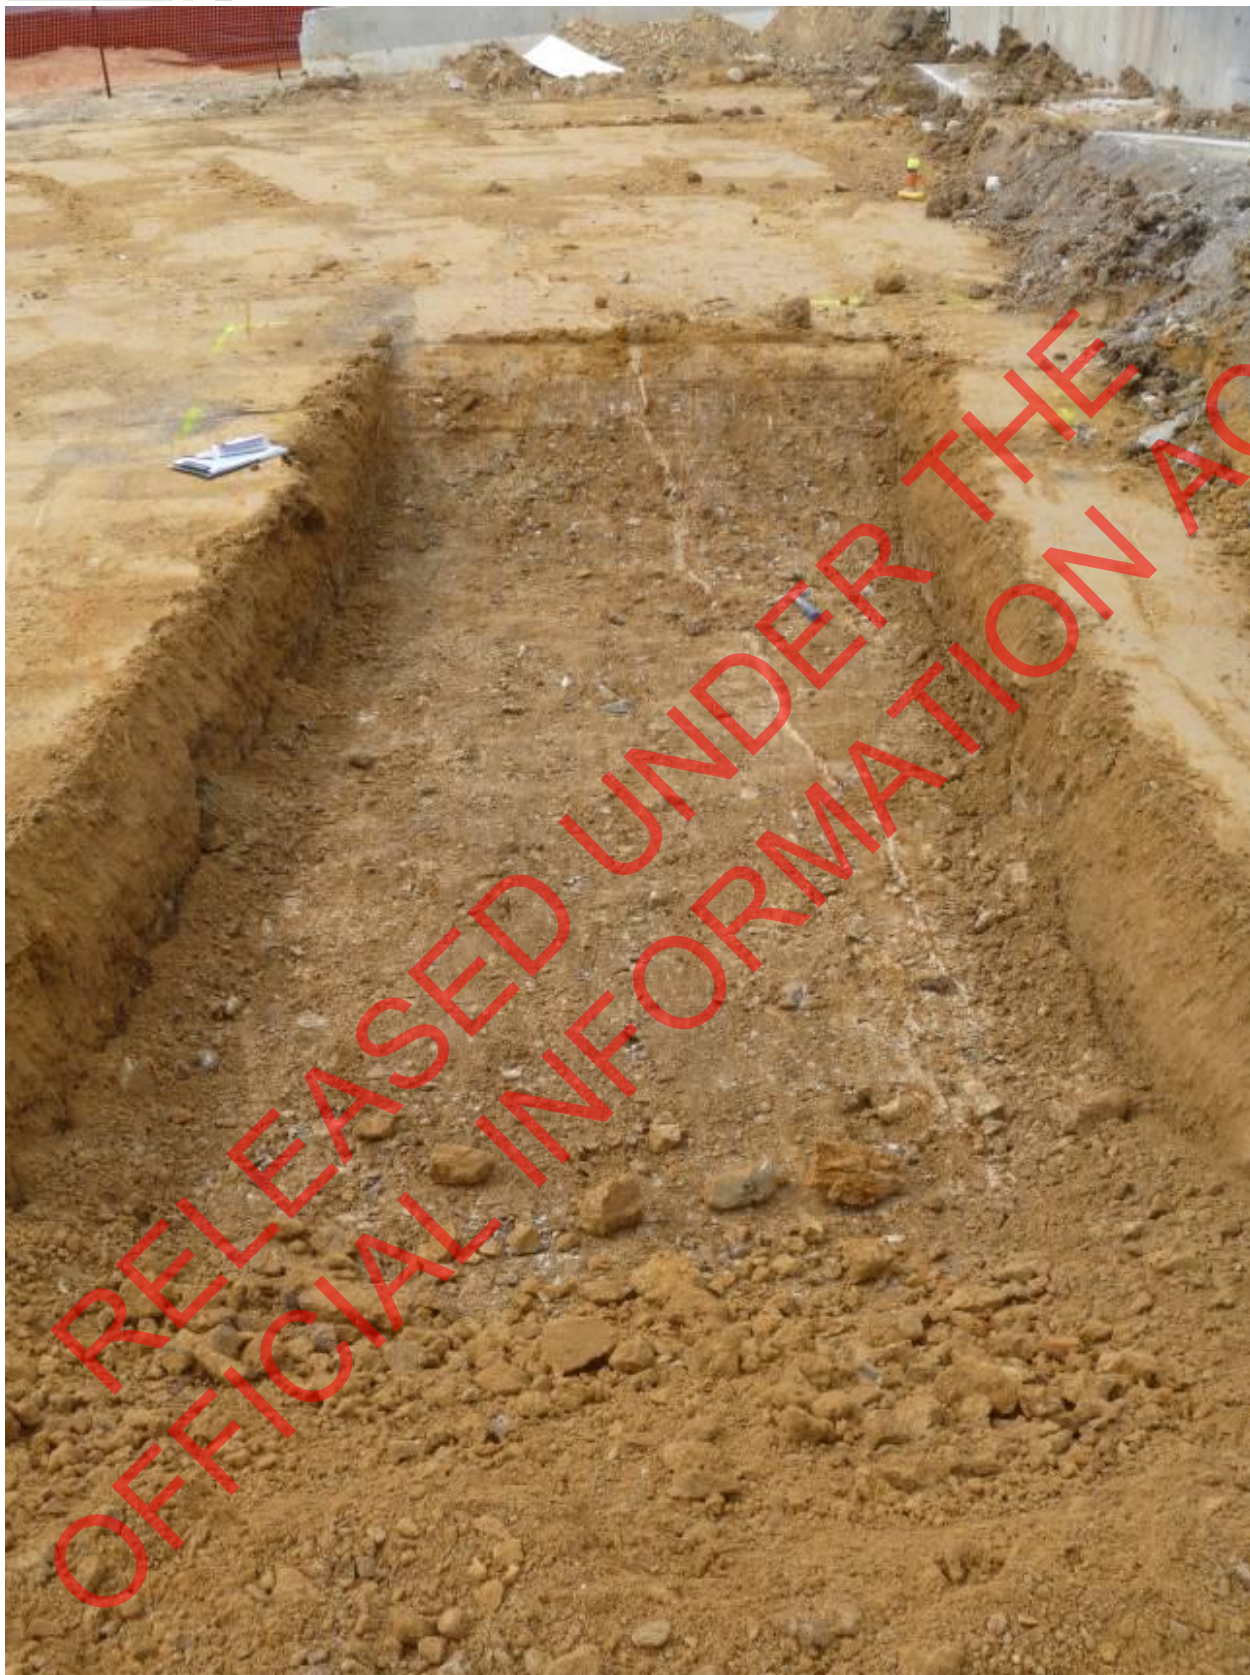
Photograph 10: Large crack extending into Layer 4

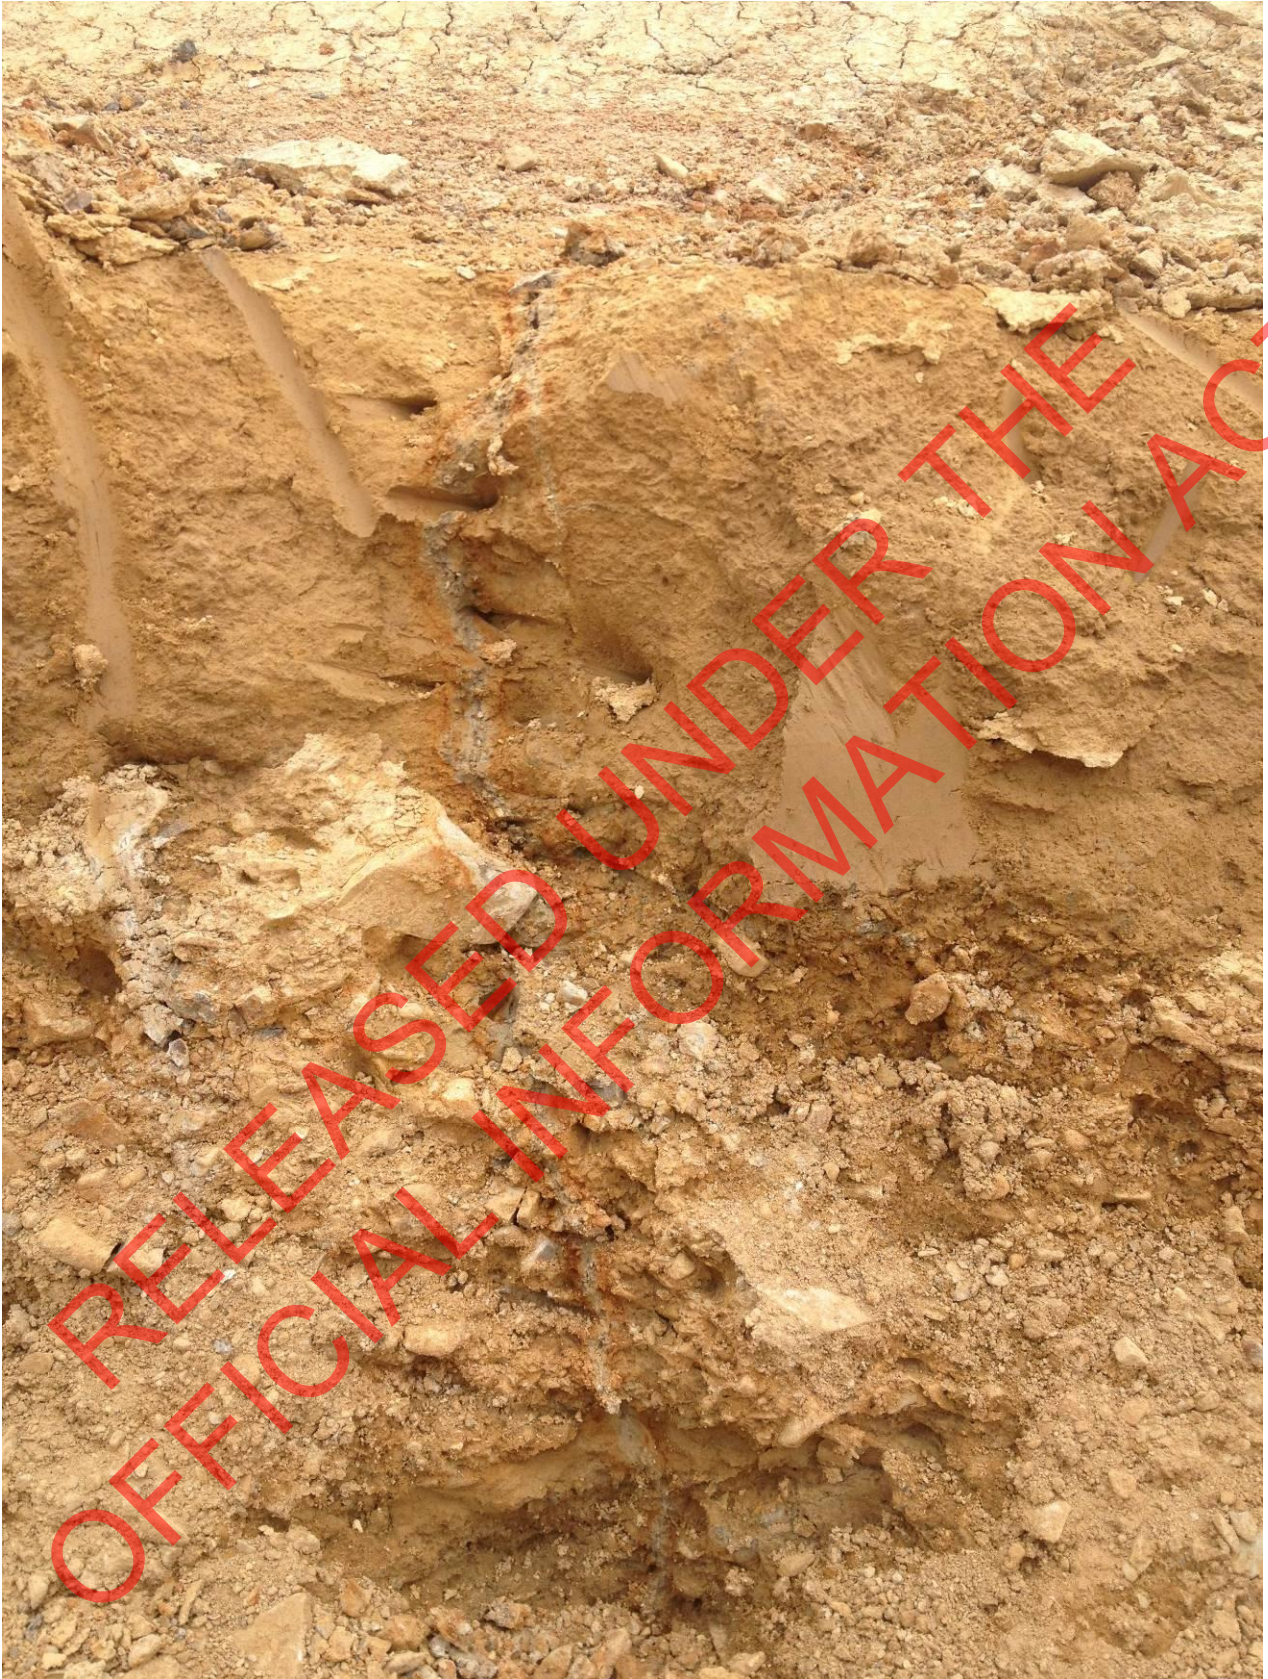
Photograph 11: Large crack extending from Layer 3 into Layer 4

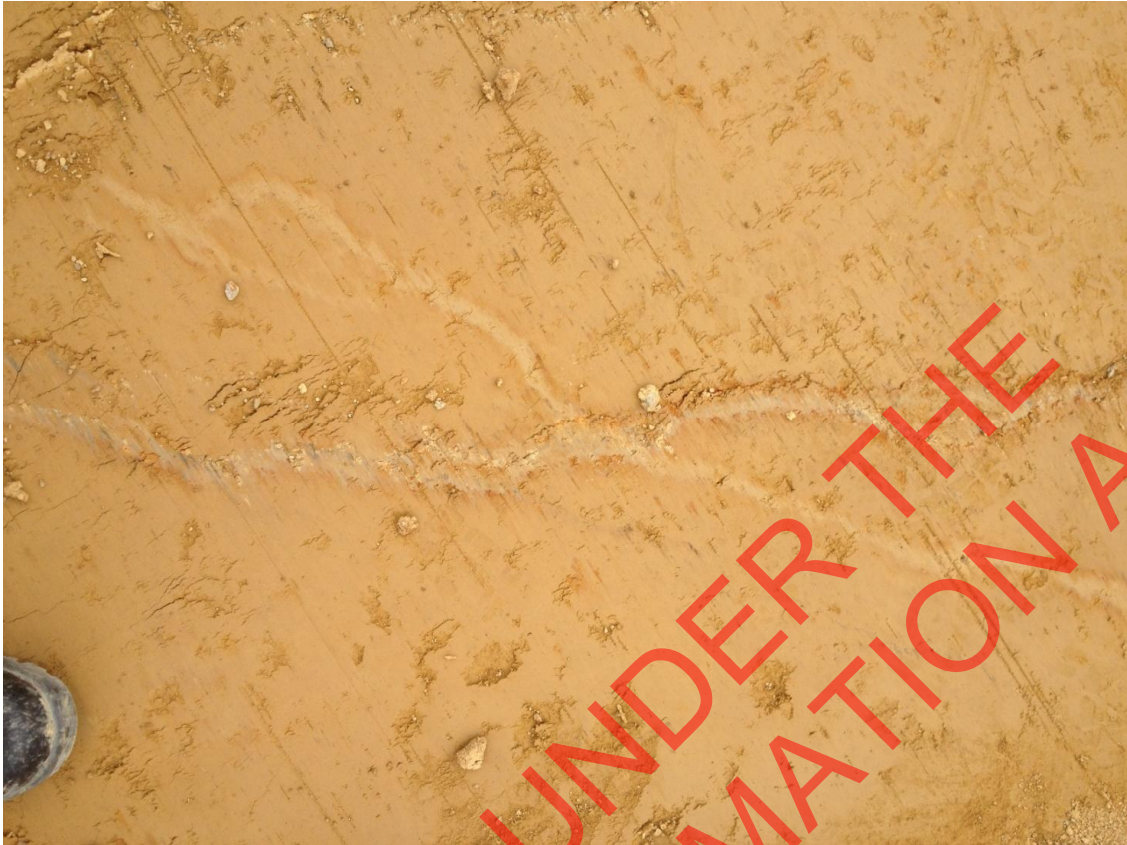
Photograph 12: Bifurcating / cross cutting cracks

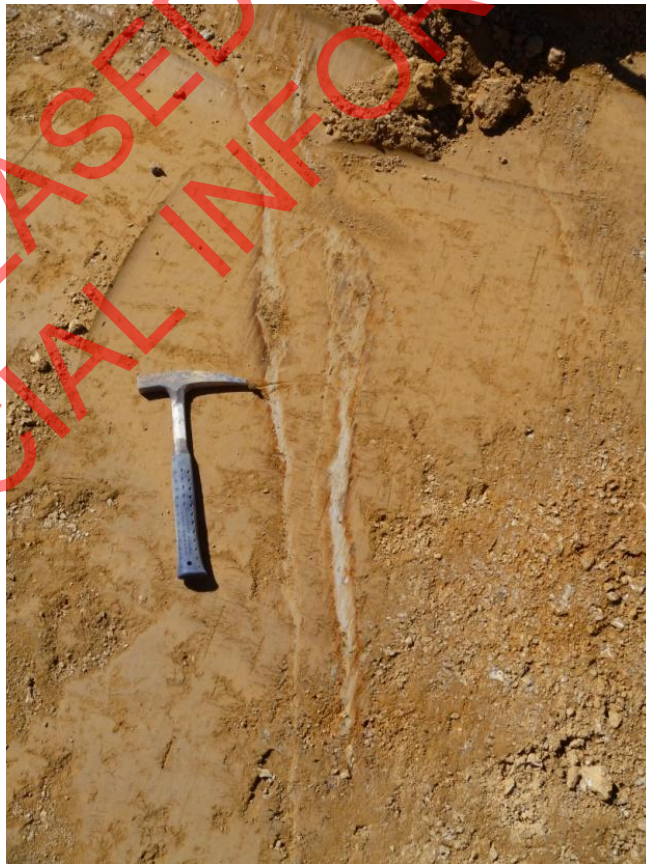
Photograph 13: Large cracks

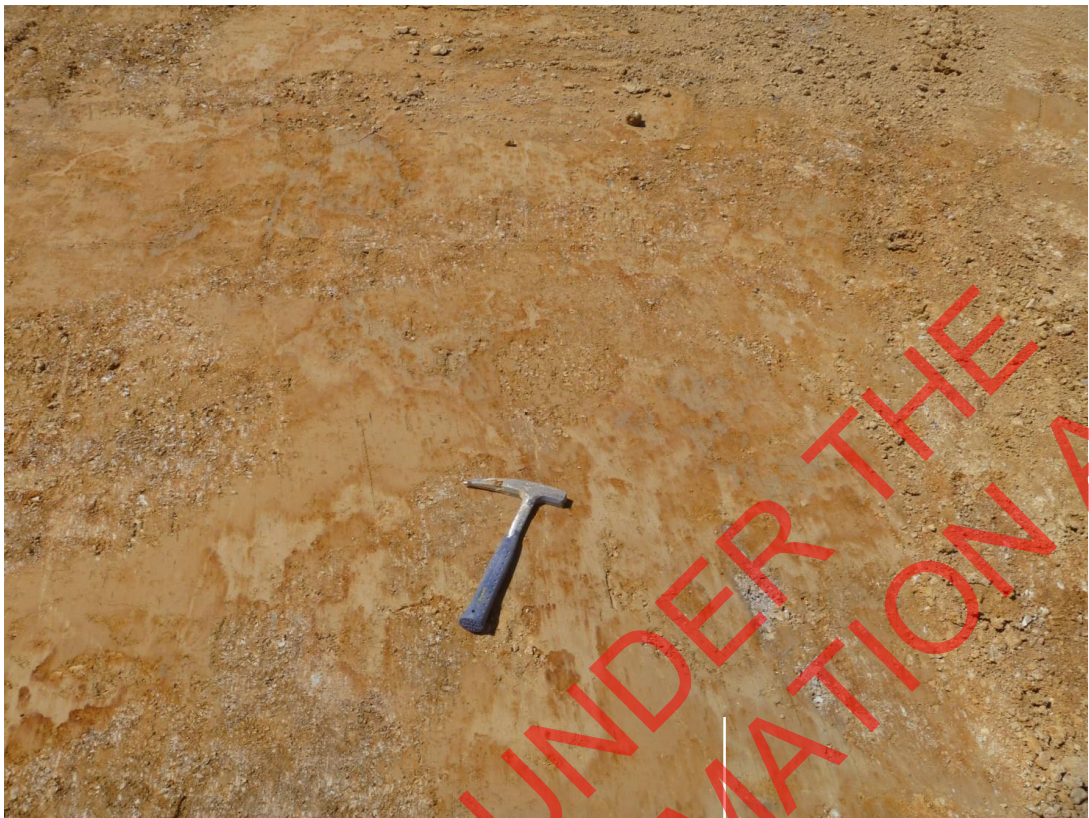
Photograph 14: Clay infill at top of Layer 3

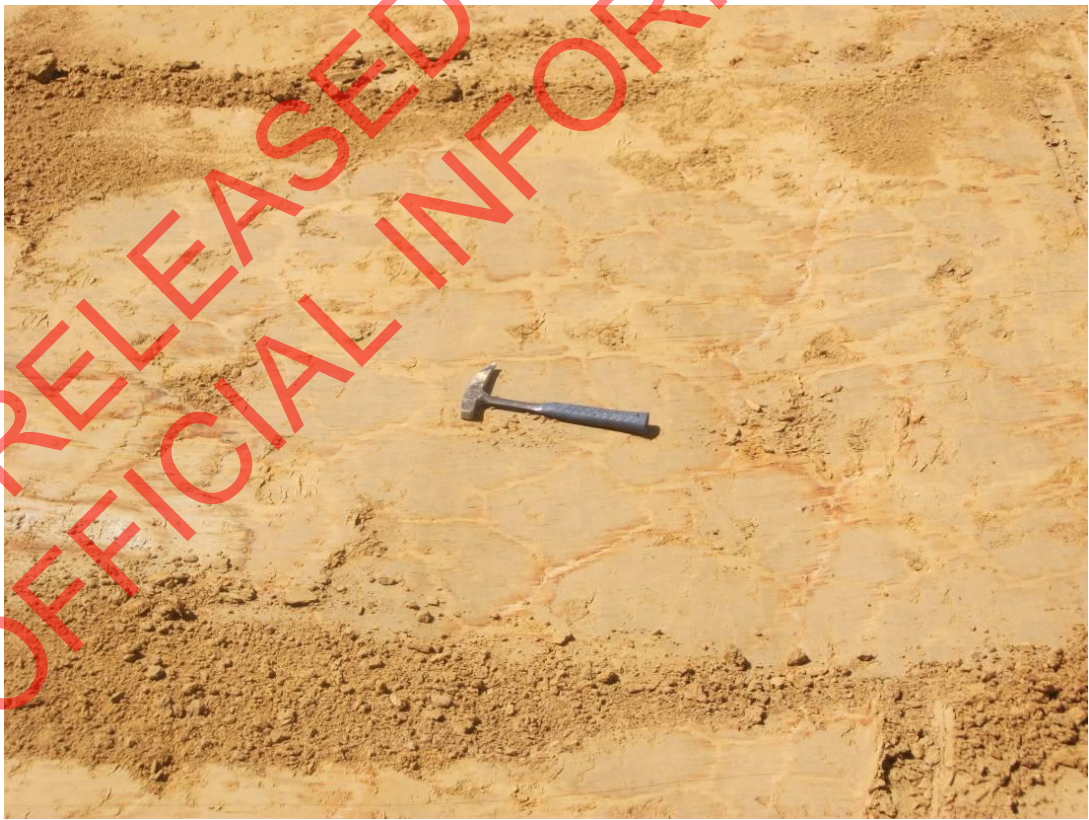
Photograph 15: Clay infill around desiccation cracks at top of Layer 3

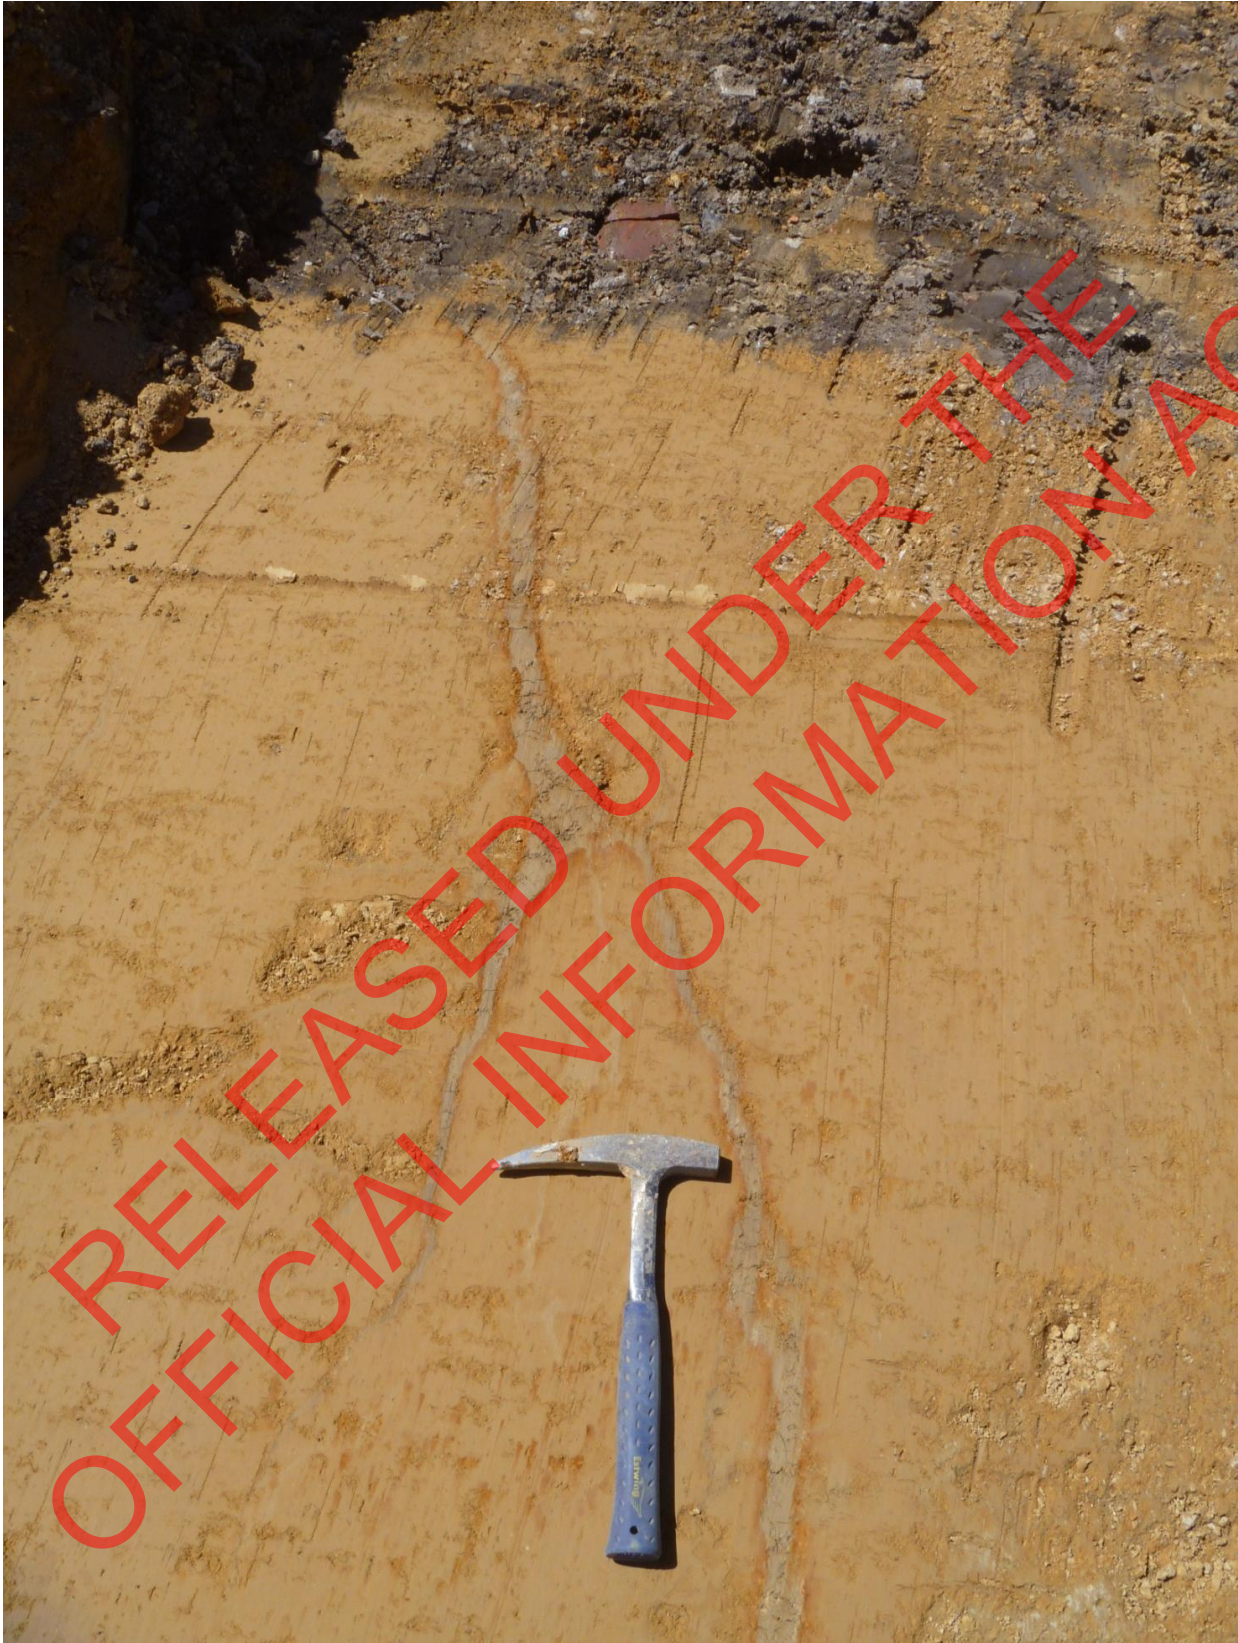
Photograph 16: Bifurcating cracks

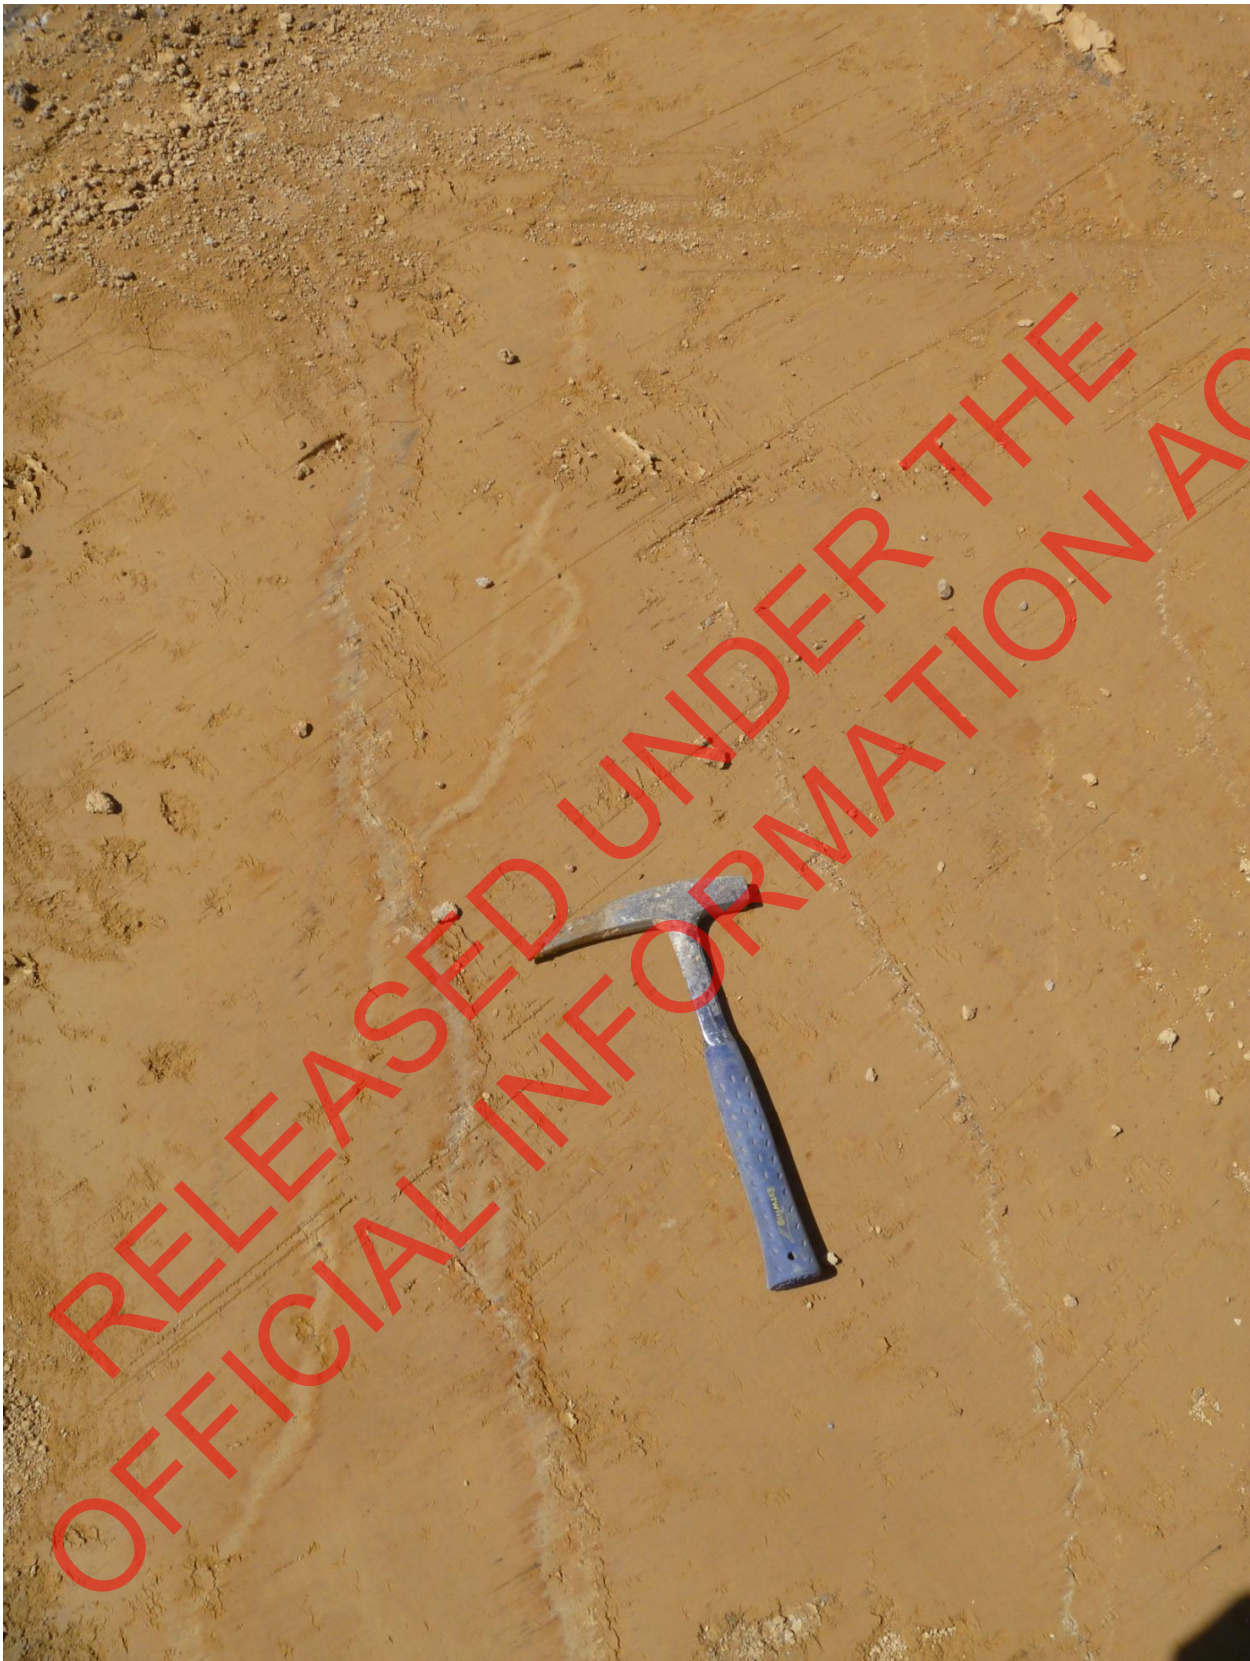
Photograph 17: Cross cutting cracks
