# Asset Assessment Report

## Waiau Pa Domain Reserve

### Clarks Beach Road, Waiau Pa

Date: 03/05/2017 Assessor : S7(2)(a) Privacy

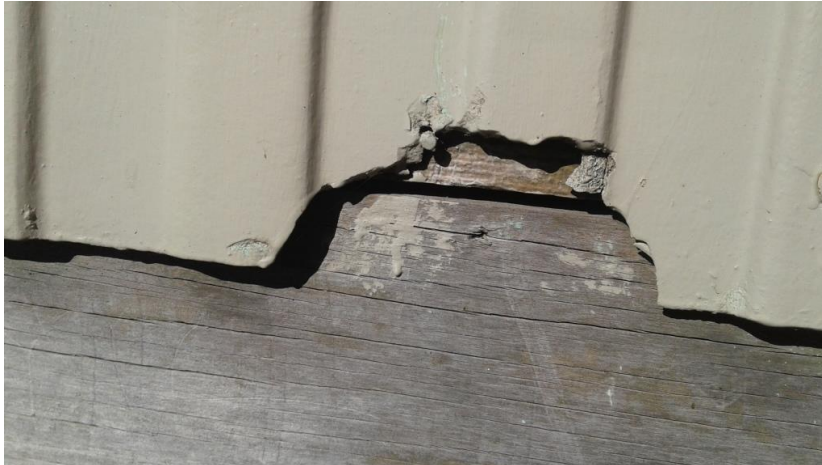
**5.1** The main cladding for the building is made of fibrolite directly fixed to the external timber frame of the building. No building paper or insulation was found behind the fibrolite cladding.

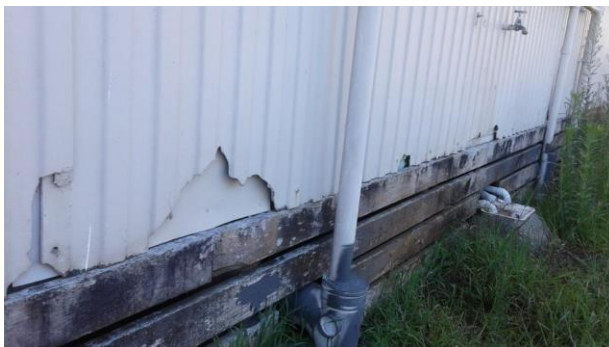
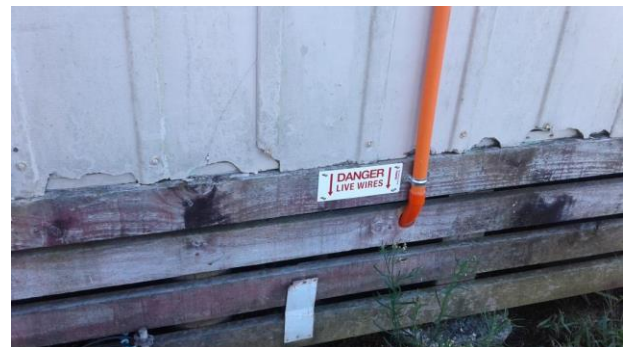
**5.2** Some of the fibrolite claddings were damaged and liners behind the broken cladding were installed to stop water ingress into the building. The condition of the cladding is rated as 5 and is required to be replaced and to comply with the current building codes. A design professional will be required to provide design solutions and detailing. We would discourage repairs to this fibrolite cladding as it is an Asbestos Containing Material (ACM). A building consent will be required due to a change of cladding system to existing building.

The results has indicated that Chrysotile (White Asbestos), Amosite (Brown Asbestos) and Crocidolite (Blue Asbestos) were presence in the profile sheet claddings on North, East, South and West Elevations. However no asbestos were detected on the flat cement board under the large windows on the east and south elevations.

From the result of asbestos analysis, it is confirmed that white asbestos, brown asbestos and blue asbestos were found in the profiled fibrolite cladding. As some of the cladding has been damaged and exposed, the risk to human health is high and is recommended to be fully replaced.

3. The exterior profiled claddings were tested positive to Chrysotile, Crocidolite and Amosite which are dangerous asbestos to human health. As some of the cladding has been broken and exposed to environment, a full replacement is recommended.

6. The damaged fibrolite cladding is recommended to be sealed immediately or to be covered with temporary plywood or similar wood board. The fibrolite cladding is not friable and is reasonably stable if they are not disturbed. Signs to advise contractors for awareness of asbestos are required to be installed around the building.

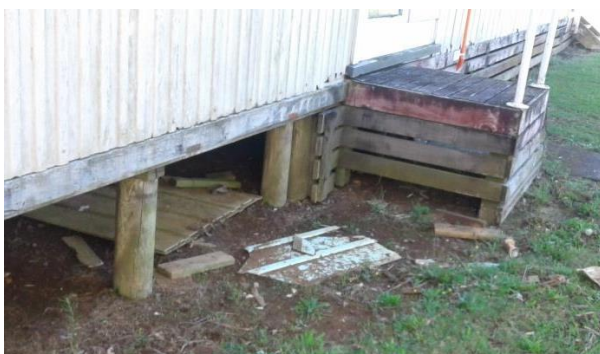
**5.3** Some of the broken pieces of fibrolite were lying around the building. It is required to be removed and disposed of for Health and Safety reasons.

4. All loose fibrolite lying on the ground around the building is recommended to be removed and disposed immediately.
5. The cracked water tank is recommended to be replaced.

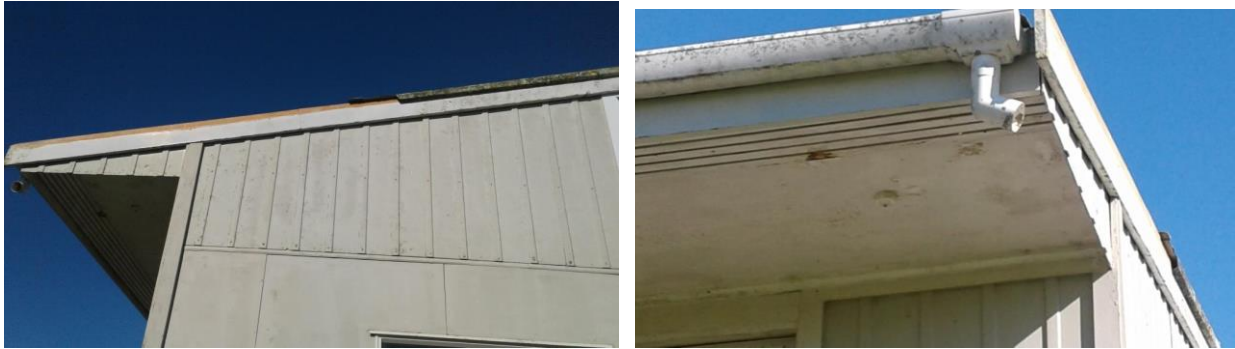
**5.4** There is no access to the roof void and the roof was inspected visually from the ground level. The roofing is of metal iron covering. Some of the fascia flashings have gone missing while some of the downpipes were not connected to stormwater system. The condition of the roof, gutter and downpipe is very poor and recommend to be replaced.

The condition rating of the envelope of the building is very poor. Deficiencies to the roofing, roof flashings, gutter and downpipes have been identified to multiple areas. It is believed that they have reached the end of their serviceable life and required replacement.

1. The roof and roof flashing are in very poor condition and requires full replacement.
2. The gutter and downpipes are in very poor condition and requires full replacement.

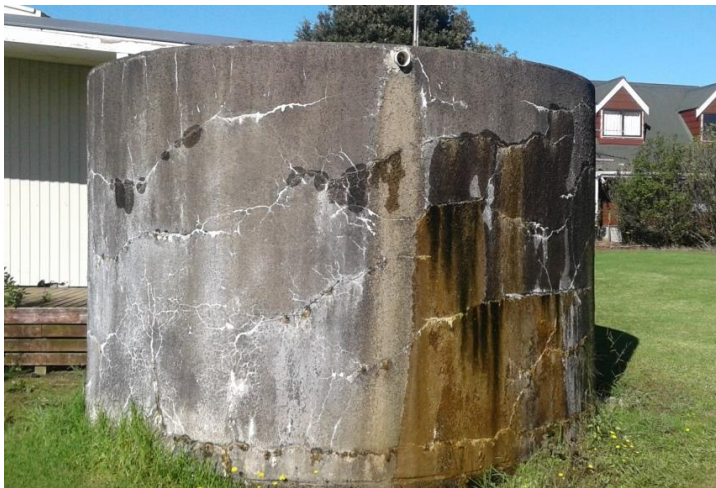
**5.5** The water tank by the building was serious damaged. Cracks were formed around the water tank. Water from the tank has been leaking out into the field. The condition rating of the tank is 5 and is required to be replaced.

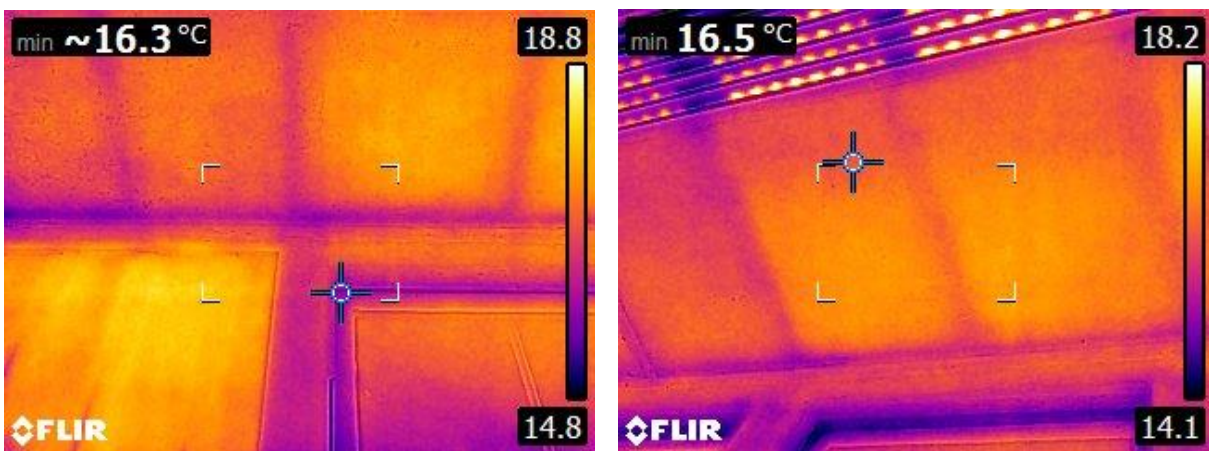
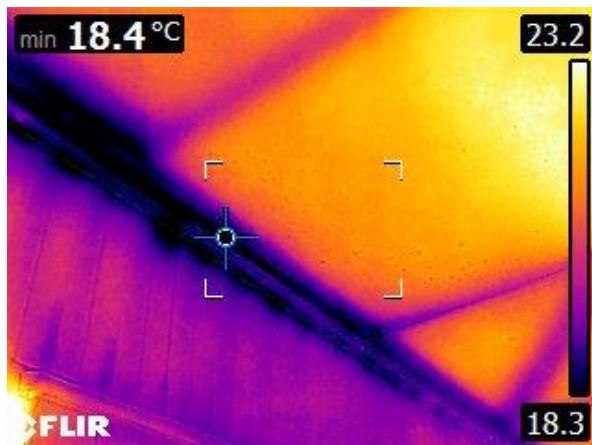
**5.6** Due to the limited access into the building, the moisture content of the timber frame cannot be measured. Moisture ingress into the building cannot be established. However a thermal imagine camera were used on site to identify possible water leaking around the building. The dark line at the eaves indicates high moisture content.

The exterior claddings have been damaged in multiple areas and water ingress has been evidenced by the use of thermal image camera. The type of cladding construction would not comply with the current building codes. A full replacement of cladding is recommended.
