REPORT

**SOUTH KARORI BRIDGE REPLACEMENTS -
PHASE 1**

Prepared for Wellington Water

September 2016

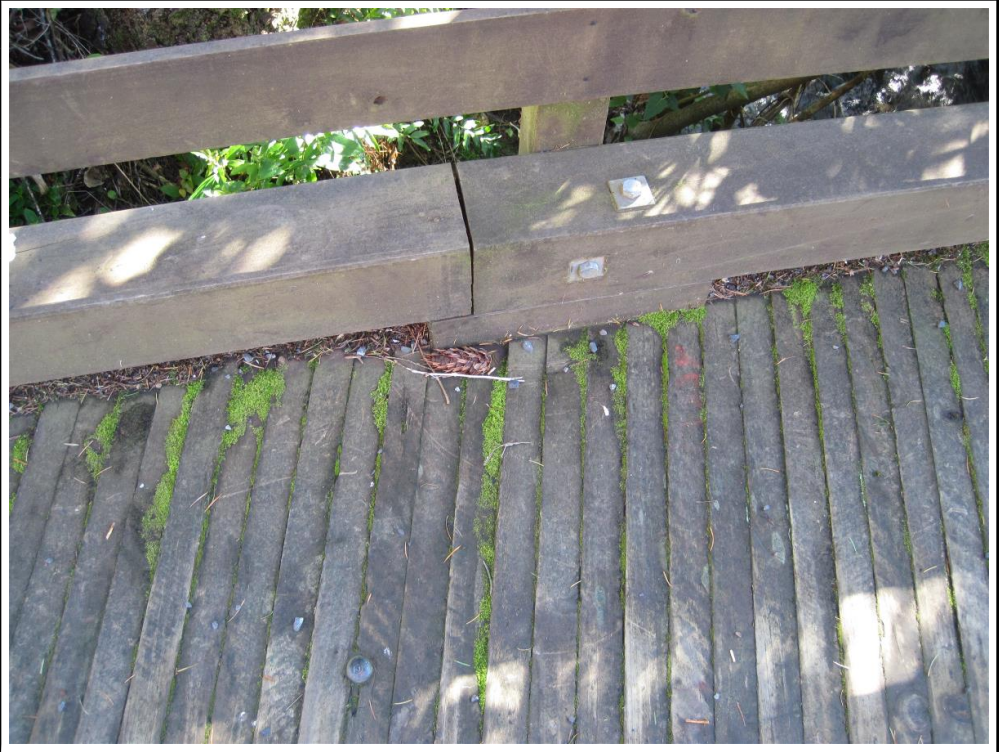
Photograph ID: 9

Comments:
Moss growing on deck

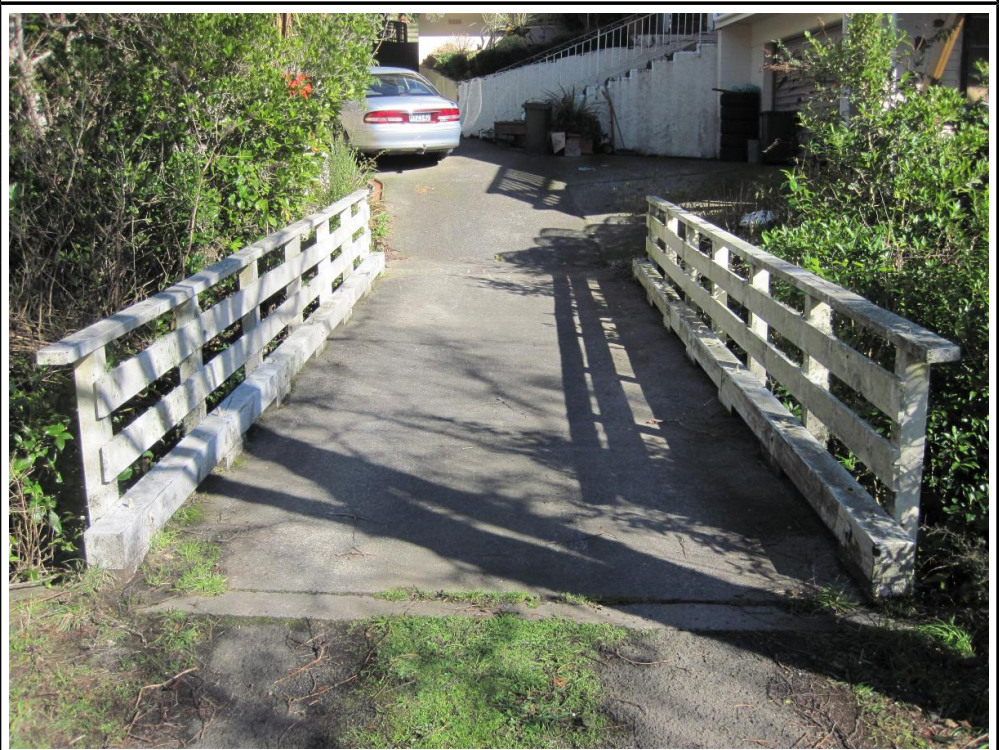
Photograph ID: 10

The handrails on all the bridges do not meet the required height in the New Zealand Building Code. Also, due to the timber being of an unknown strength, a conservative assumption has been made. With this assumed timber strength the handrails do not have sufficient capacity to resist the loads recommended handrail loads in the NZTA Bridge Manual. It is recommended that all the handrails on the bridges are replaced.

Comments:
General photo - handrails are not high enough

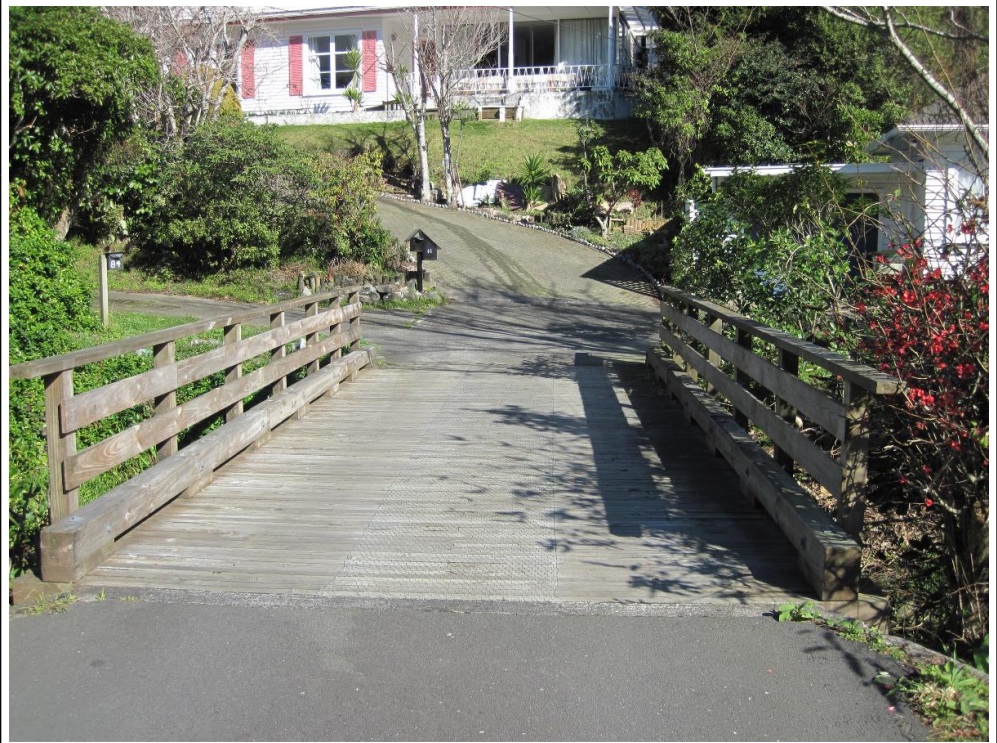
Photograph ID: 17

Comments:
General photo - handrails are not high enough

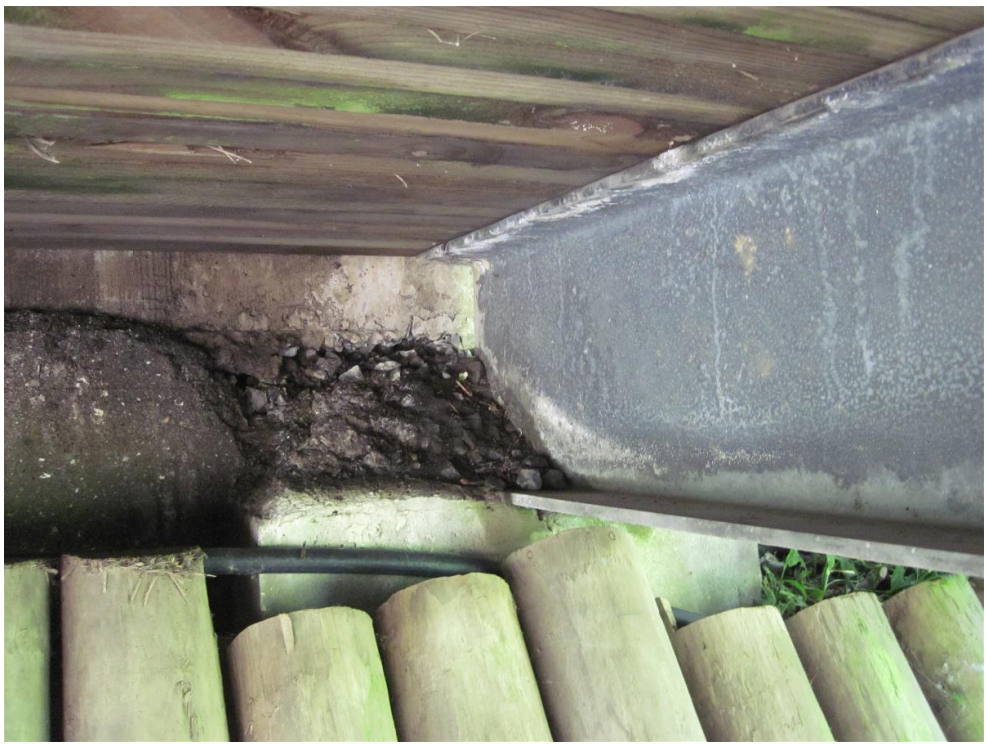
Photo Location: 80-84 South Karori Road			
Direction:			
Survey Date: 16/08/2016			
Comments: Bearing sills full of dirt around beams			
Photograph ID: 20

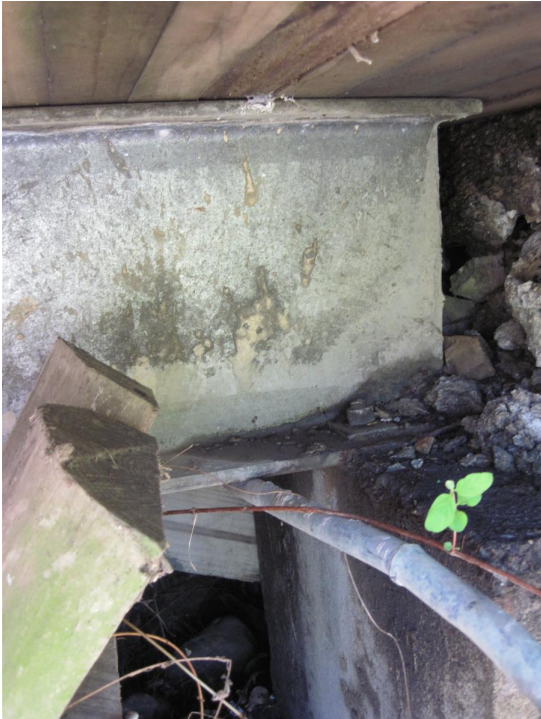
The bearing shelves on all the vehicle bridges other than bridge at 76-78 South Karori Road have very short bearing sills. To make the bridges more resilient it is recommended to improve the length of the bearing sills by installing a steel corbel to the abutment under the end of each beam.

Photo Location: 80-84 South Karori Road			
Direction:			
Survey Date: 16/08/2016			
Comments: Short bearing sills

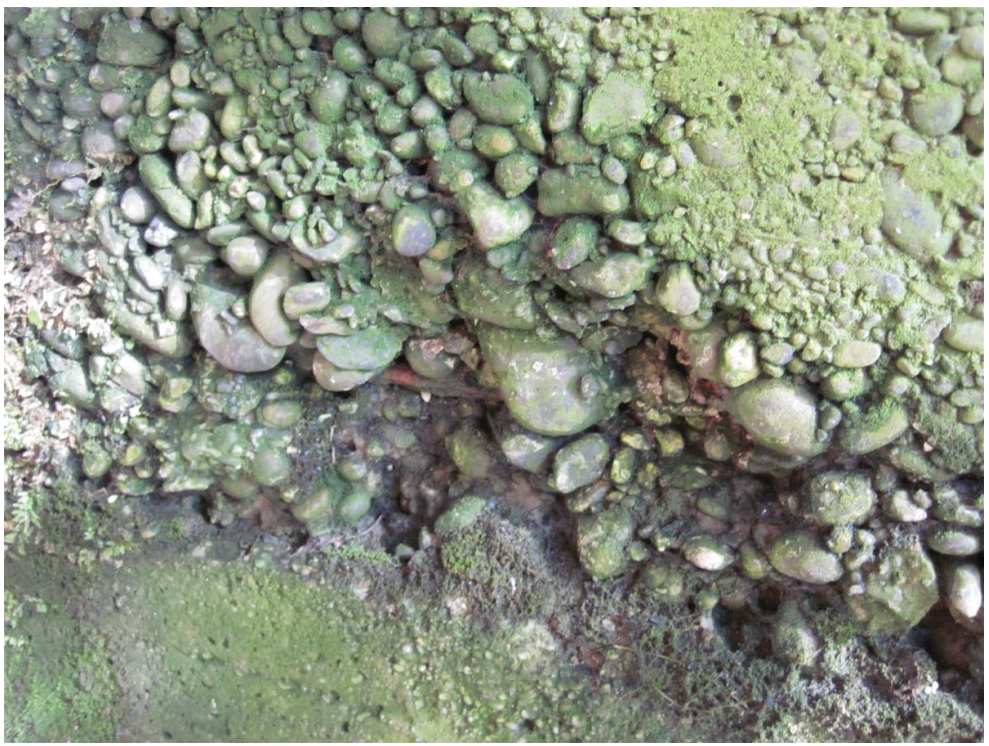
Photograph ID: 28

Photo Location: 76-78 South Karori Road	
Direction:	
Survey Date: 16/08/2016	
Comments: Boney concrete below water outlet in abutment

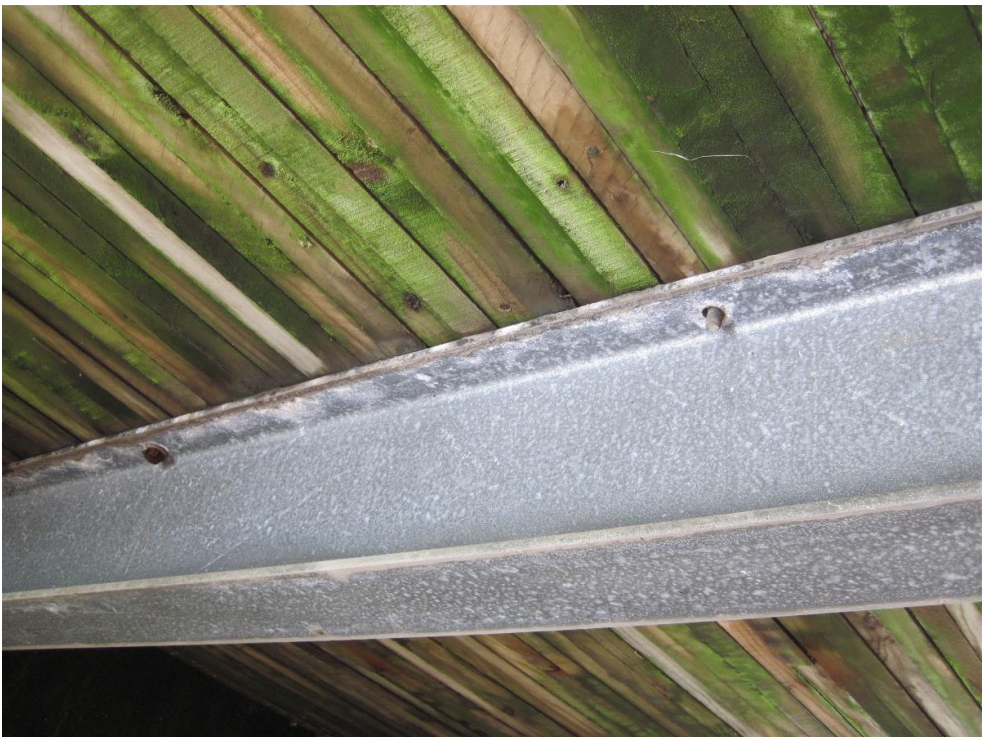
Photo Location: 76-78 South Karori Road			
Direction:			
Survey Date: 16/08/2016			
Comments: Some bolts are badly corroded

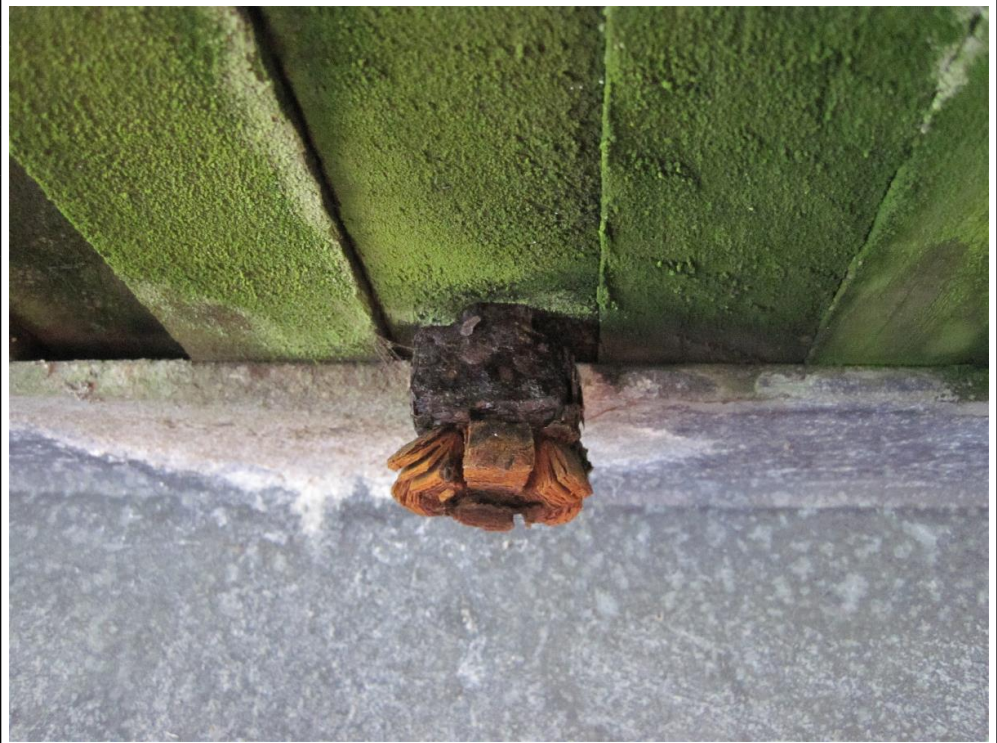
Photograph ID: 33
Photo Location: 46 South Karori Road
Direction:
Survey Date: 16/08/2016
Comments: Heavily corroded clamps

This bridge currently has a very low live load capacity due to the poor connection detail between the laminated timber deck and the steel beams. This live load capacity could be significantly improved if the existing clip-type fixings are replaced with new bolts that securely fix through the top flanges of beams to the deck, thus providing improved lateral restraint to the beams. Further improvement could be achieved by installing diaphragms.

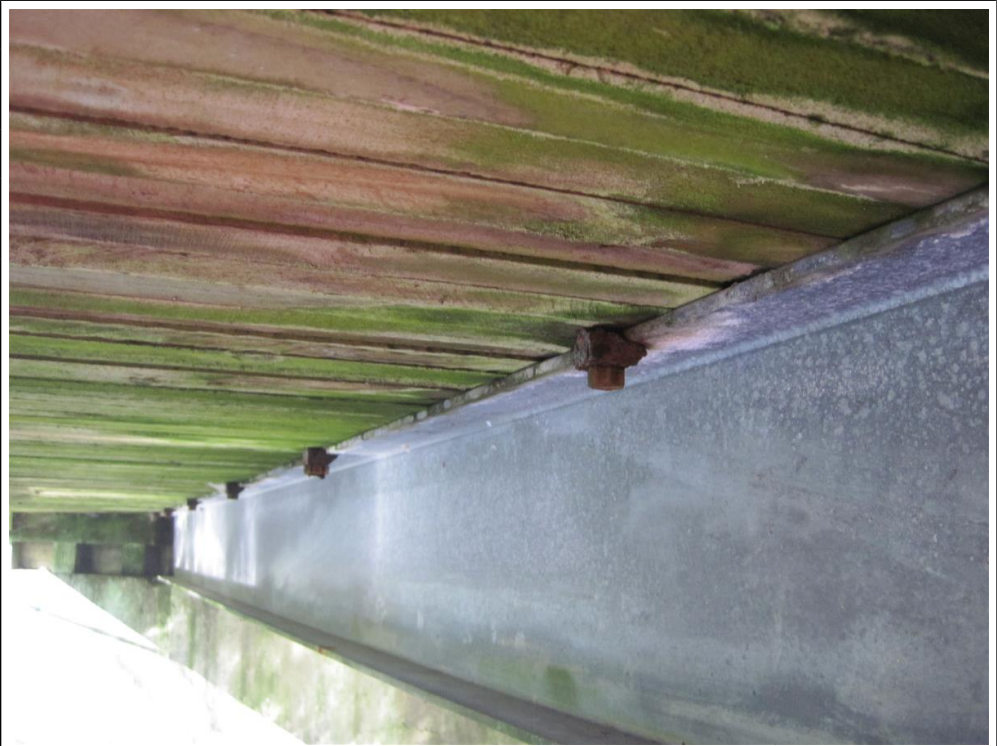
Photograph ID: 34
Photo Location: 46 South Karori Road
Direction:
Survey Date: 16/08/2016
Comments: Heavily corroded clamps

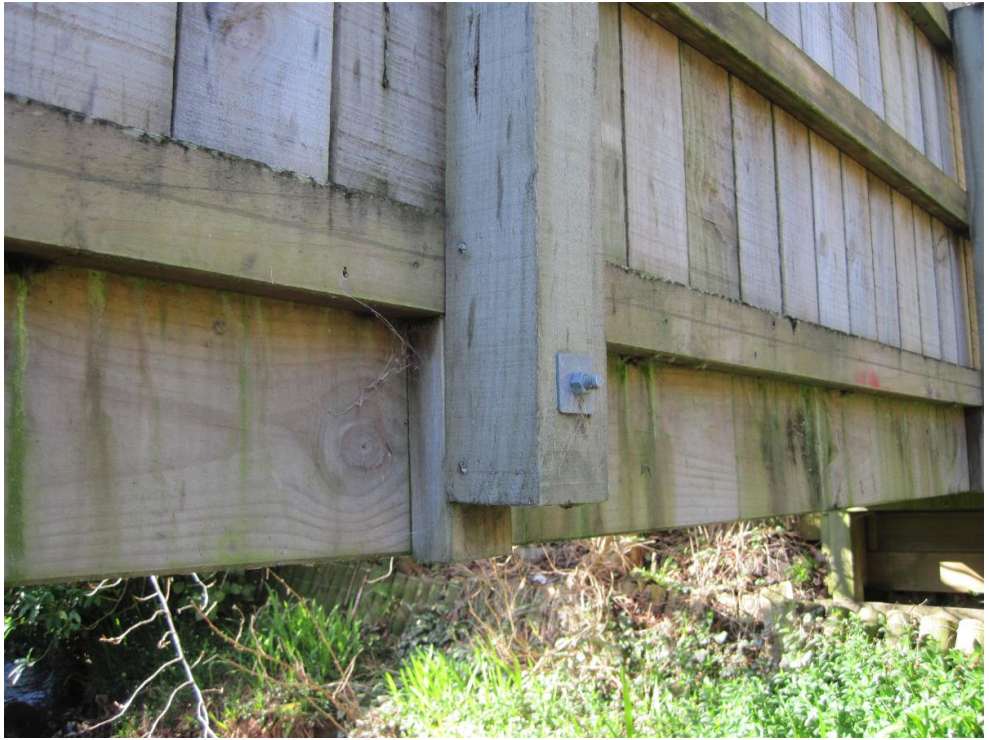
Bridge 2 does not meet current best practice requirements as laid out in SNZ HB 8630:2004. It also fails the loading requirements for single person usage which is a point load of 3.6kN in accordance with the above standard. The most immediate safety concern is that of the handrails. The handrails are loose and have poor connection details meaning that they are currently unsafe.

Photo Location: 52 South Karori Road			
Direction:			
Survey Date: 16/08/2016			
Comments: Handrails connected only by a single bolt, this is unstable			
Photograph ID: 40

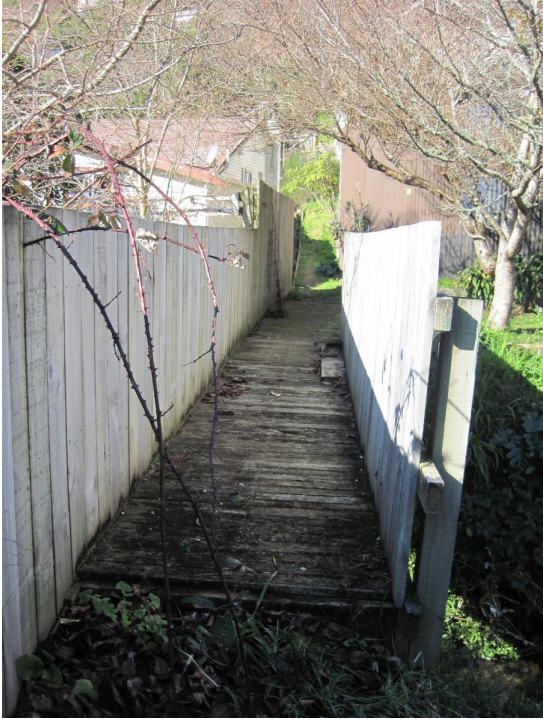
Photo Location: 52 South Karori Road			
Direction:			
Survey Date: 16/08/2016			
Comments: Handrails are flimsy and can be deflected easily
