Technical review on the boron treatment of LVL to meet H1.2 conditions
in New Zealand

Laurie J Cookson

Date: 29 June 2016

Client: Ministry of Business, Innovation and Employment, Wellington,
New Zealand.

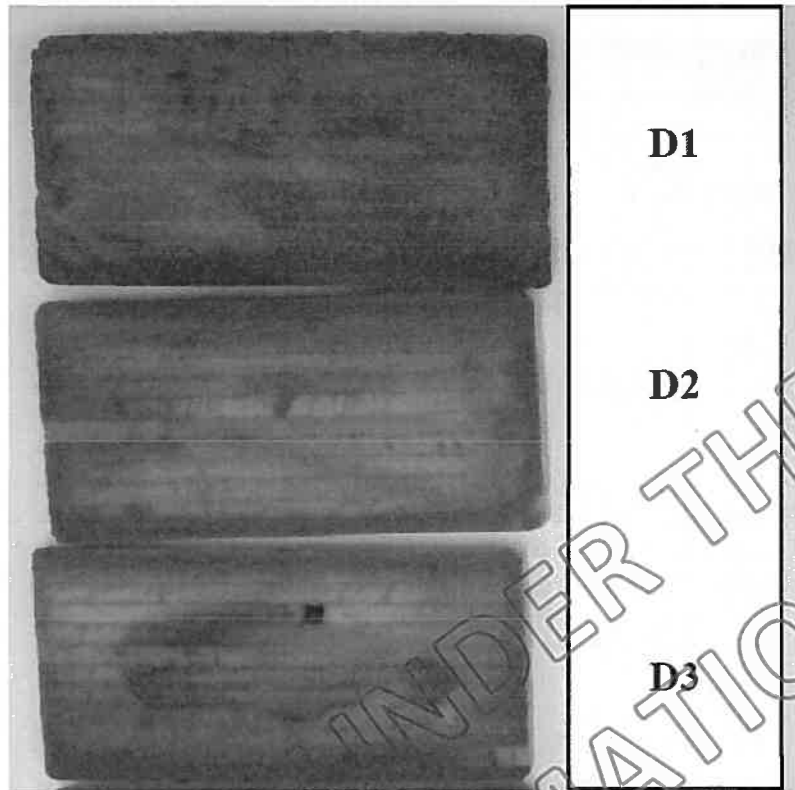
An example of the penetration obtained in the Scion samples was provided in its appendix, and those for samples D1-D3 are replicated in Figure 5. D1 appears to be fully penetrated. However, some of the interior veneers in D2 and D3 have limited penetration.

Figure 5. Boron penetration in 90 x 45 mm J-Frame. The darker red areas show boron penetration, while the paler yellow areas show a lack of penetration. From Simpson and Singh (2016).

While JNL is justified in using 'evidence of distribution' to determine penetration in J-Frame and obtain CodeMark approval, the phrase is too weak to ensure durability. Decay may begin on the edge of a veneer that has limited penetration. Also, if J-Frame is cut or machined after treatment, then unpenetrated sapwood could be exposed and will be susceptible to decay. A similar problem was demonstrated in glulam treated after gluing with light organic solvent preservatives (Cookson, 2013). Therefore, a Verification Method should also be used to test the durability of J-Frame under H1.2 conditions to prove its B2 durability. A similar opinion was provided by s 9(2)(a) on 5 August 2015 where penetration and retention 'require underpinning by efficacy trials that demonstrate comparable decay resistance performance of H1.2 LVL.' The final proof of what works will be obtained from durability trials, rather than untested penetration pattern specifications.

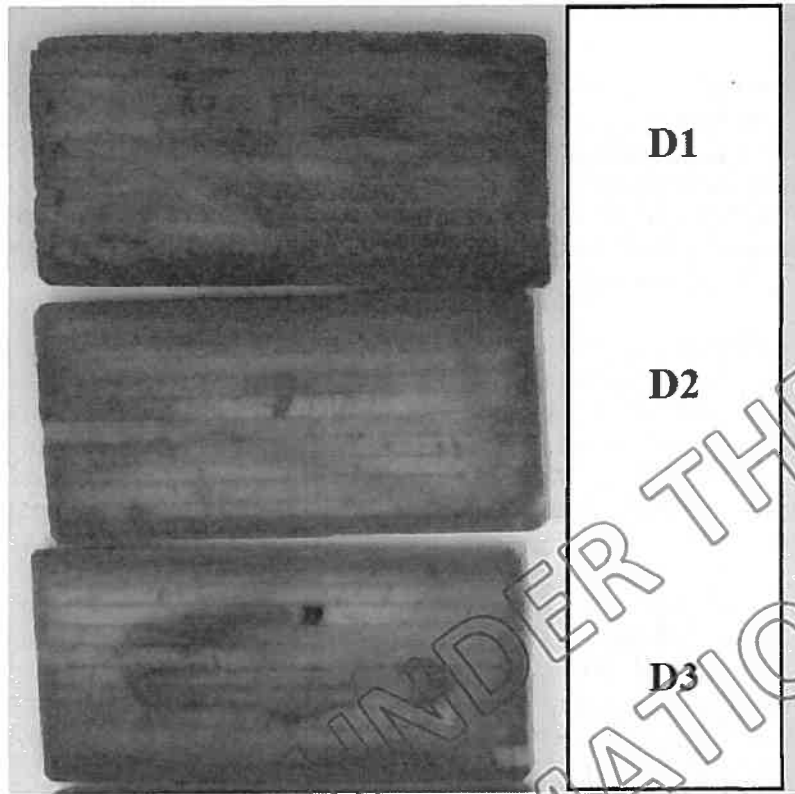
An example of the penetration obtained in the Scion samples was provided in its appendix, and those for samples B1-D3 are replicated in Figure 7. D1 appears to be fully penetrated. However, some of the interior veneers in D2 and D3 have limited penetration (yellowish colouration), although it is not clear whether the cause is unpenetrated heartwood or sapwood.

Figure 7. Boron penetration in 90 x 45 mm J-Frame. The darker red areas show boron penetration, while the paler yellow areas show a lack of penetration. From Simpson and Singh (2016).

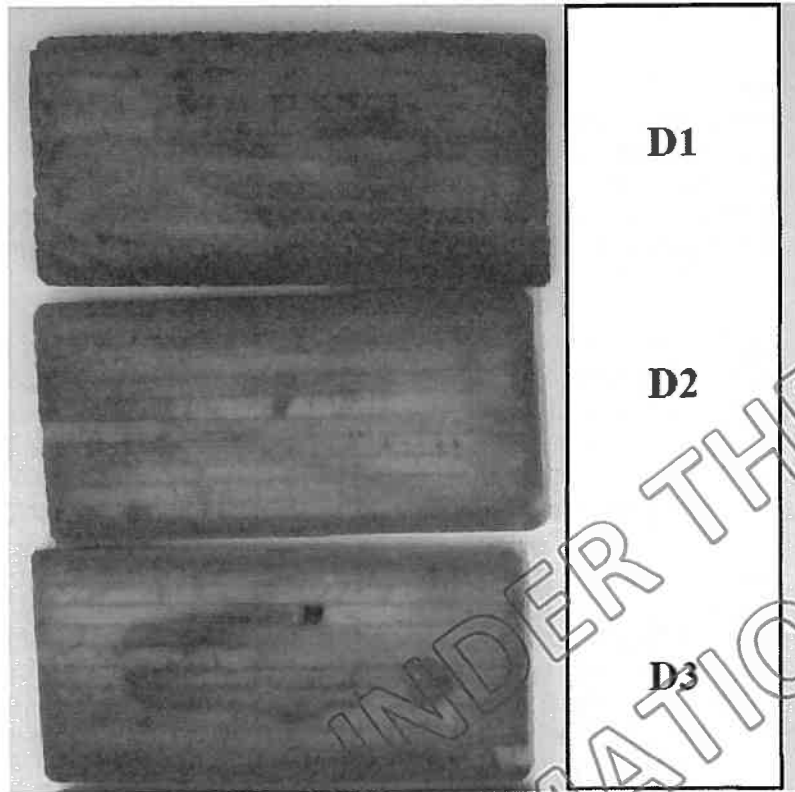
Figure 7. Boron penetration in 90 x 45 mm J-Frame. The darker red areas show boron penetration, while the paler yellow areas show a lack of penetration. From Simpson and Singh (2016).

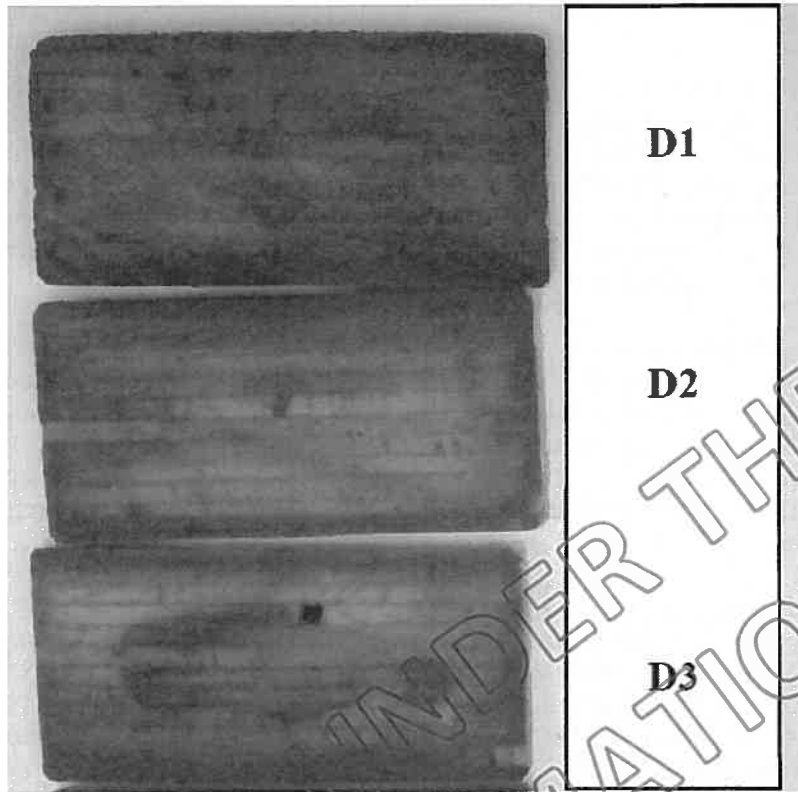
Figure 7. Boron penetration in 90 x 45 mm J-Frame. The darker red areas show boron penetration, while the paler yellow areas show a lack of penetration. From Simpson and Singh (2016).
