HUB FILE NOTE

Scope of Works

CLM **2011 / 048858**

6 Scarff Place

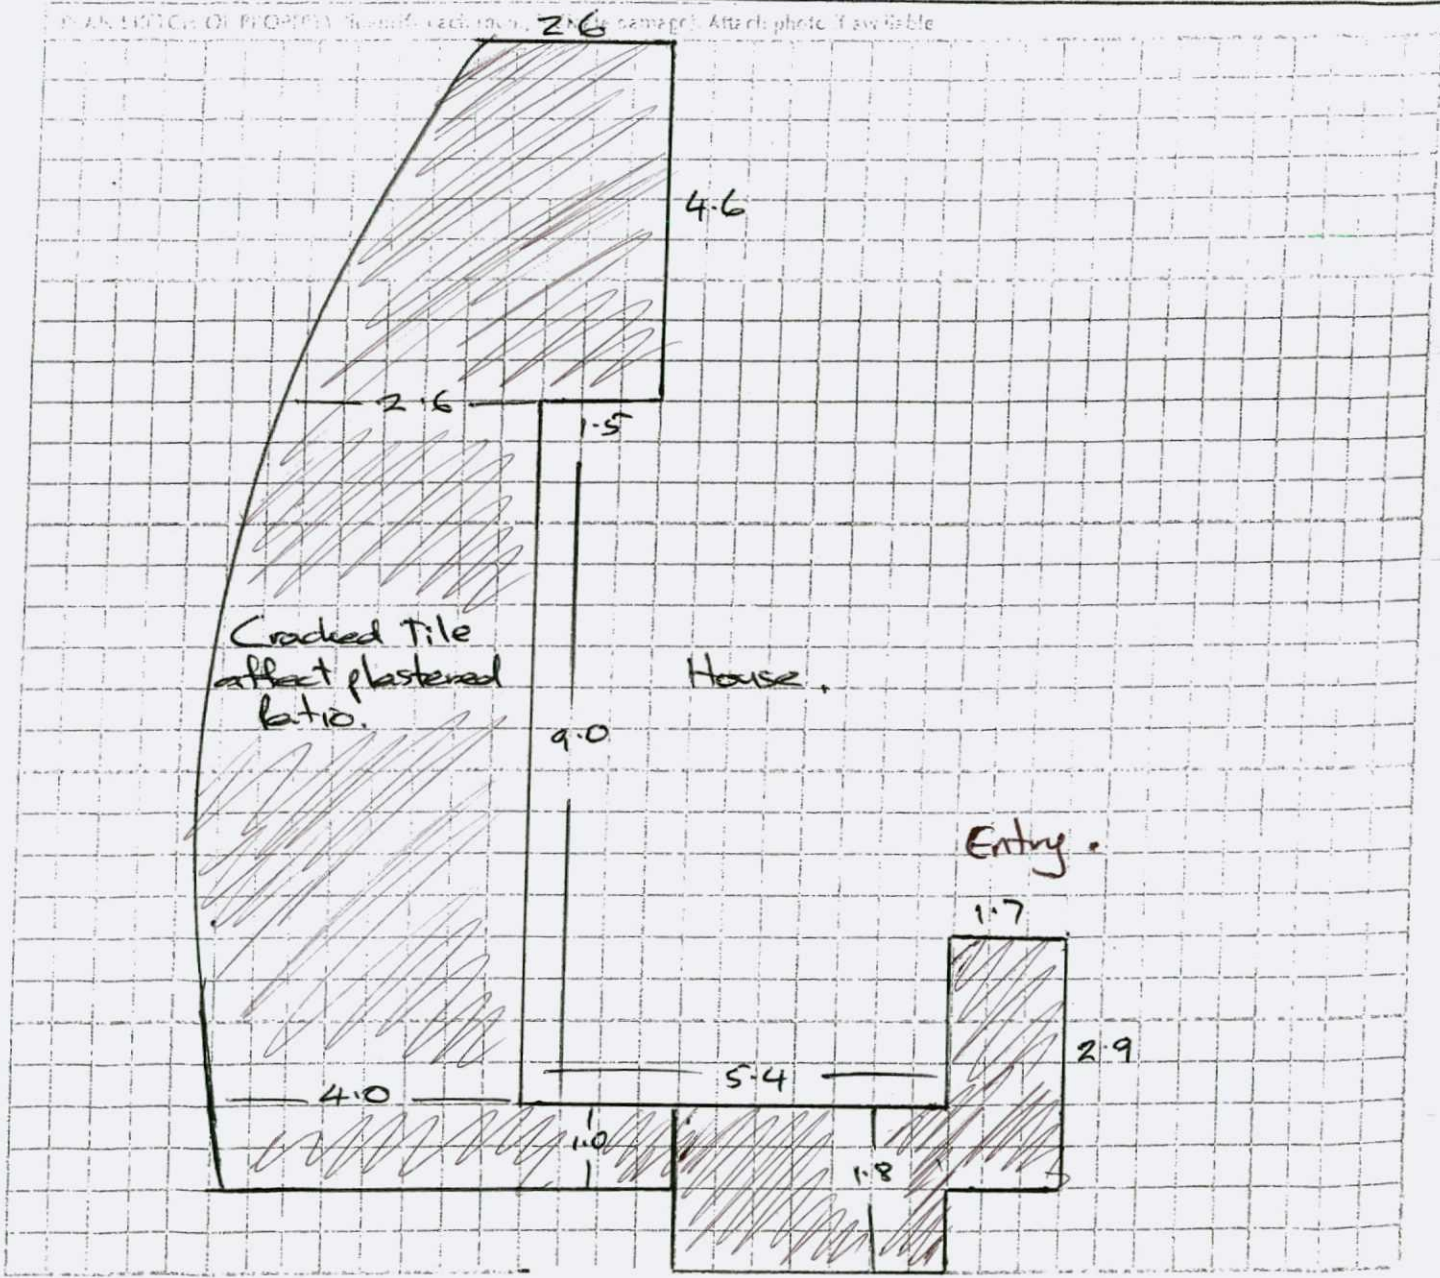
Sketch Plan of Property

Description: The Plastered tile affect patio to the front of the House has been EQ damaged

Shaded area of Tile affect plastered batio covered by EQC

Repair strategy: Remove and replace the damaged plastered patio
