FNDC MARITIME ASSETS PICTURE REPORT 2016

Prepared By:
FNHL

Updated on July 2016

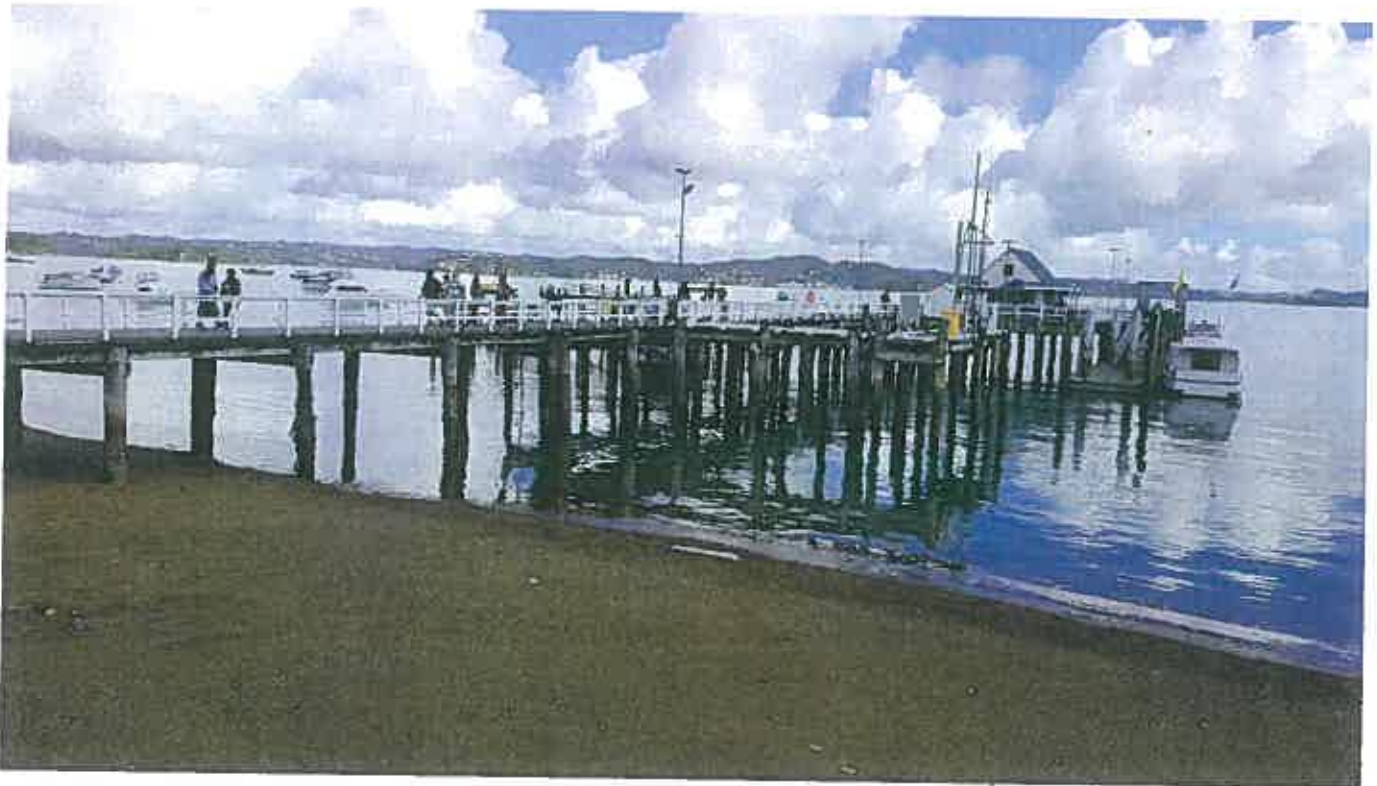
Overall view of Russell Wharf

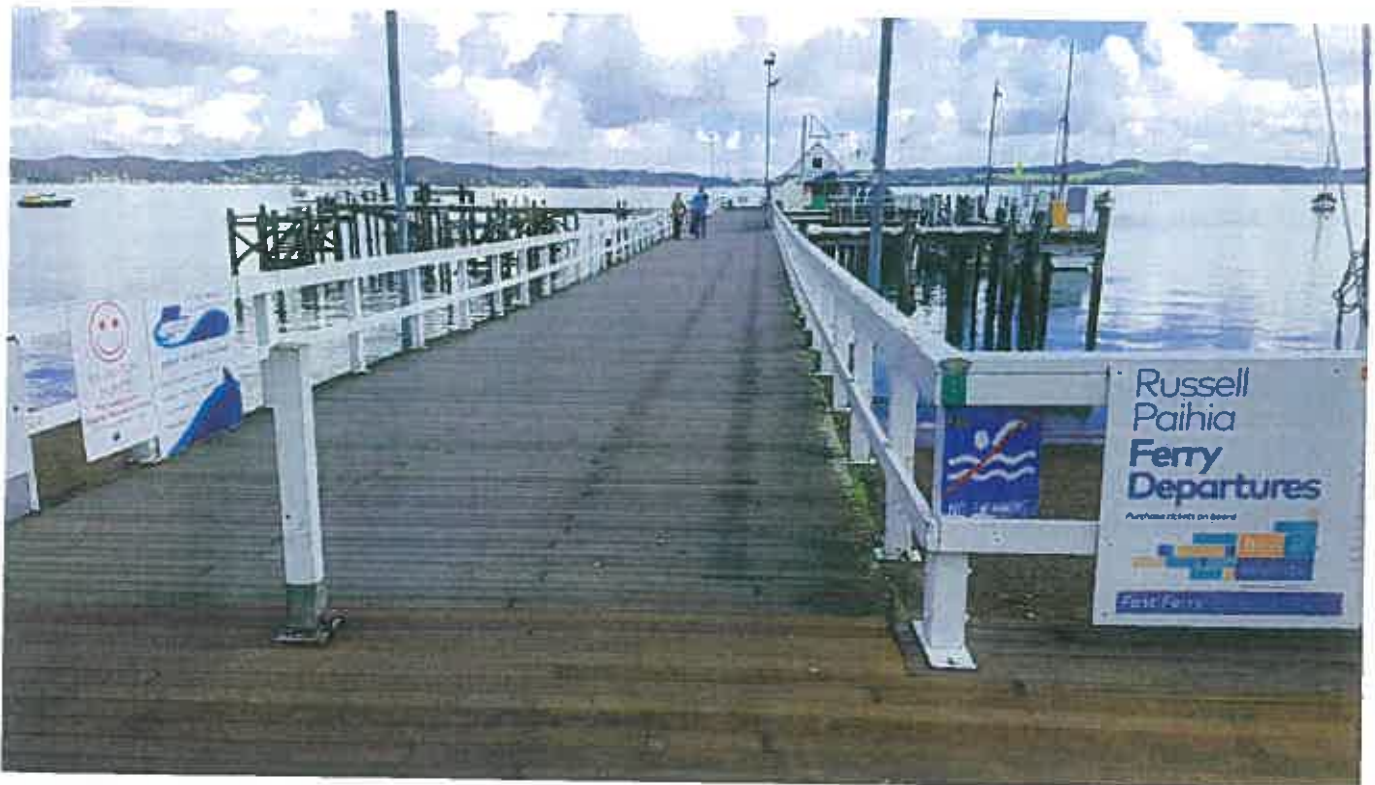
View of Approach Bridge at Russell Wharf

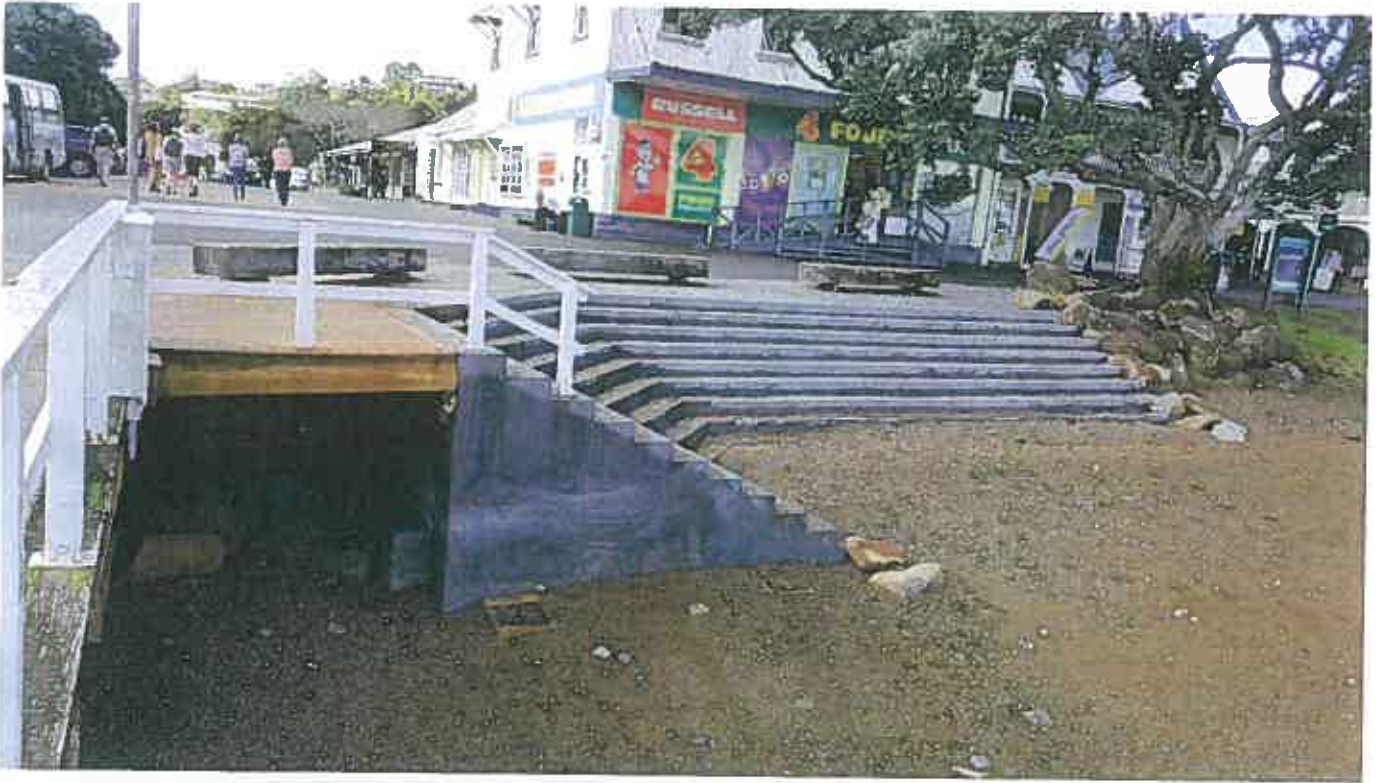
Recently constructed concrete steps towards beach in 2016

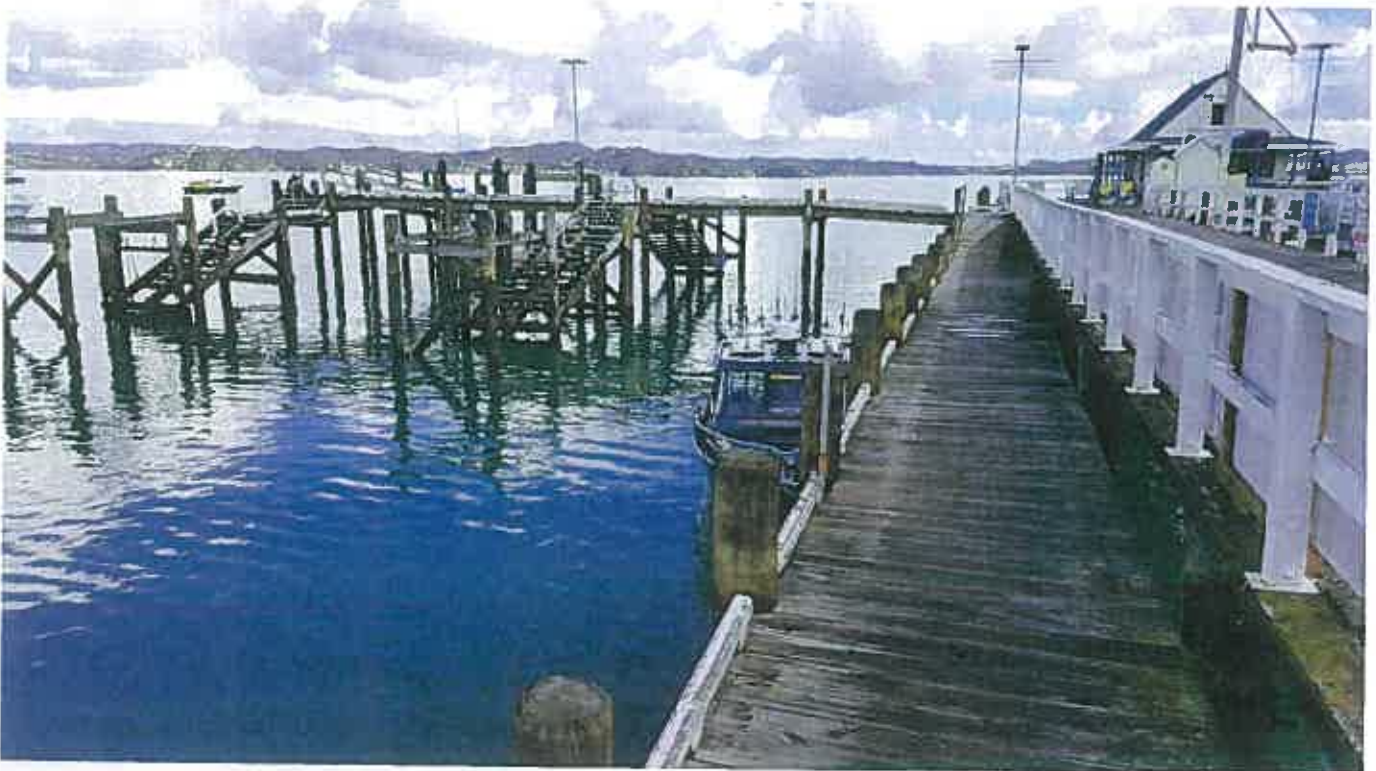
View of remaining landing steps at southern access way

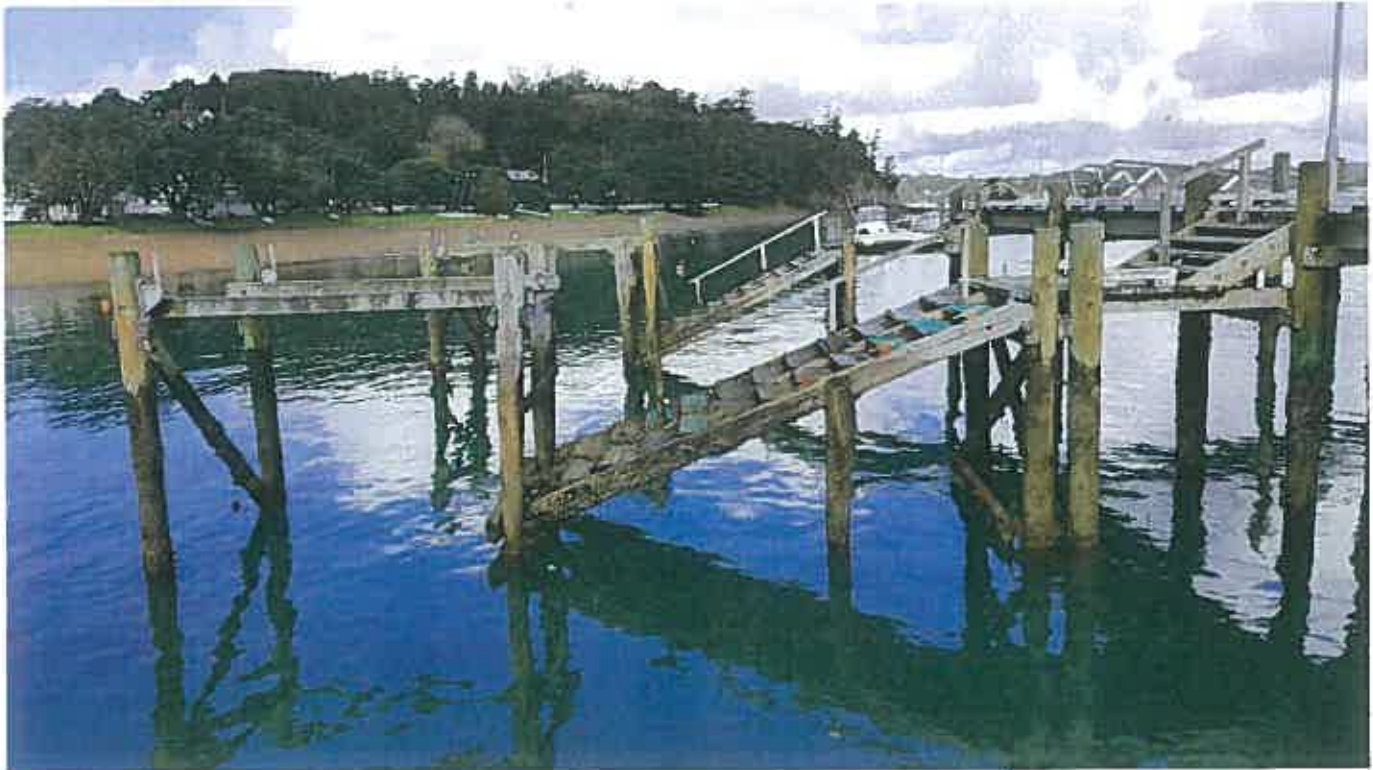
View of remaining landing steps at southern access way – Recommended to replace with floating pontoons at in future

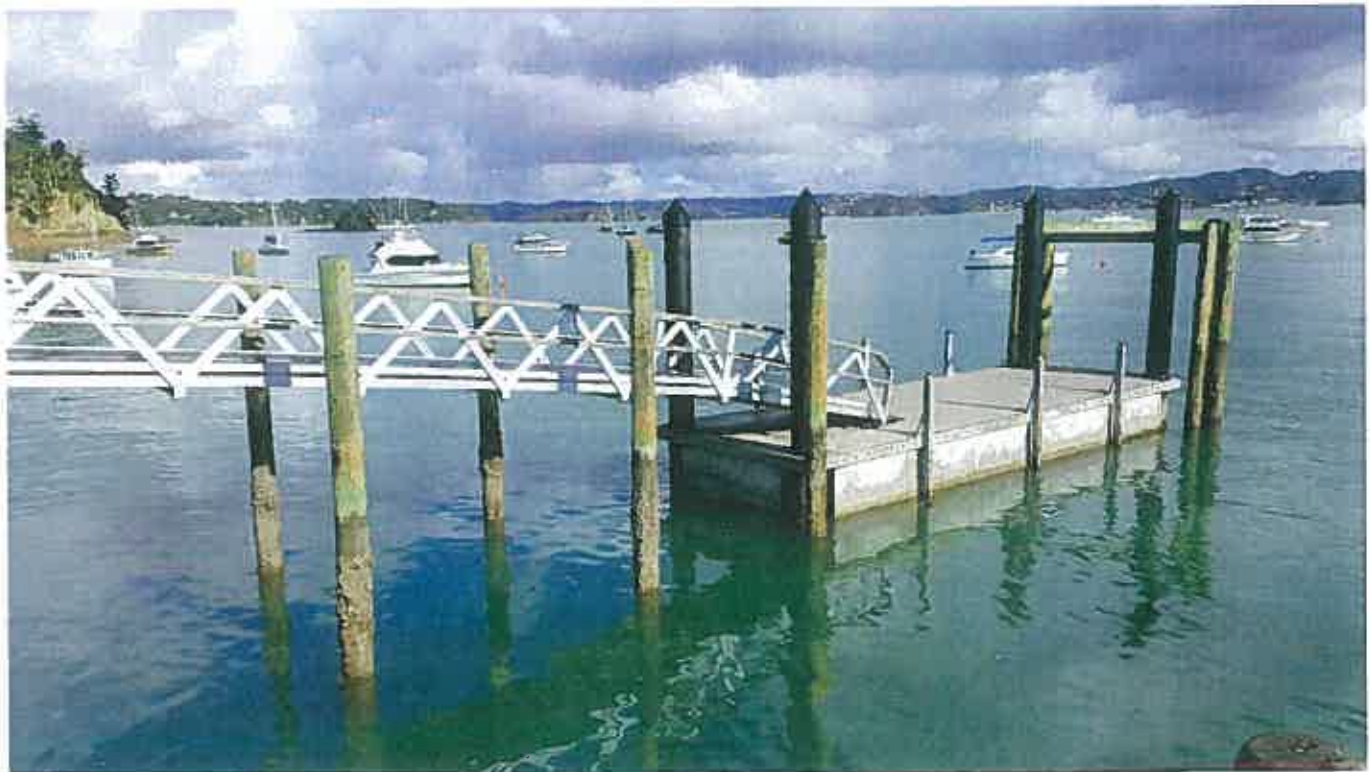
View of recently renewed cruiseship pontoon at end of Southern access way in 2012

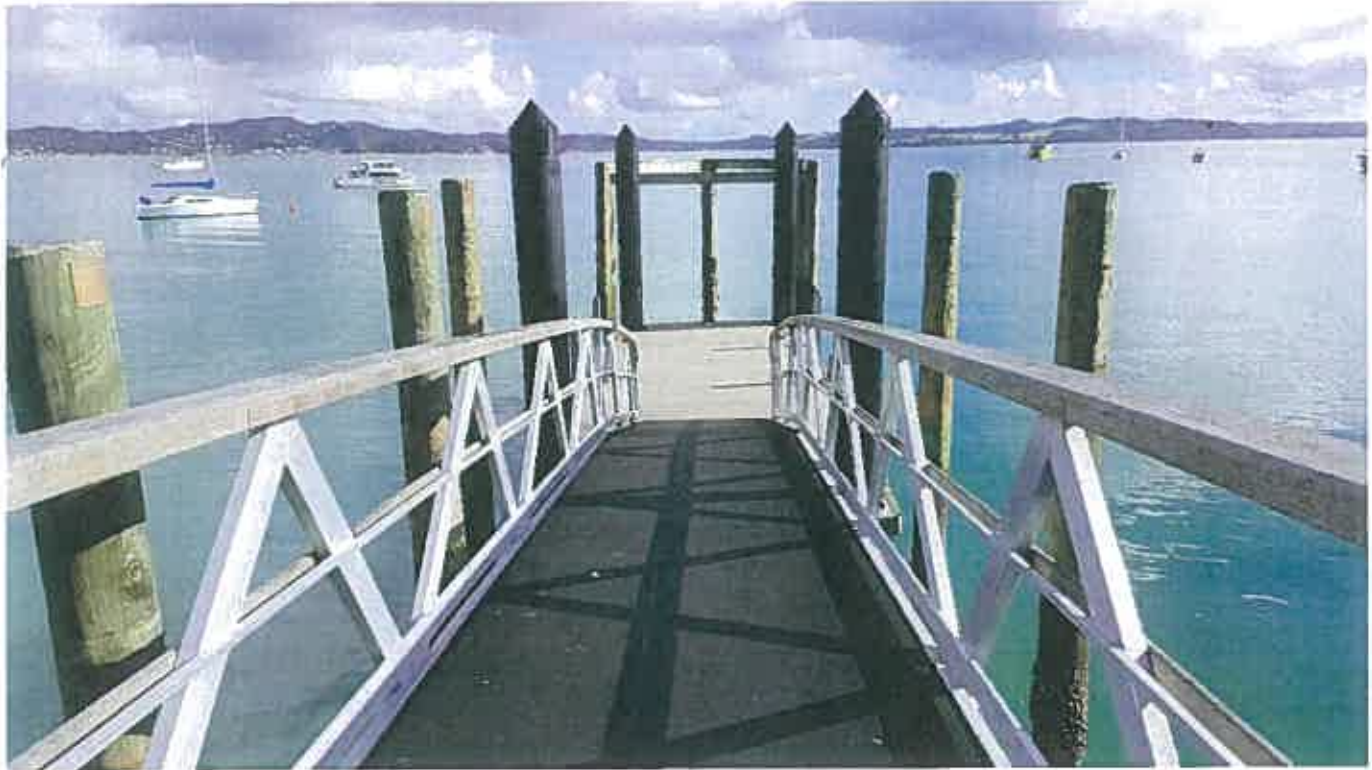
View of recently renewed cruiseship pontoon (concrete pontoon and aluminium gangway) in 2012

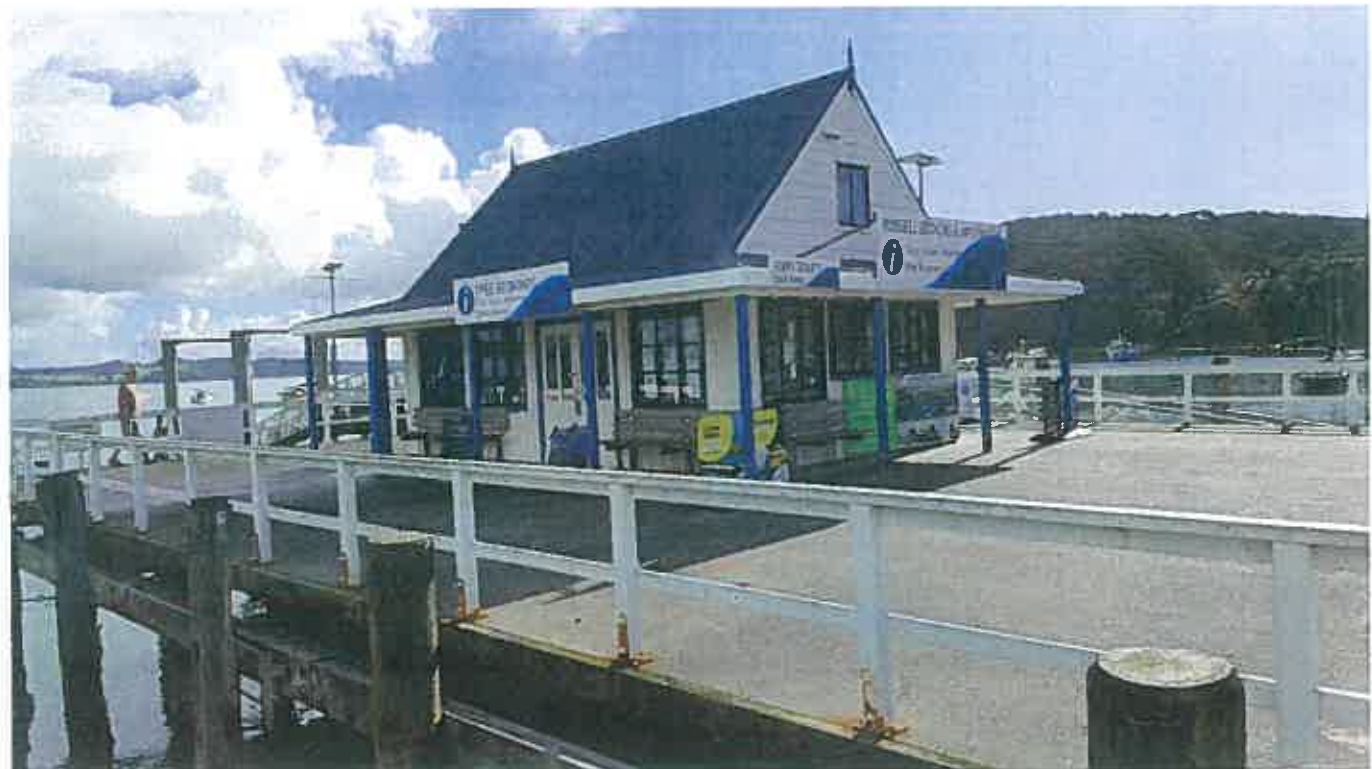
View of concrete platform and kiosk at Russell Wharf

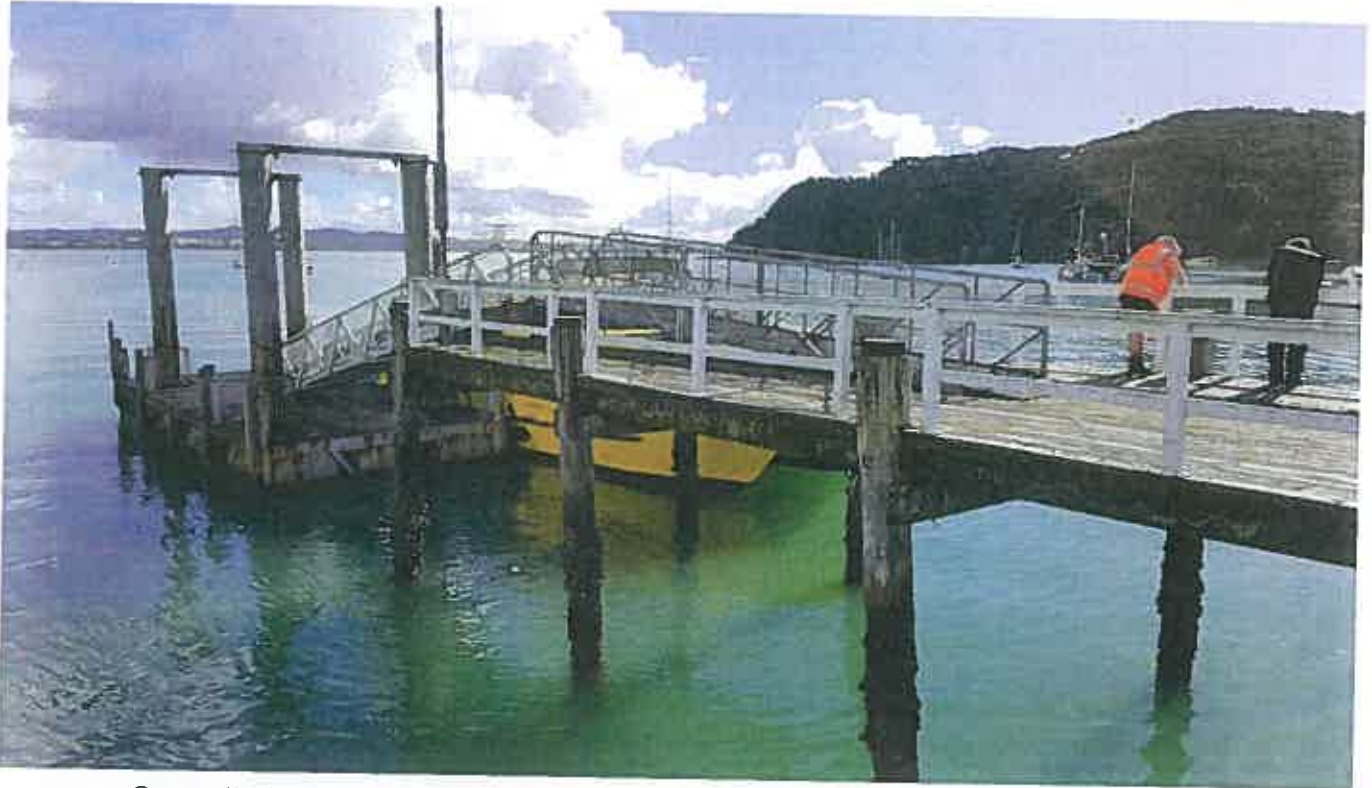
Overall view of Aluminium gangway and old steel pontoon that requires renewal soon

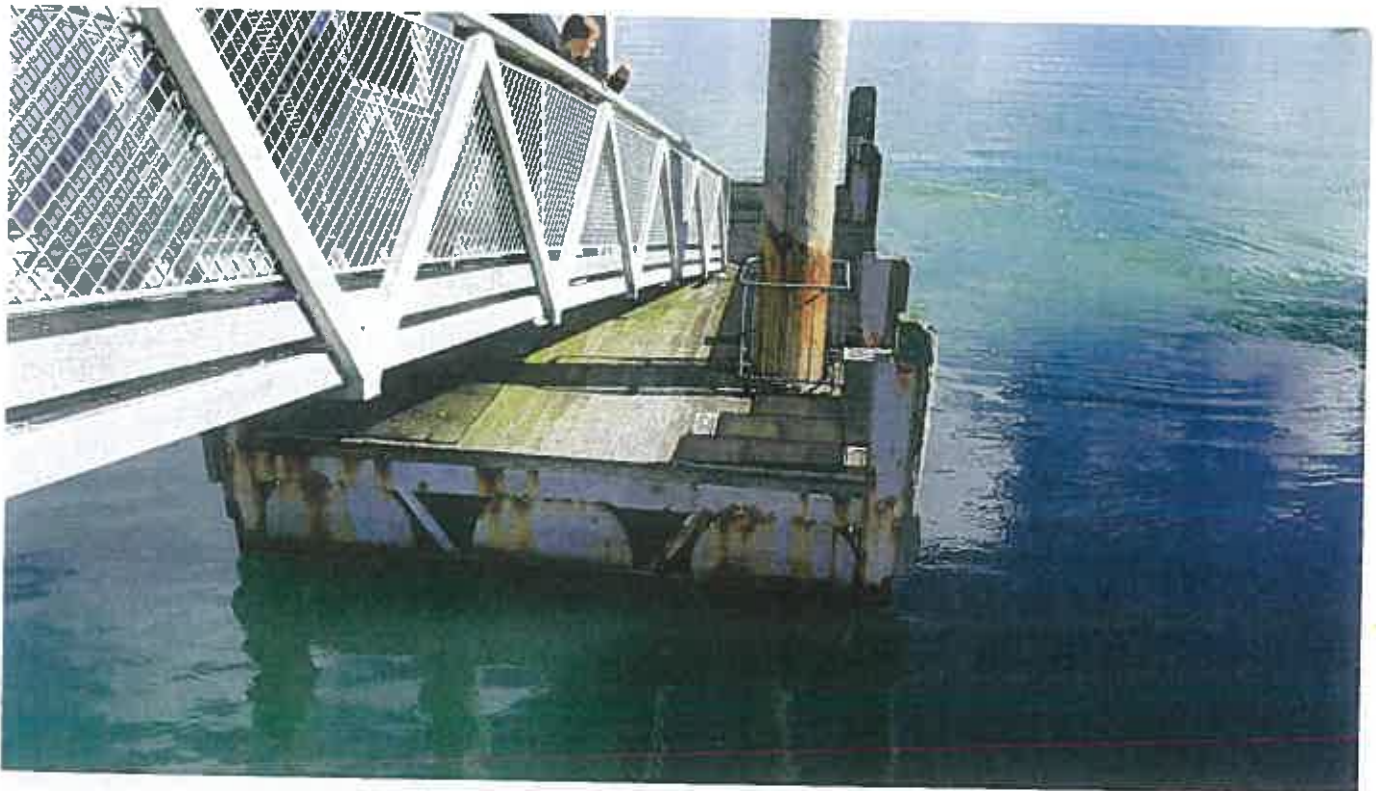
Deteriorating condition of rusted steel pile guide & piles & Steel pontoon (Repair work ongoing as required on steel pile guides until renewal)

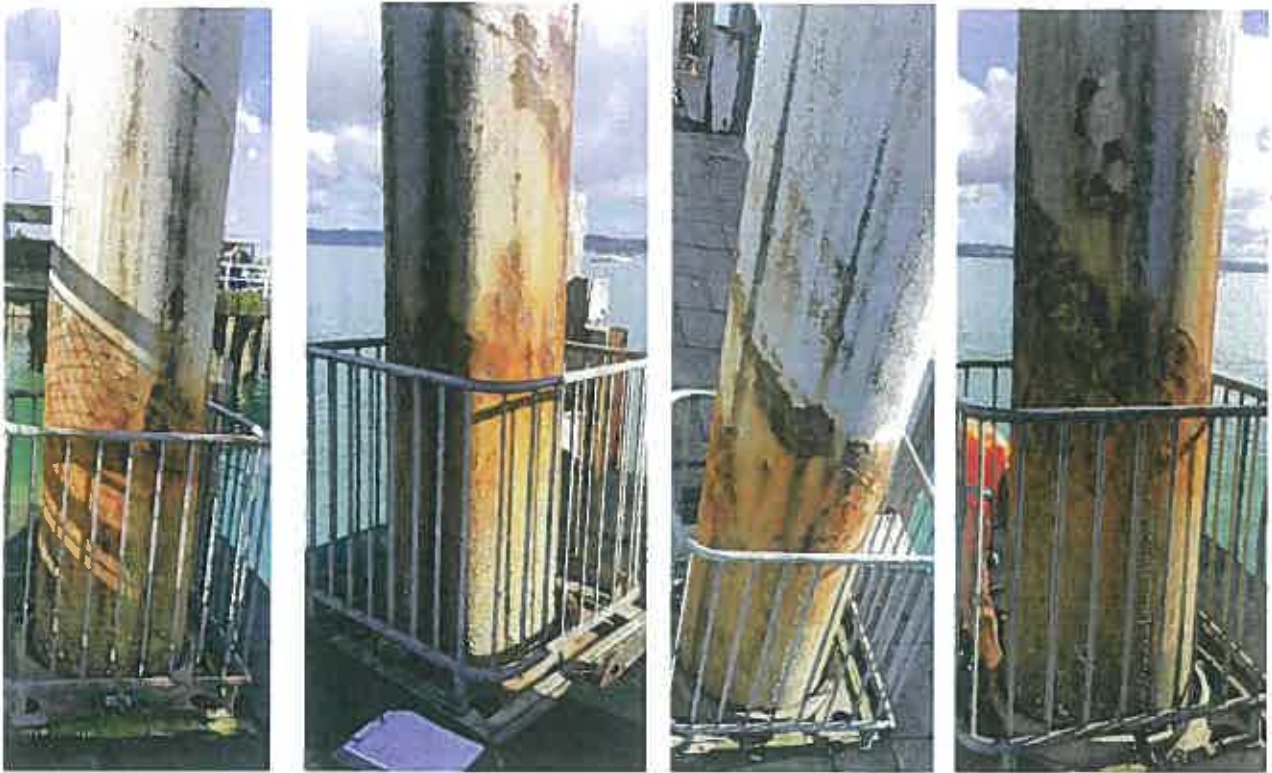
**Deteriorating condition of rusted steel pile guide & piles at Steel pontoon
(Repair work ongoing as required on steel pile guides until renewal)**

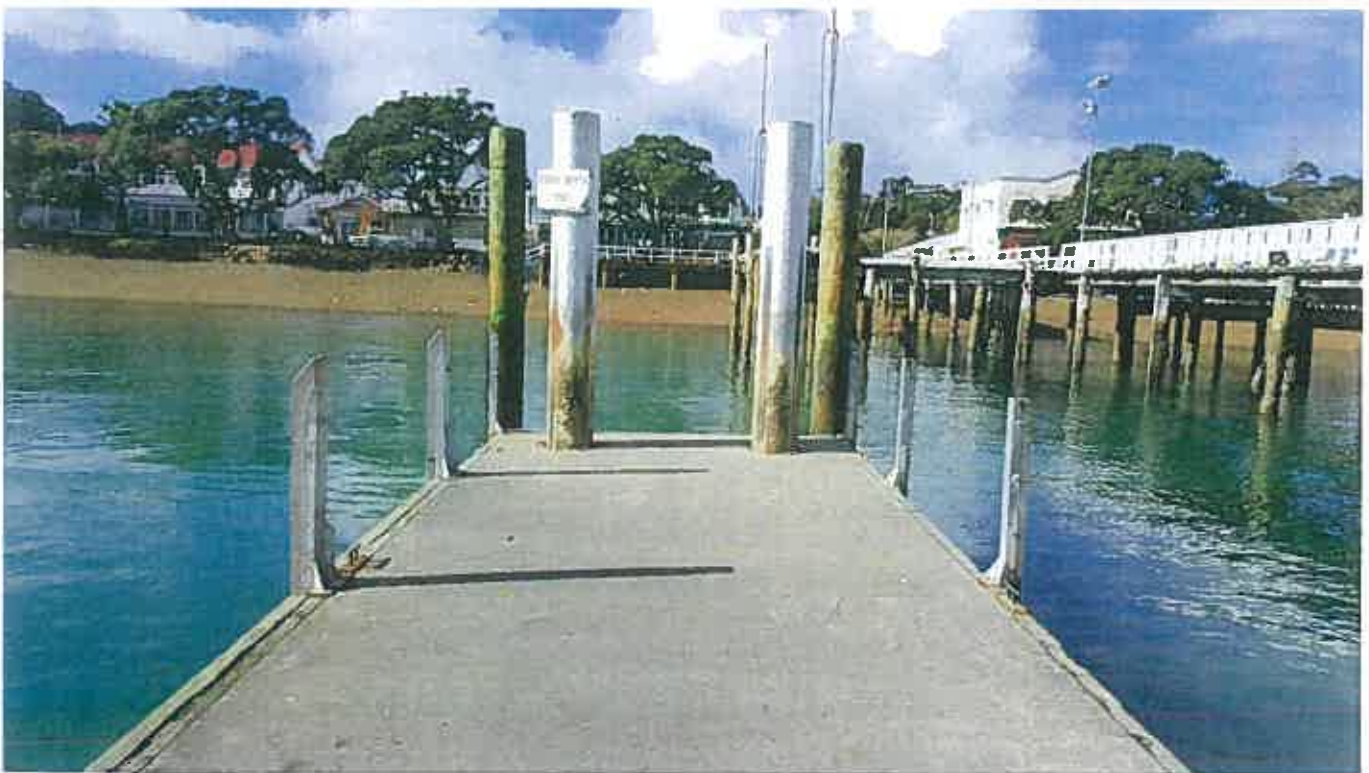
Existing concrete floating pontoon & aluminium gangway (Vertical stanchions upgrade and working well)

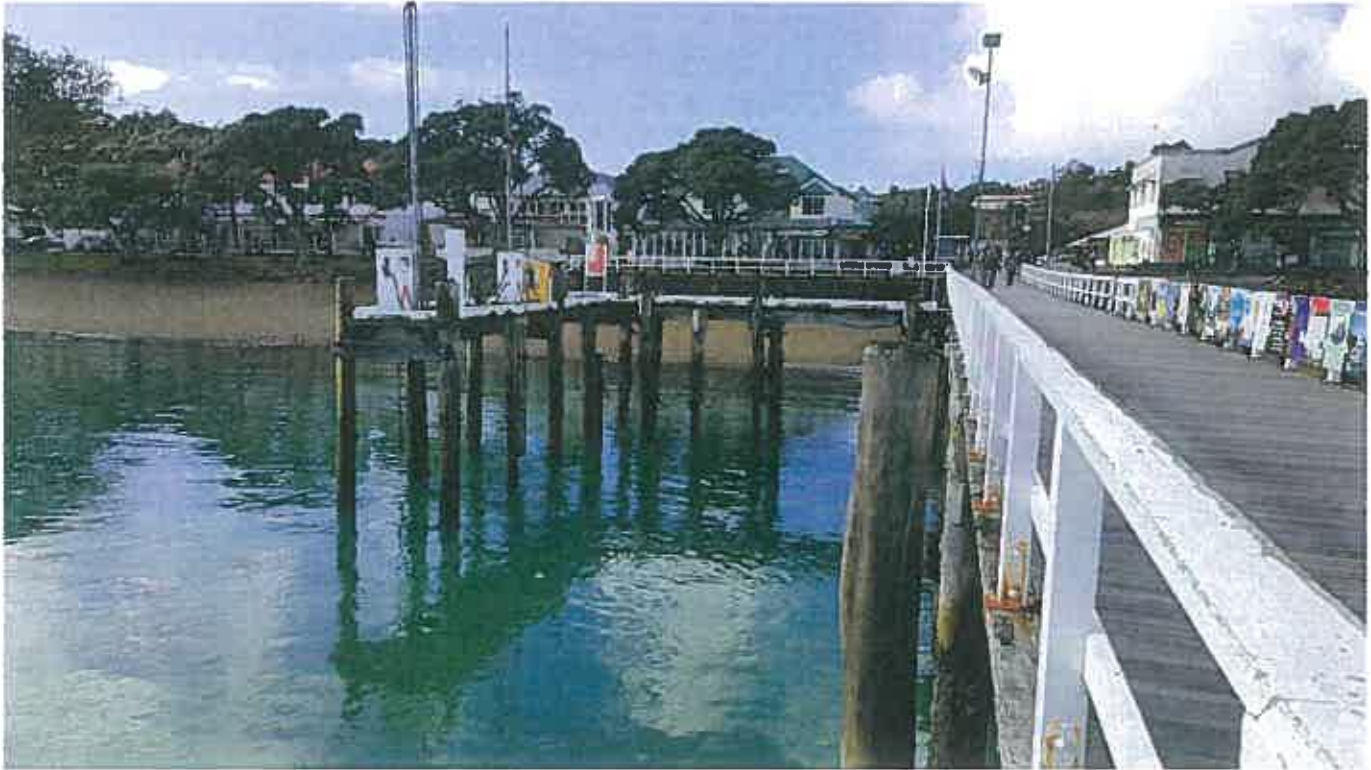
View of existing old fuel jetty (Requires renewal – due on 2015/16)

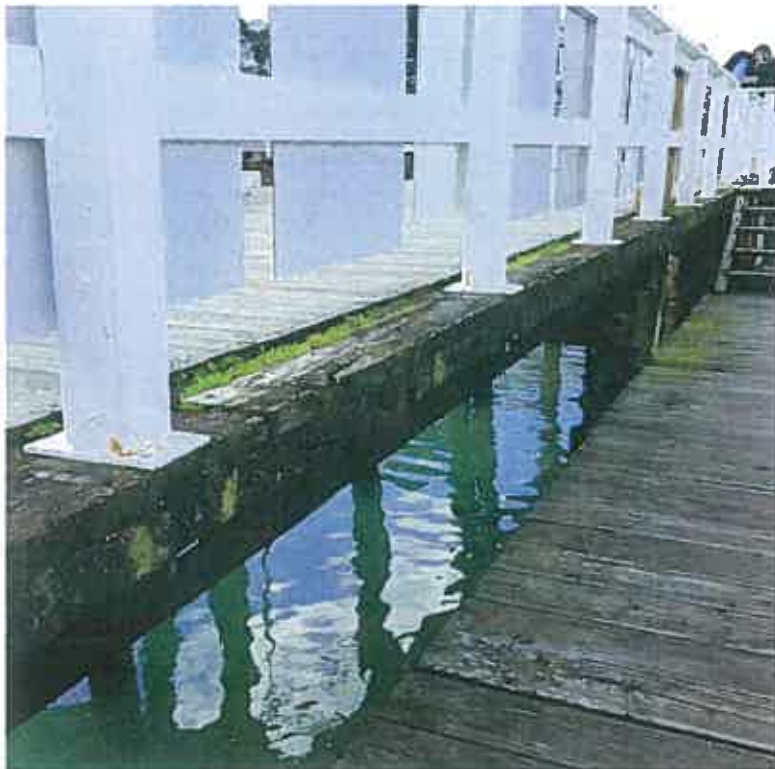
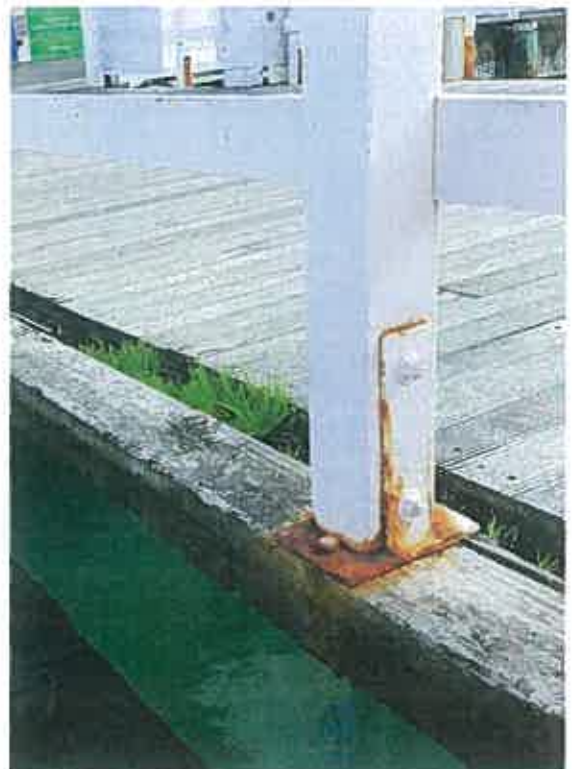
Outer boundary timber planks on approach bridge started rotting that requires cleaning and renewal and also requires renewal of handrail post footing plate

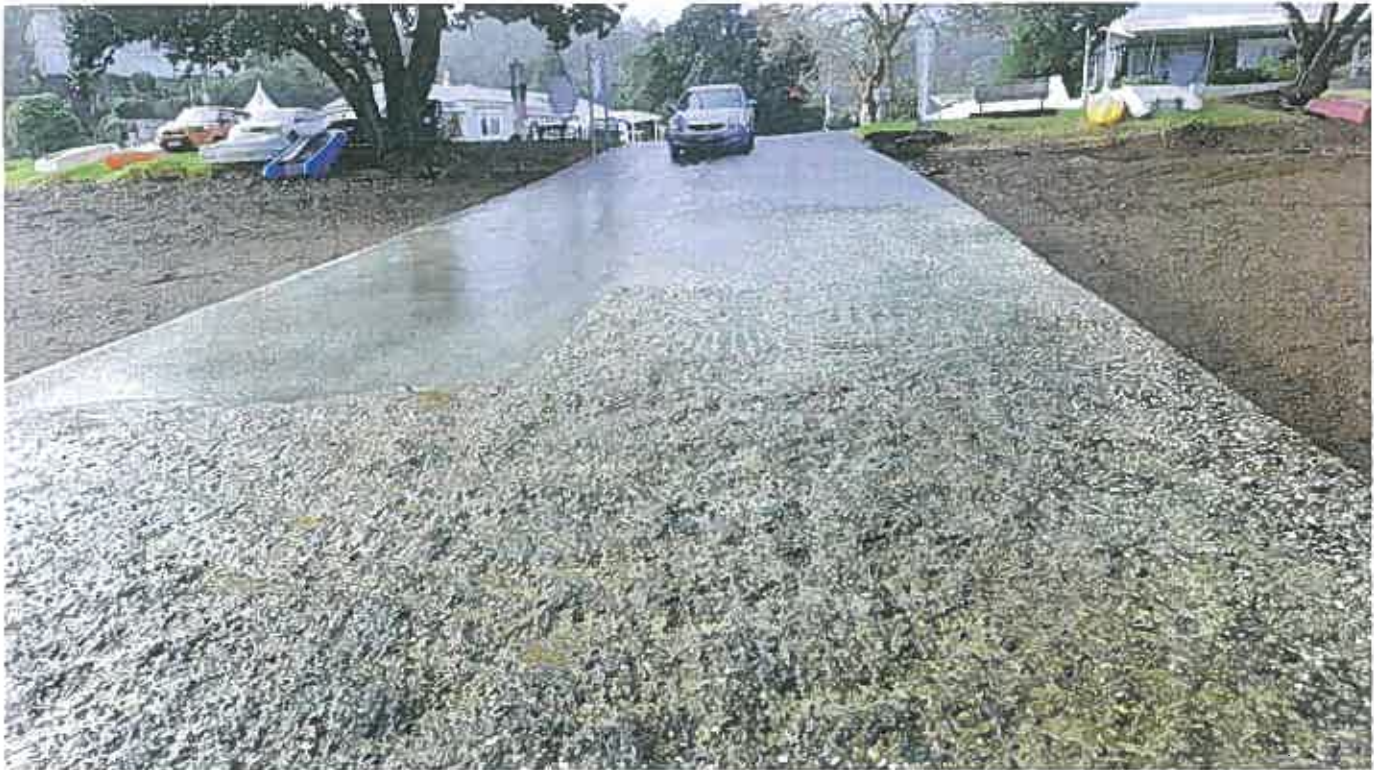
Very rough surface finish on mid and toe of boat ramp after renewal in 2012-13 (hard to clean problem)

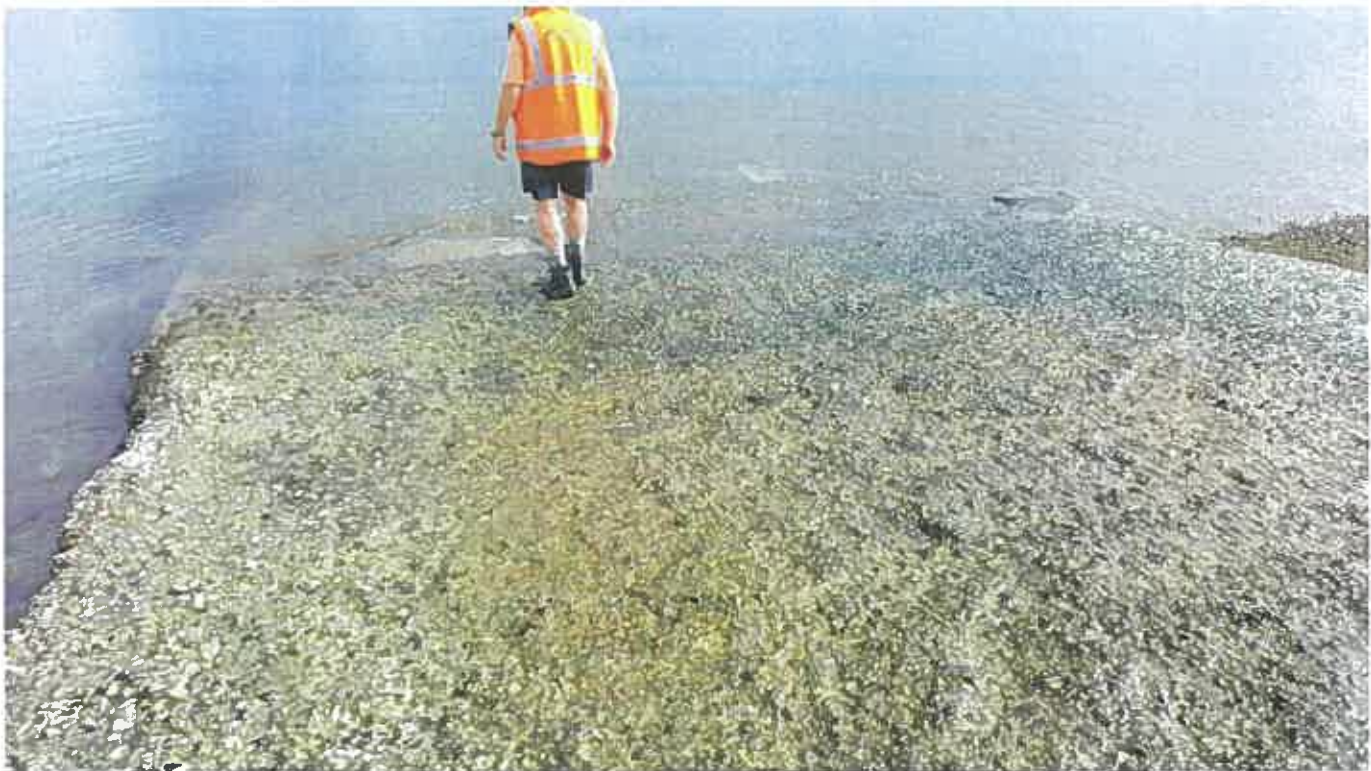
Very rough surface finish on toe of boat ramp (hard to clean problem)

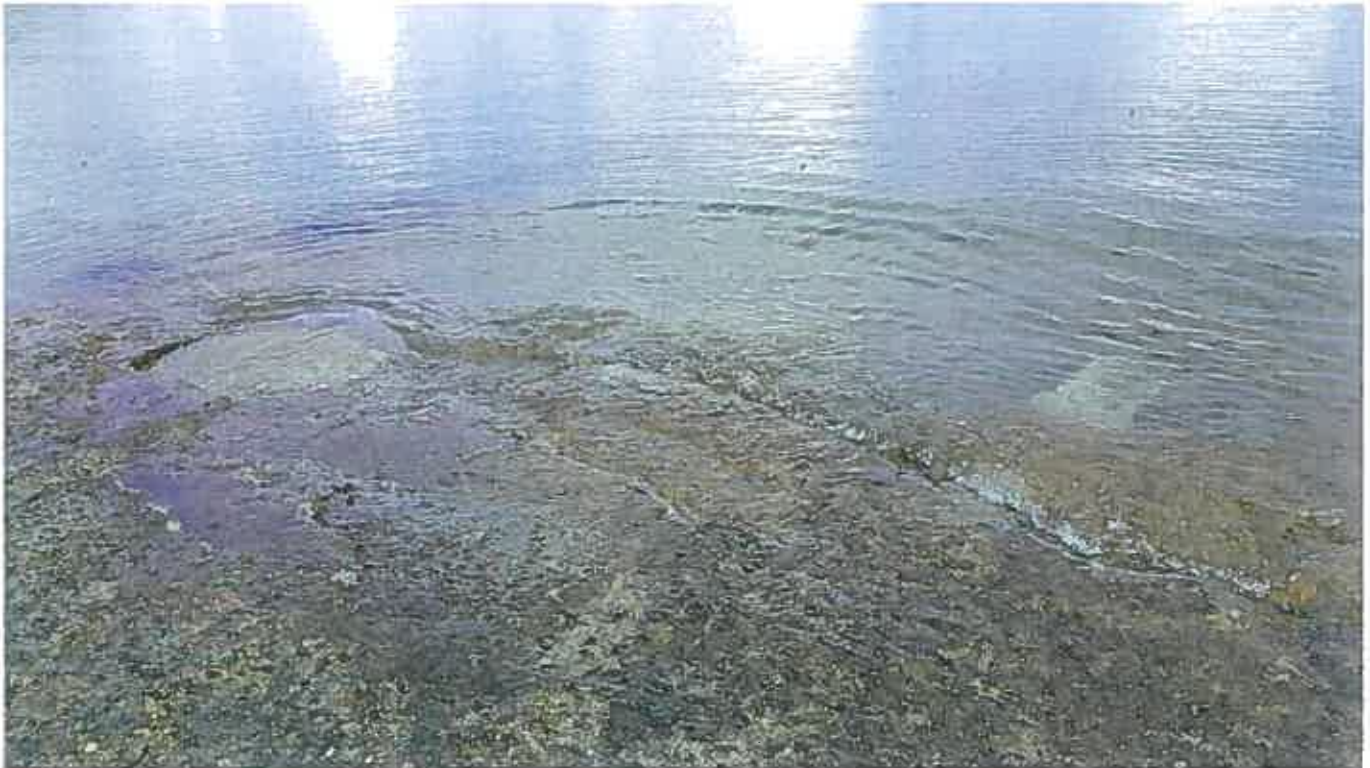
Recent damage on recently concreted boat ramp exposing old concrete ramp

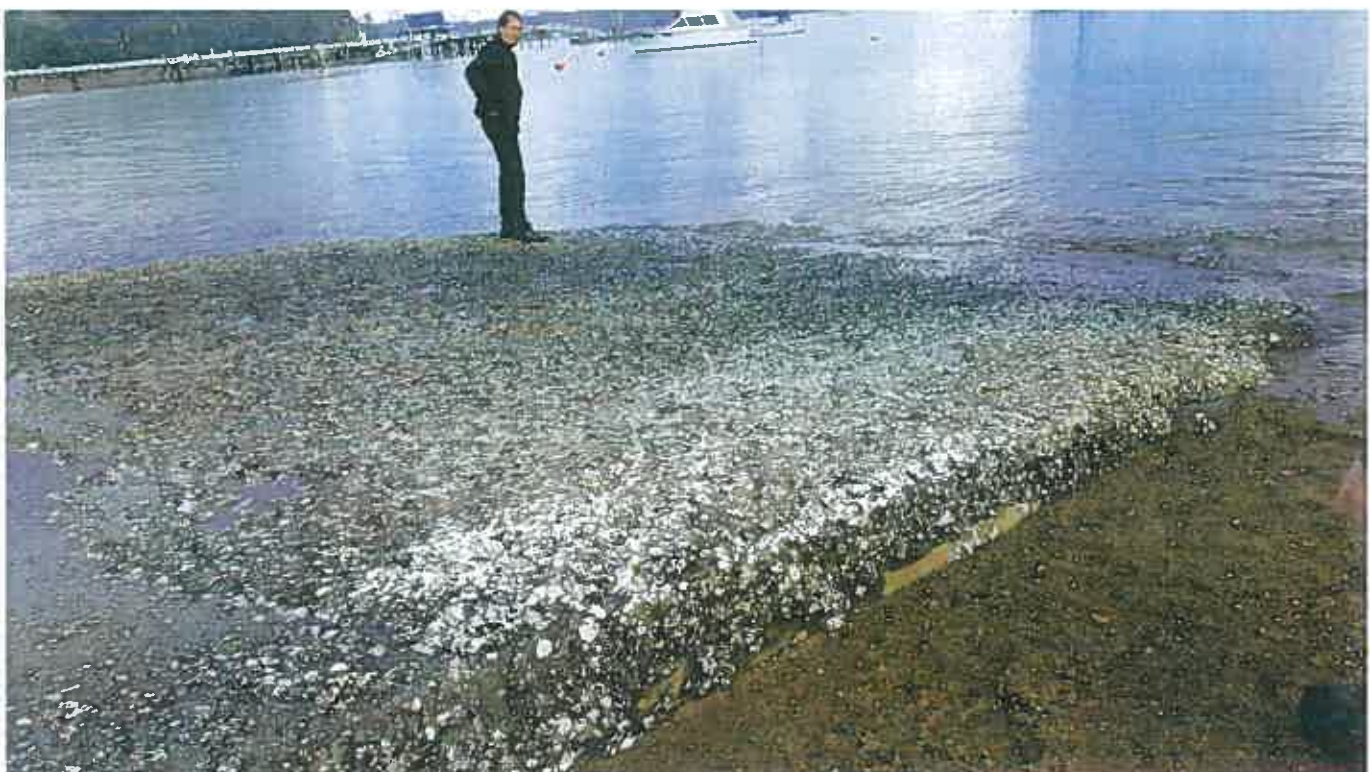
Very rough surface finish on toe of boat ramp (hard to clean problem)
