**Basin Reserve Museum Stand
Condition Assessment**

Basin Reserve Museum Stand Condition Assessment

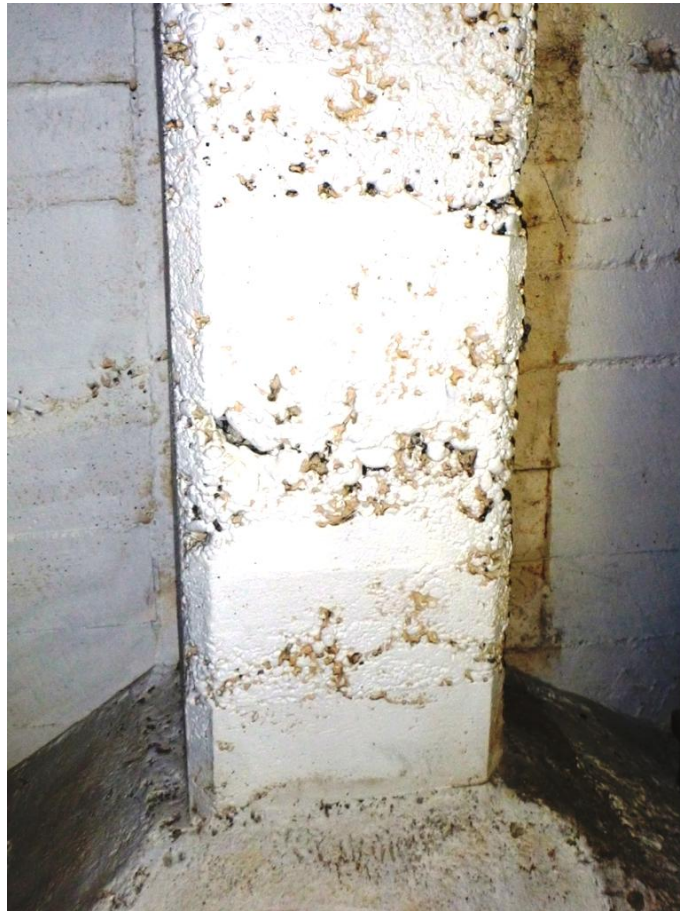
Figure 1. Poor concrete compaction in the base of concrete perimeter column (Sussex Street elevation; basement archive room).

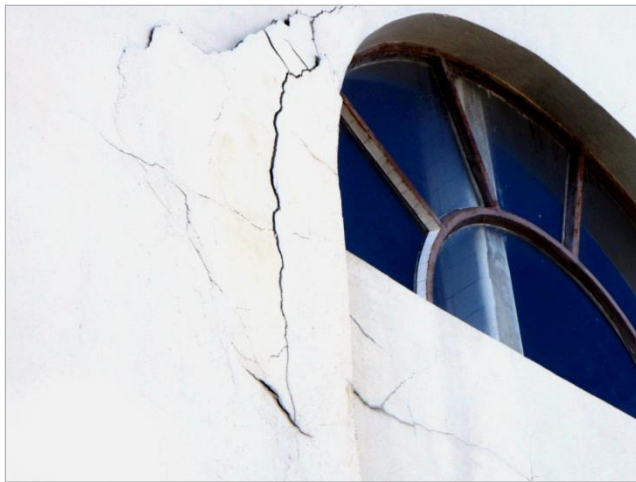
In all cases where exploratory breakout was undertaken at spalls on the Sussex Street elevation, the underlying reinforcement was revealed to be heavily corroded. Loss of cross section typically exceeding 50% and frequently the corrosion was so severe that the bars no longer possess any structural integrity. On the basis of these findings, the minimum maintenance requirement for this elevation is the removal of the window frames and systemic reconstruction of the reinforced concrete around window openings and reveals.

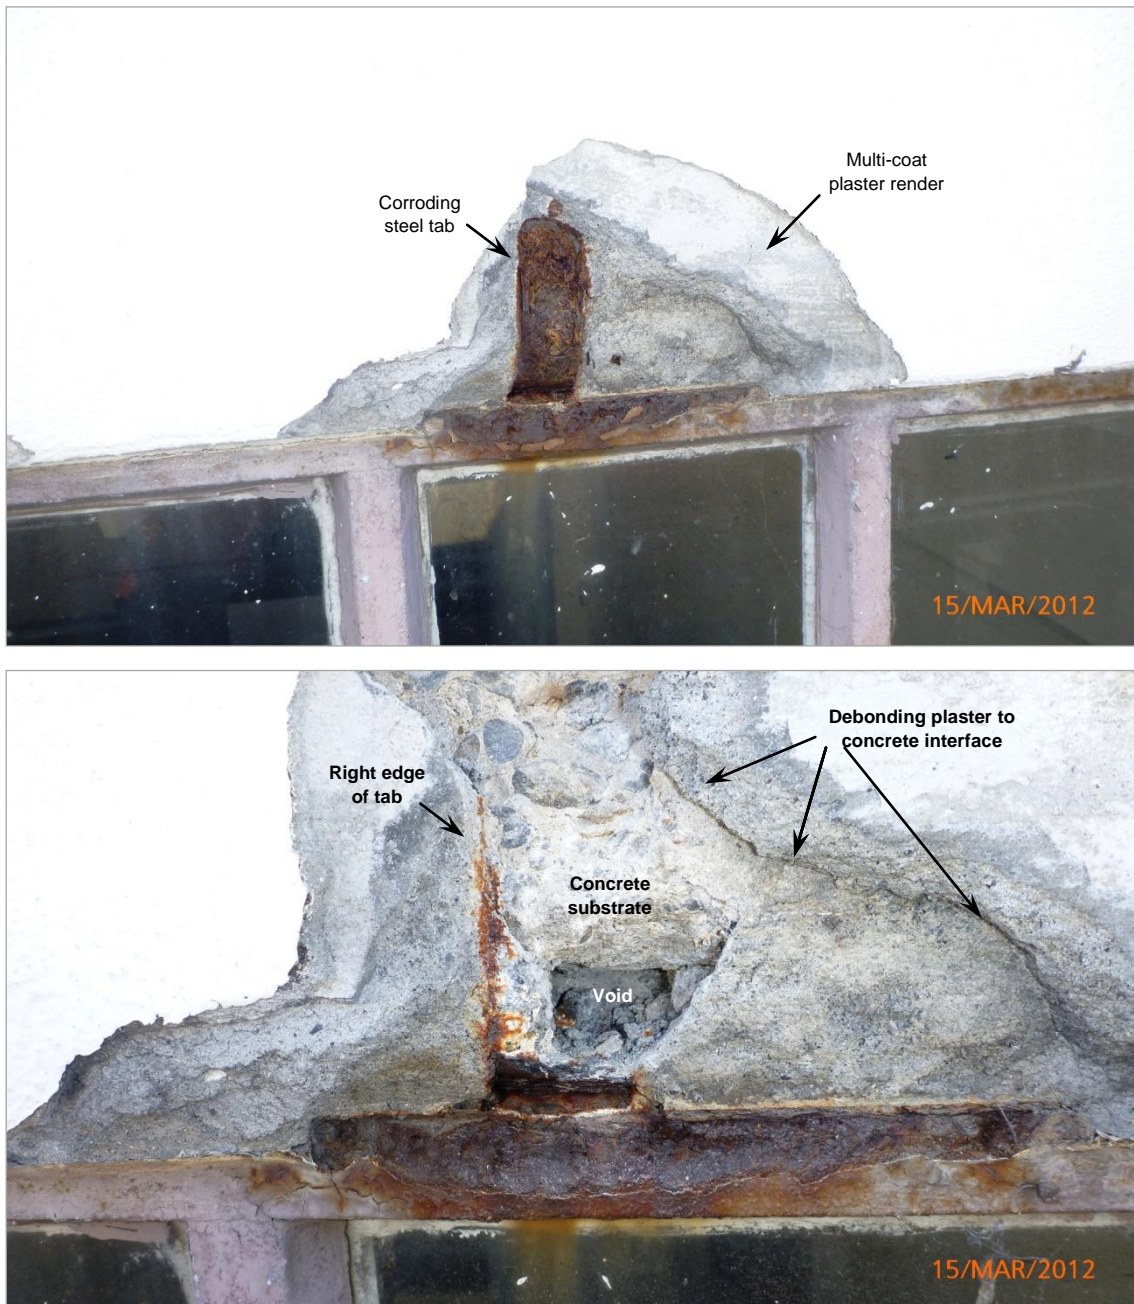
Figure 3. Examples of window frame corrosion and associated spalling on the Sussex Street elevation above the ground floor window on Bay 2. Note in the bottom picture that the ca. 30 mm gap between the top of the frame and the window opening in the concrete has been incompletely filled with mortar; the resulting void may have allowed moisture to accumulate directly above the unprotected frame, explaining the intense corrosion at this position.

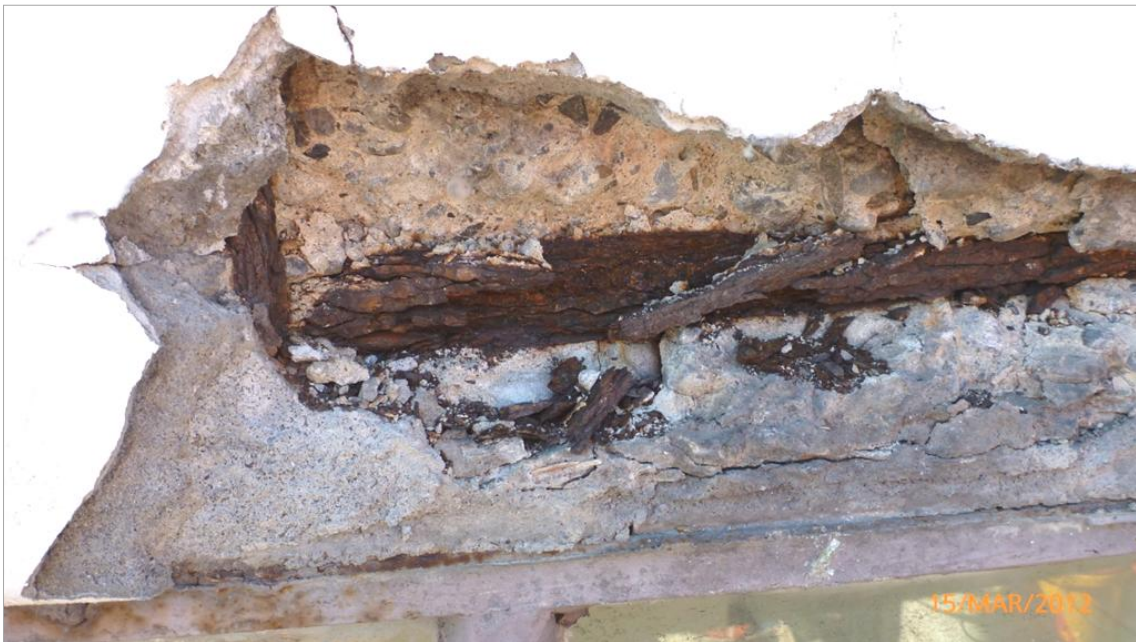
Figure 4. Completely corroded lintel bar above ground floor window (2nd bay from North). Note that aside from the plaster render, there is minimal protective concrete cover to this bar.

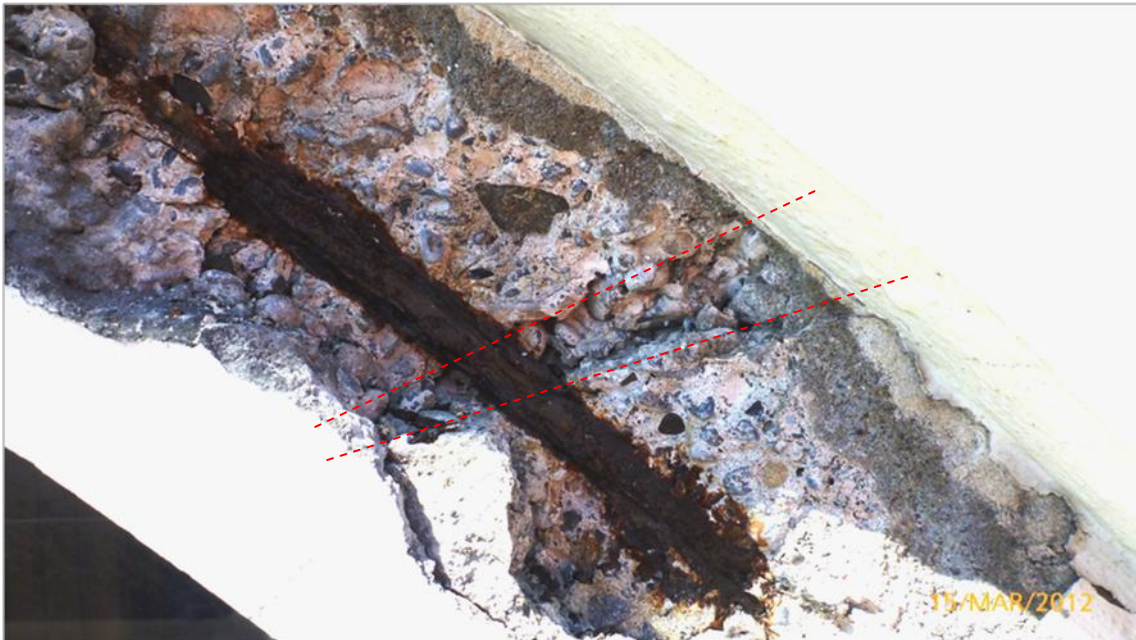
Figure 5. Heavily-corroded trim bar above the Bay 6 gallery window. The reinforcement is encapsulated in poor quality concrete which affords little corrosion protection to the steel; in particular note the rubble material between the dotted lines, which presumably represents a badly-executed cold joint in the construction process.

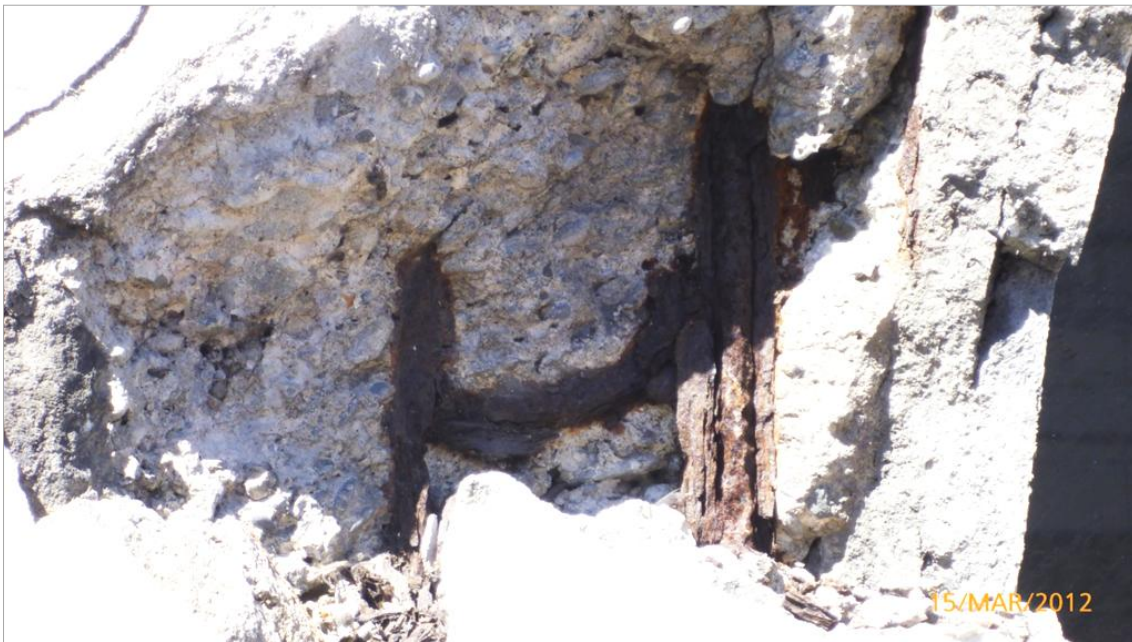
Figure 6. Corroding bars exposed at spall adjacent to Bay 9 gallery window (refer to Figure 2(i) for view of spall prior to breakout). The reinforcement is embedded in loosely-compacted concrete, which has afforded little protection against corrosion.

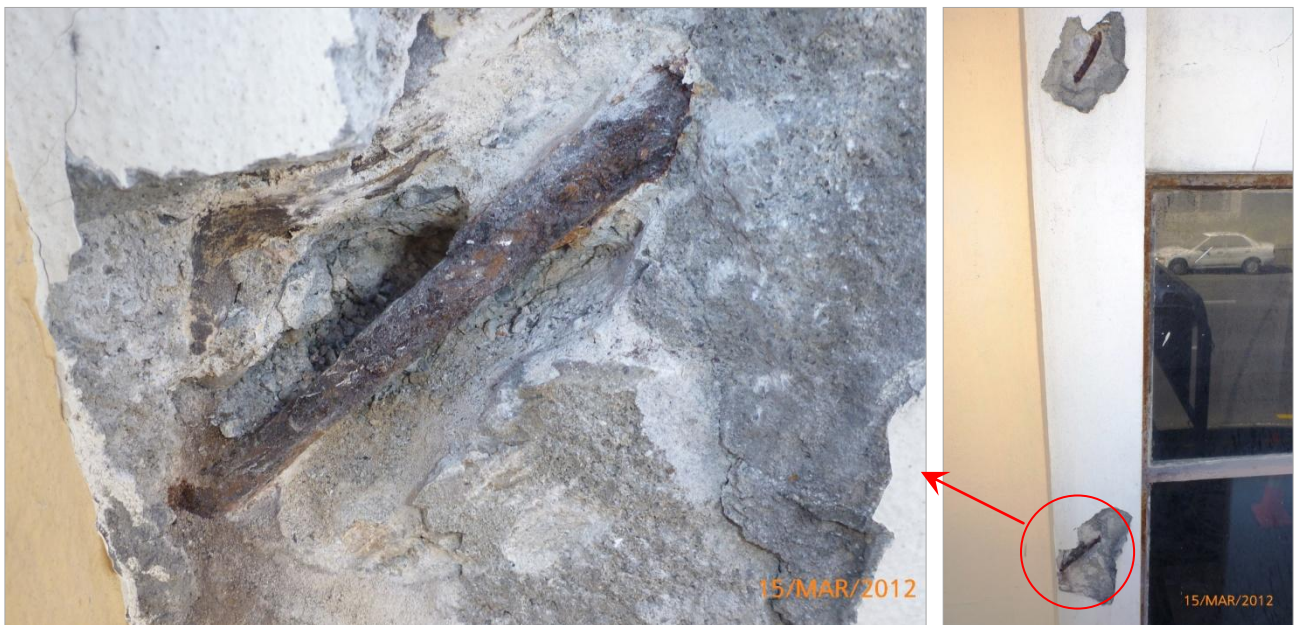
Figure 7. Exploratory breakout of spalls adjacent to the left side of the Bay 3 window reveal. This diagonal hoop reinforcement appears to tie vertical trim bars around the window openings into the main column reinforcement. The original bar diameter appears to be 1/2" but loss of section due to corrosion in the worst area approaches 50%. The bar is almost on the surface of the concrete, directly below the plaster system.

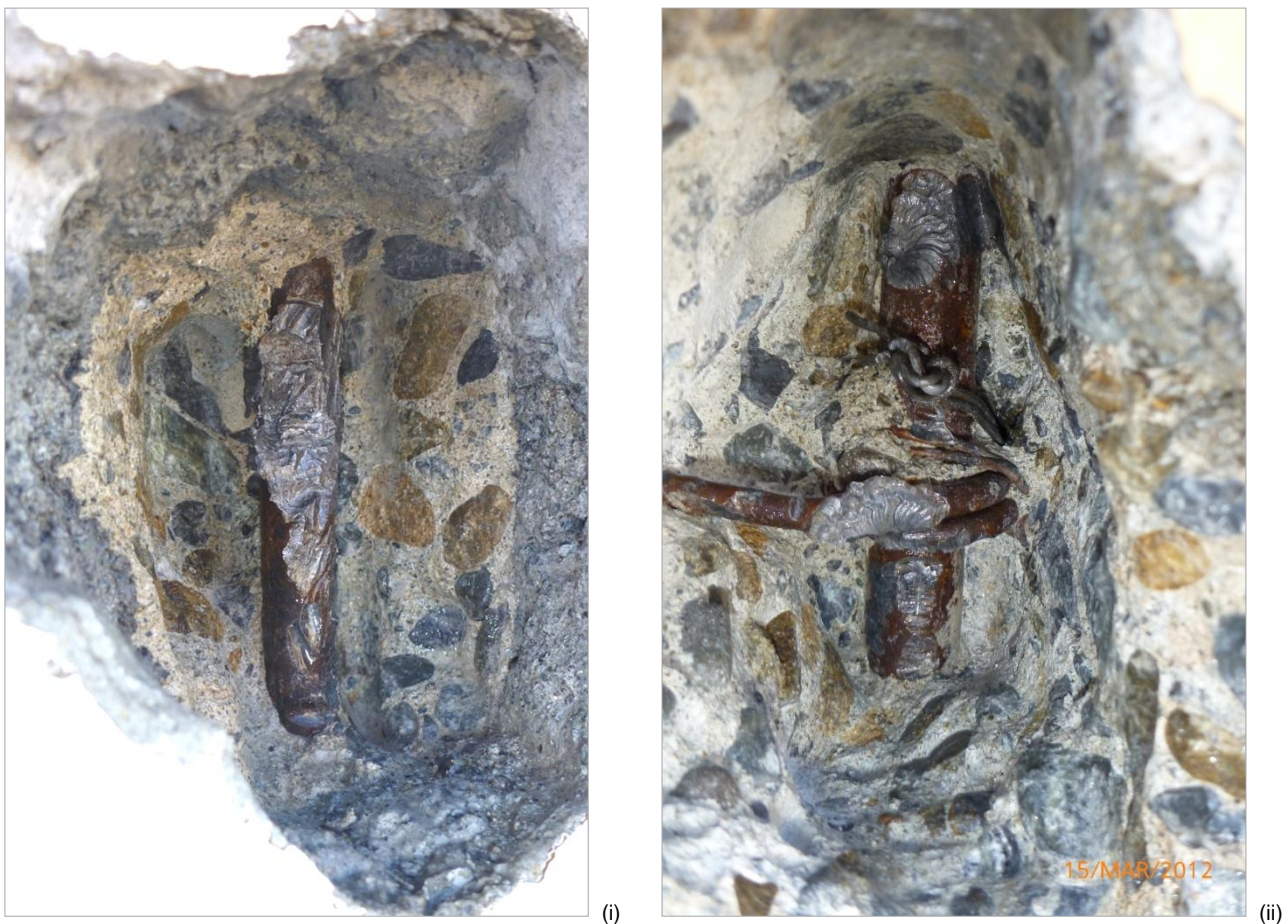
Figure 8. Condition of reinforcement in sound concrete: (i) $\frac{3}{8}$ " diameter bar in middle of wall panel between Bay 2 windows and (ii) $\frac{5}{8}$ " diameter bar with $\frac{3}{16}$ " stirrup in adjacent perimeter column C27. Both bars display faint signs of active corrosion, suggesting they have been depassivated.

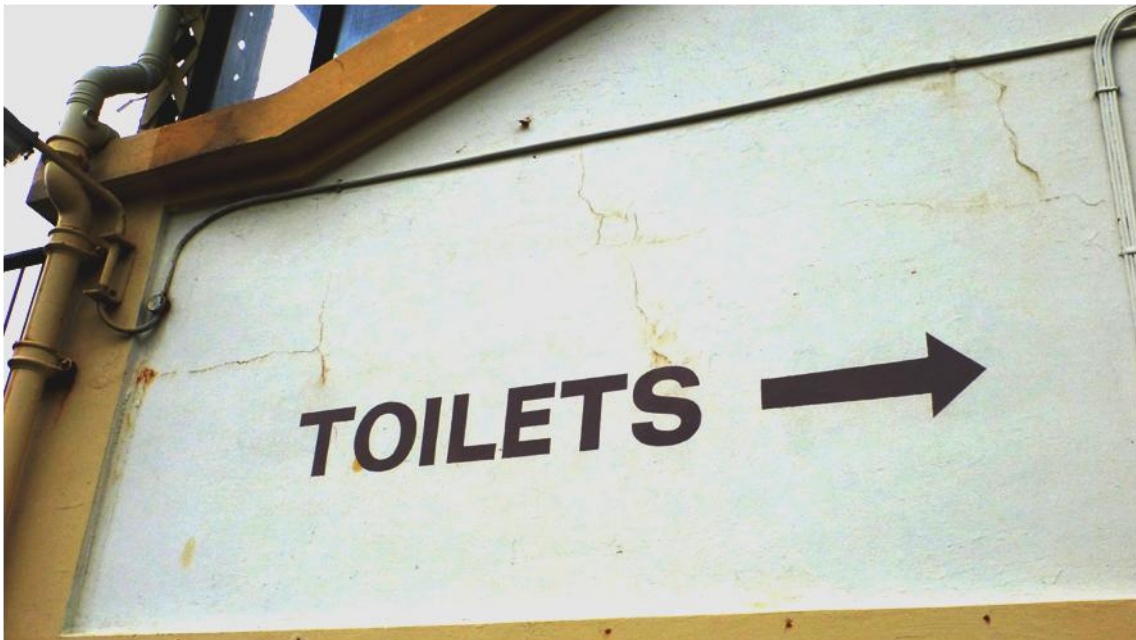
Figure 9. Cracking in the solid plaster finish applied to the northern elevation.

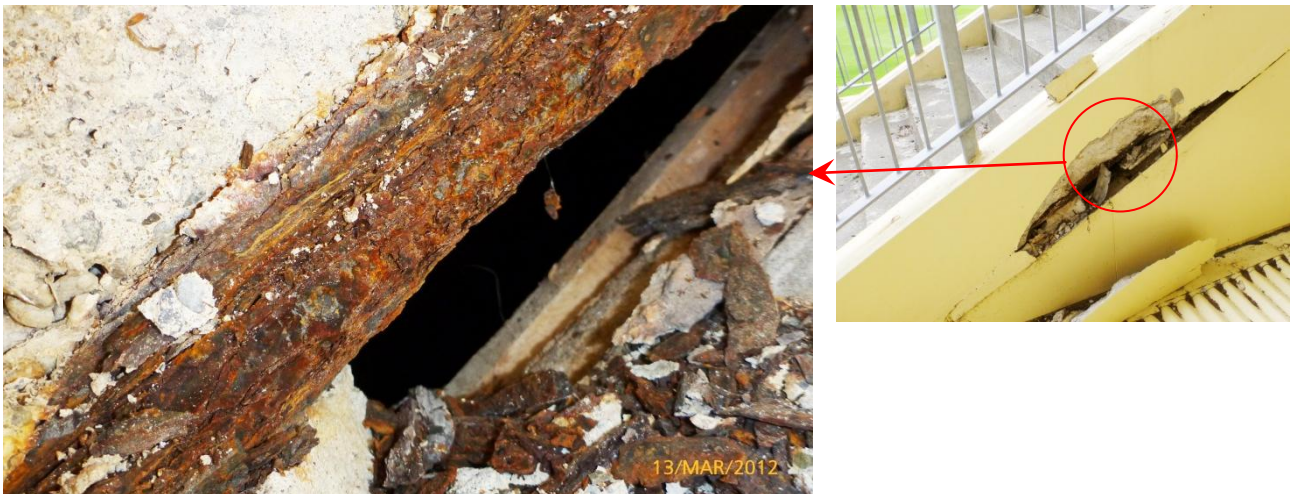
Figure 10. Spall on the inner spring beam of the northern stand access stairs.

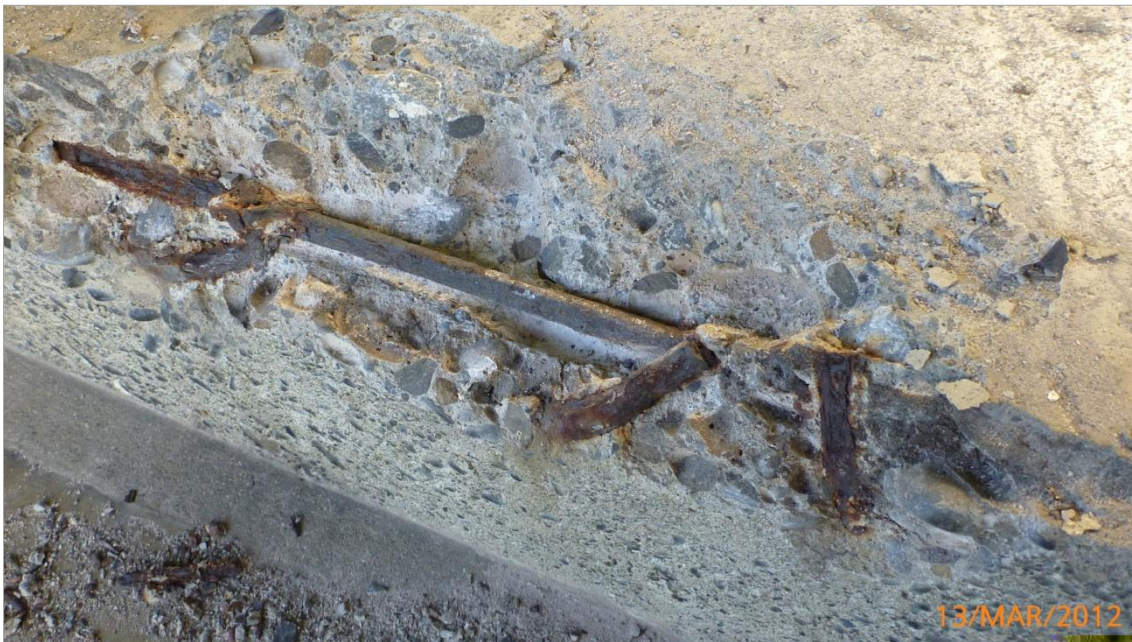
Figure 12. Corrosion along the top of bleacher riser beams as a result of a combination of poor concrete quality, consequent carbonation, and insufficient cover. Section loss on the principal reinforcement estimated as 30%.

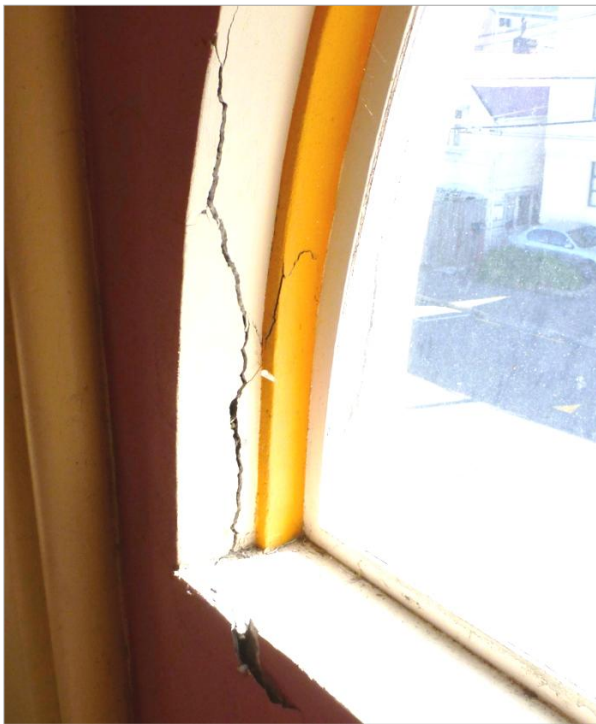
As might be expected in an enclosed and predominantly dry interior environment, the condition of the concrete elements is generally good within the interior of the stand. The most striking spalls occur on the window surrounds in the southern half of the Distributing Gallery along the wall facing Sussex Street (Figure 13). These defects exactly replicate those observed on the exterior façade, i.e. they arise as a result of water leakage around window frames allowing corrosion propagation on reinforcement that has become depassivated because it is embedded in low quality/cover concrete with little resistance to carbonation. The severity of corrosion on the reinforcement is somewhat less in these spalls than on the exterior, with section loss on one 5/8" diameter bar exposed in the worst-case estimated at 30% (Figure 14).

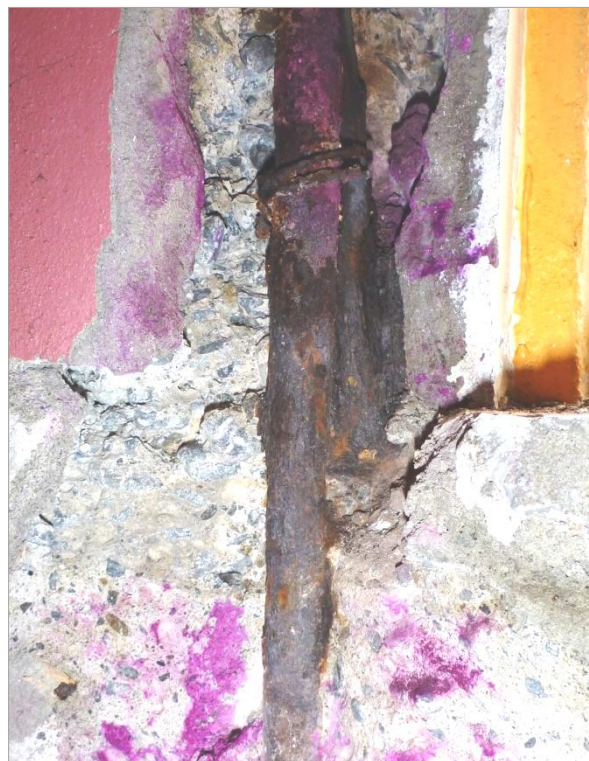
Figure 14. Exposed reinforcement responsible for spall in Figure 13(i). Cover to the $\frac{5}{8}$ " dia. vertical bar is 47 mm (including plaster layer) but the concrete is rumbly and deficient in cement paste. The purple colour is due to phenolphthalein indicator.

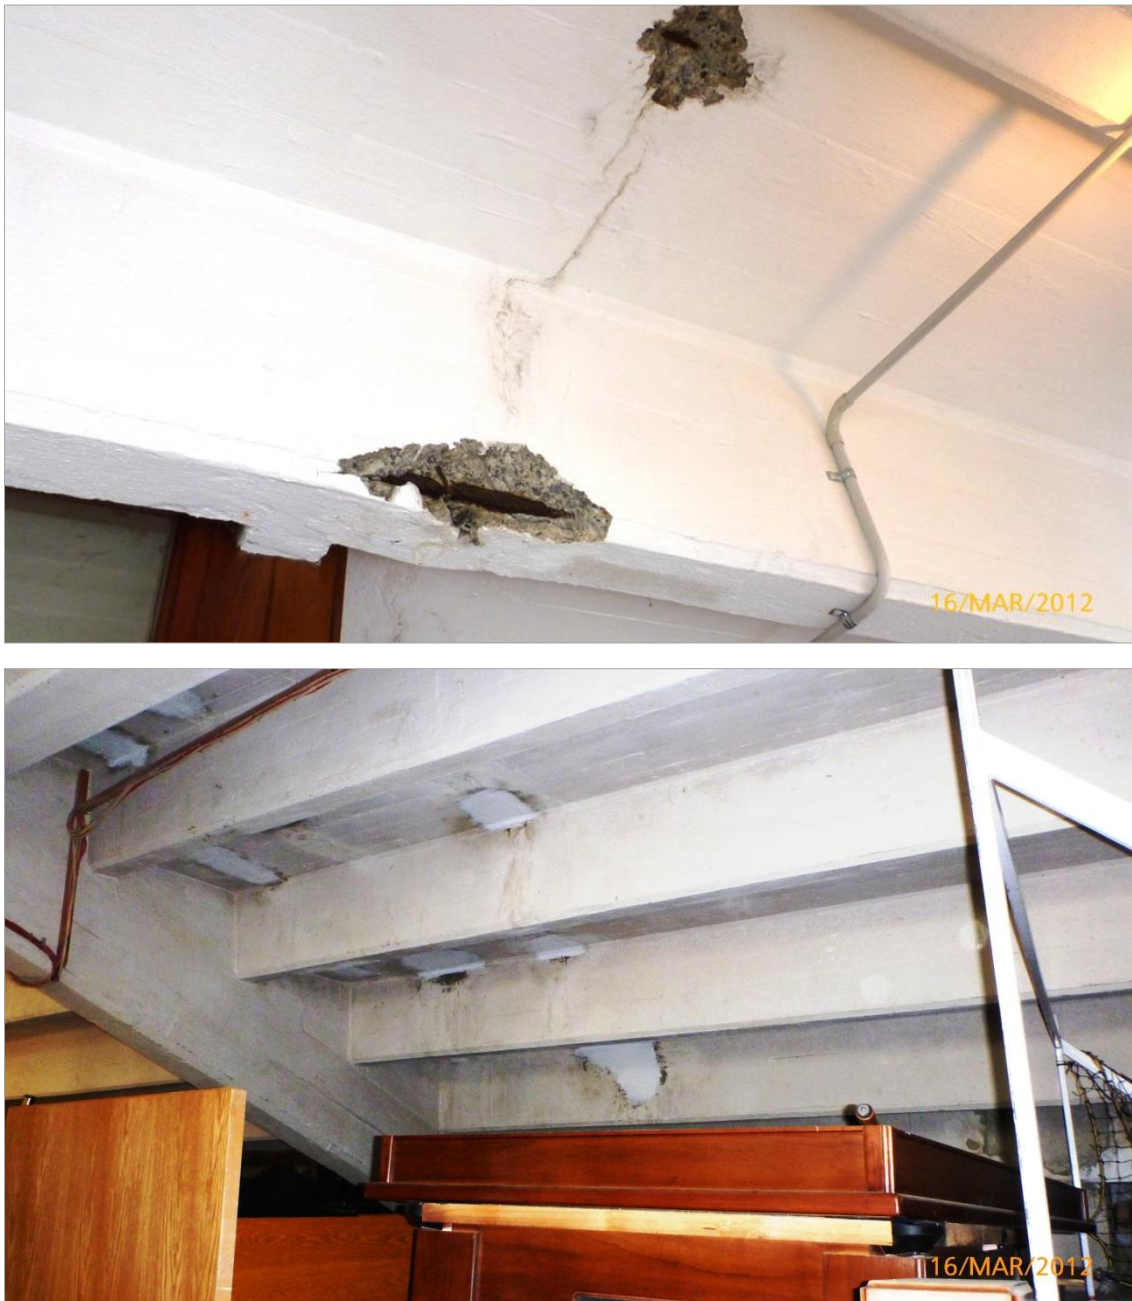
Figure 15. Examples of developing and patch repaired spalls on the undersides of riser beams. The spalls typically occur along the lines of shrinkage cracks or construction joints in the concrete that permit water entry from the exterior terraced seating.

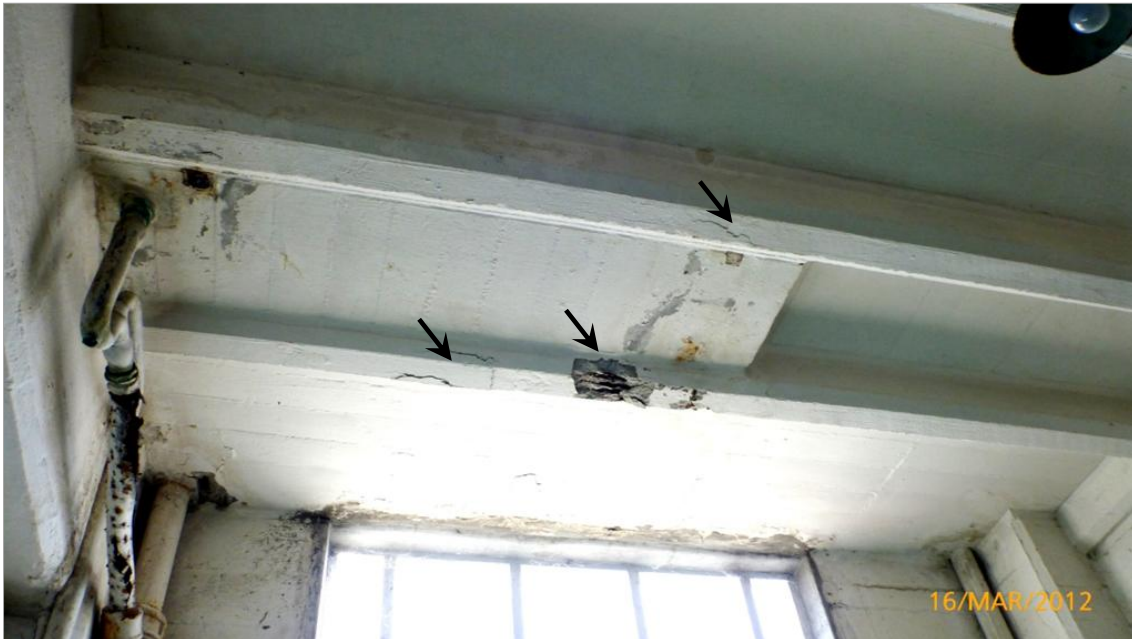
Figure 16. Spalling of the secondary beams that support the Distributing Gallery floor.

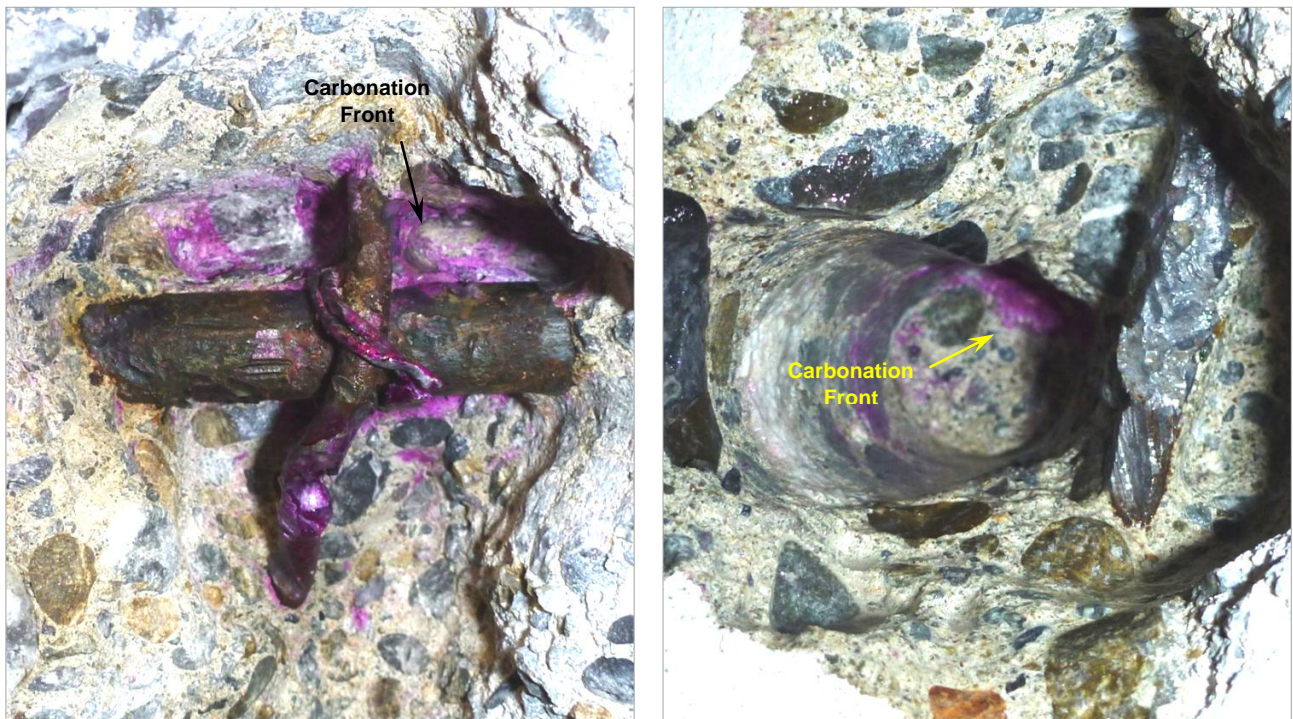
Figure 17. Exploratory breakout of riser beams in good condition showing main tension steel on bottom edge of beam (left) and stirrup in vertical face (right), both displaying superficial active corrosion. In both cases the concrete has been sprayed with a phenolphthalein indicator to determine carbonation depth. Note that the region of protective alkaline concrete signified by the purple staining commences substantially behind the bar. The hole in the right hand image needed to be drilled to 70 mm before uncarbonated concrete was encountered.

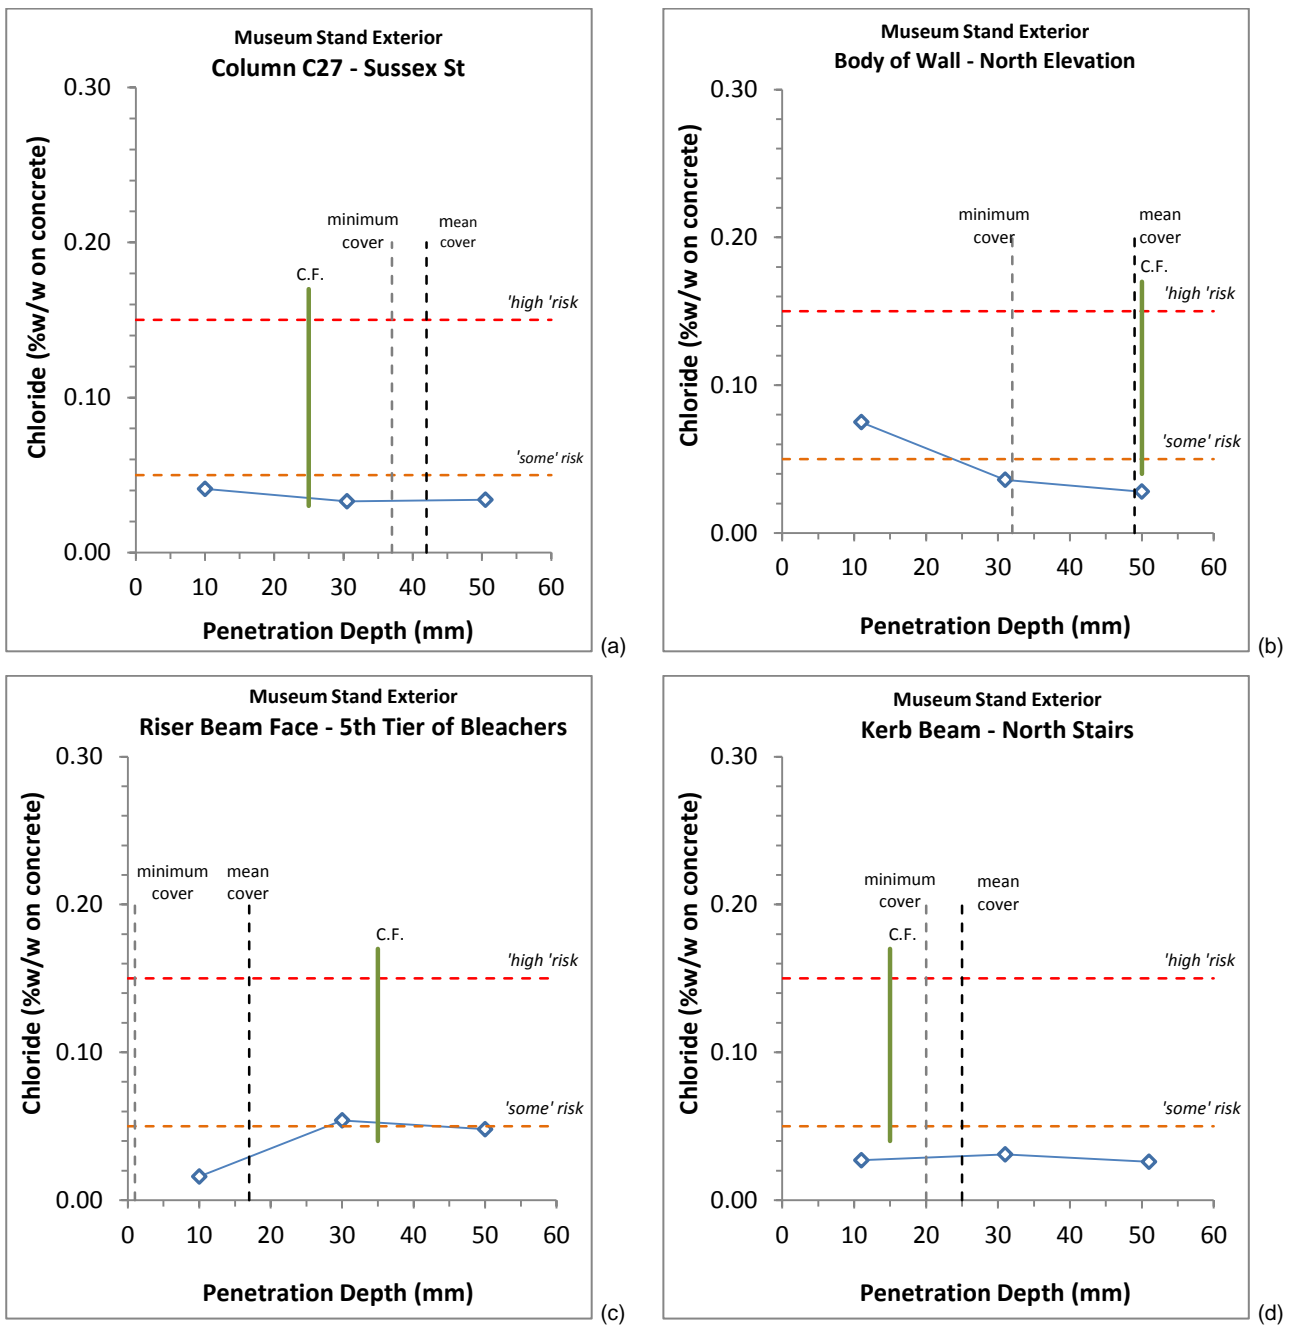
Figure 18. Chloride contamination profiles, depth of reinforcement cover and position of the carbonation front for selected elements on the exterior façades of the Museum Stand.

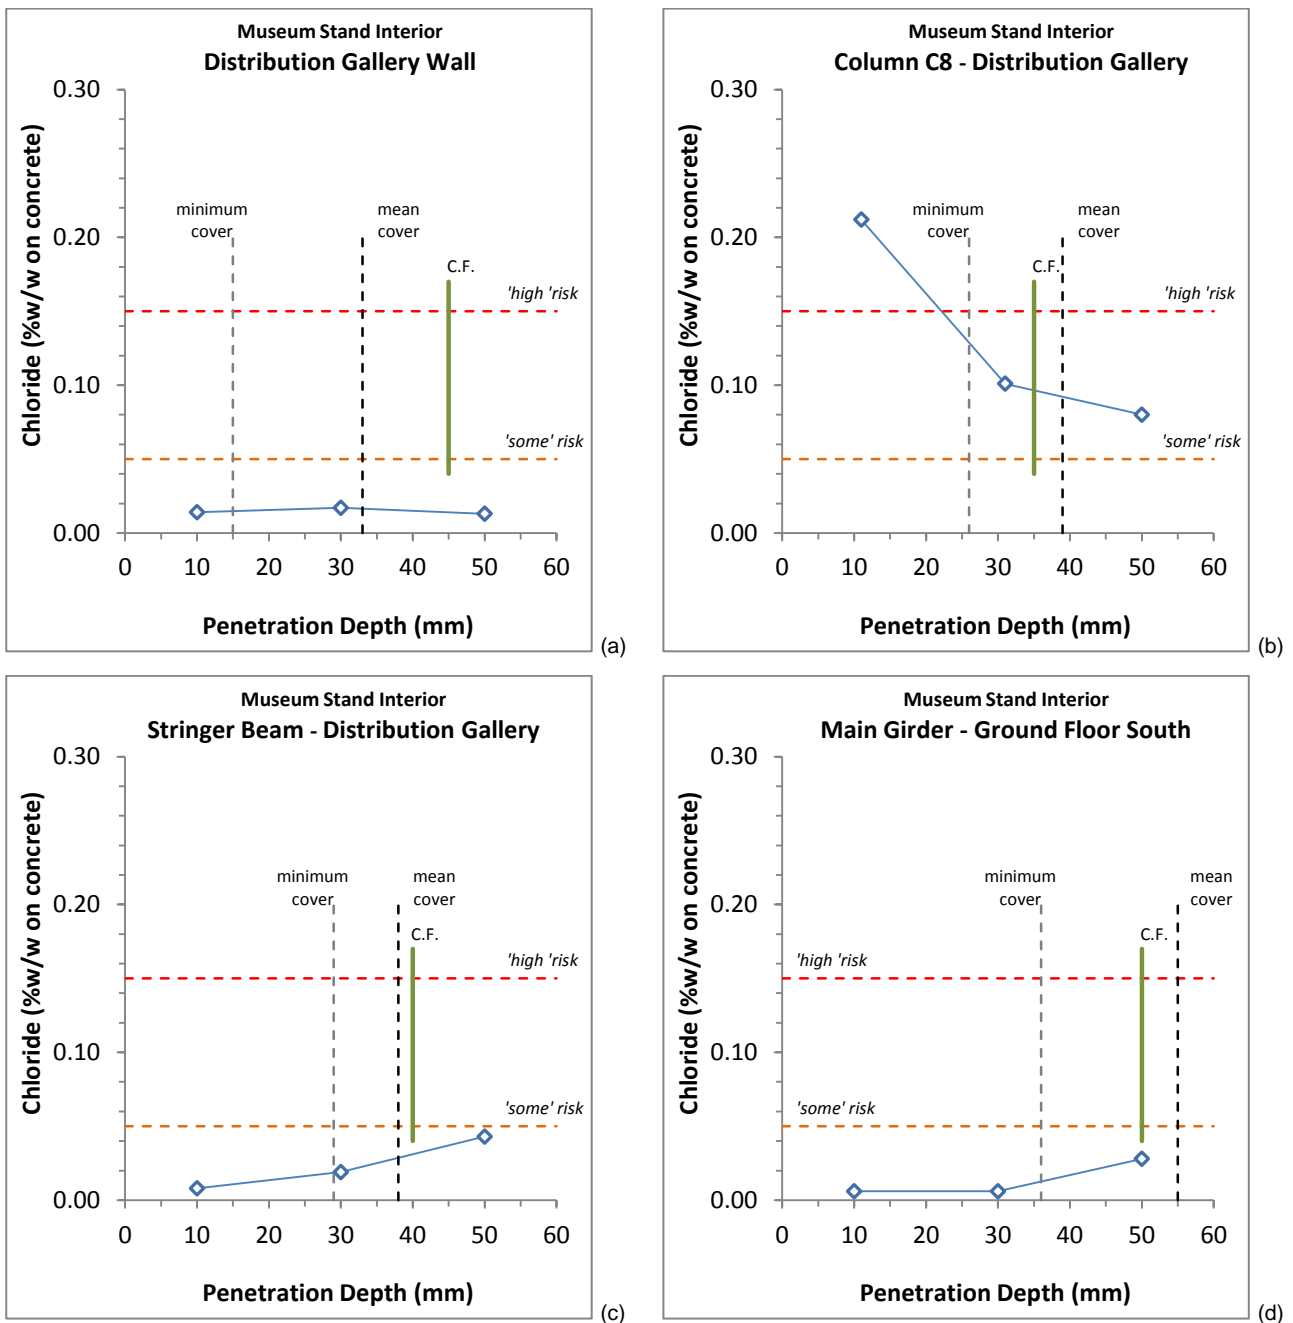
Figure 19. Chloride contamination profiles, depth of reinforcement cover and position of the carbonation front for selected elements within the interior of the Museum Stand.

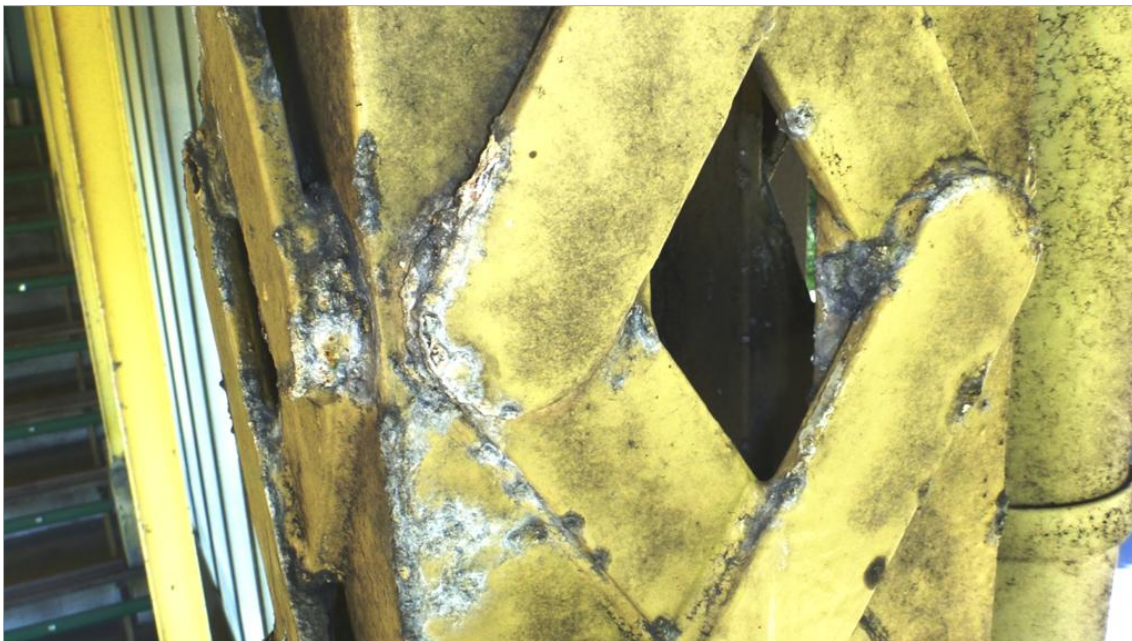
Figure 20. Typical blistering to the protective coating on the edges of the steel work on the main roof support columns (Northern end column shown).

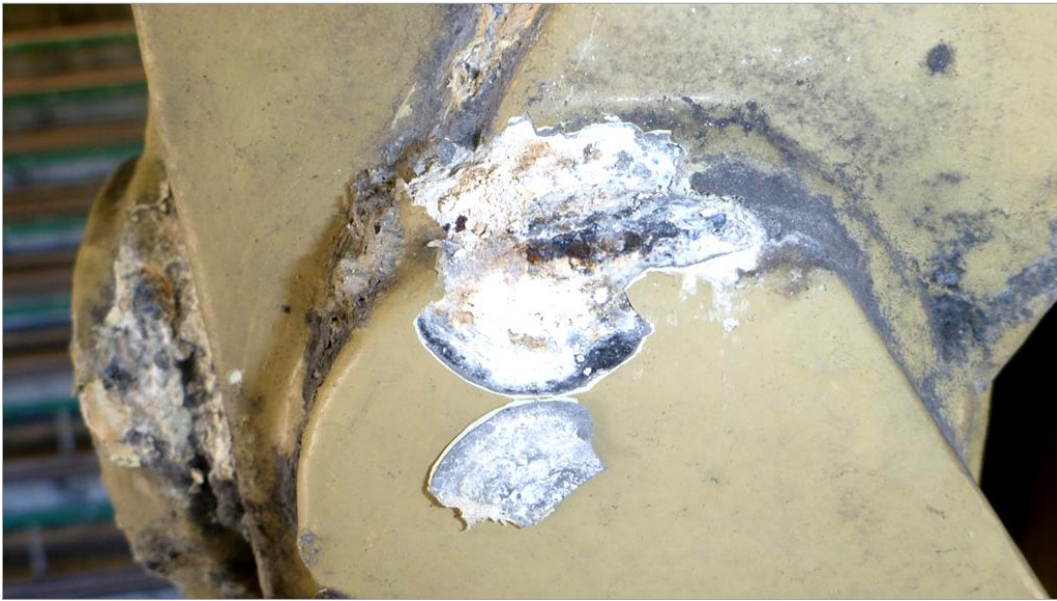
Figure 21. 'White rust' under paint blister, indicating rapid consumption of the hot-dip galvanising that protects the underlying weld and base steel against corrosion.

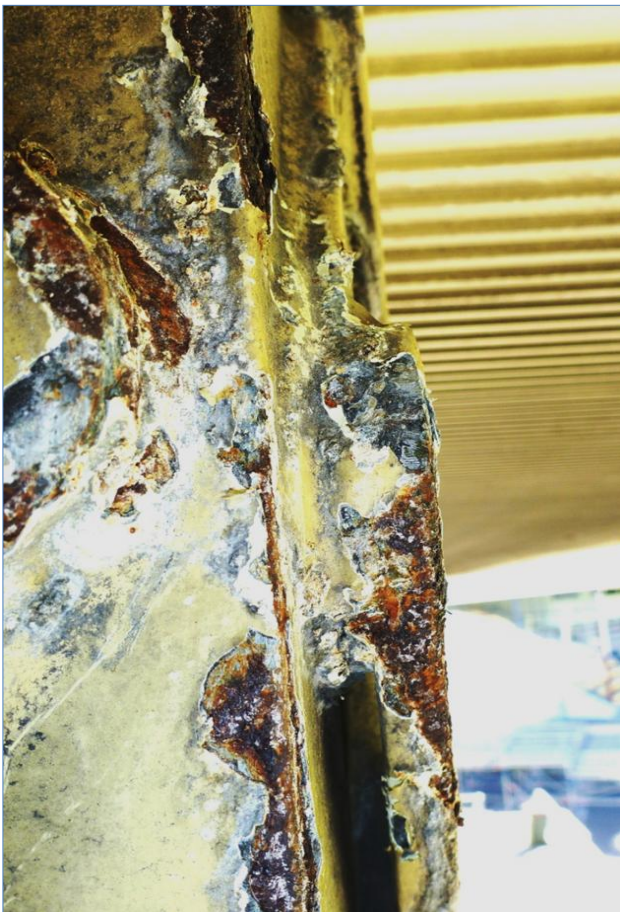
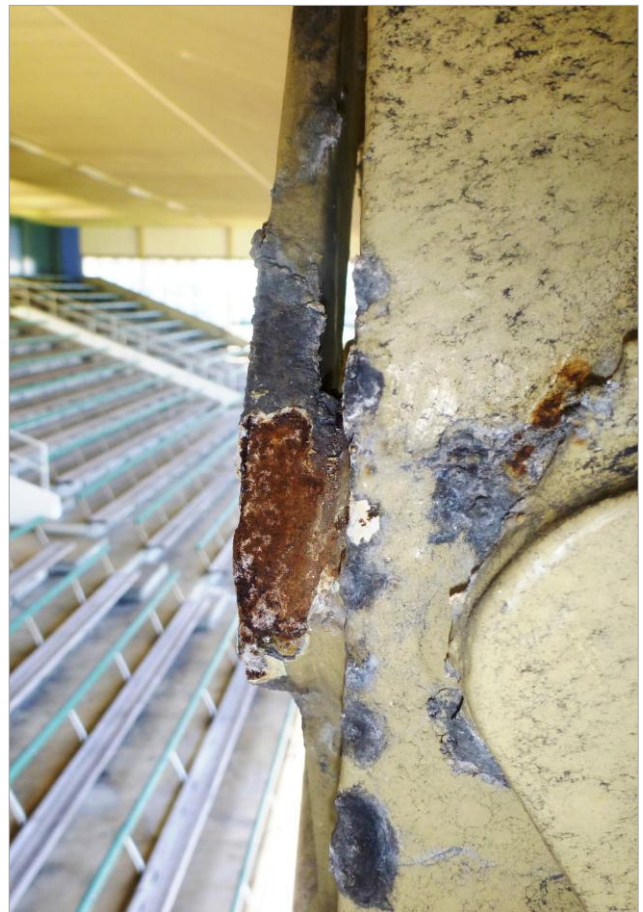
Figure 22 Corrosion of base steel observed after chipping away coating in more heavily deteriorating areas.

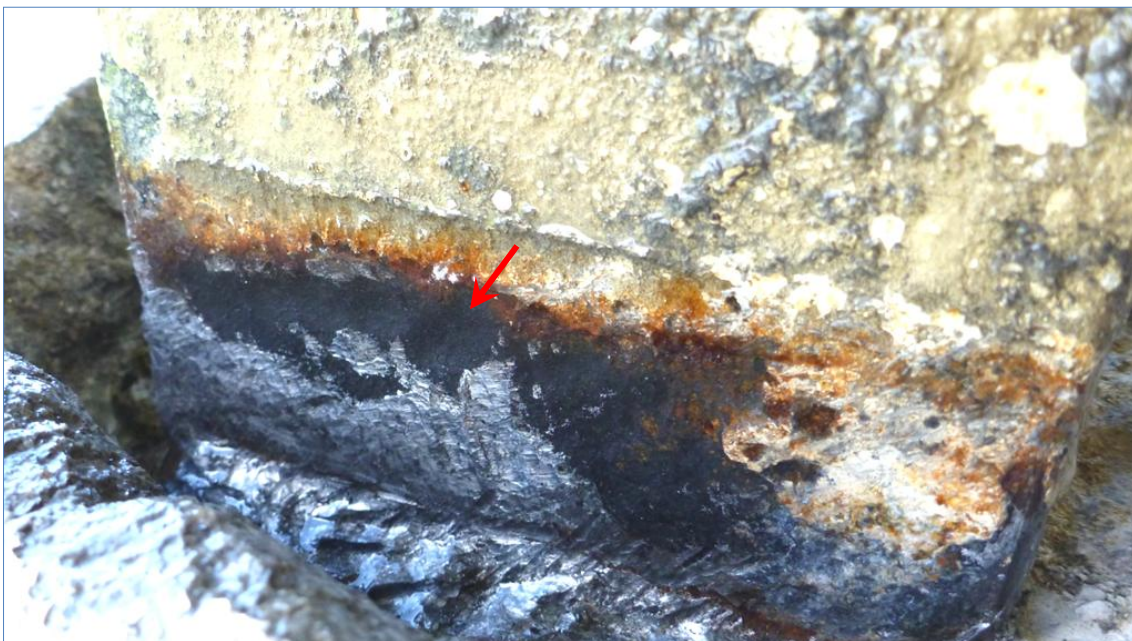
Figure 23. Narrow band of pitting corrosion present on column angles where they are embedded in a concrete pedestal. The arrowed pit is approximately 2 mm deep.

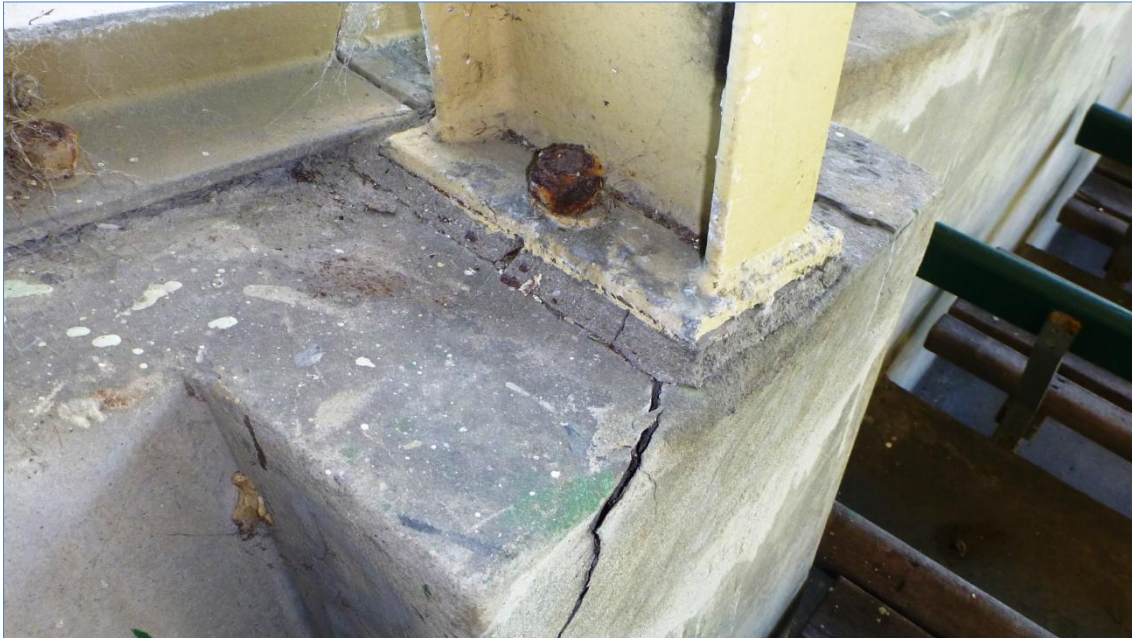
Figure 24. Characteristic example of spalling to concrete column pedestal at connection with secondary roof support column. The bolt and nut fixing the column are heavily corroded.

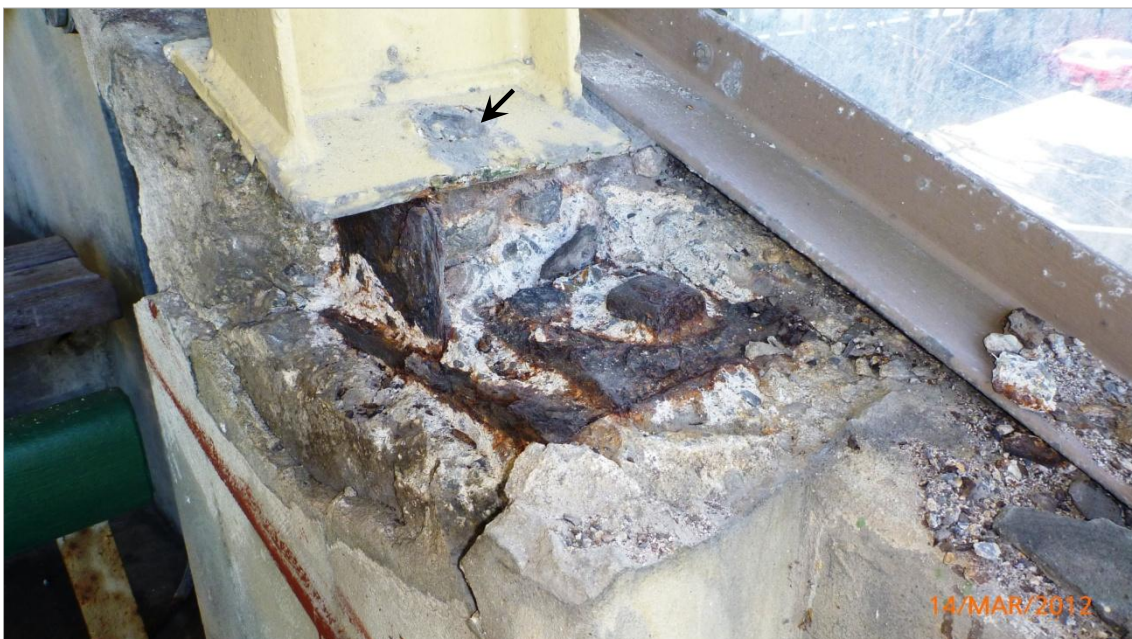
Figure 25. Exploratory breakout of the pedestal showing remnants of the original RSJ and connection to the structural concrete column. Note that the new RSJ is not bolted on this side.
