**Basin Reserve Museum Stand
Condition Assessment**

Basin Reserve Museum Stand Condition Assessment

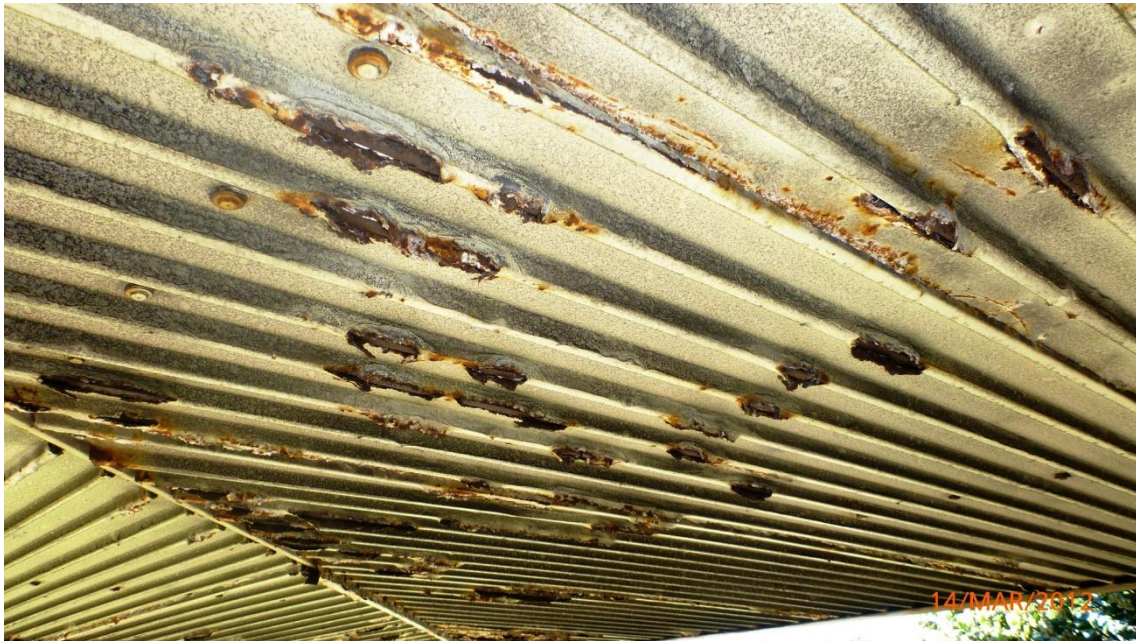
Figure 26. Corrosion of roof soffit lining – southern eave.

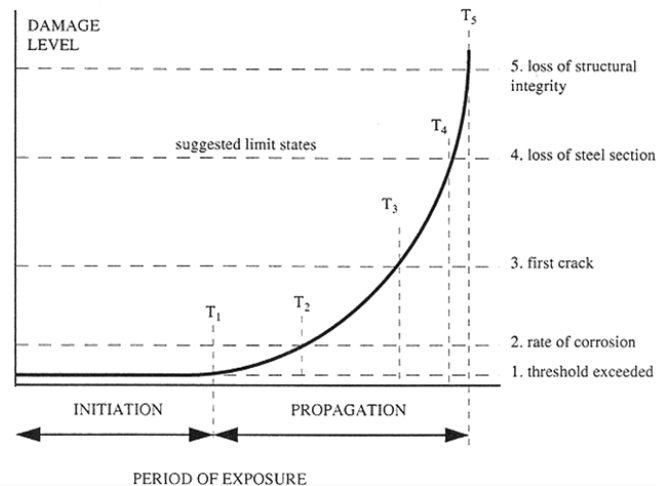
Figure 27. Simple reinforcement corrosion deterioration model and suggested serviceability limit states.¹⁰

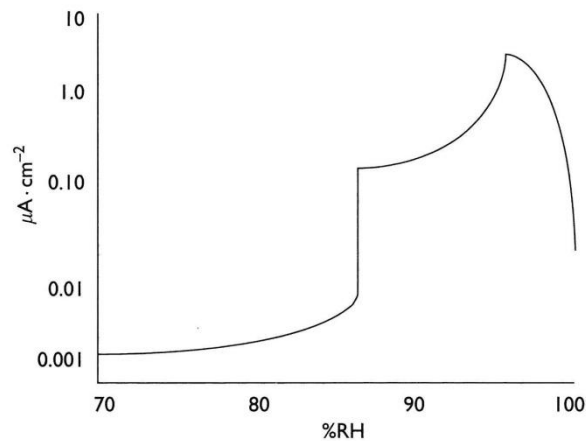
Figure 28. Variation of corrosion rate in carbonated concrete as a function of internal relative humidity.⁸
