## Minor ACD Clearance Certificate

Reference No: AC0117.32

### Stride Properties

Level 3  
7-9 Fanshawe Street  
Auckland 1010

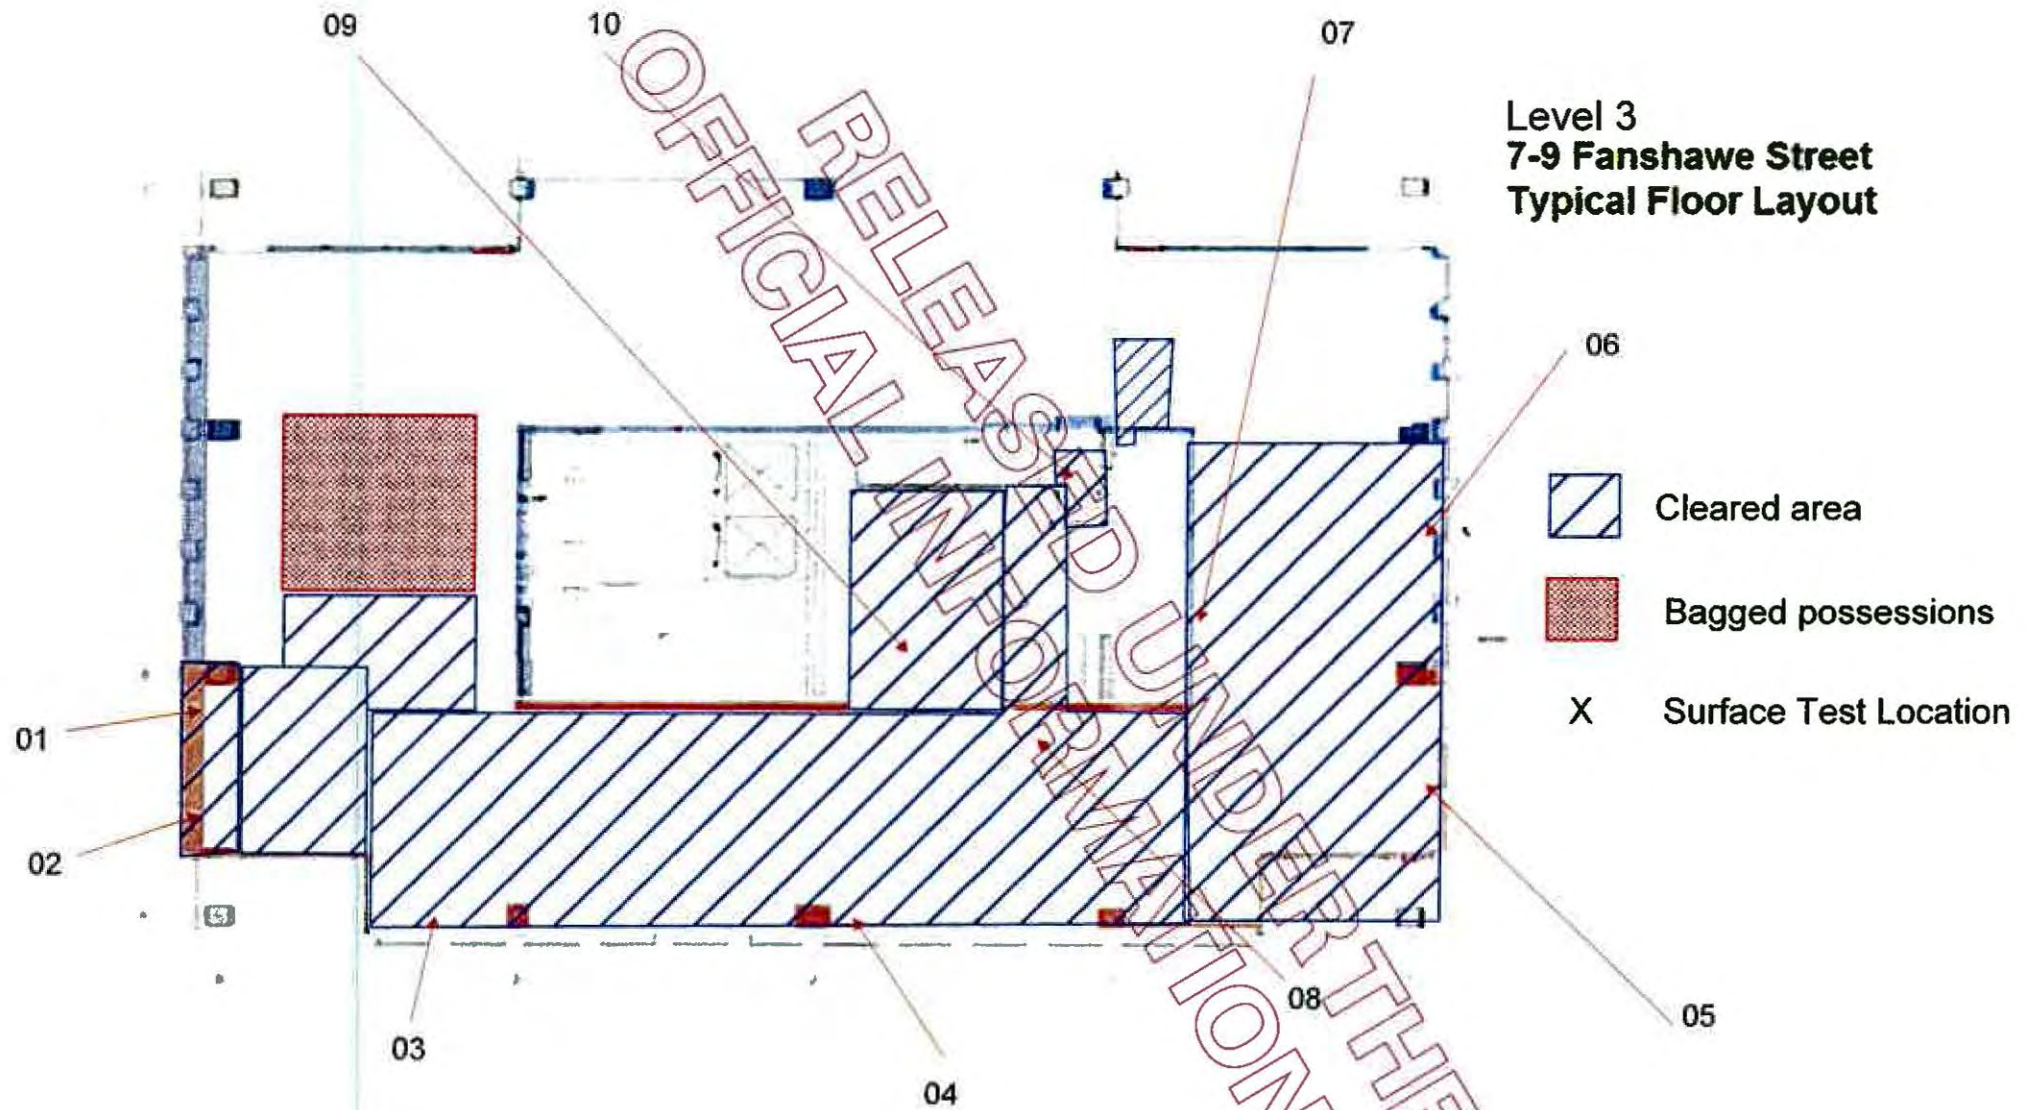
**Level 3  
7-9 Fanshawe Street  
Typical Floor Layout**

Lab ID	Sample ID	Sample Details	Sample Type	Size / Weight cm/g	Fibres Identified	Asbestos Present
001	SW01	Refer to plan	Dust / Debris	N/A	NAD, ORF	No
002	SW02	Refer to plan	Dust / Debris	N/A	NAD, ORF	No
003	SW03	Refer to plan	Dust / Debris	N/A	NAD, ORF	No
004	SW04	Refer to plan	Dust / Debris	N/A	NAD, ORF	No
005	SW05	Refer to plan	Dust / Debris	N/A	NAD, ORF	No
006	SW06	Refer to plan	Dust / Debris	N/A	NAD, ORF	No
007	SW07	Refer to plan	Dust / Debris	N/A	NAD, ORF, SMF	No
008	SW08	Refer to plan	Dust / Debris	N/A	NAD, ORF	No
009	SW09	Refer to plan	Dust / Debris	N/A	NAD, ORF	No
010	SW10	Refer to plan	Dust / Debris	N/A	NAD, ORF	No

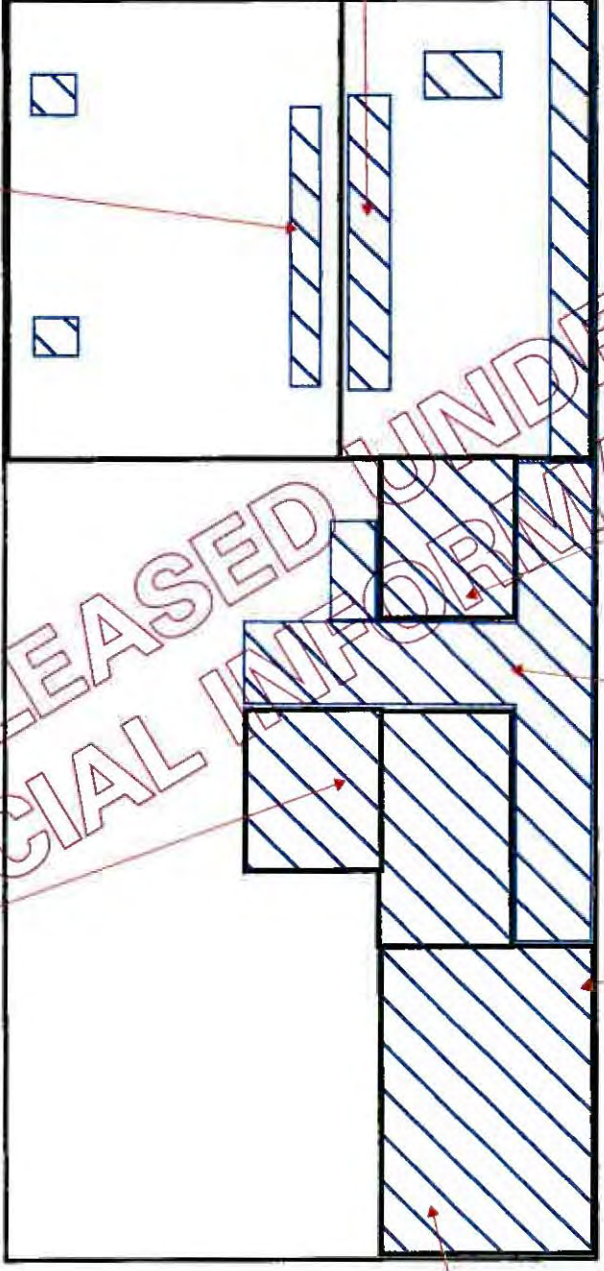
Landmark Office Surface Testing Plans

Cleared work areas

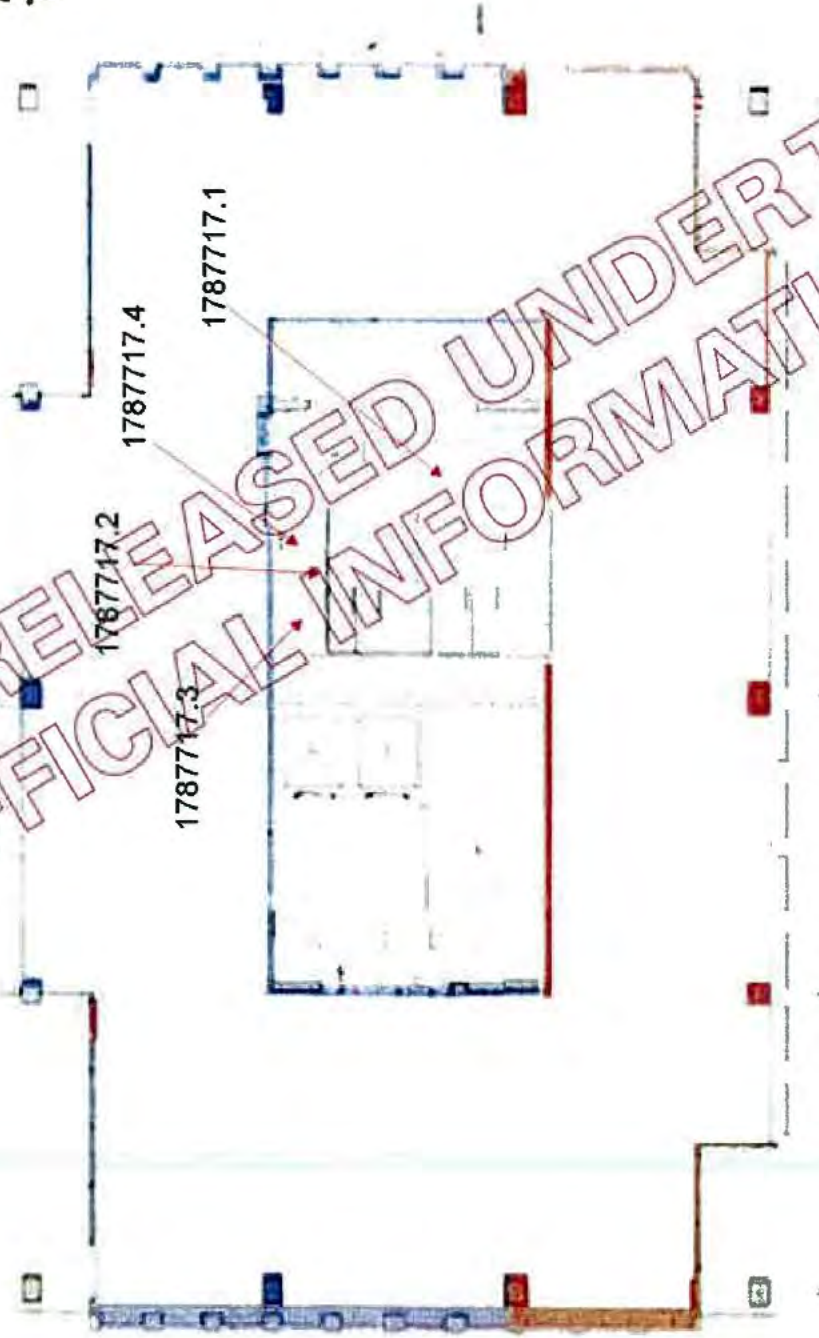
Dust Sampling Locations

No asbestos was detected within the composite surface tests and debris samples taken from the following areas on 6<sup>th</sup> June:

- Level 6 – Corridor from staircase to toilet
- Level 6/7 – Lower part of staircase leading up to level 7
- Level 6/7 – Upper part of staircase leading up to level 7
- Level 7 – Top of staircase

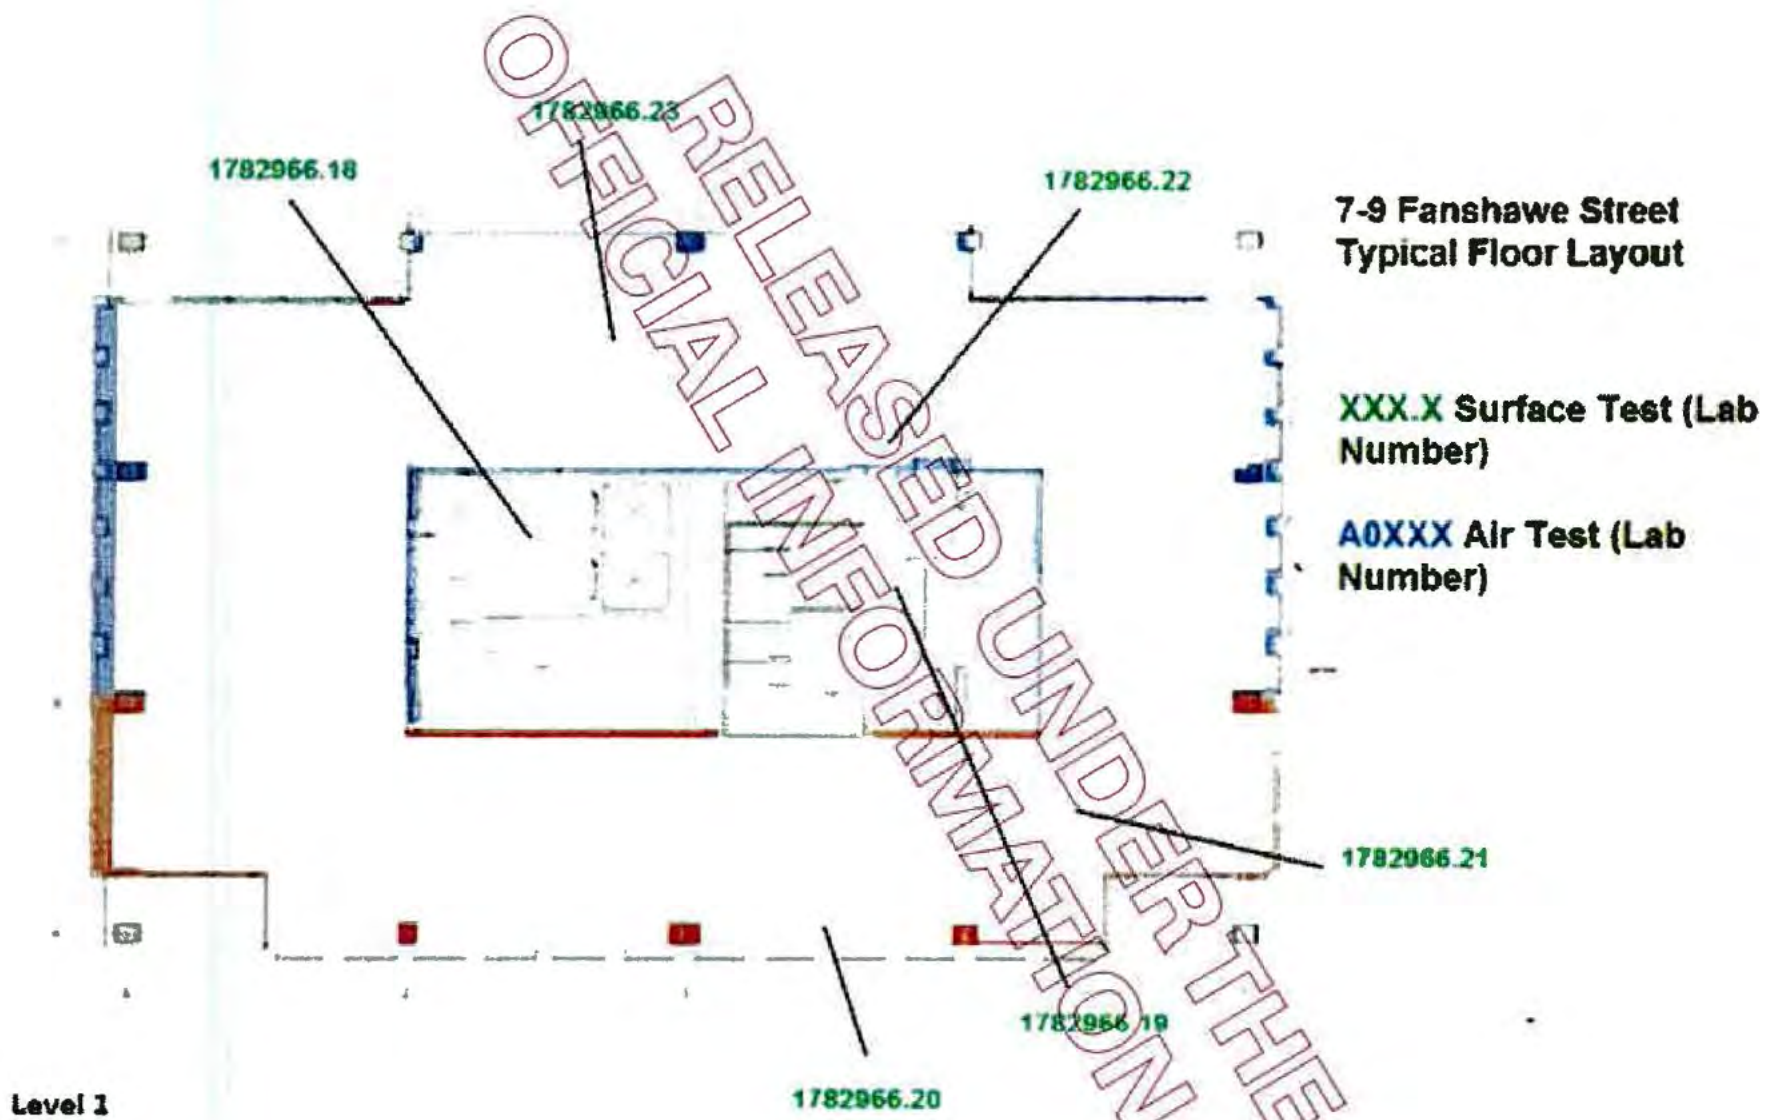
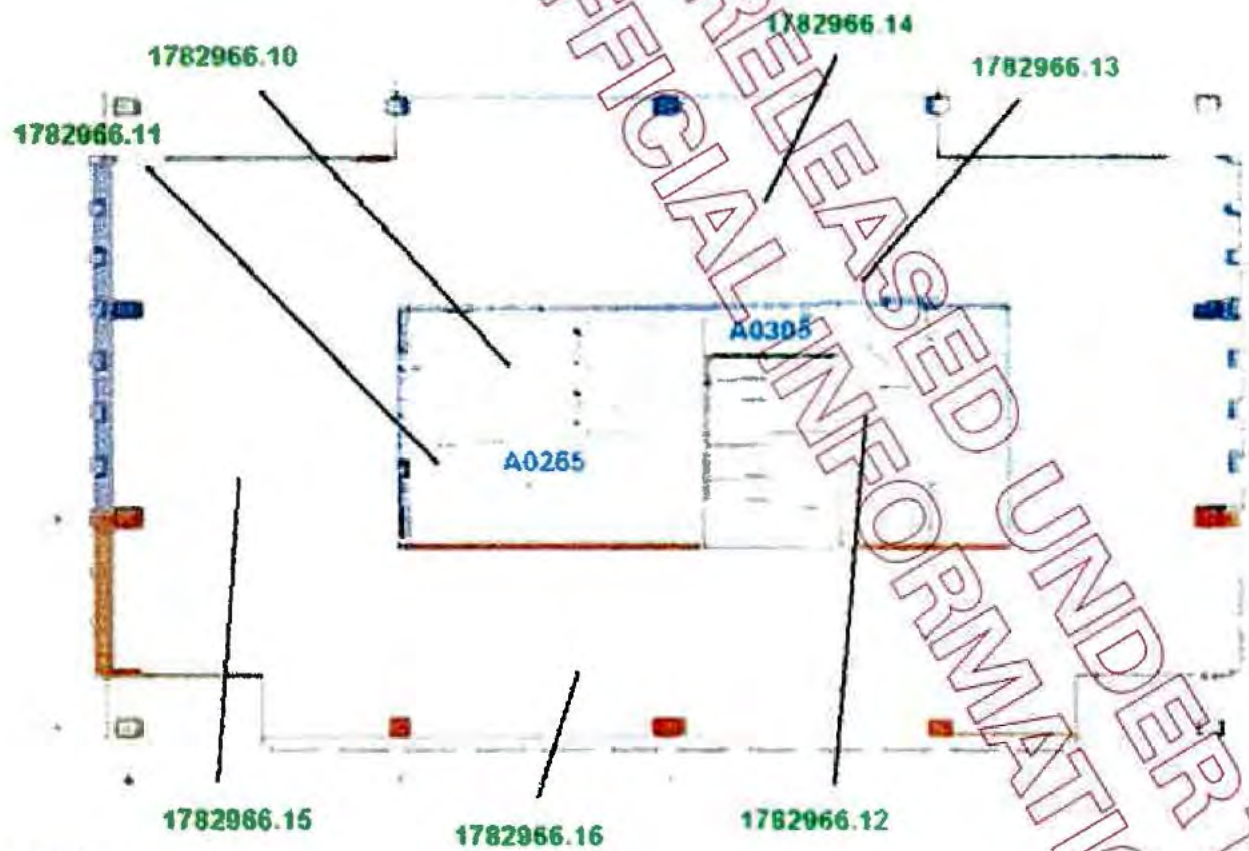
**7-9 Fanshawe Street  
Typical Floor Layout**

**An additional sample of debris on the floor of Level 4 (within the previously live asbestos removal enclosure) was found to contain crocidolite (blue) asbestos, but no asbestos was detected within any of the surface tests taken from all other levels to dry areas not affected by water.**

During the inspection, it was noted that the source of the water running through Levels 1-3 appeared to be from within Level 4. Therefore, asbestos has had to be presumed within all areas of Levels 1-3 affected by the percolating water. All of the surface tests referenced above were not taken from water damaged areas.
