### 7-9 Fanshawe Street Typical Floor Layout

### 7-9 Fanshawe Street – Basement to Level 5 Rear Staircase – Dust Sampling

## Clearance Certificate

# Clearance Certificate Friable Asbestos

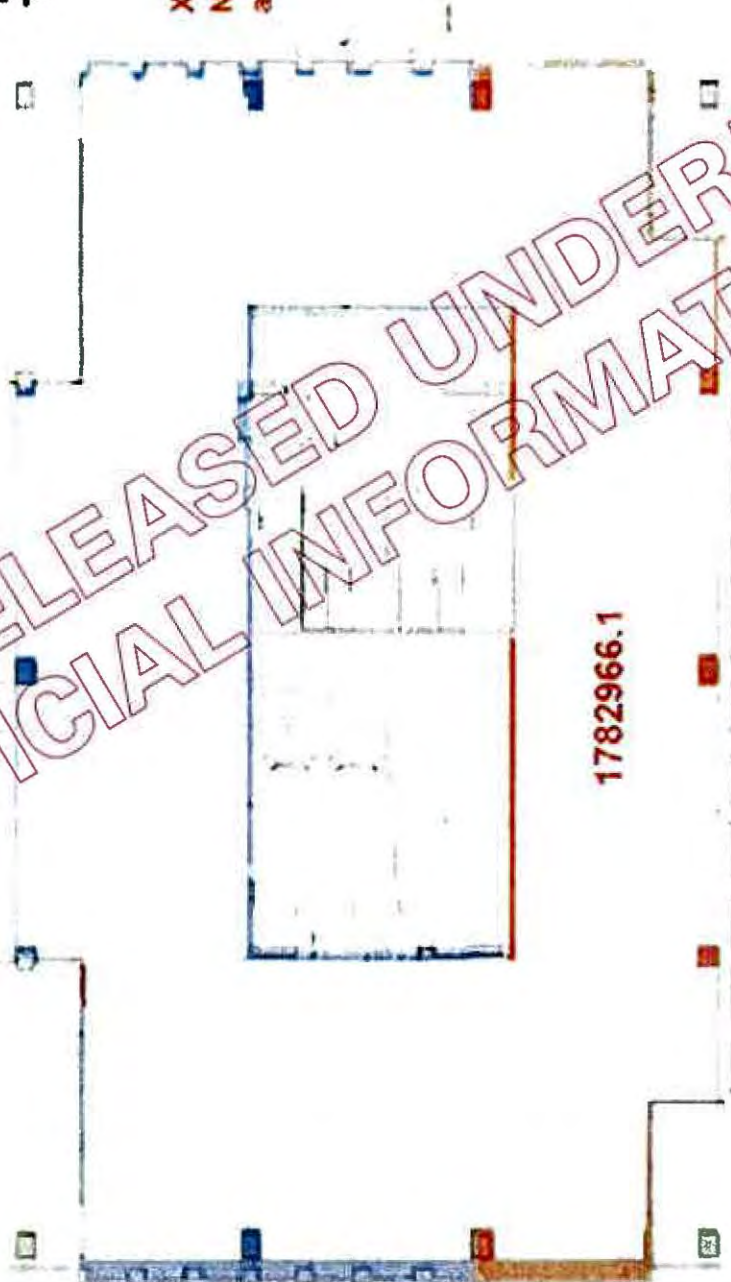
**Level 4**

**XXX.X - Debris sample (Lab  
Number) - Positive for  
asbestos**

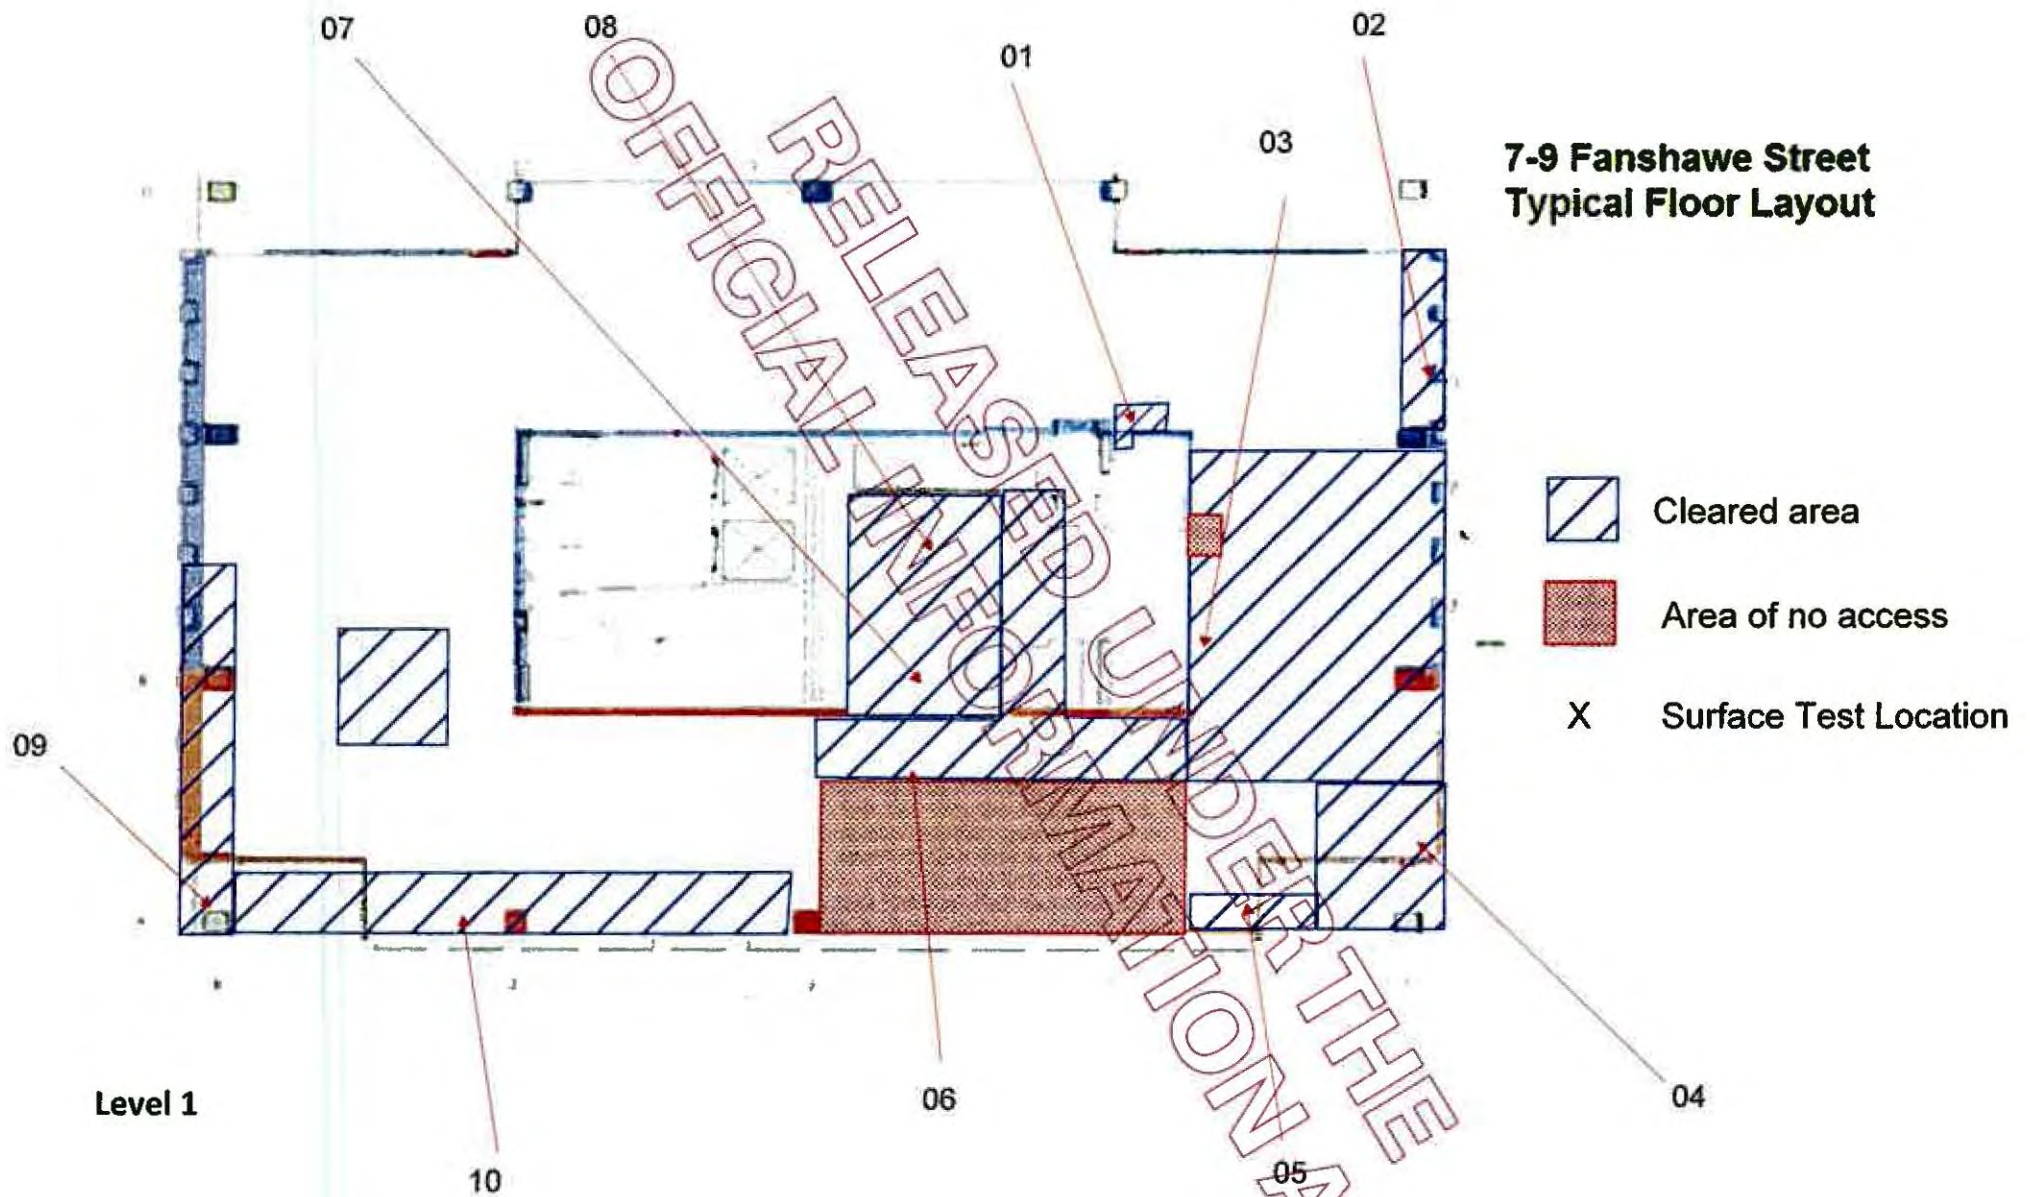
**Appendix B – LEVEL 1 SAMPLING PLAN**

The following were assessed and found to be satisfactory:	Yes	No	Not Assessed	Details
Enclosure dryness			✓	
Enclosure / work area condition & integrity	✓			
Plant / equipment covers removed			✓	
Ceiling / wall / floor surface cleanliness	✓			
Culvert / drain / sump cleanliness			✓	
Boiler / tank / pipe work etc. cleanliness	✓			
Support bracket cleanliness			✓	
Trays / cable / conduit cleanliness			✓	
Nuts / bolts / flanges / hatch cleanliness			✓	
Light fitting cleanliness			✓	
Ledge / window sill / shelf cleanliness	✓			
Screw holes / axonal nails cleaned or drilled			✓	
Plant / equipment (covered or uncovered during removal) cleanliness (esp. oily surfaces)			✓	
Portable equipment cleanliness			✓	
Polythene sheeting cleanliness (inc folds)			✓	
Enclosure / work area surface vacuum cleaning	✓			
Additional Notes	Work carried out as minor ACD, air monitoring performed during works all below 0.01f/ml. There were two areas of no access – the Vector room and a cupboard by the kitchen ( <b>Marked on plan</b> ).

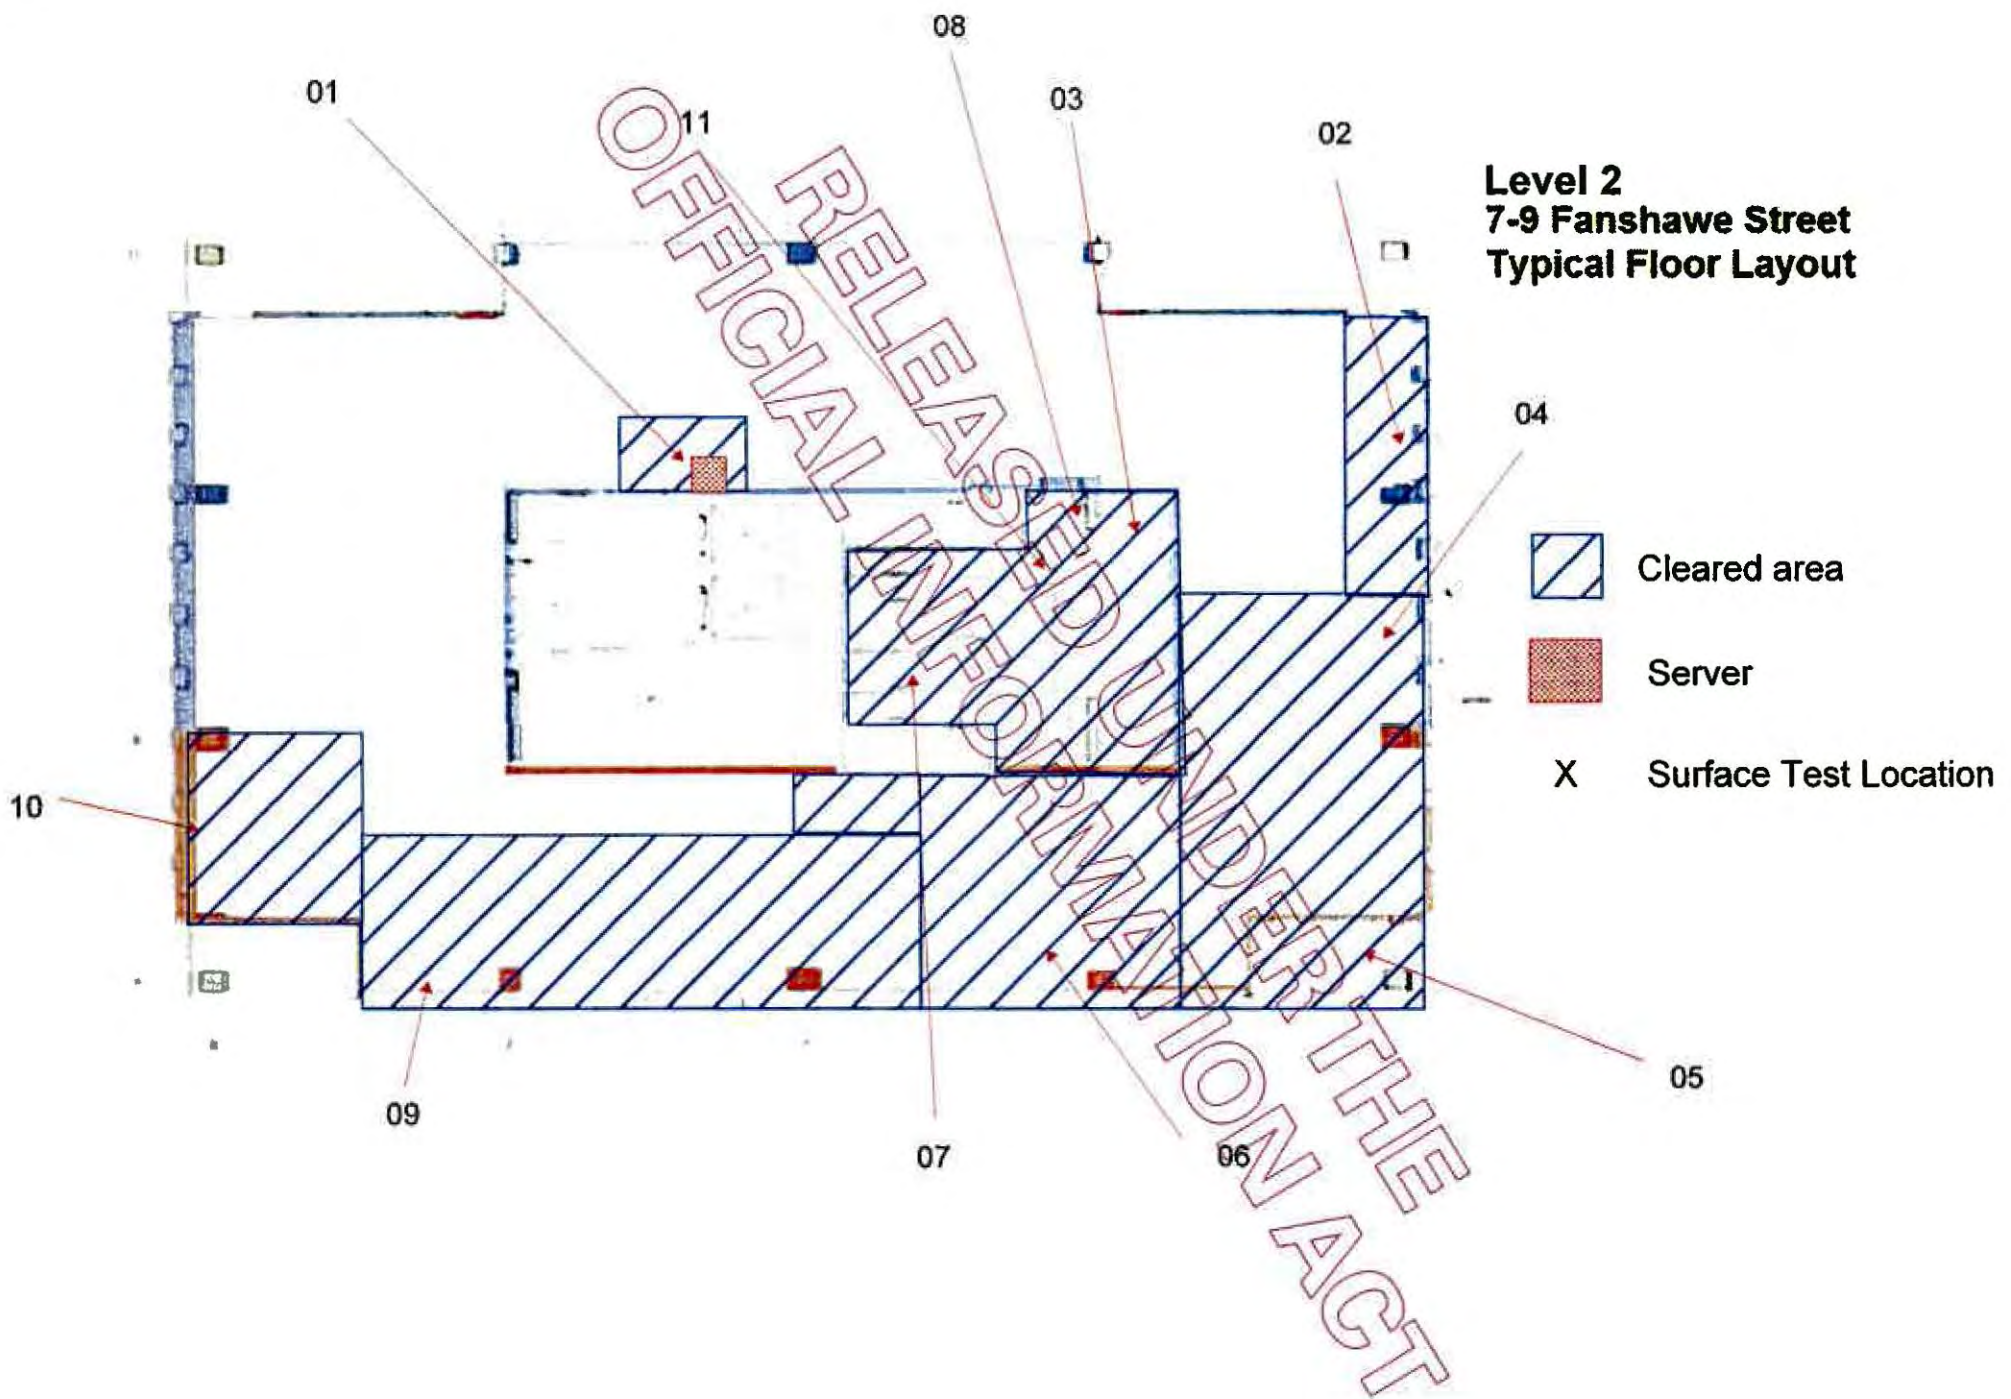
**Level 2  
7-9 Fanshawe Street  
Typical Floor Layout**

The following were assessed and found to be satisfactory:	Yes	No	Not Assessed	Details
Enclosure dryness			√	
Enclosure / work area condition & integrity	√			
Plant / equipment covers removed			√	
Ceiling / wall / floor surface cleanliness	√			
Gully / drain / sump cleanliness			√	
Boiler / tank / pipe work etc. cleanliness	√			
Support bracket cleanliness			√	
Trays / cable / conduit cleanliness			√	
Nuts / bolts / flanges / hatch cleanliness			√	
Light fitting cleanliness			√	
Ledge / window sill / shelf cleanliness	√			
Screw holes / around nails cleaned or drilled			√	
Plant / equipment (covered or uncovered during removal) cleanliness (esp. oily surfaces)			√	
Portable equipment cleanliness			√	
Polythene sheeting cleanliness (inc. folds)			√	
Enclosure / work area surface vacuum cleaning	√			
Additional Notes	Work carried out as minor ACD, air monitoring performed during works all below 0.01f/ml. Bagged possessions remain to be viewed by occupant before disposal. Carpet remains below server in Epson office.
