File Title: 5720037 - Unknown PCBU, please update - Response

Location: 19 Wentworth Street, Gore

# Asbestos Sampling Survey

19 Wentworth St, Gore

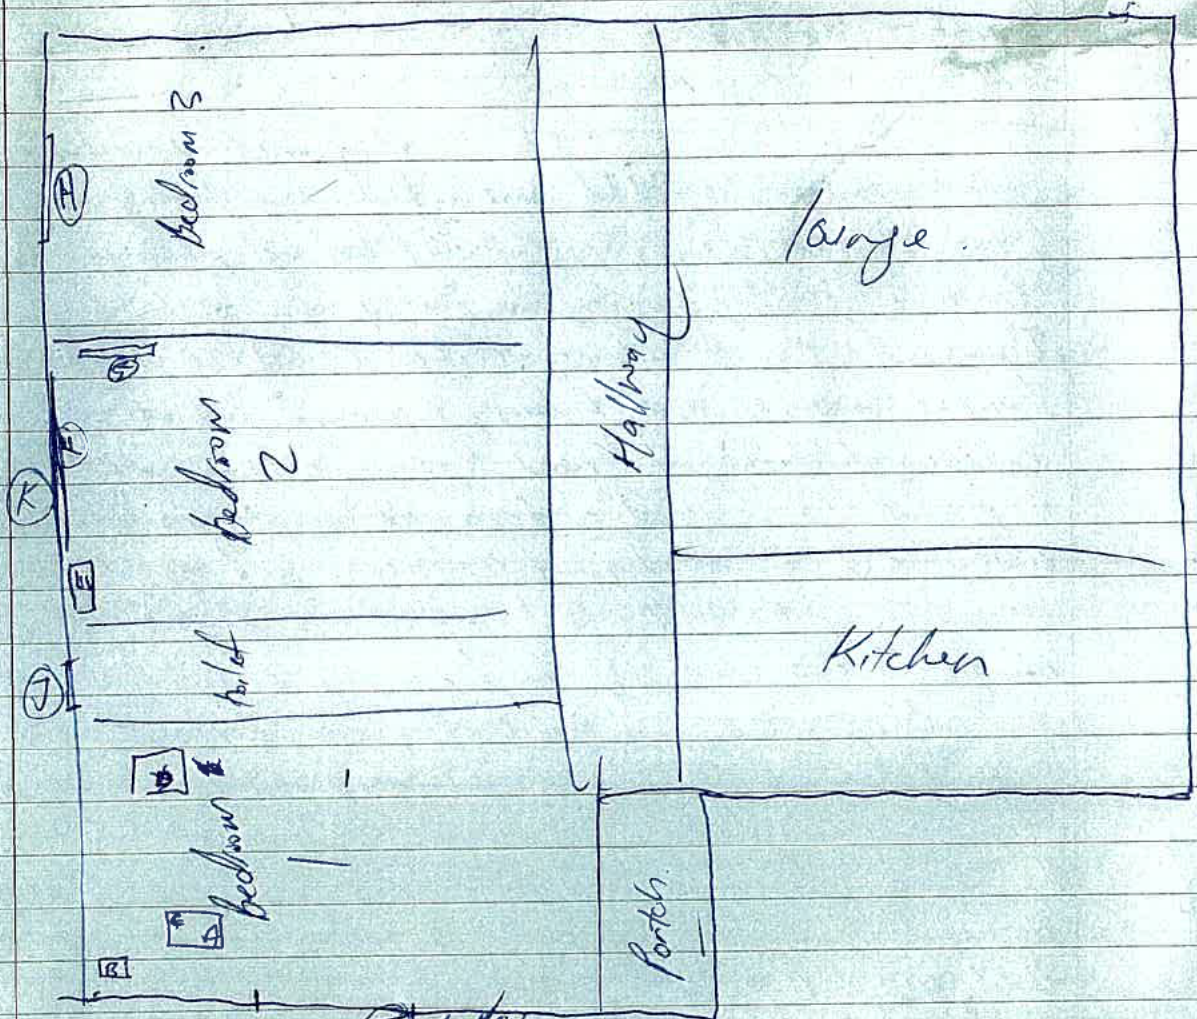
Bedroom 1 - (I) Window Window

Sample 1. taken bedrooms 1 taken top of white storage box and sports bag. (A) (B)

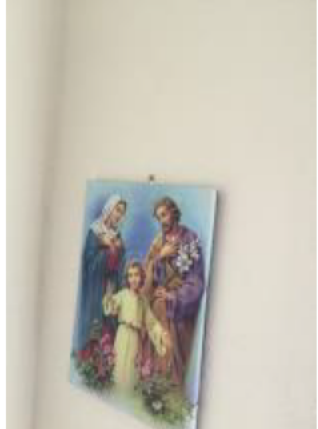
Survey Date:	Lead Surveyor	Building	Floor	Confirmed/Presumed Asbestos
	24/10/2018	Jake Davenport	19 Wentworth Street, Gore	Ground Floor	No Asbestos Detected
	Room Name	Item Location		Quantity/Unit	
	Bedroom 2	Dust/Debris to top of picture		2sqm	
	Sample No (S,SP,P,As,NSM)	Material/Suspect Material	Surface Treatment	Extent of Damage	Accessibility
	S03 - S	Dust	Completely Unsealed	High Damage	Accessible
	Risk Score				
	0				
	Recommended Action	No Action Required			
Surveyor Comments

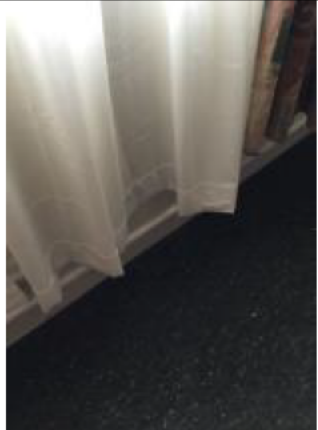
Survey Date:	Lead Surveyor	Building	Floor	Confirmed/Presumed Asbestos
	24/10/2018	Jake Davenport	19 Wentworth Street, Gore	Ground Floor	No Asbestos Detected
	Room Name	Item Location		Quantity/Unit	
	Bedroom 2	Dust/Debris to skirting below window		2lm	
	Sample No (S,SP,P,As,NSM)	Material/Suspect Material	Surface Treatment	Extent of Damage	Accessibility
	S04 - S	Dust	Completely Unsealed	High Damage	Accessible
	Risk Score				
	0				
	Recommended Action	No Action Required			
Surveyor Comments

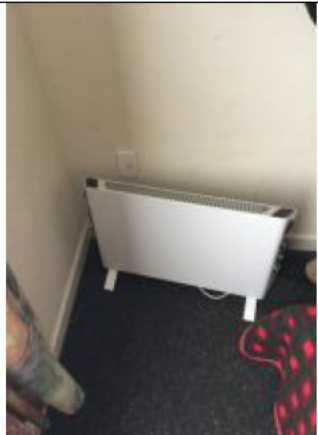
Survey Date:	Lead Surveyor	Building	Floor	Confirmed/Presumed Asbestos
	24/10/2018	Jake Davenport	19 Wentworth Street, Gore	Ground Floor	No Asbestos Detected
	Room Name	Item Location		Quantity/Unit	
	Bedroom 2	Dust/Debris within storage heater		1sqm	
	Sample No (S,SP,P,As,NSM)	Material/Suspect Material	Surface Treatment	Extent of Damage	Accessibility
	S05 - S	Dust	Completely Unsealed	High Damage	Accessible
	Risk Score				
	0				
	Recommended Action	No Action Required			
	Surveyor Comments

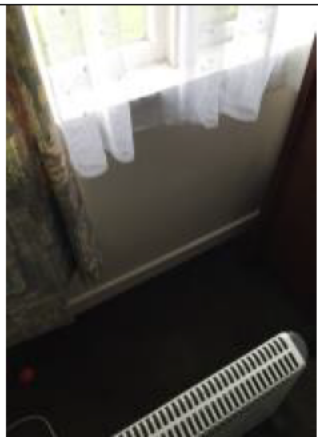
Survey Date:	Lead Surveyor	Building	Floor	Confirmed/Presumed Asbestos
	24/10/2018	Jake Davenport	19 Wentworth Street, Gore	Ground Floor	No Asbestos Detected
	Room Name	Item Location		Quantity/Unit	
	Bedroom 3	Dust/Debris to skirting below window		2lm	
	Sample No (S,SP,P,As,NSM)	Material/Suspect Material	Surface Treatment	Extent of Damage	Accessibility
	S06 - S	Dust	Completely Unsealed	High Damage	Accessible
	Risk Score				
	0				
	Recommended Action	No Action Required			
	Surveyor Comments

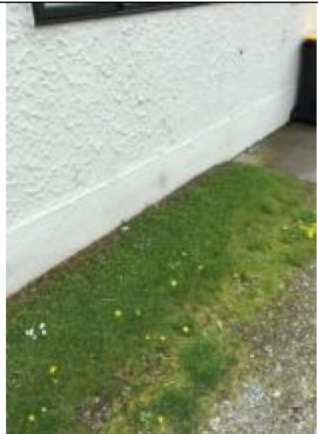
Building	Floor Type	Room	Item Location	Material	Quantity / Units	Extent of Damage	Surface Treatment	Accessibility	Sample Information	Asbestos Type	Risk Score	Recommended Action
19 Wentworth Street, Gore	Site / Grounds	External	Soil below Window 1	Soil	8sqm	High Damage	Completely Unsealed	Accessible	S07-S	Chrysotile	7	Restrict entry and repair or remove

Survey Date:	Lead Surveyor	Building	Floor	Confirmed/Presumed Asbestos
	24/10/2018	Jake Davenport	19 Wentworth Street, Gore	Site / Grounds	Chrysotile
	Room Name	Item Location		Quantity/Unit	
	External	Soil below Window 1		8sqm	
	Sample No (S,SP,P,As,NSM)	Material/Suspect Material	Surface Treatment	Extent of Damage	Accessibility
	S07 - S	Soil	Completely Unsealed	High Damage	Accessible
	Risk Score				
	10				
	Recommended Action	Restrict entry and repair or remove			
Surveyor Comments

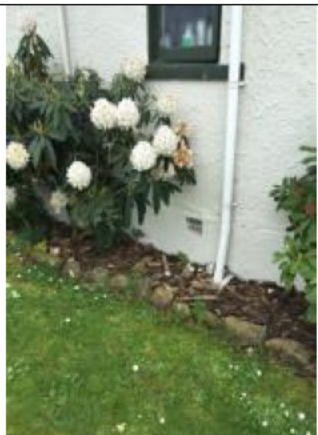
Survey Date:	Lead Surveyor	Building	Floor	Confirmed/Presumed Asbestos
	24/10/2018	Jake Davenport	19 Wentworth Street, Gore	Site / Grounds	No Asbestos Detected
	Room Name	Item Location		Quantity/Unit	
	External	Soil below Toilet window		8sqm	
	Sample No (S,SP,P,As,NSM)	Material/Suspect Material	Surface Treatment	Extent of Damage	Accessibility
	S08 - S	Soil	Completely Unsealed	High Damage	Accessible
	Risk Score				
	0				
	Recommended Action	No Action Required			
Surveyor Comments
