# Old Mangere Numerical Capacity Review

## January 2016

**AMA – SPECIAL INSPECTION**
**Old Mangere Bridge**

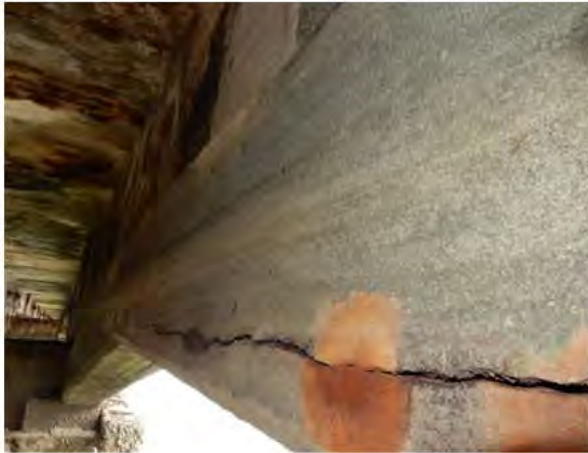
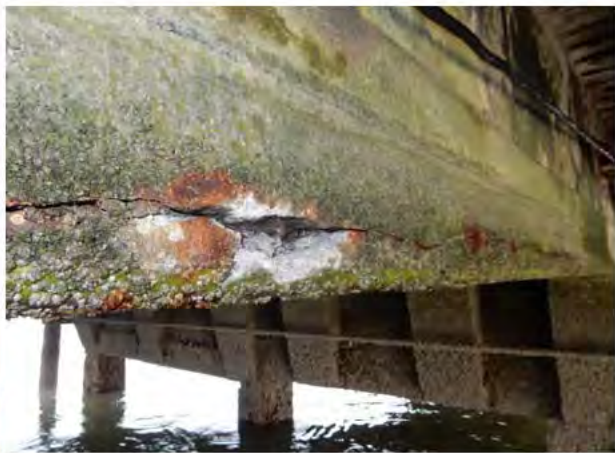
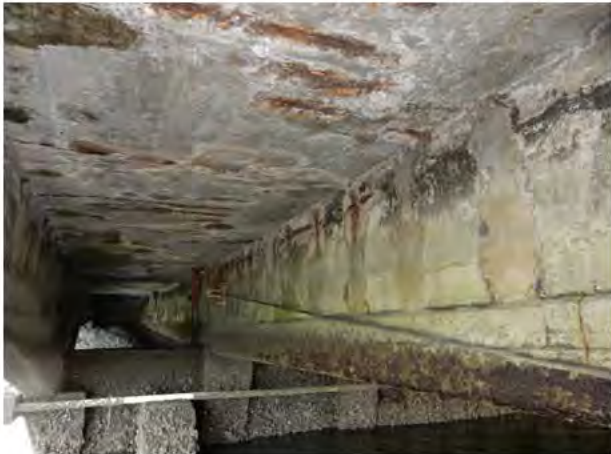
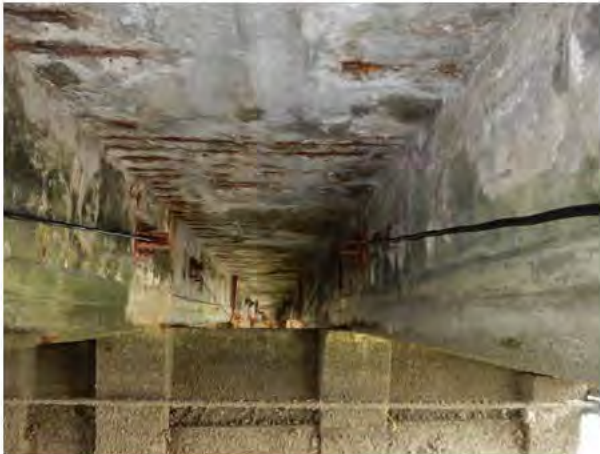
Comments: All the beams are showing signs of delamination and loss of section to the reinforcement. Previous repairs have failed and are hiding the true deterioration of the structure. Black low oxygen corrosion was noted where the concrete broke off the beam. Generally all the concrete sounded spongy/brittle when struck with a hammer.

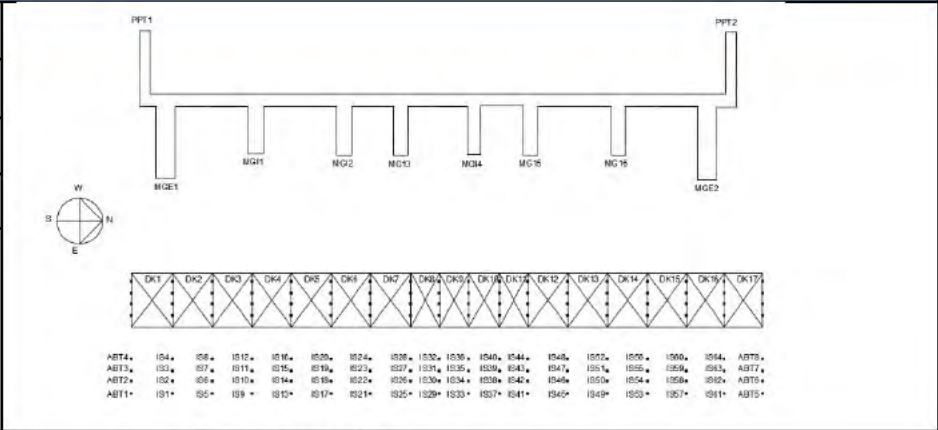
9. Intermediate Support 5-8

Component: IS5-IS8 Piers & Cross Head Beam
Defect Type: Spalling, Delamination and displacement
Extent: D
Severity: 5
Priority: HIGH

Comments: The crosshead beam in-between MGI5 & MGI6 has a crack the full depth. The area was previously clamped but the clamps are loose and no longer functional. The cross head beam above MGE2 is crushed with a number of cracks. Generally all the concrete sounded spongy when struck with a hammer

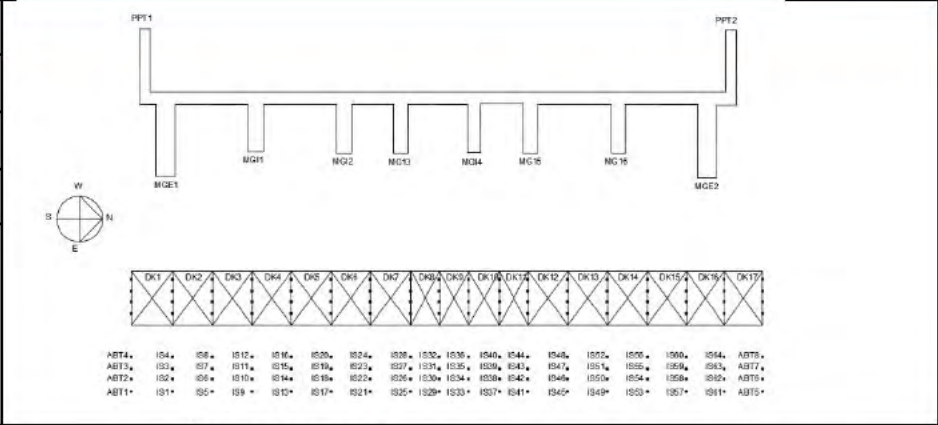
10. Span 3

Component: All Elements
Defect Type: Spalling & Delamination
Extent: D
Severity: 5
Priority: HIGH

Comments: All elements on the deck have areas of delamination and loss of section to reinforcement. The majority of the beams bottom reinforcement are floating in mid-air with 100% section loss to the shear links

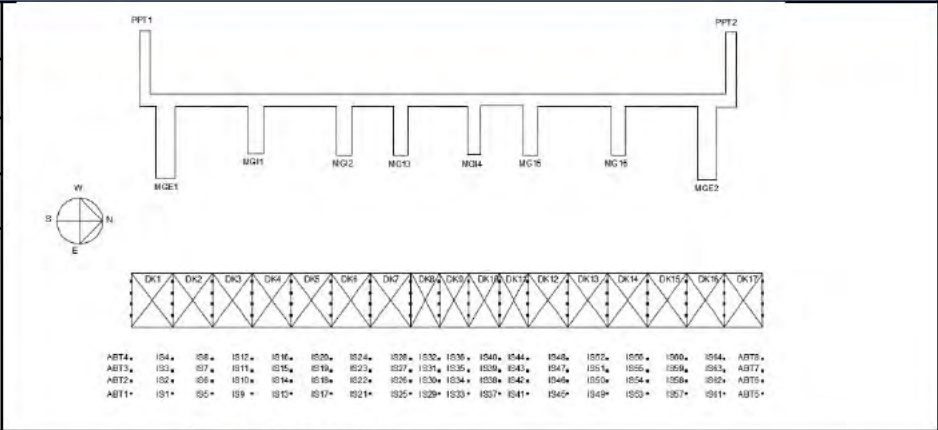
19. Intermediate Support 29-32

Component: IS29-IS32 Piers & Cross Head Beam  
 Defect Type: Spalling, Delamination and cracking  
 Extent: D  
 Severity: 5  
 Priority: HIGH

Comments: There are full depth cracks on the cross head beams under MGE1. There are stepped cracks to the soffit of all the cross beams as a result of delamination and rust jacking.

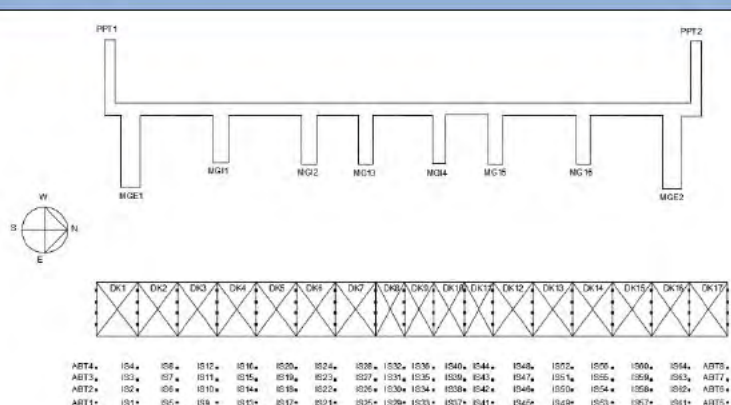
23. Intermediate Support 41-44

Defect confirmed at this inspection [D18]	
<p>Component: IS41-IS44 Piers &amp; Cross Head Beam</p> <p>Defect Type: Spalling, Delamination and cracking</p> <p>Extent: D</p> <p>Severity: 5</p> <p>Priority: HIGH</p>

<p>Risk Severity: 5+</p>	<p>Risk Score: 20+</p>
<p>Comments: There transverse cracks on IS38 &amp; IS40. The piles sound and feel spongy when struck with a hammer and areas delaminated when hit.</p>	
<div style="display: flex; justify-content: space-around;"> <div style="text-align: center;">

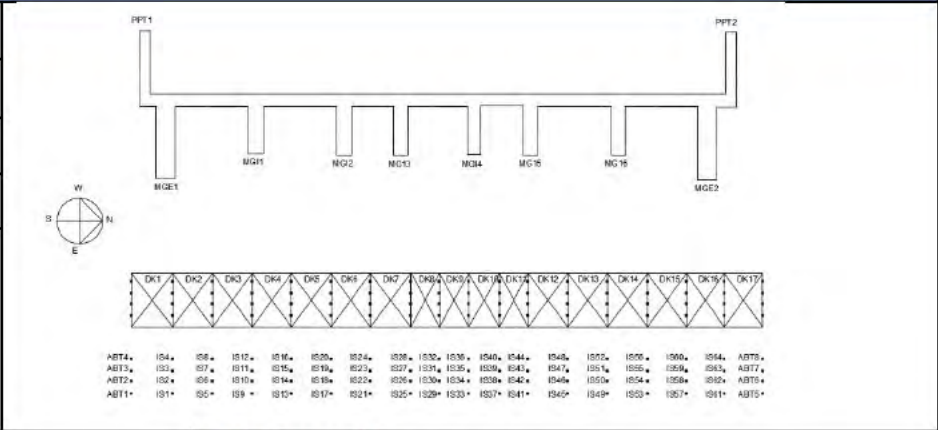
Component: IS45-IS48 Piers & Cross Head Beam  
 Defect Type: Spalling, Delamination and cracking  
 Extent: D  
 Severity: 5  
 Priority: HIGH

Comments: There is extensive cracking and delamination of the cross head beams and the tops of the piles. The concreted delaminated when struck and generally is spongy when hit.

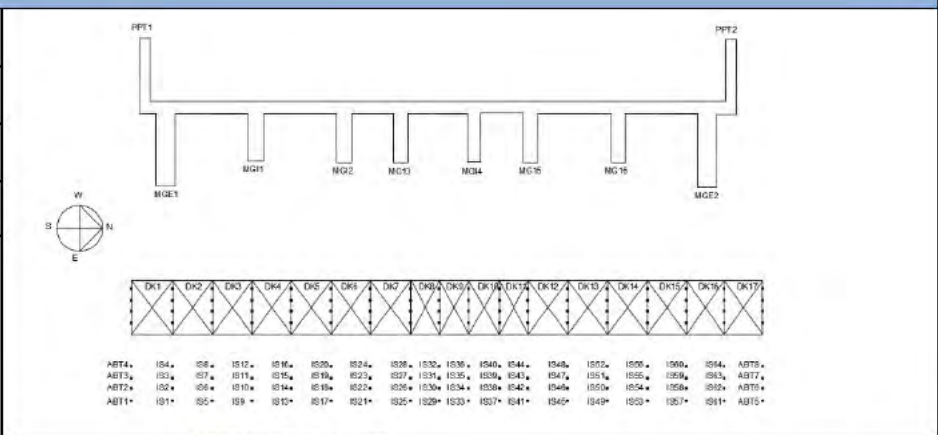
Component: IS45-IS48 Piers & Cross Head Beam
Defect Type: Spalling, Delamination and cracking
Extent: D
Severity: 5
Priority: HIGH

**Comments:** There is extensive cracking and delamination of the cross head beams and the tops of the piles. IS46 & IS47 main reinforcement has buckled in the corners there is extensive crush and cracking of the concrete at this location. The cross head is heavily delaminated at this location. The concrete generally is spongy when struck. The horizontal strut to pier connection has cacking and very spongy when struck.

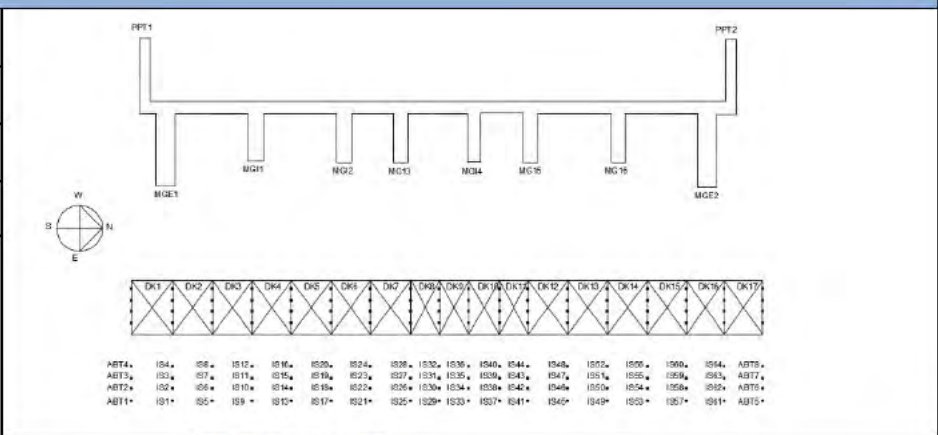
Component: IS45-IS48 Piers & Cross Head Beam
Defect Type: Spalling, Delamination and cracking
Extent: D
Severity: 5
Priority: HIGH

Comments: There is extensive cracking and delamination of the cross head beams and the tops of the piles. IS46 & IS47 main reinforcement has buckled in the corners there is extensive crush and cracking of the concrete at this location. The cross head is heavily delaminated at this location. The concreted generally is spongy when struck

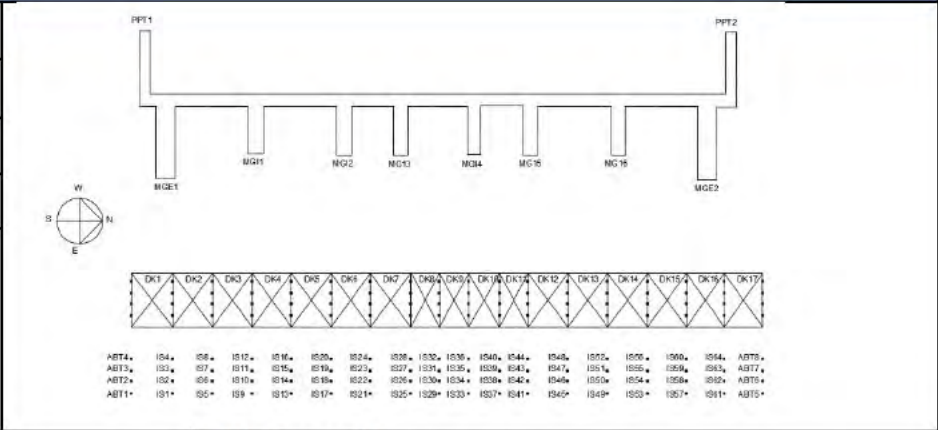
28. Intermediate Support 49-52

Component: IS49-IS52 Piers & Cross Head Beam  
 Defect Type: Spalling, Delamination and cracking  
 Extent: D  
 Severity: 5  
 Priority: HIGH

Comments: There is extensive cracking and delamination of the cross head beams and the top of pile 51. The corner reinforcing is buckled and there are transverse cracks across the pile. The concreted generally is spongy when struck.

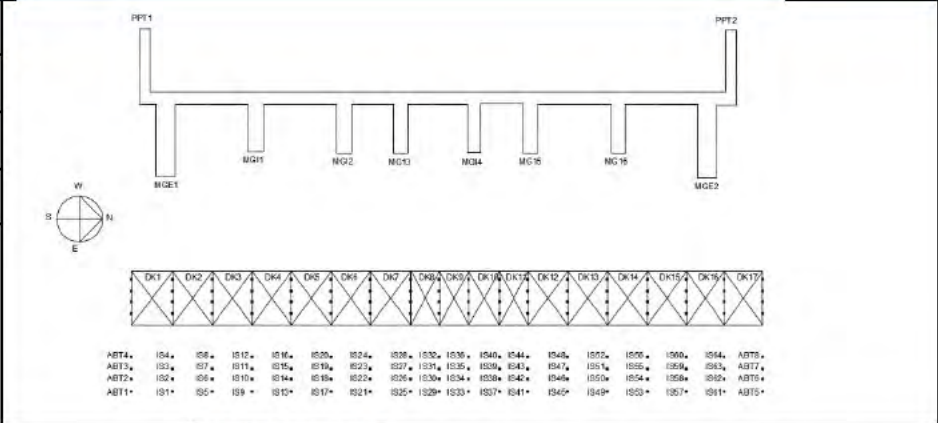
Component: All Elements  
 Defect Type: Spalling & Delamination  
 Extent: D  
 Severity: 5  
 Priority: HIGH

Comments: All elements on the deck have areas of delamination and loss of section to reinforcement. There are fracture to the abutment that surround the piles support at this location. The ends of the beams have heavily delaminated and loss of section to the reinforcement. The bed stones area are, missing, loose or heavily cracked.

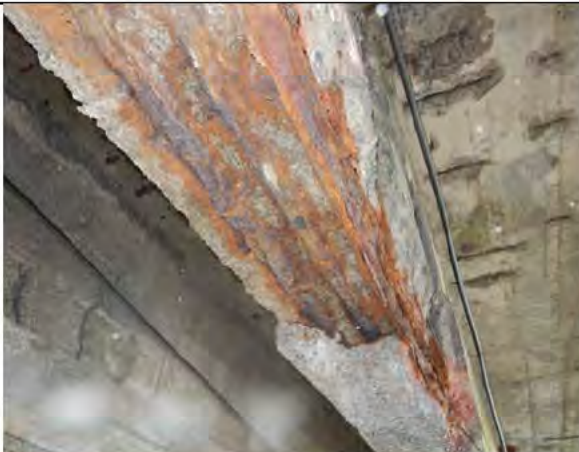
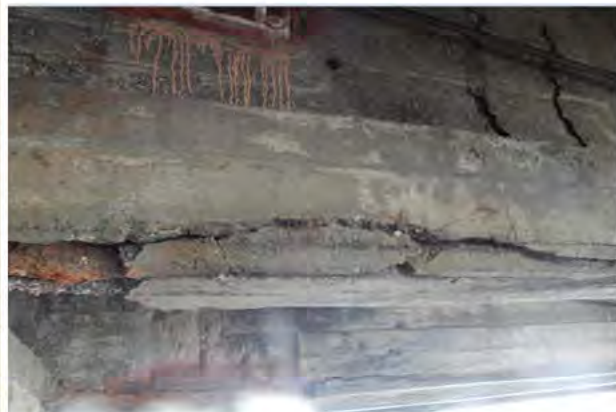
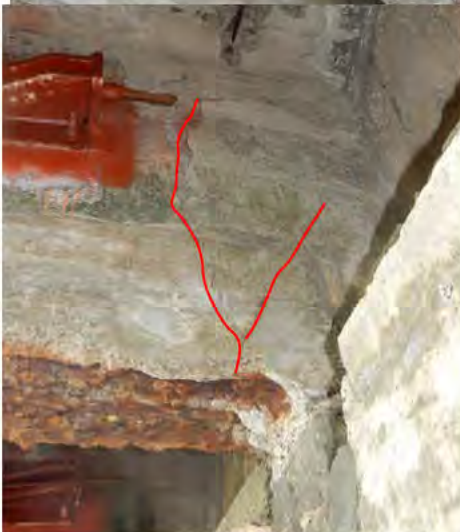
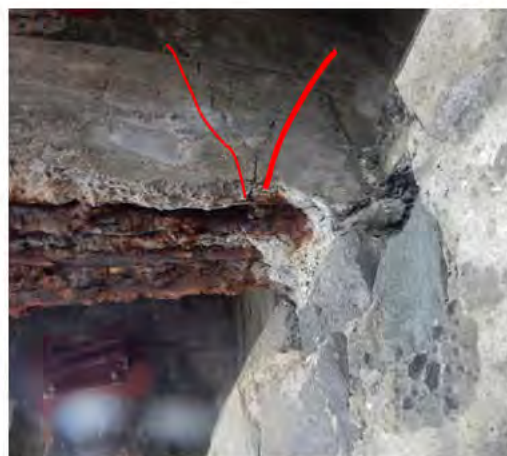
Comments: All elements on the deck have areas of delamination and loss of section to reinforcement. The ends of the beams have heavy delaminated and loss of section to the reinforcement. The previous post-tension system seems to be crushing the concrete and there appears to be shear cracks at the supports.

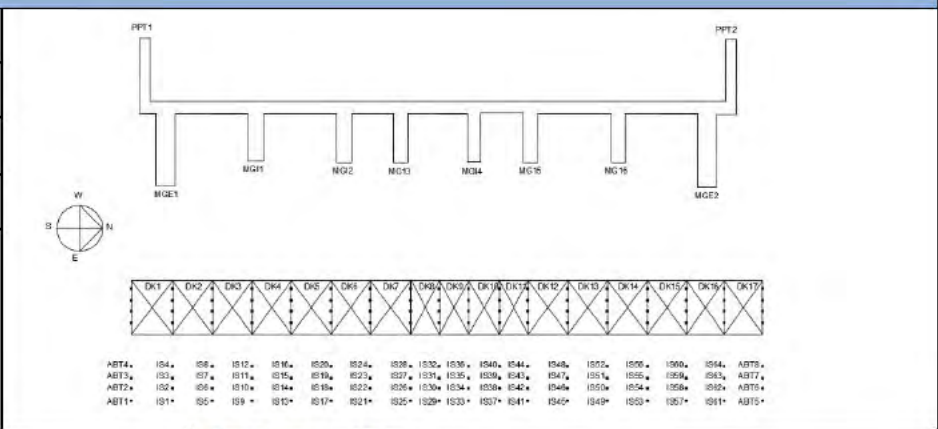
Component: All Elements
Defect Type: Cracking
Extent: D
Severity: 5
Priority: HIGH

Comments: Cracking to strengthening slab which appears to go the full width of the bridge, in span 5/6 over the pier and span 2 at the point of contra-flexure

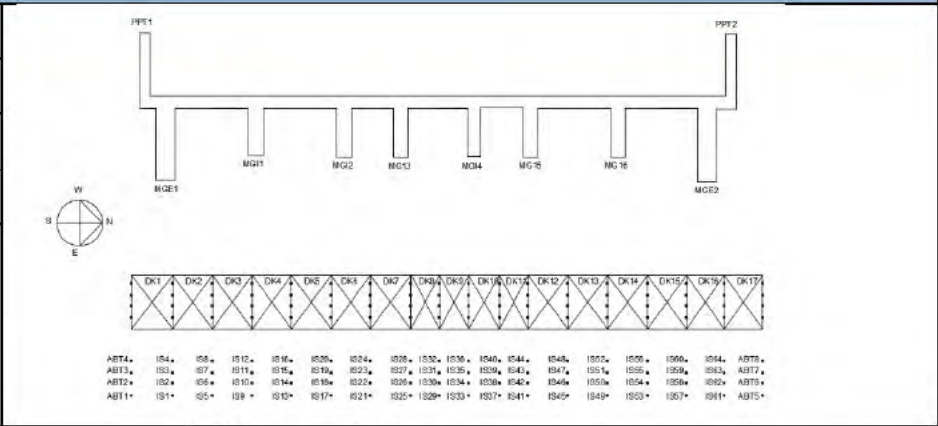
Component: Parapet
Defect Type: Leaning
Extent:
Severity:
Priority: HIGH

Comments: Parapet leaning on the west side. AMATrac has been raised to replace with new handrail.

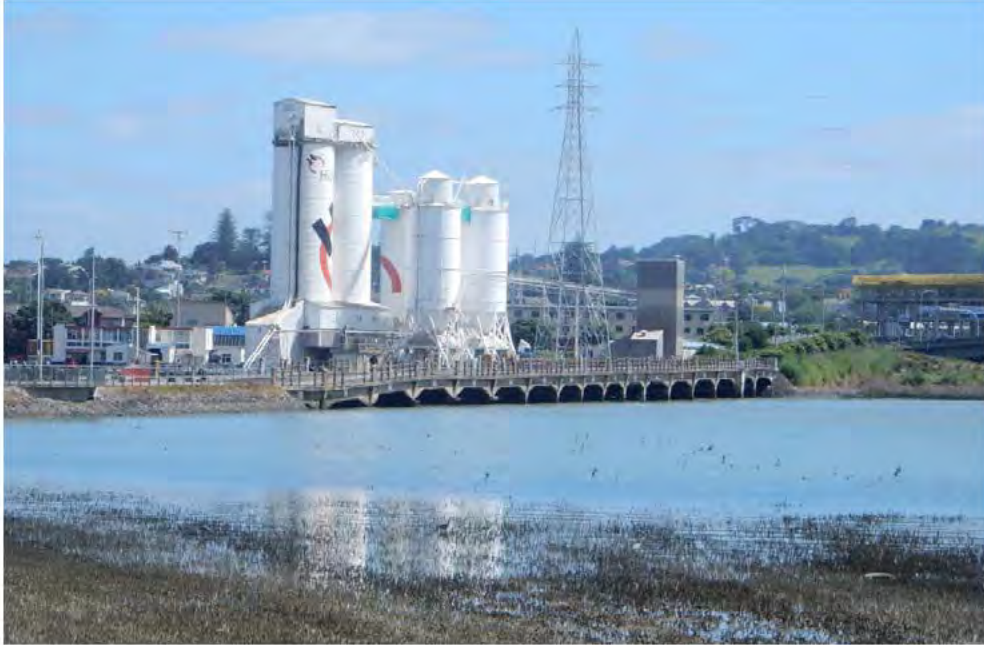
1. General View looking North (Note settlement of south span)
