## Methamphetamine Test Certificate

## Housing New Zealand Corporation Retest 1 Methamphetamine Assessment

Site Assessment Date	13 <sup>th</sup> July 2017
Sample Team	s 9(2)(a)
Report Author	
Report Checked by	
Key Technical Person	
Property Reference	TUS0002661
Works Order	WO1656541
Author Signature	KTP Signature
s 9(2)(a)	s 9(2)(a)

# Housing New Zealand Corporation Post-remediation Methamphetamine Assessment

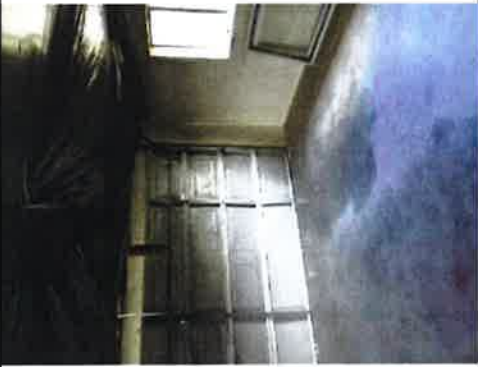
<p><b>Picture 1: Garage</b></p>	<p><b>Picture 2: Garage Window Frame – 0.19 µg/100cm<sup>2</sup></b></p>	<p><b>Picture 3: Lounge</b></p>	<p><b>Picture 4: Kitchen/Dining</b></p>

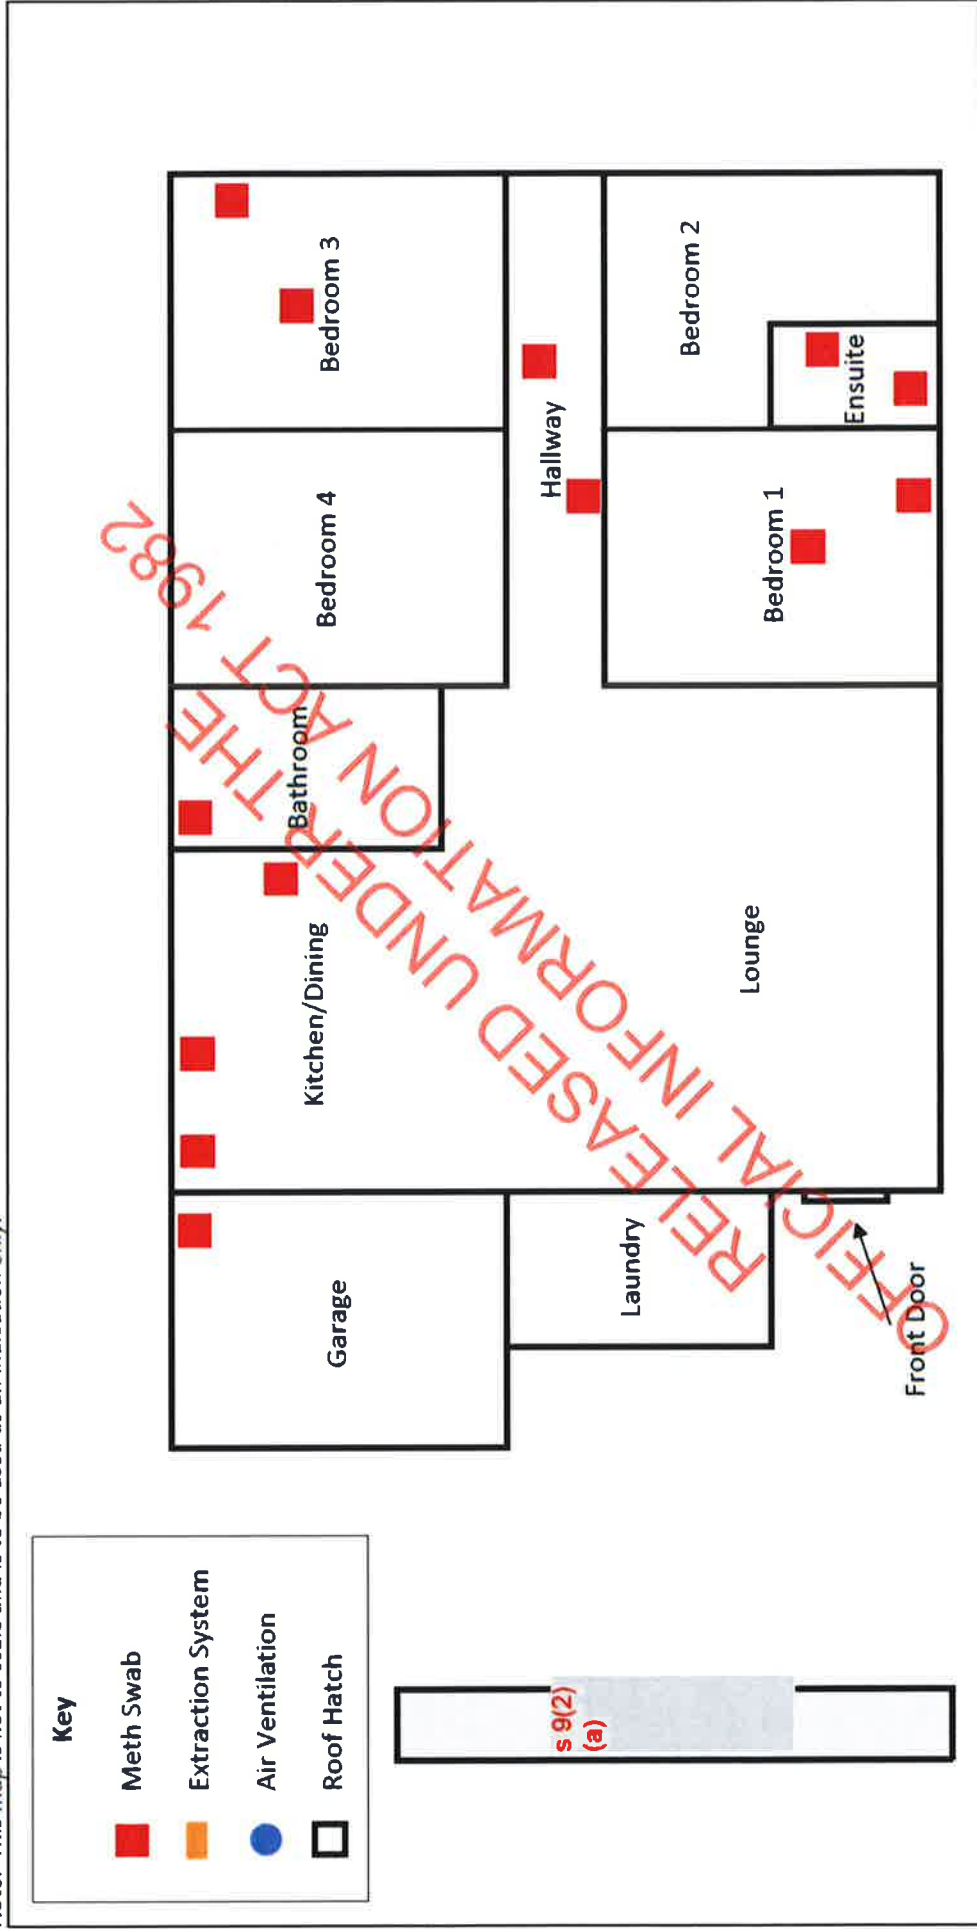
Figure 1 Site Map Showing Sample Locations

Methamphetamine was detected above the Ministry of Health recommended level of 2.0 µg/100cm<sup>2</sup> in the garage.

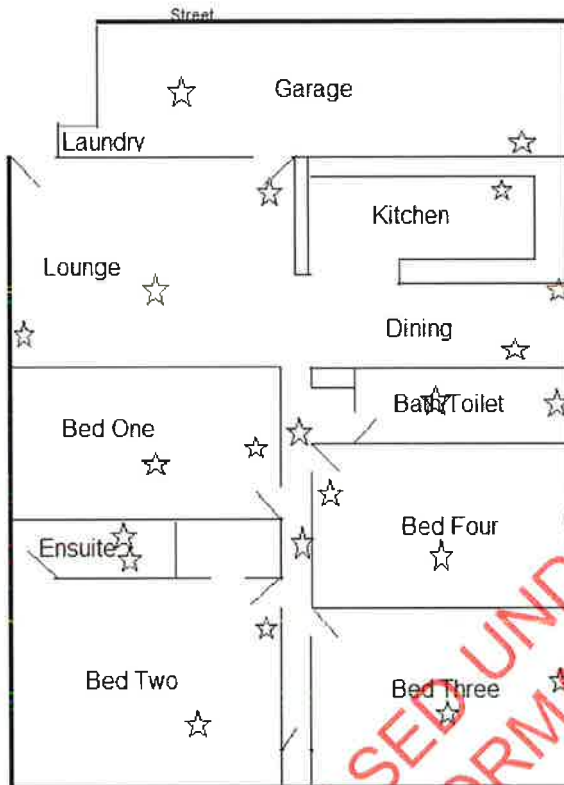
### Floor Plan:

Drawing is not to Scale  
Stars indicate approximate sampling locations.

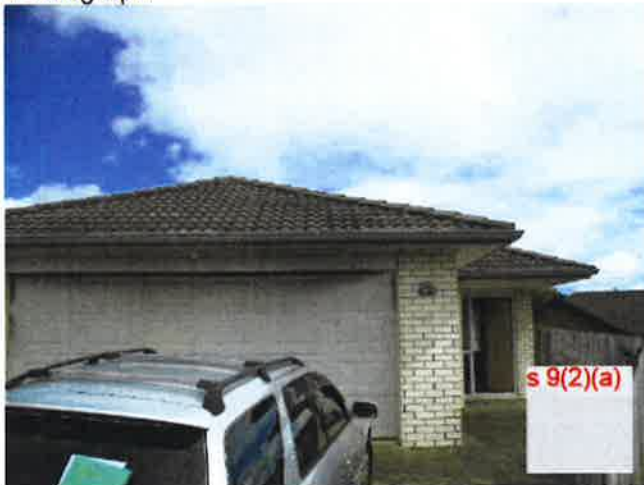
Photograph 1 – House

Outside the dwelling there was no evidence of fire pits, rubbish burial or vegetation die back that would indicate soil or ground water contamination. There was no rubbish or personal belongings observed in the front or back yards.

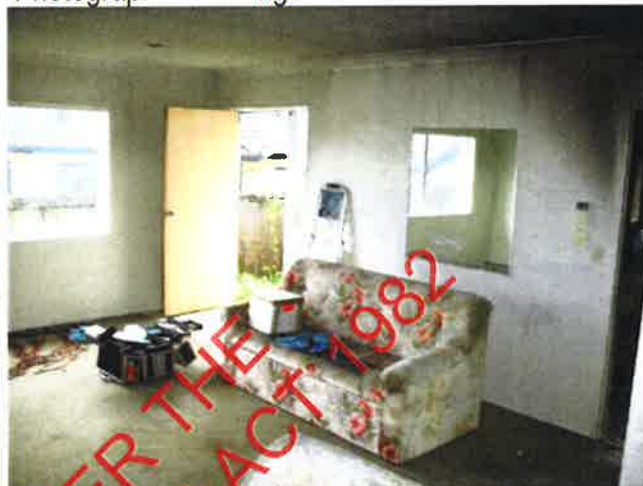
Photograph 2 – Lounge

The property was no longer occupied but did contain some personal items and furniture, especially in the garage. The inside of the dwelling was smoke damaged and the garage was both smoke and fire damaged. The carpets were stained throughout and were missing in bedroom four (only underlay remaining). There were small holes and some larger holes (which were hastily repaired) in the walls throughout with damage to some of the bedroom doors as well as damage to a cabinet in the kitchen. A window in the garage and one panel of the dining room sliding door were broken and boarded up. The front door appears to have been replaced and did not contain a locking system. The closet door in Bedroom four was missing. It appears that some attempt was made to clean the smoke damage in the kitchen/dining and bedrooms prior to the assessment.

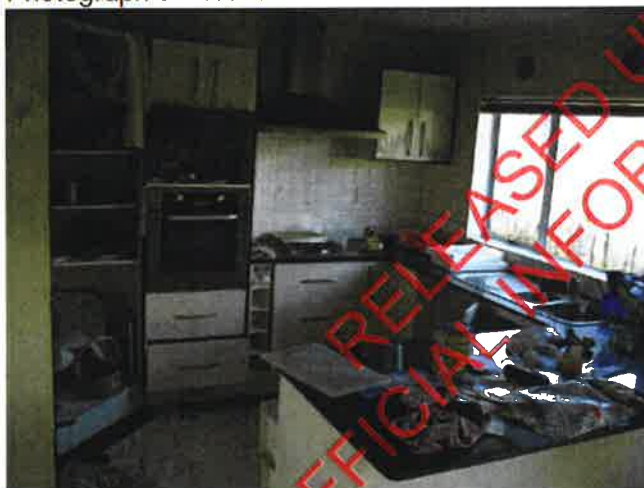
Photograph 3 – Kitchen

Area	Walls	Ceilings	Floors	Other – Blinds, Tiles, Cabinets etc.
Kitchen	Painted Plaster Board	Painted Plaster Board	Tile	Tile Backsplash, fan ventilation hood, plastic coated cabinets. Under sink cabinet damaged, no fridge. Light smoke damage. Some post fire cleaning apparent.
Dining Room	Painted Plaster Board	Painted Plaster Board	Tile	Sliding door damaged on panel boarded up, heavy smoke damage and appears cleaning attempted. Heavy smoke damage. Light smoke damage. Some post fire cleaning apparent.
Lounge	Painted Plaster Board	Painted Plaster Board	Carpet	Front door does not appear to be original and has not dead bolt. Stick of incense sticking out from wall, many small holes in walls. Some furniture remaining. Heavy smoke damage.
Hallway/Stairs	Painted Plaster Board	Painted Plaster Board	Carpet	Moderate smoke damage
Bedroom One	Painted Plaster Board	Painted Plaster Board	Carpet	Various holes in walls hastily repaired. Light smoke damage. Light smoke damage. Some post fire cleaning apparent. Closet door damage.
