**PROPERTY 5**

**West Harbour: post remediation inspection and testing**

*West Harbour: inspection and testing*

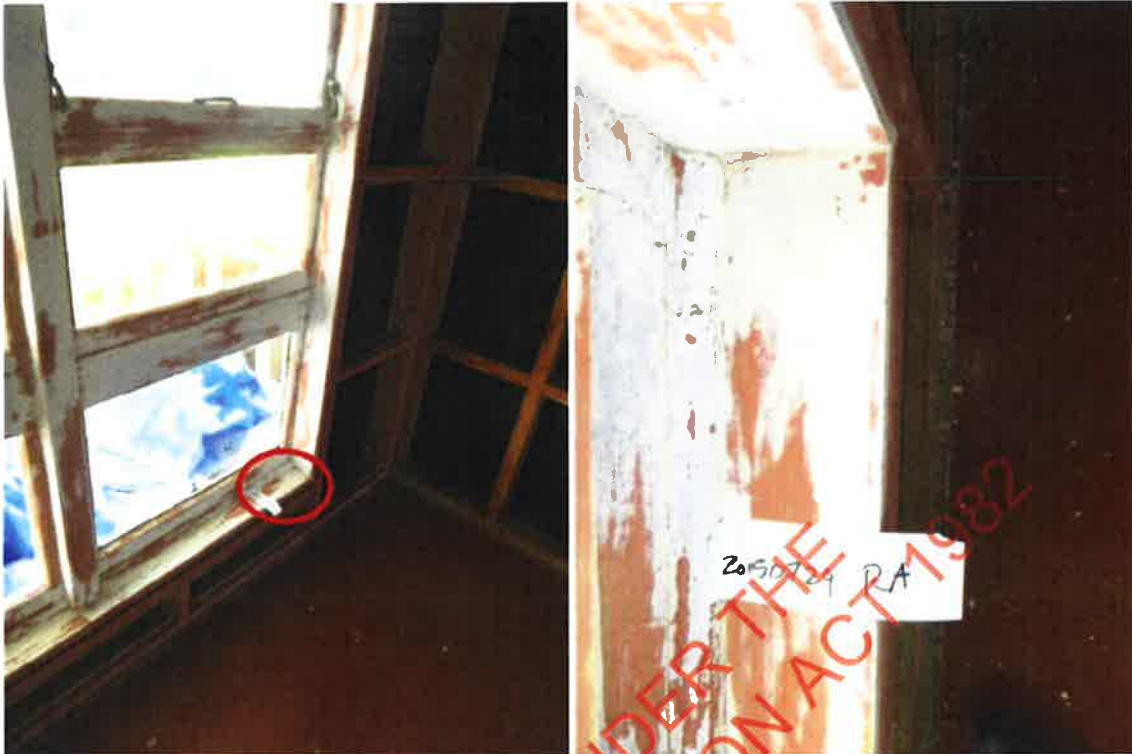
Living room 1 window sill: methamphetamine was detected on this surface at 0.30  $\mu\text{g}/100\text{cm}^2$ .

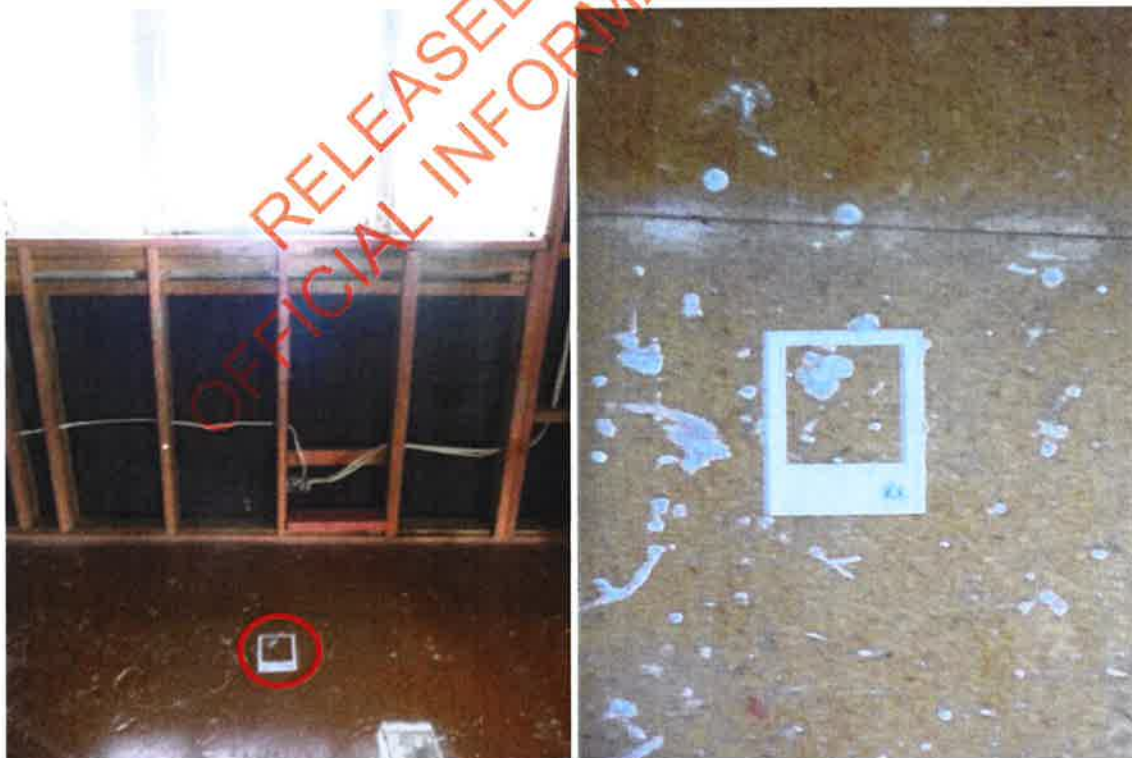
Bedroom 1 floor: methamphetamine was detected on this surface at a trace concentration.

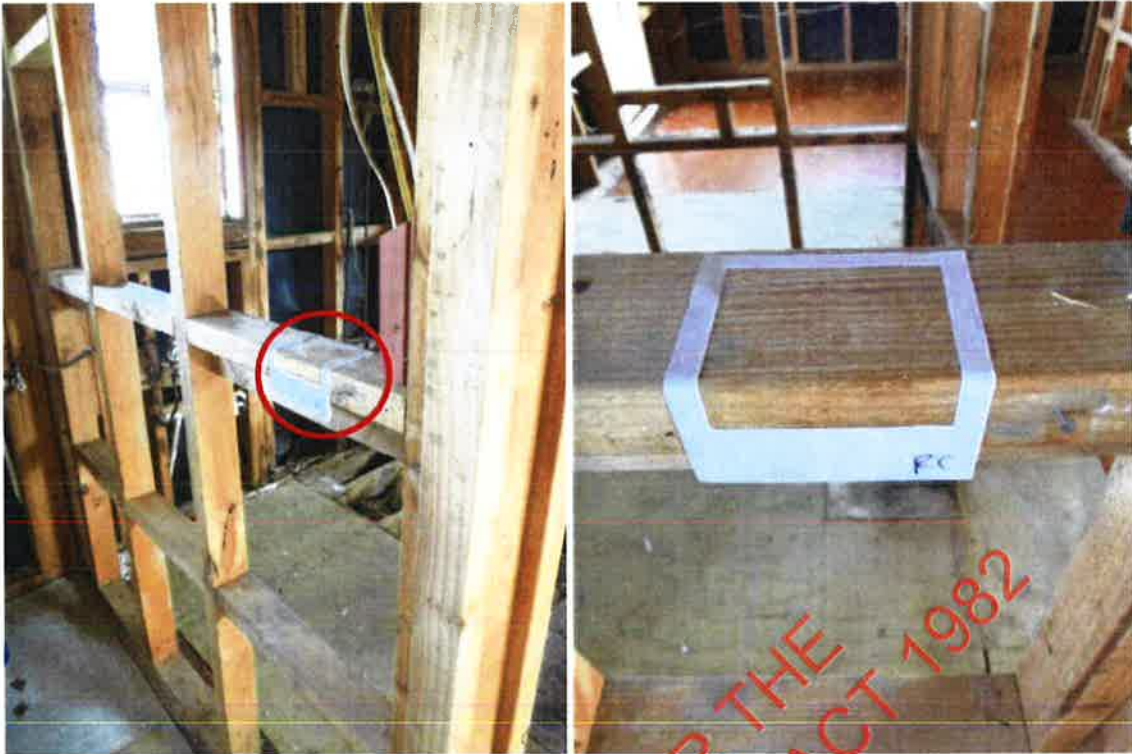
Toilet room framing: methamphetamine was detected on this surface at  $0.07 \mu\text{g}/100\text{cm}^2$ .

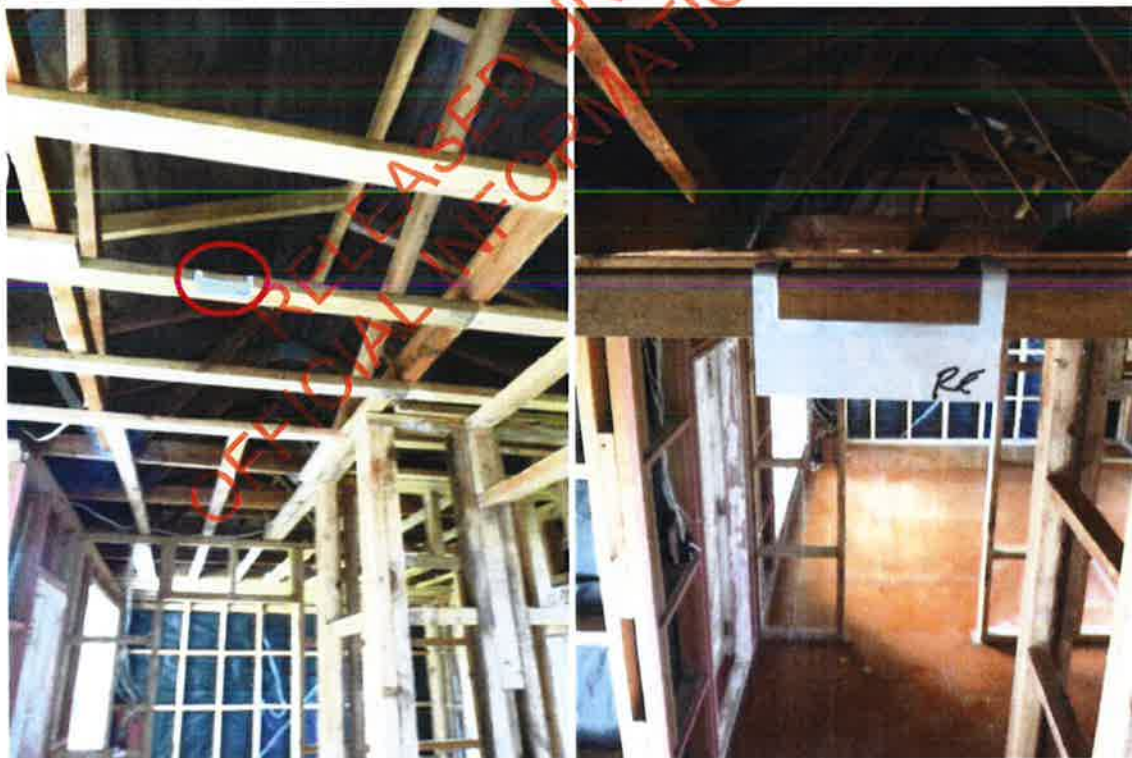
Living room 2 ceiling framing: methamphetamine was detected on this surface at a trace concentration.

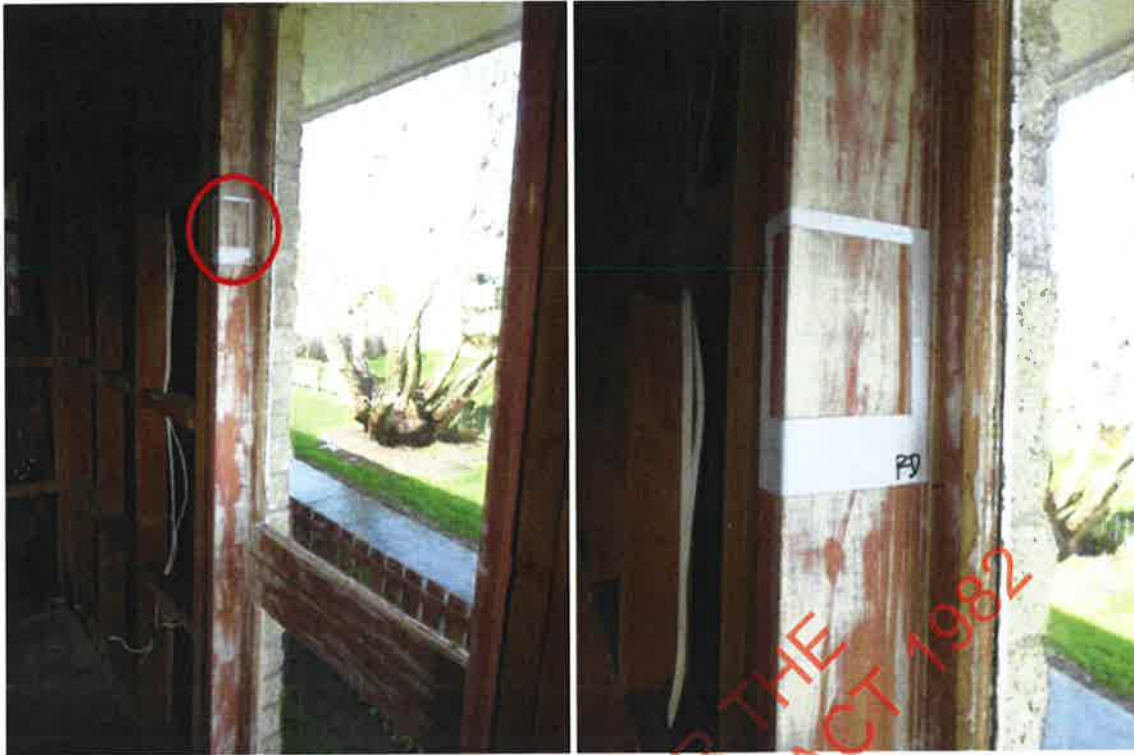
Bedroom 2 window surrounds: methamphetamine was detected on this surface at  $0.12 \mu\text{g}/100\text{cm}^2$ .

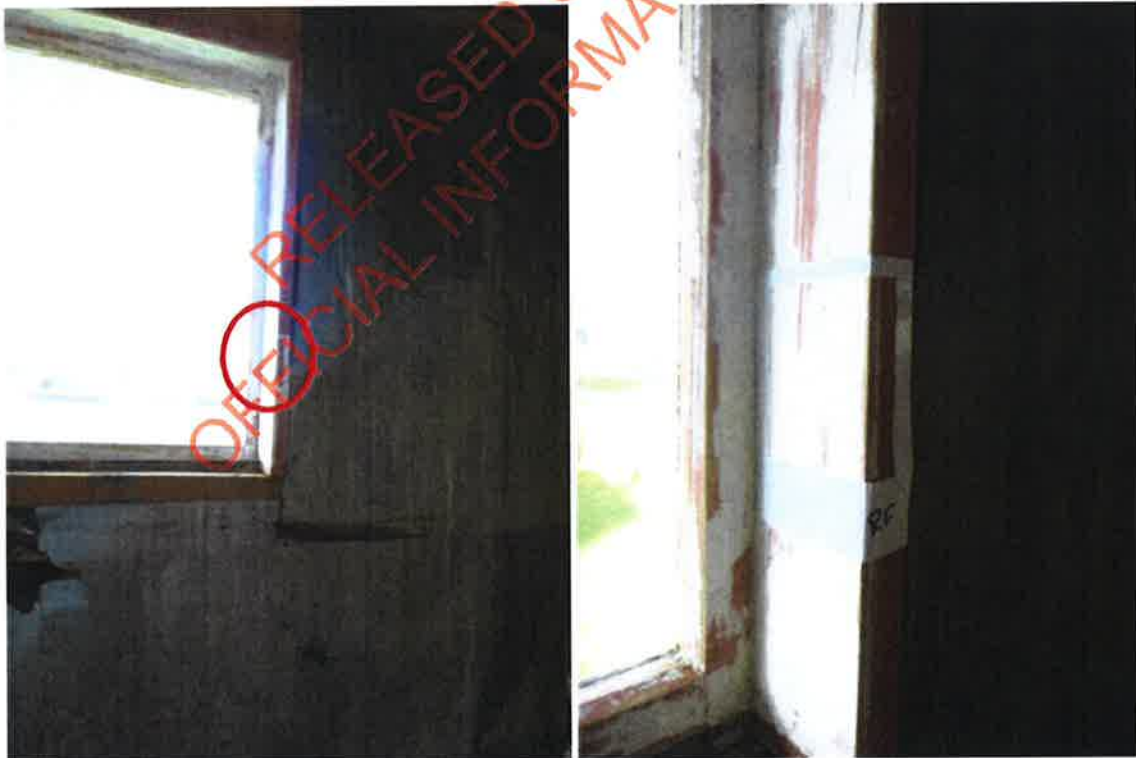
Kitchen window surrounds: methamphetamine was detected on this surface at  $0.10 \mu\text{g}/100\text{cm}^2$ .

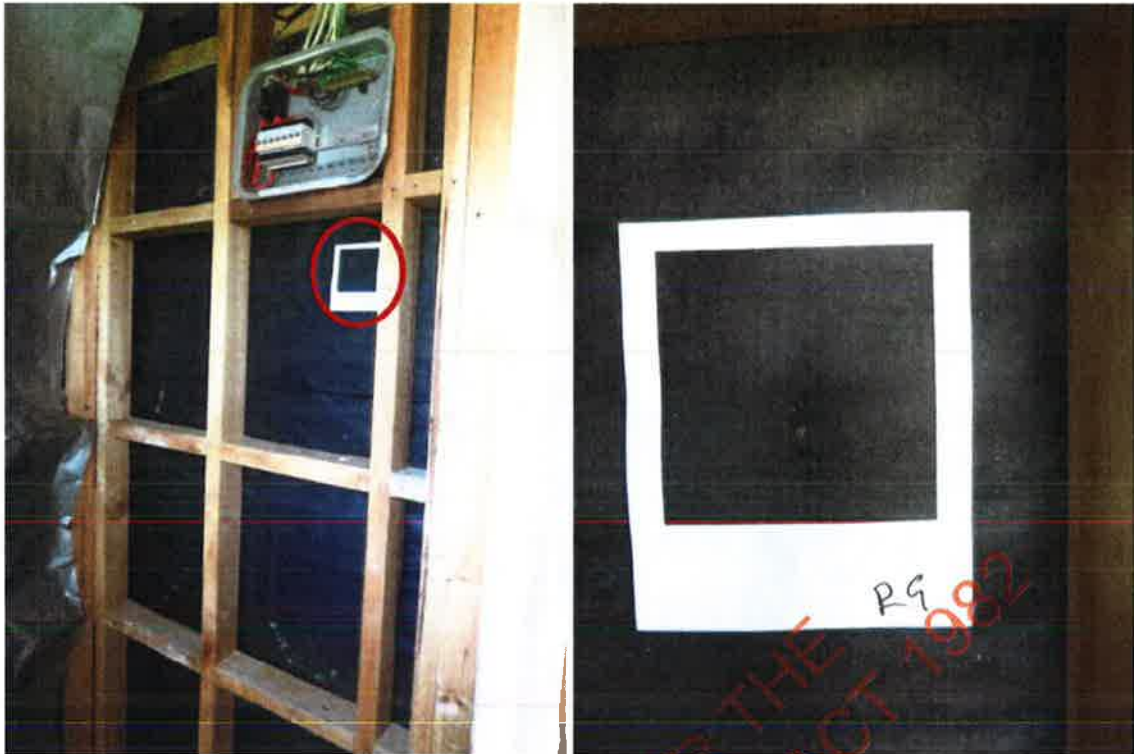
Laundry building paper: methamphetamine was detected on this surface at  $0.26 \mu\text{g}/100\text{cm}^2$ .

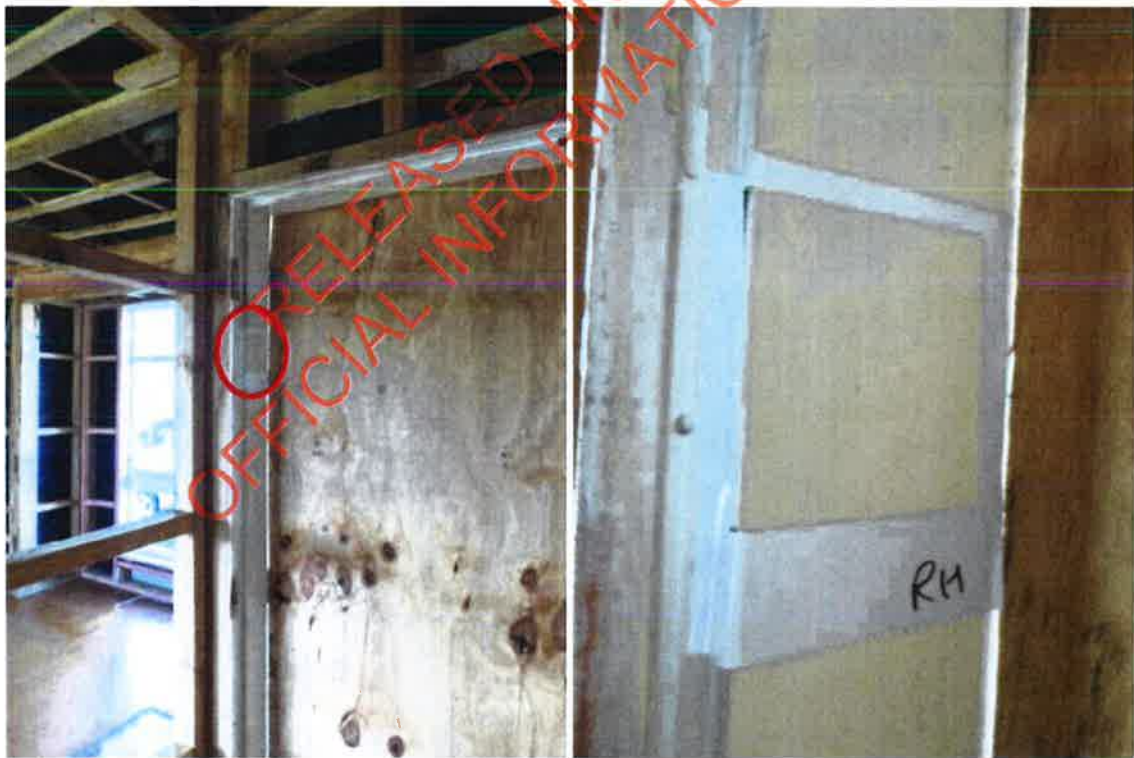
Entry door frame: methamphetamine was detected on this surface at  $0.35 \mu\text{g}/100\text{cm}^2$ .

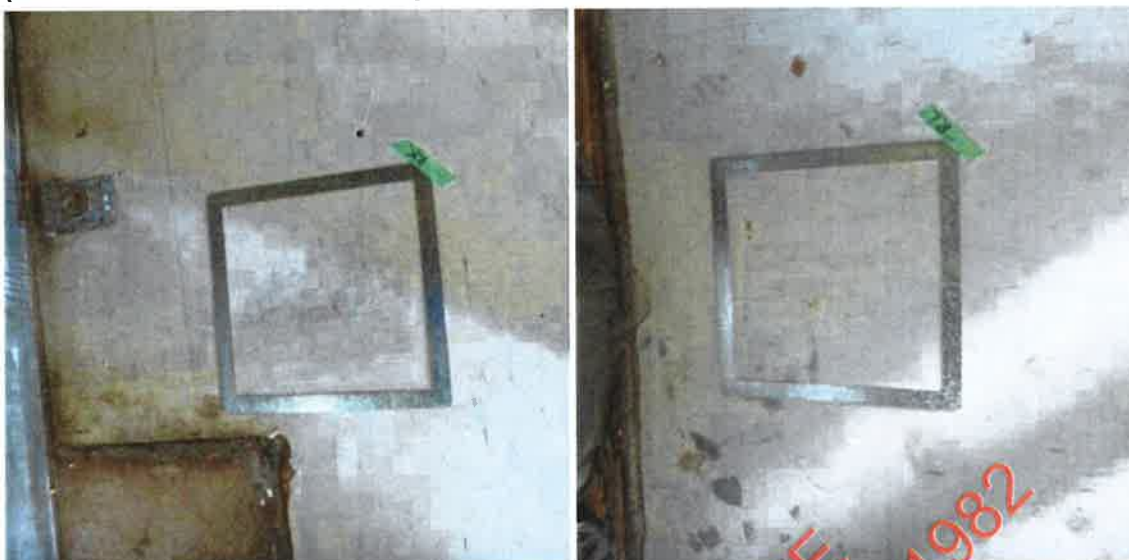
Kitchen (left) and laundry (right) floors: mercury was not detected on these surfaces. Lead was detected on these surfaces. The results indicates the levels detected are below the Ministry of Health guideline for lead.

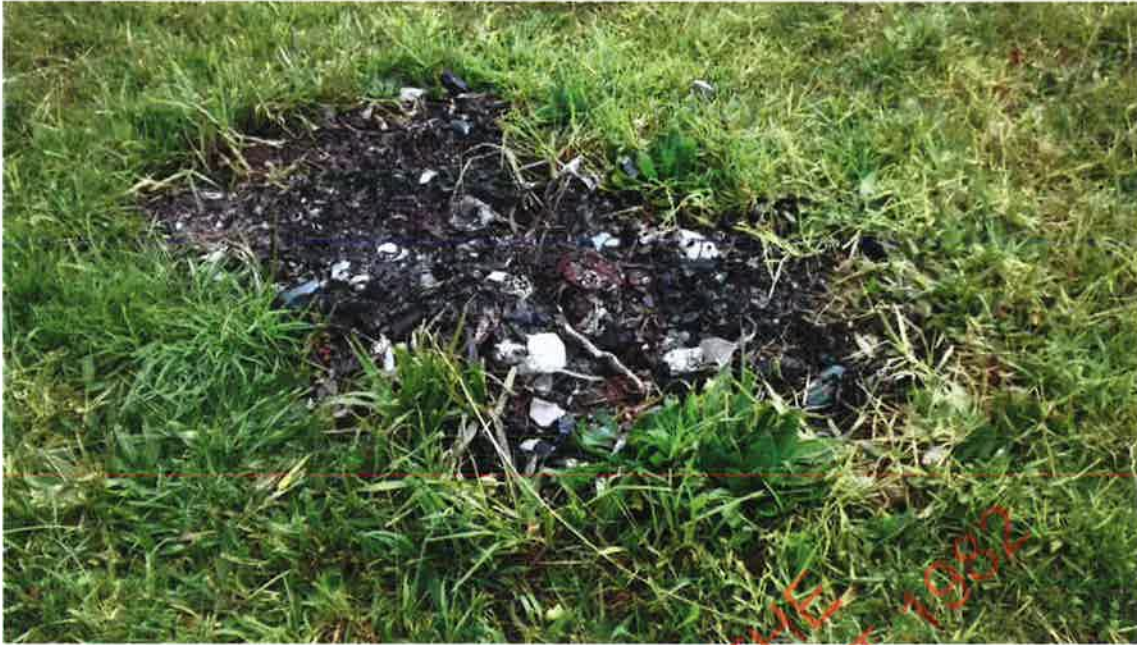
14. Visual assessment of the grounds has been undertaken. Chemical containers were not identified. A fire pit and an area of dead grass was noted at the site.

Burn pit located in the back yard: the soil in this area should be dug out on a precautionary basis.

15. Concentrations of all compounds tested for were below the Ministry of Health remediation guidelines or were not detected.
16. On a precautionary basis, we recommend you engage professionals to dig out the soil in the fire pit and area of dead grass to 50cm beyond their margins and to a depth of 30cm, or to the 'B' (clay) horizon if this is encountered first. Soil that is removed should be disposed of to landfill in accordance with Territorial Authority regulations.
17. Photographic evidence of the soil removal should be provided upon completion of work.

4. Soil that is removed should be disposed of to landfill in accordance with Territorial Authority regulations.

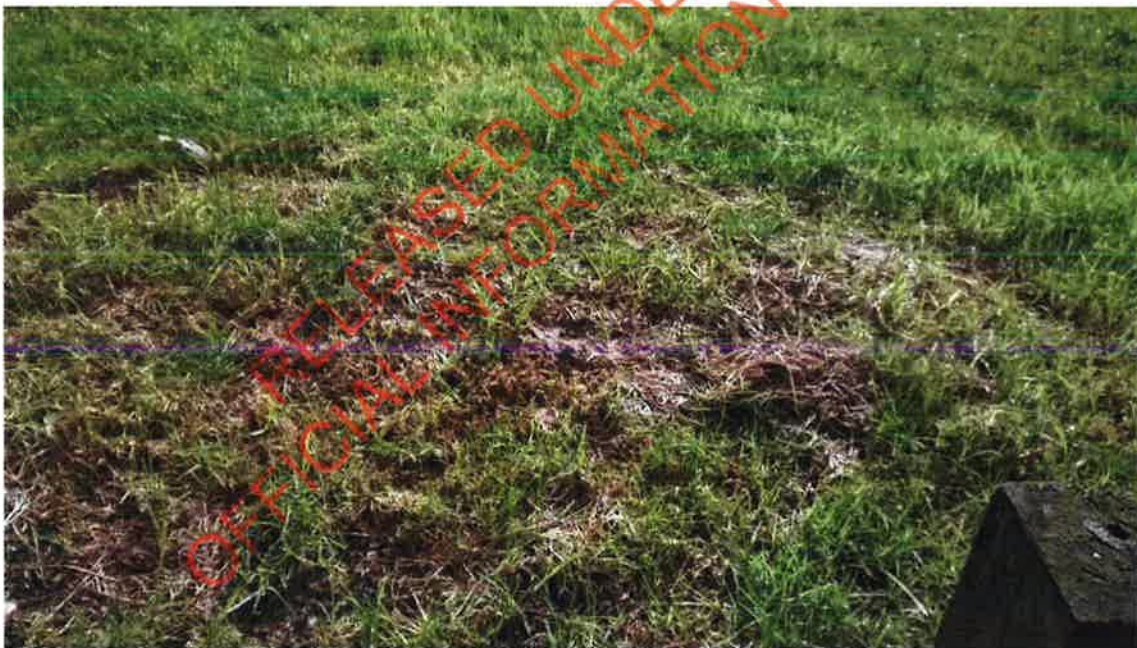
Area of dead grass near the fence: the soil in this area should be dug out on a precautionary basis.

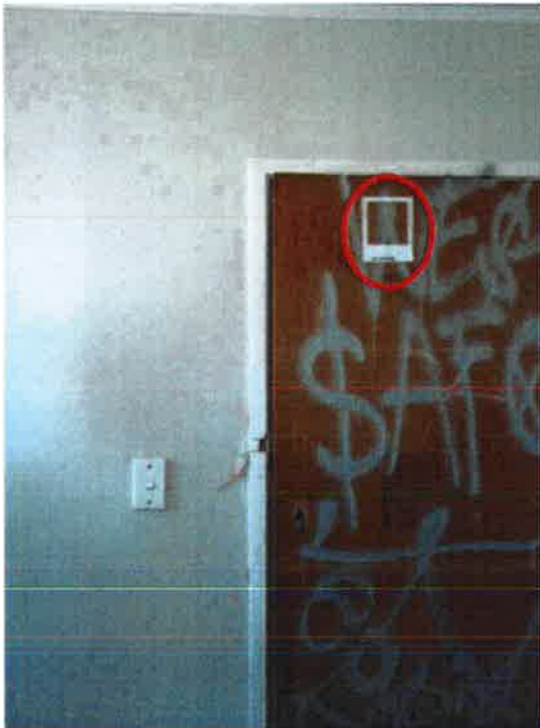
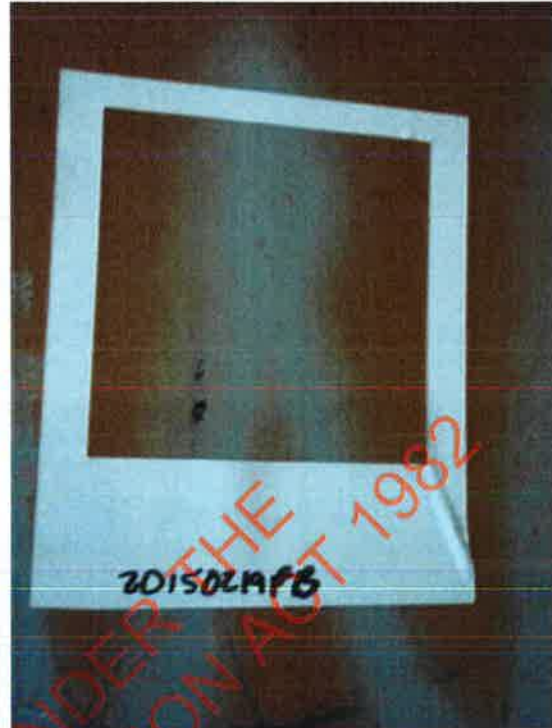
Bedroom 1 door: methamphetamine was detected on this surface at 4.06  $\mu\text{g}/100\text{cm}^2$ .

46. Door handles should be cleaned *or* disposed of.
47. Doors with painted/varnished frames and glass panes should have paint/varnish removed (including the frame) *or* be disposed of. Glass panes should be cleaned.
48. Interior doors without glass panes should be disposed of *or* cleaned. *Please ensure all surfaces of the door are thoroughly cleaned.*

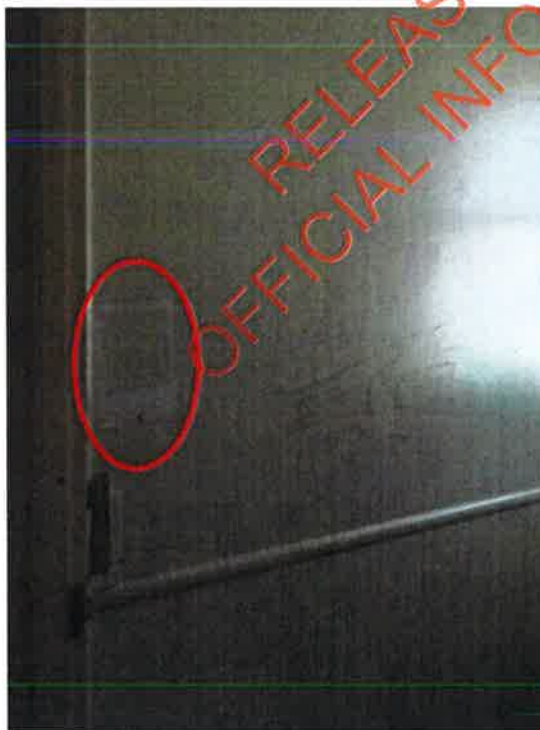
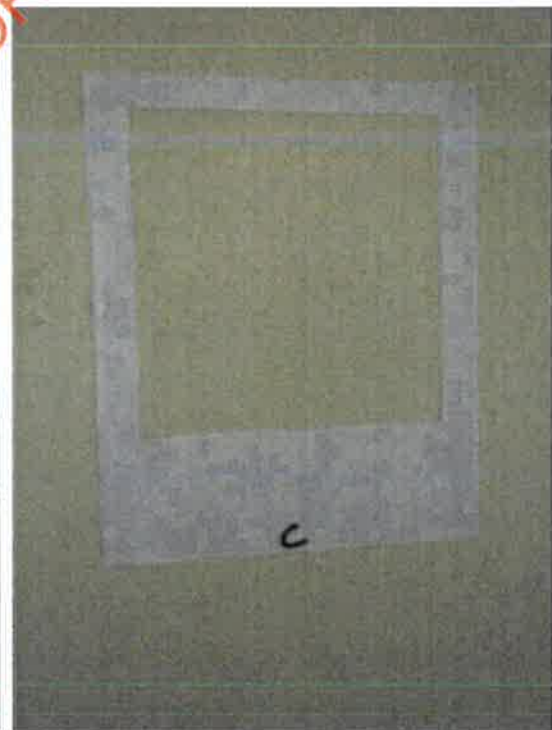
Toilet wall: methamphetamine was detected on this surface at 3.19  $\mu\text{g}/100\text{cm}^2$ .

39. Walls and skirting boards should be disposed of in the hallway, bathroom, toilet, kitchen, both living rooms and bedrooms 1 and 2.

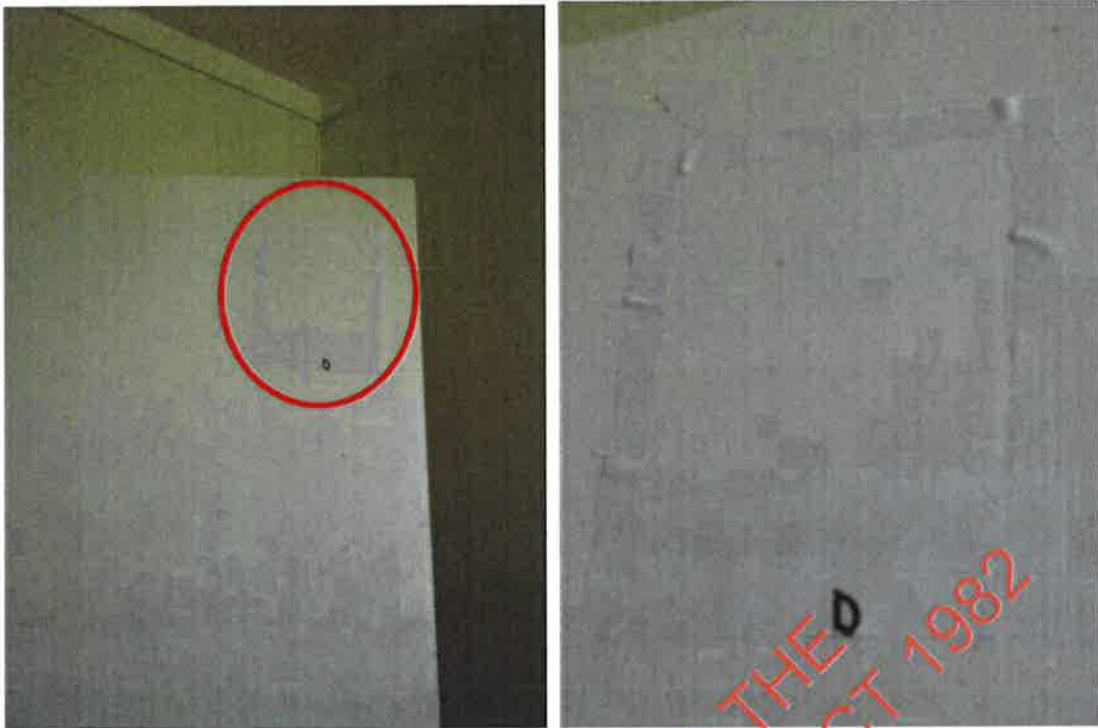
Bathroom door: methamphetamine was detected on this surface at  $6.99 \mu\text{g}/100\text{cm}^2$ .

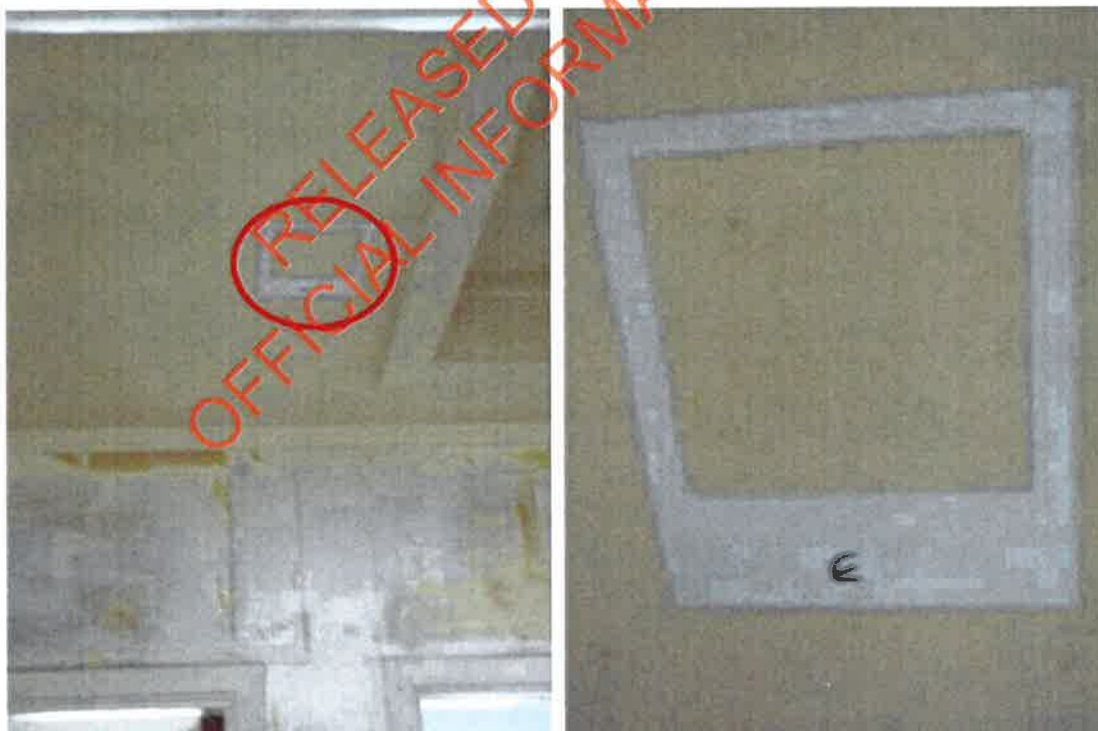
Hallway ceiling: methamphetamine was detected on this surface at  $10.6 \mu\text{g}/100\text{cm}^2$ .

35. Ceiling and mouldings should be disposed of in the hallway, bathroom, toilet, kitchen, both living rooms and bedrooms 1 and 2.
36. Ceiling and mouldings should be thoroughly cleaned in the laundry, bedroom 3 and the storage room.
37. All roof-space insulation should be disposed of and the ceiling space HEPA vacuumed and washed if accessible. The roof-space area should be contained by battening plastic sheeting across areas where ceiling materials have been removed.

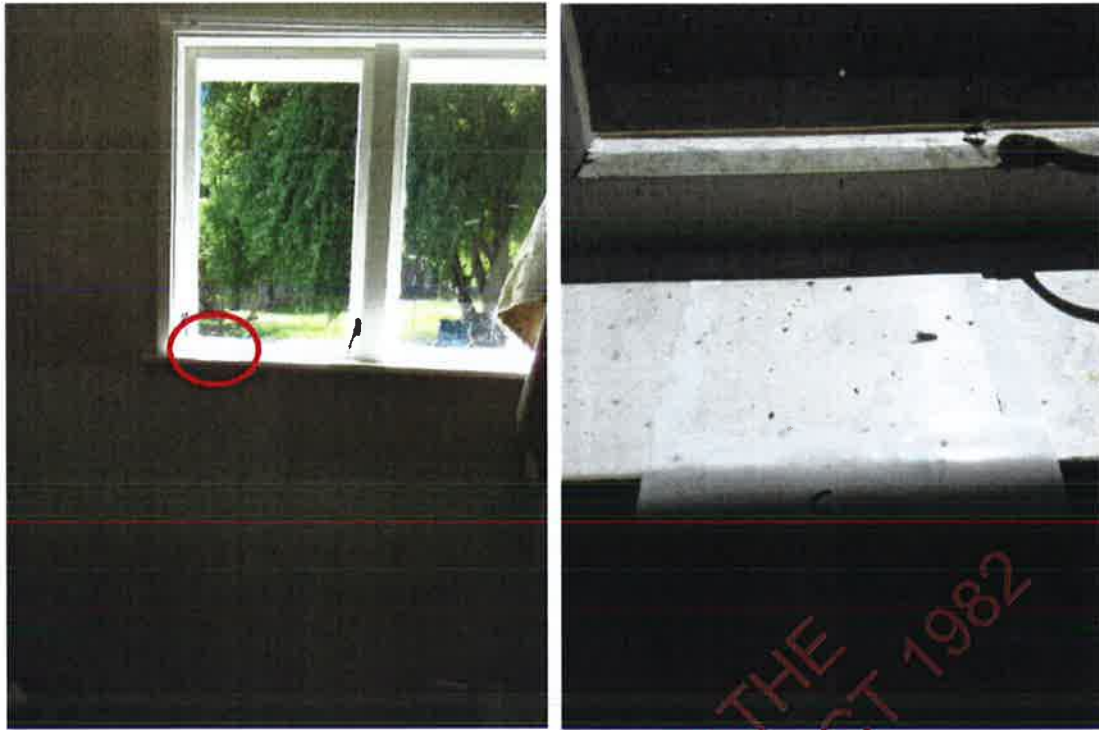
Bedroom 2 window sill: methamphetamine was detected on this surface at 1.36  $\mu\text{g}/100\text{cm}^2$ .

42. Window panes should be cleaned.
43. Window sills/frames/surrounds should have paint removed in the hallway, bathroom, toilet, kitchen, both living rooms and bedrooms 1 and 2.
44. All other sills/frames/surrounds should be cleaned.

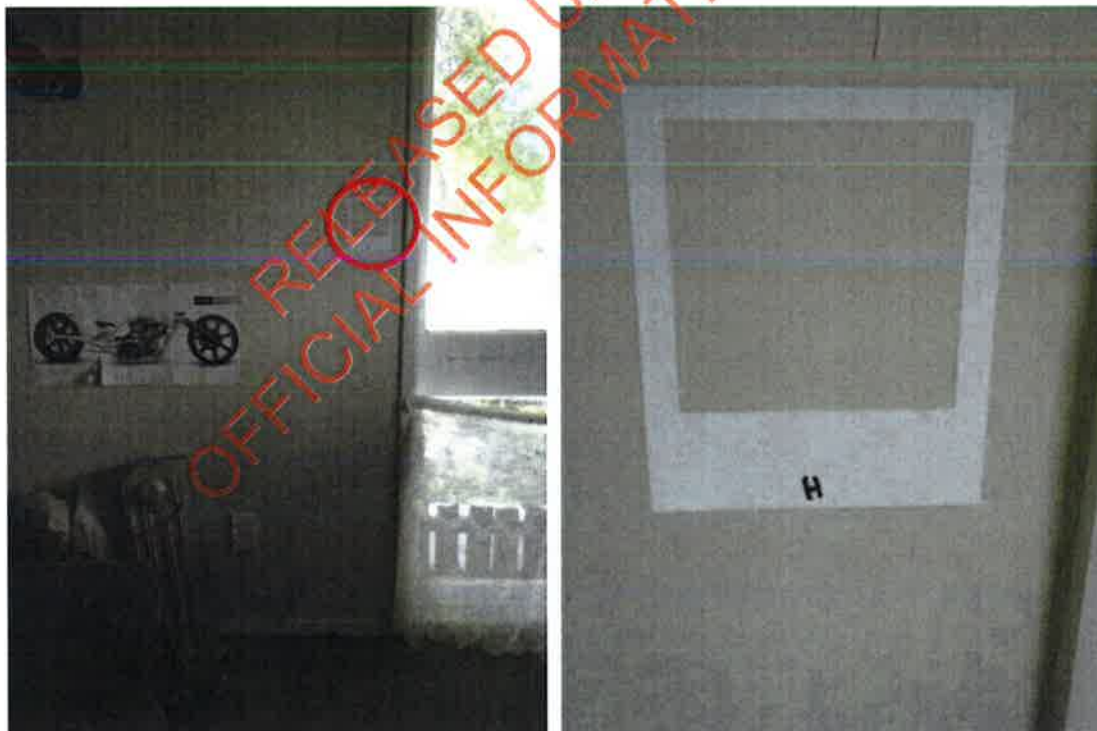
Bedroom 3 wall: methamphetamine was detected on this surface at 0.50  $\mu\text{g}/100\text{cm}^2$ .

40. Walls and skirting boards should be thoroughly cleaned in the laundry, bedroom 3 and the storage room.

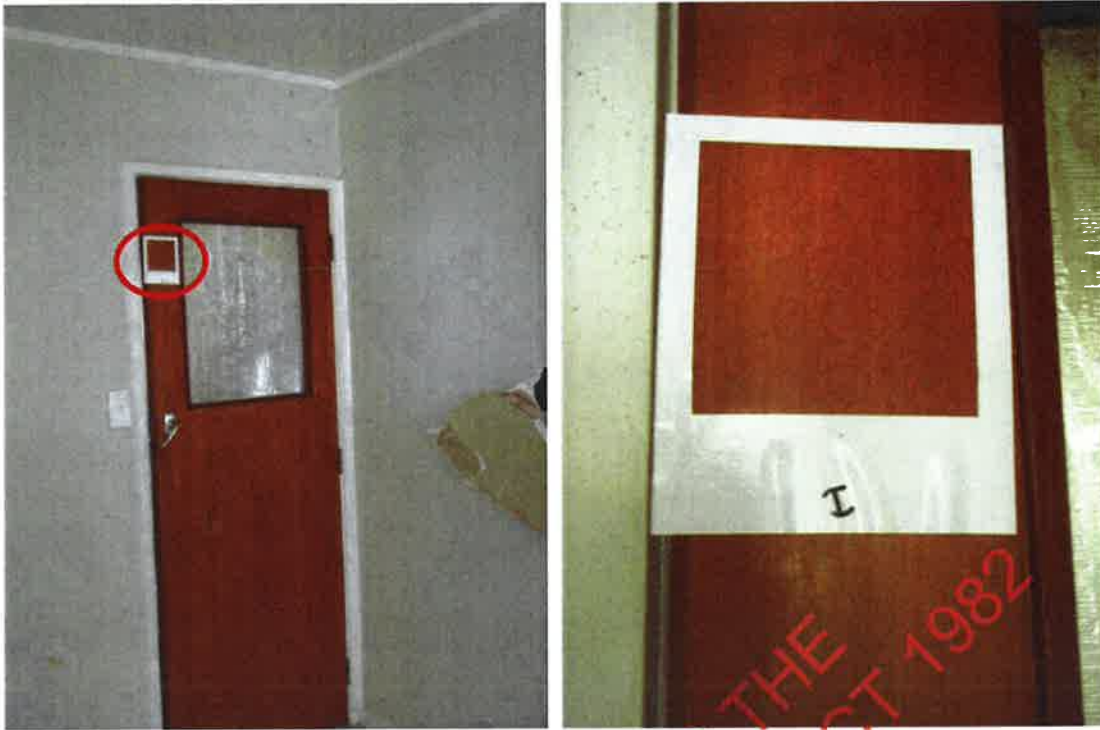
Living room 2 door: methamphetamine was detected on this surface at 9.04  $\mu\text{g}/100\text{cm}^2$ .

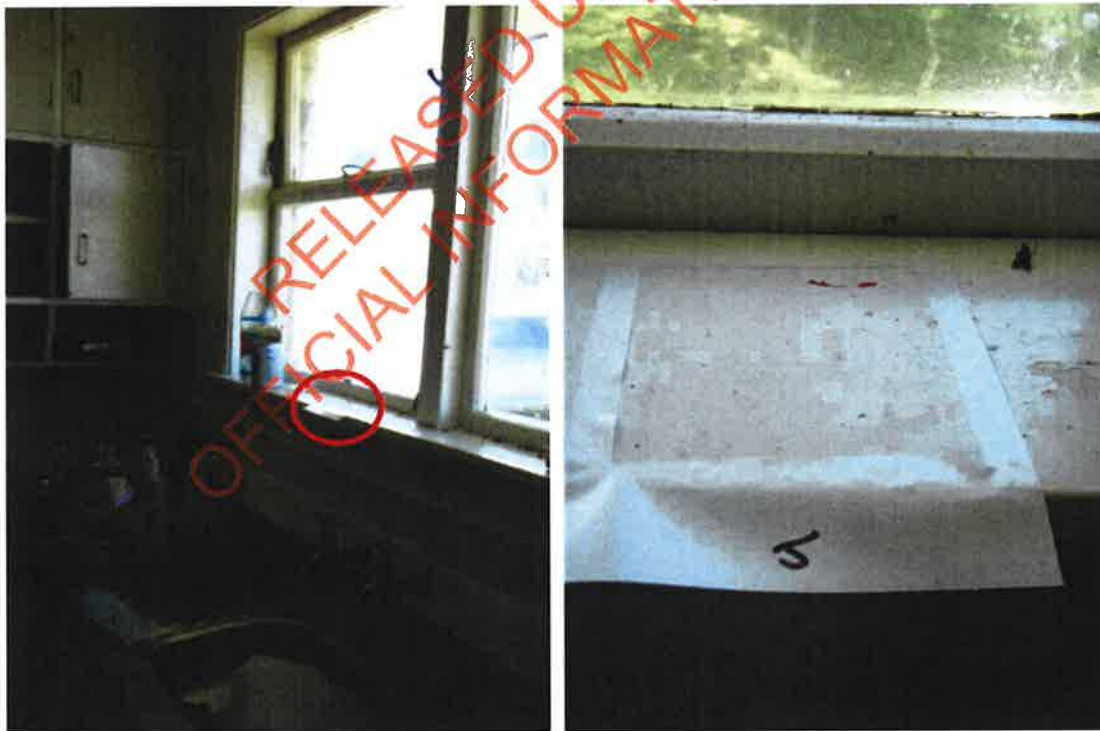
Kitchen window sill: methamphetamine was detected on this surface at 1.18  $\mu\text{g}/100\text{cm}^2$ .

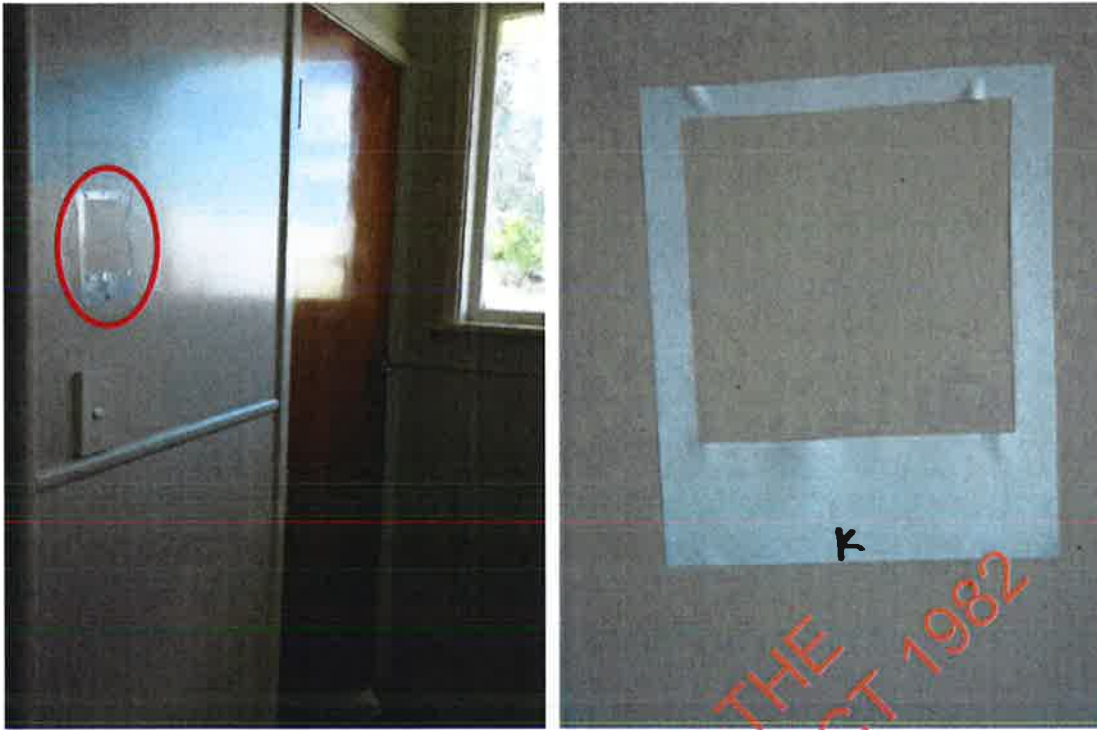
Laundry wall: methamphetamine was detected on this surface at 0.79  $\mu\text{g}/100\text{cm}^2$ .

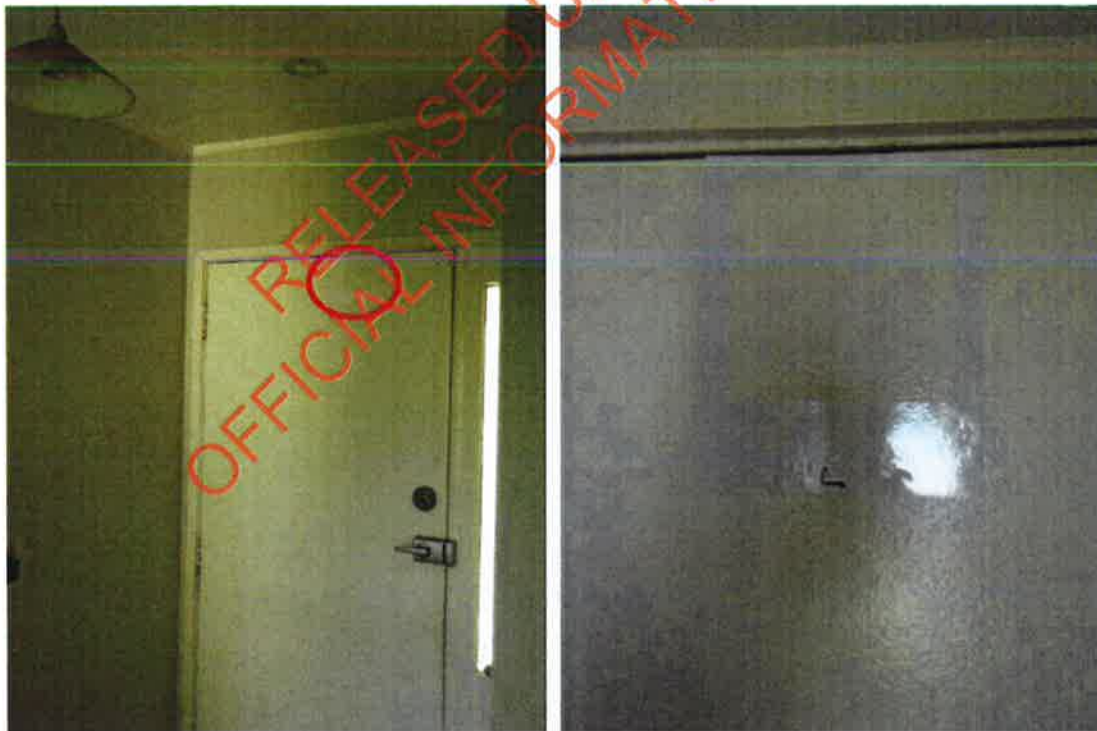
Entry door: methamphetamine was detected on this surface at 19.22  $\mu\text{g}/100\text{cm}^2$ .

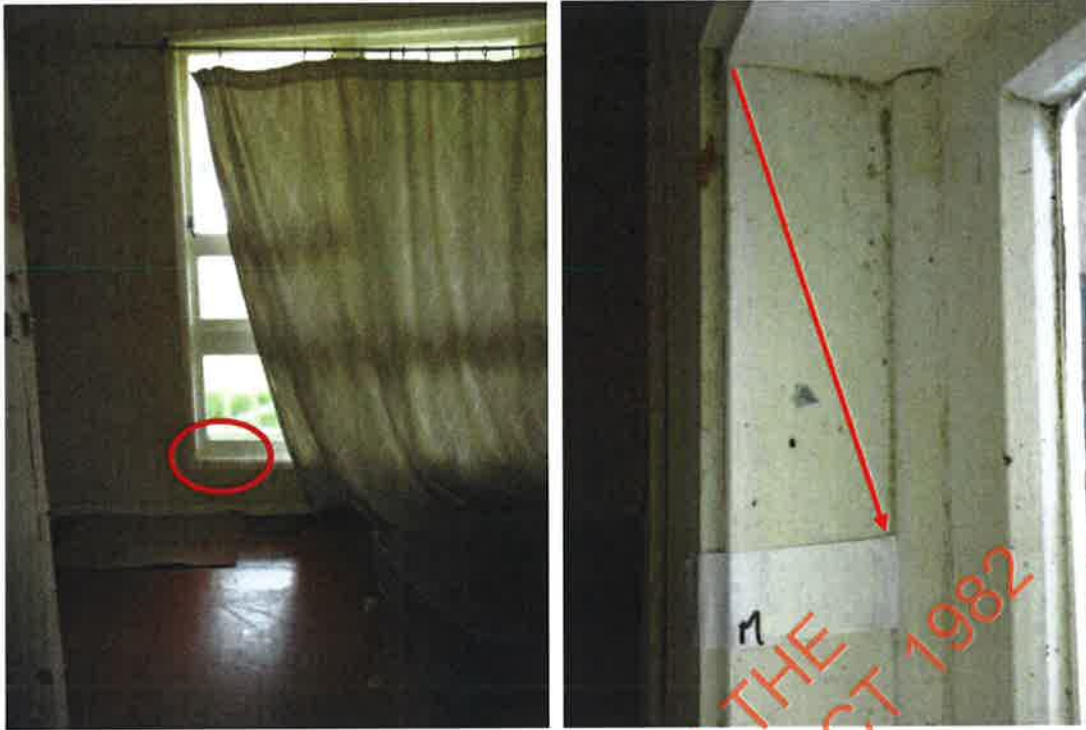
Living room 1 window sill: methamphetamine was detected on this surface at 8.69  $\mu\text{g}/100\text{cm}^2$ .

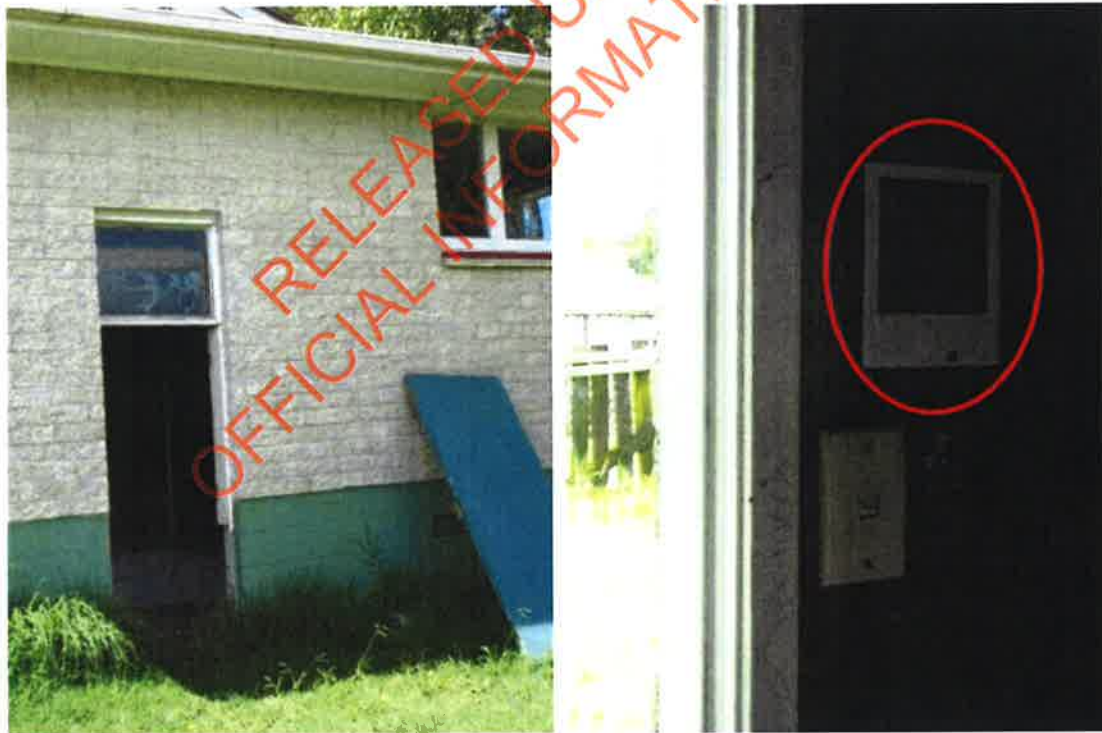
Storage room wall: methamphetamine was detected on this surface at a trace concentration.
