**Wellington Central Library, 101
Wakefield Street, Wellington**

Targeted Damage Evaluation Report
following the November 2016 Kaikoura
Earthquakes

Wellington City Council

15 February 2017

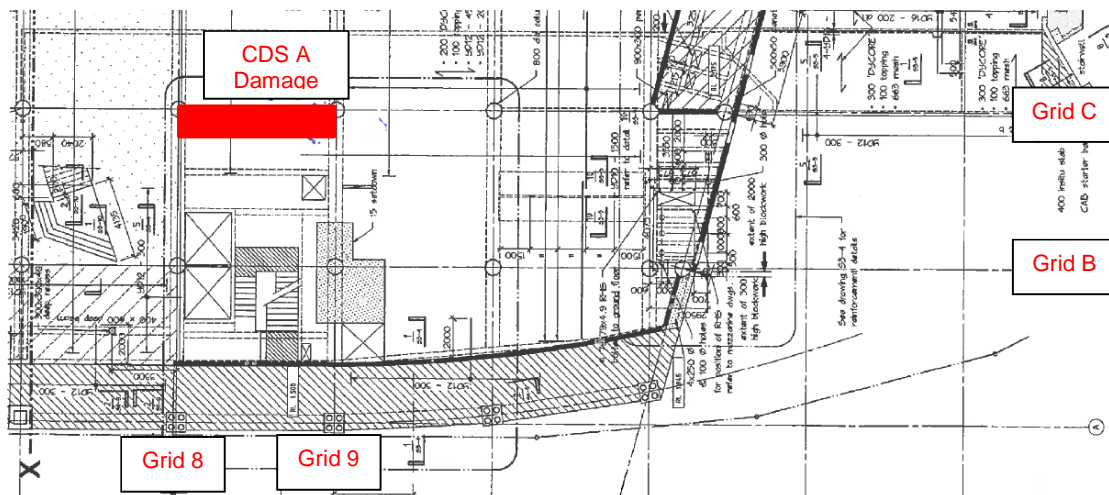
Figure 5 – Location of transverse crack to hollowcore ground floor unit

Only one crack is found on a single hollowcore precast unit to be of concern and classified as CDS A in accordance with the TDE Guidelines which will require repair work. This is a transverse crack across a hollowcore unit on ground level Grid 9/B-C. The dimension of the panel is 8m x 1.2m. Figure 5 shows the location.

Based on the extent and nature of the damage observed, we believe there is no need for the occupancy of the building to be changed. However, the area above and below the damaged hollowcore unit needs to be vacant until propping has been provided. Repair works are required to restore the integrity of the floor unit in one location.

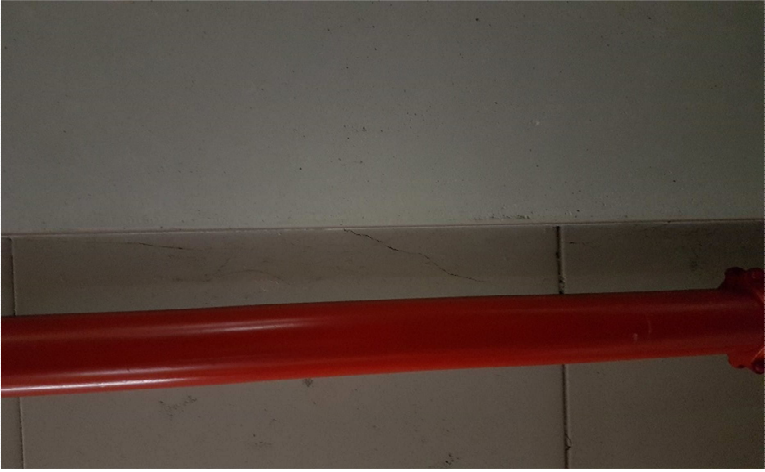
ID.	Location & comments	Photographs
1.	<p>Underside of Ground Floor Level Grid 3/B-C.</p> <p>Diagonal crack. This crack was existing as observed from a photo taken in 2013.</p>

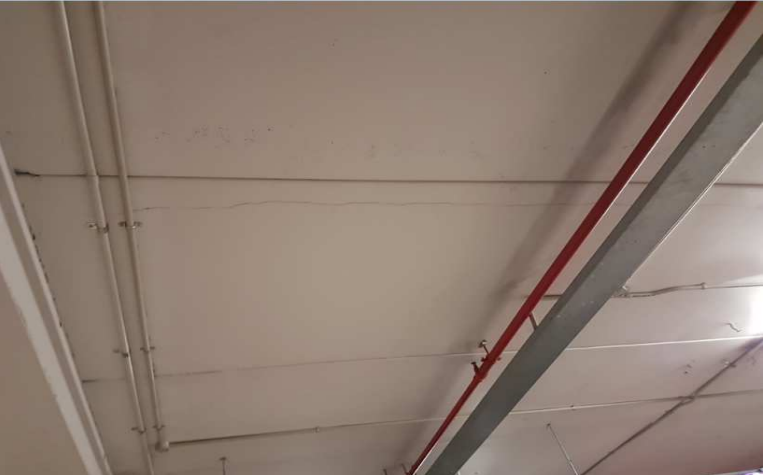
2.	<p>Underside of Ground Floor Level Grid 5/B-C.</p> <p>Longitudinal cracking in the direction of floor span. This crack was existing as observed from a photo taken in 2013.</p>

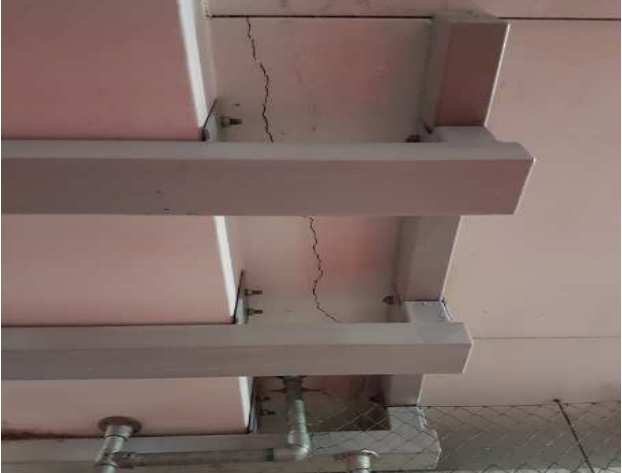
3.	<p>Underside of Ground Floor Level Grid 6/C.</p> <p>Transverse cracking (perpendicular to the direction of floor span). Occurred following the earthquakes in 2013. Support brackets provided.</p>

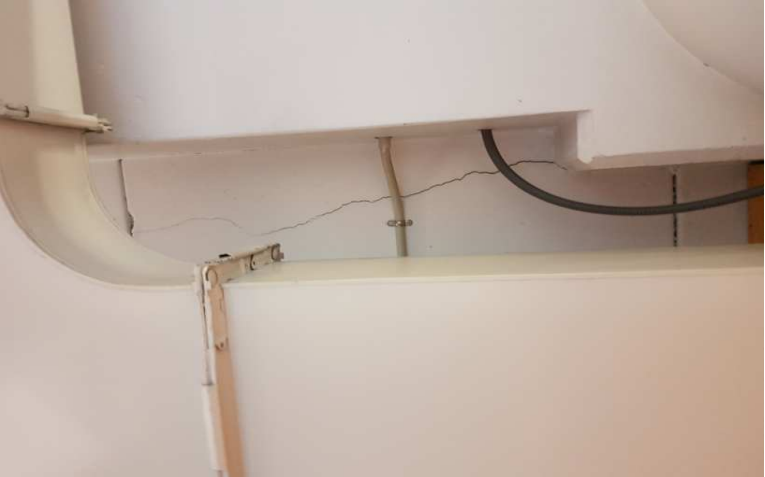
<p>4.</p>	<p>Underside of Ground Floor Level Grid 9/B-C. Significant transverse cracking (perpendicular to the direction of floor span). Its width range between 1 and 2 mm. The panel needs to be repaired.</p>

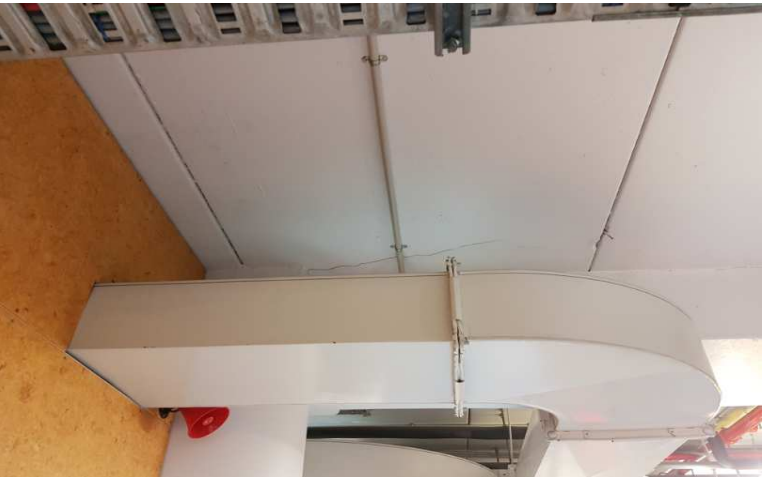
<p>5.</p>	<p>Underside of Ground Floor Level Grid 9/B-C. Significant transverse cracking (perpendicular to the direction of floor span). Its width range between 1 and 2 mm. The panel needs to be repaired.</p>

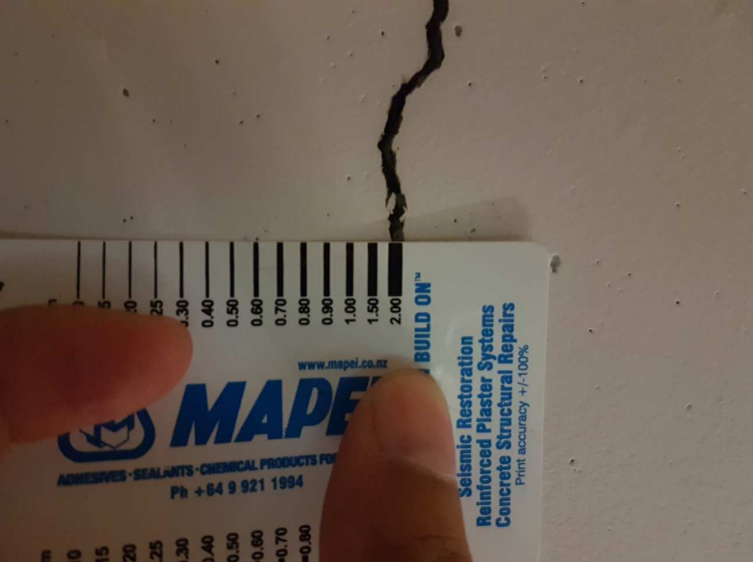
<p>6.</p>	<p>Underside of Ground Floor Level Grid 9/B-C. Significant transverse cracking (perpendicular to the direction of floor span). Its width range between 1 and 2 mm. The panel needs to be repaired.</p>

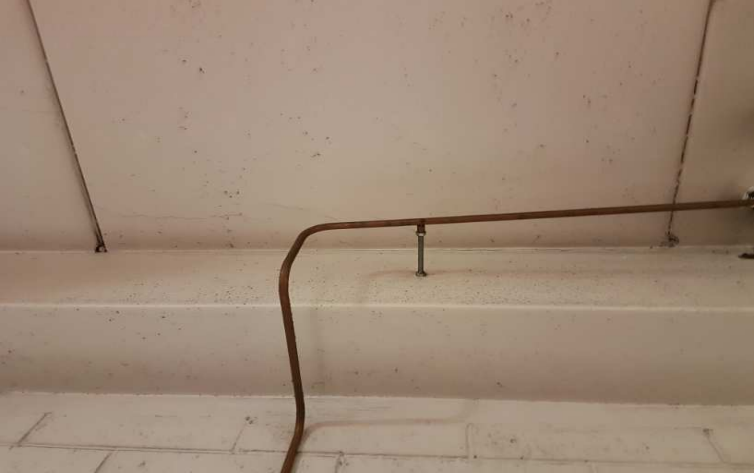
7.	<p>Underside of Ground Floor Level Grid 7/A-B.</p> <p>Transverse cracking (perpendicular to the direction of floor span). This crack was existing as observed from a photo taken in 2013.</p>

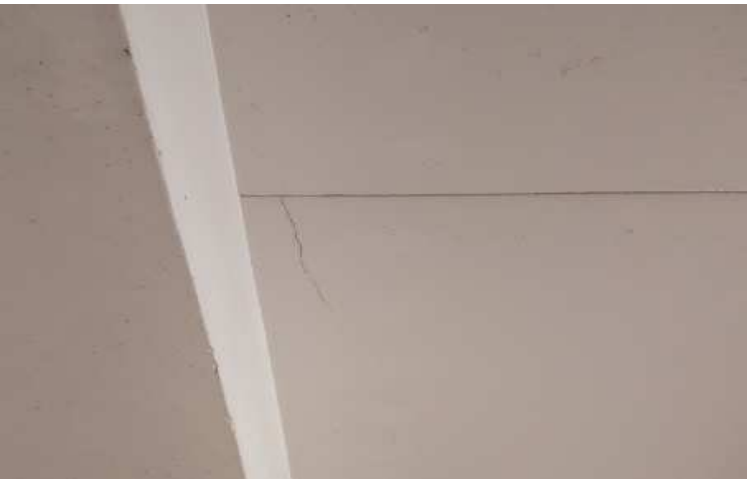
8.	<p>Underside of Ground Floor Level Grid 8/F.</p> <p>Transverse cracking (perpendicular to the direction of floor span). This crack was existing as observed from a photo taken in 2013.</p>

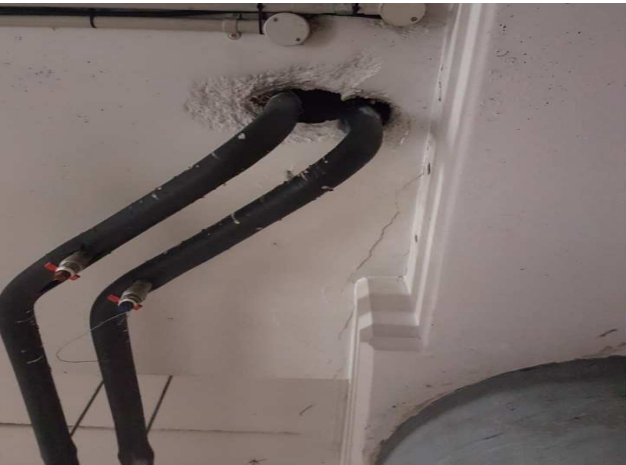
9.	<p>Underside of Ground Floor Level Grid 6/B.</p> <p>Diagonal cracking (perpendicular to the direction of floor span) adjacent to column. This crack was existing as observed from a photo taken in 2013.</p>

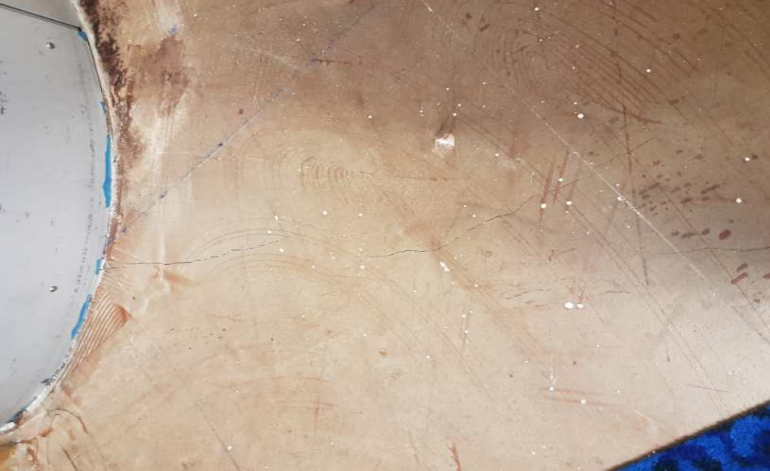
<p>10.</p>	<p>Ground Floor cracking adjacent to column near Grid 11/A.</p> <p>Crack width on the levelling compound less than 0.5mm.</p>

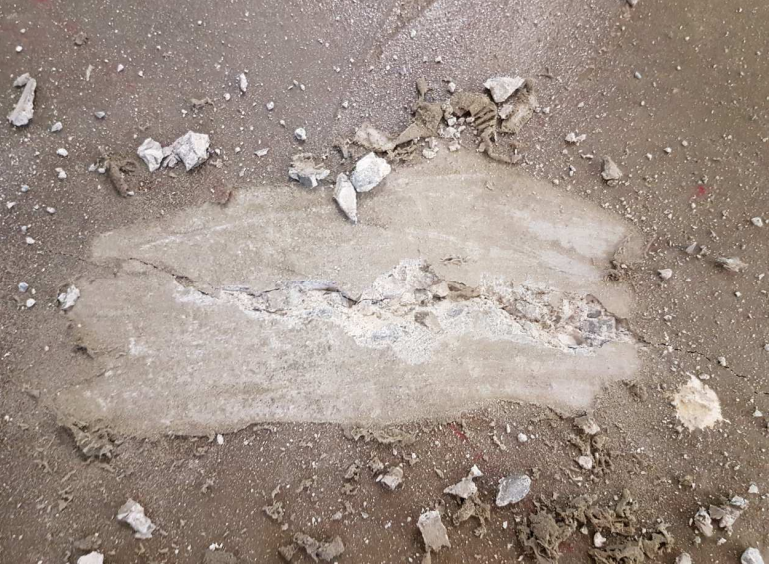
<p>11.</p>	<p>Second Floor cracking adjacent to column near Grid 11/A.</p> <p>Further investigations showed the crack to be only superficial.</p>

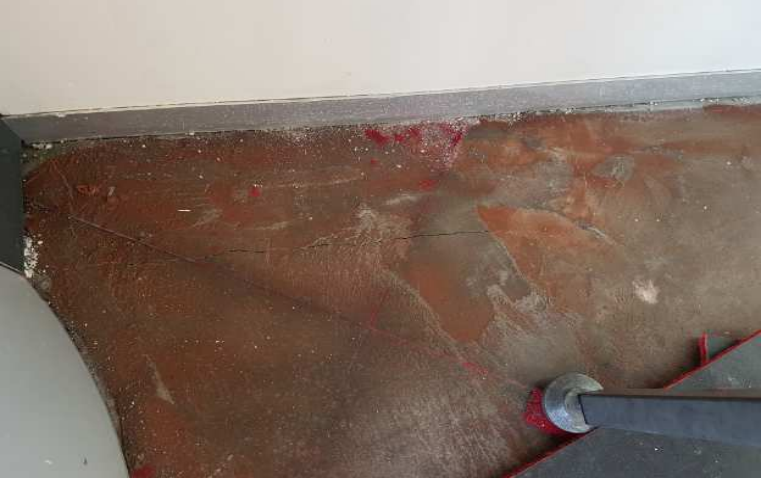
<p>12.</p>	<p>First Floor cracking adjacent to column on Grid 12/E.</p> <p>Those cracks behind the beams are not structural. They define the area above the bottom precast cladding connections.</p>

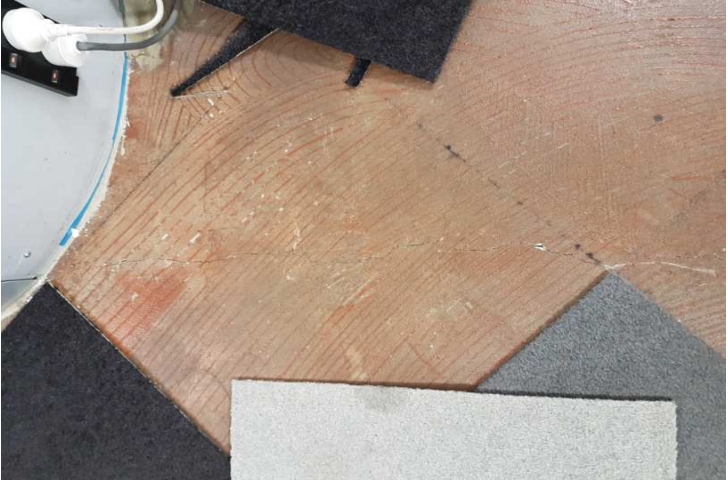
<p>16.</p>	<p>Second floor cracking adjacent to column on Grid 10/D.</p>

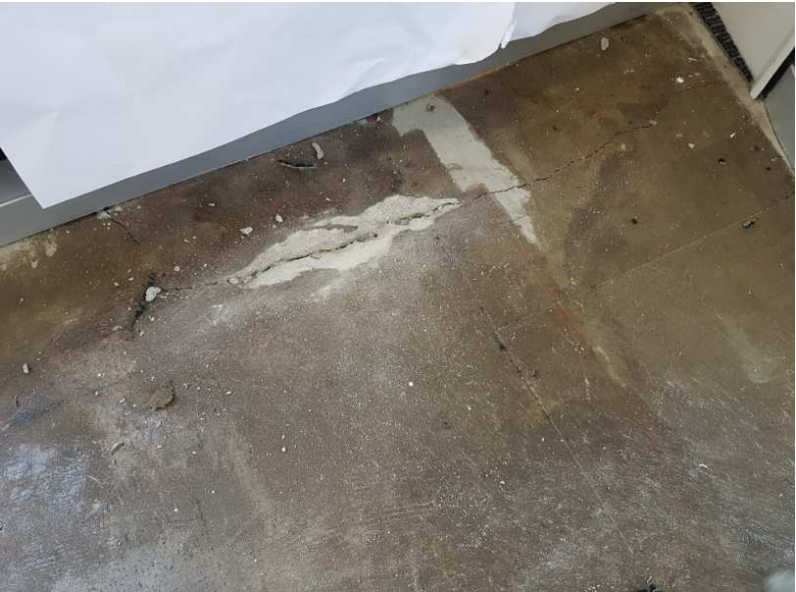
<p>17.</p>	<p>Fourth floor cracking on perimeter of building adjacent to precast panels Grid 2/C. Those cracks behind the beams are not structural. They define the area above the bottom precast cladding connections.</p>

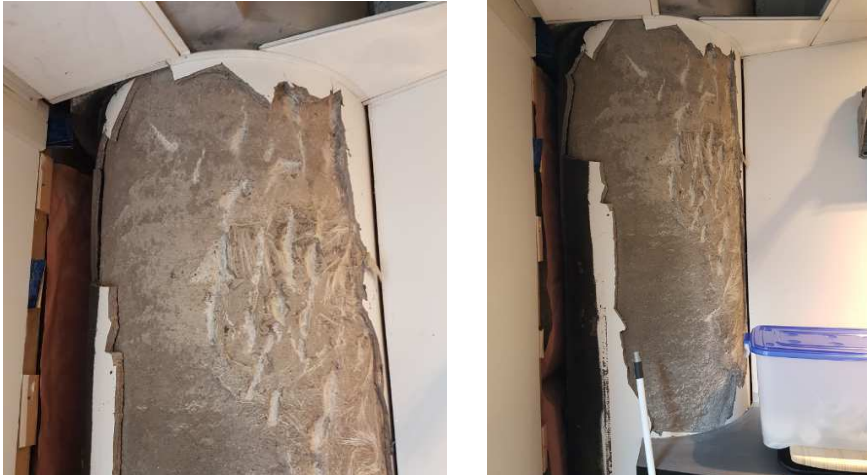
<p>18.</p>	<p>No signs of cracking to column on Grid 4/A on mezzanine level.</p>

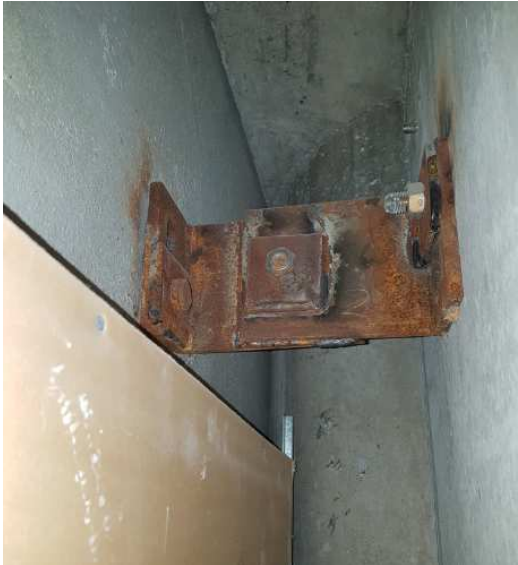
19.	No signs of earthquake damage to precast panels connections on fourth level Grid 2-3/C.

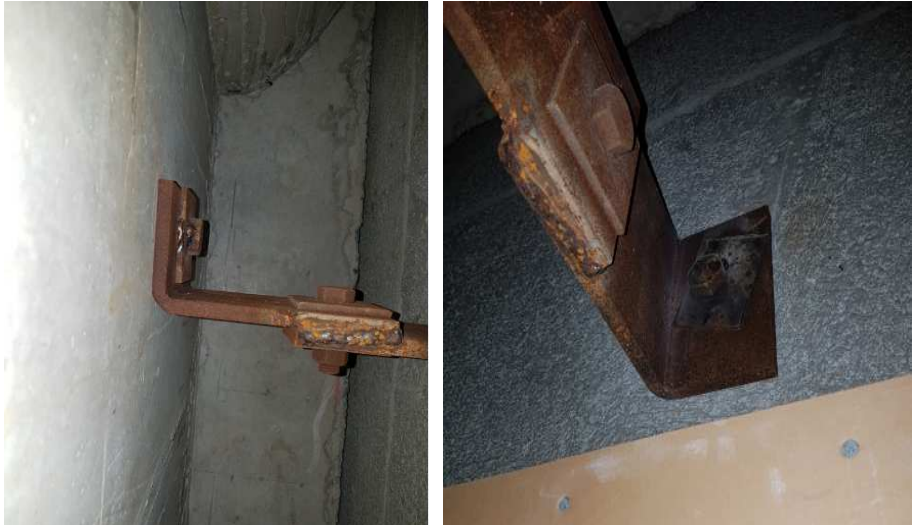
20.	No signs of earthquake damage to precast panels connections on third level Grid 10-11/A.

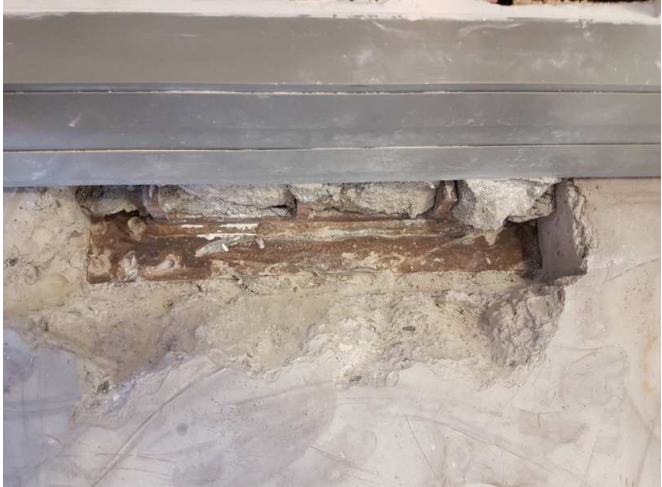
21.	Extrusive investigation of third level slab at precast panel junction on Grid 11/A indicating no significant signs of earthquake damage.

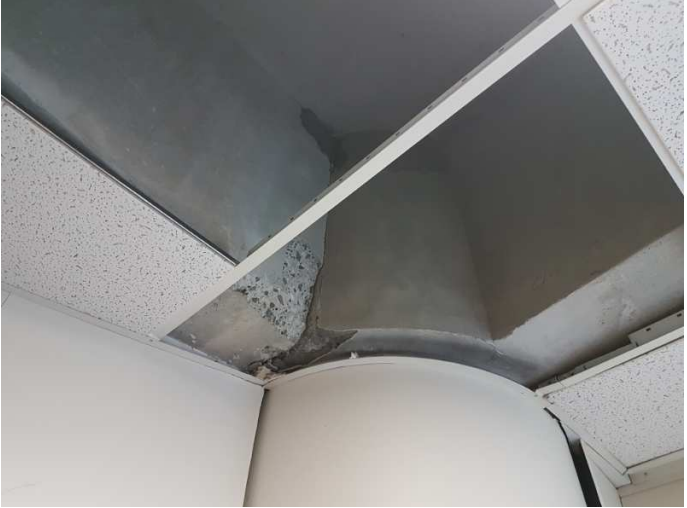
22.	Minor spalling to mezzanine level reinforced concrete beam on Grid 4/A.

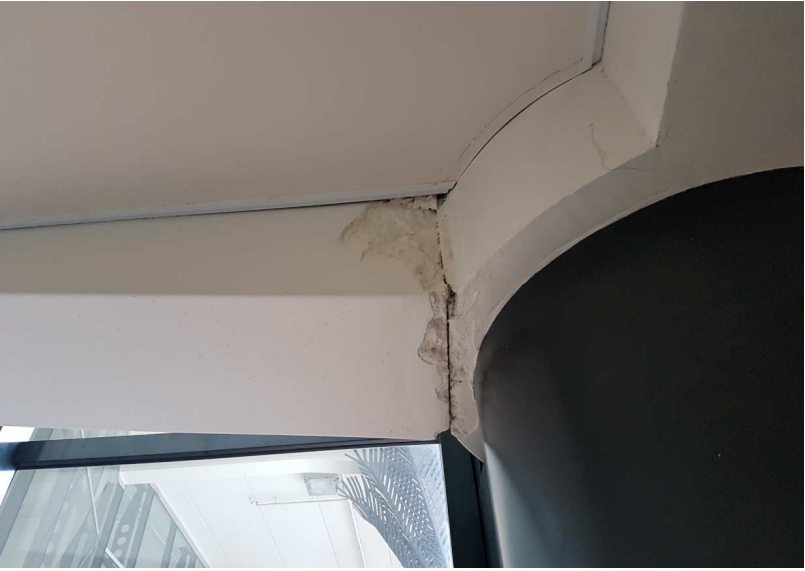
23.	No signs of recent earthquake damage to mezzanine level reinforced concrete beam on Grid 5/A.

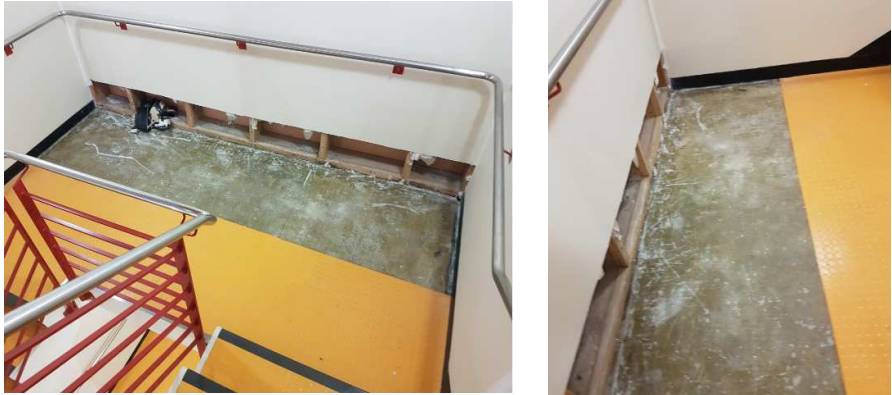
24.	No significant signs of earthquake damage to stair landing between third and fourth floor levels in south core stairwell.

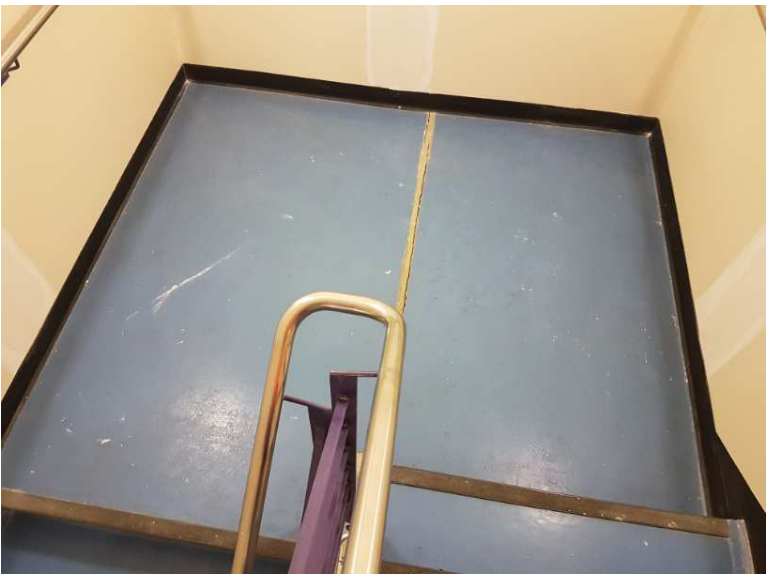
<p>25.</p>	<p>Gap opening of joint between stair units in Harris Street end stairwell.</p>

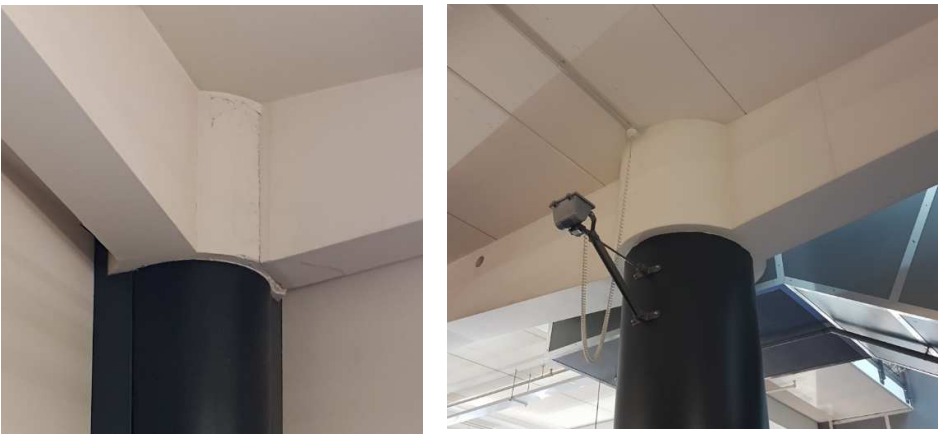
<p>26.</p>	<p>No notable earthquake damage to ground floor columns and beams.</p>

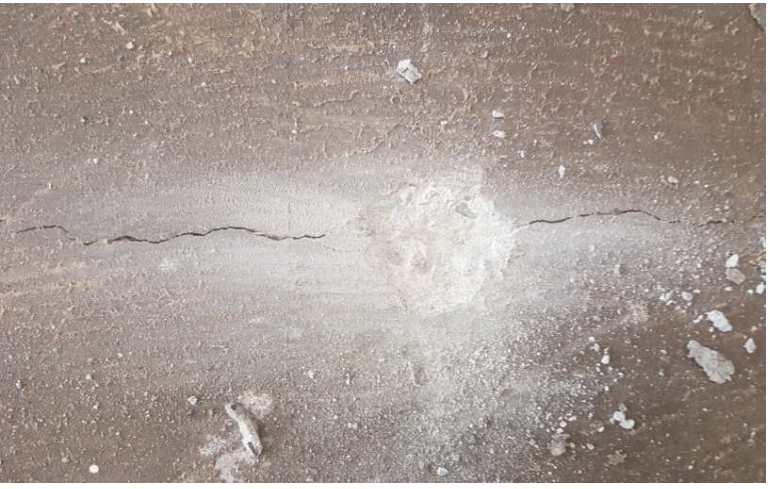
<p>27.</p>	<p>Superficial crack to ground floor on Grid 4/E-F</p>

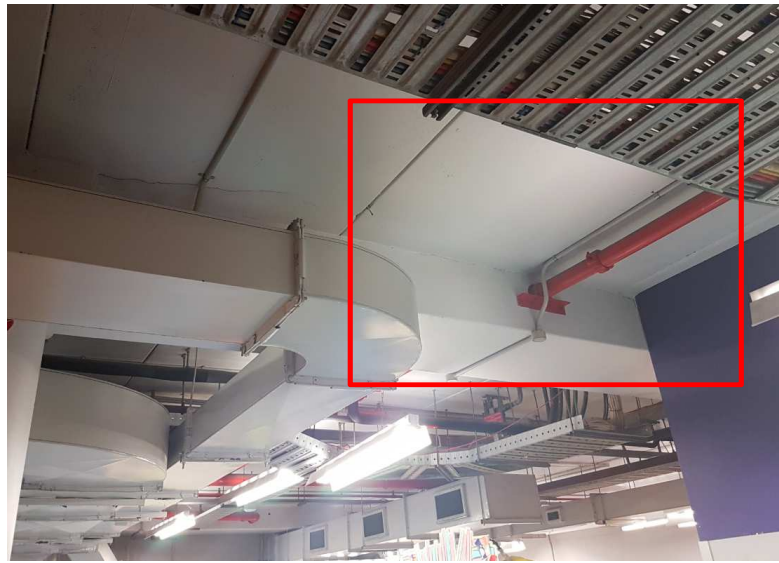
31. Ground floor panels near Grid 9-10/B.

No crack observed in the area inside the red square.
