Thorpe Road

(SH1 RP664/6258–6530)

Central Waikato Network Outcome Contract

Pavement Renewal Report

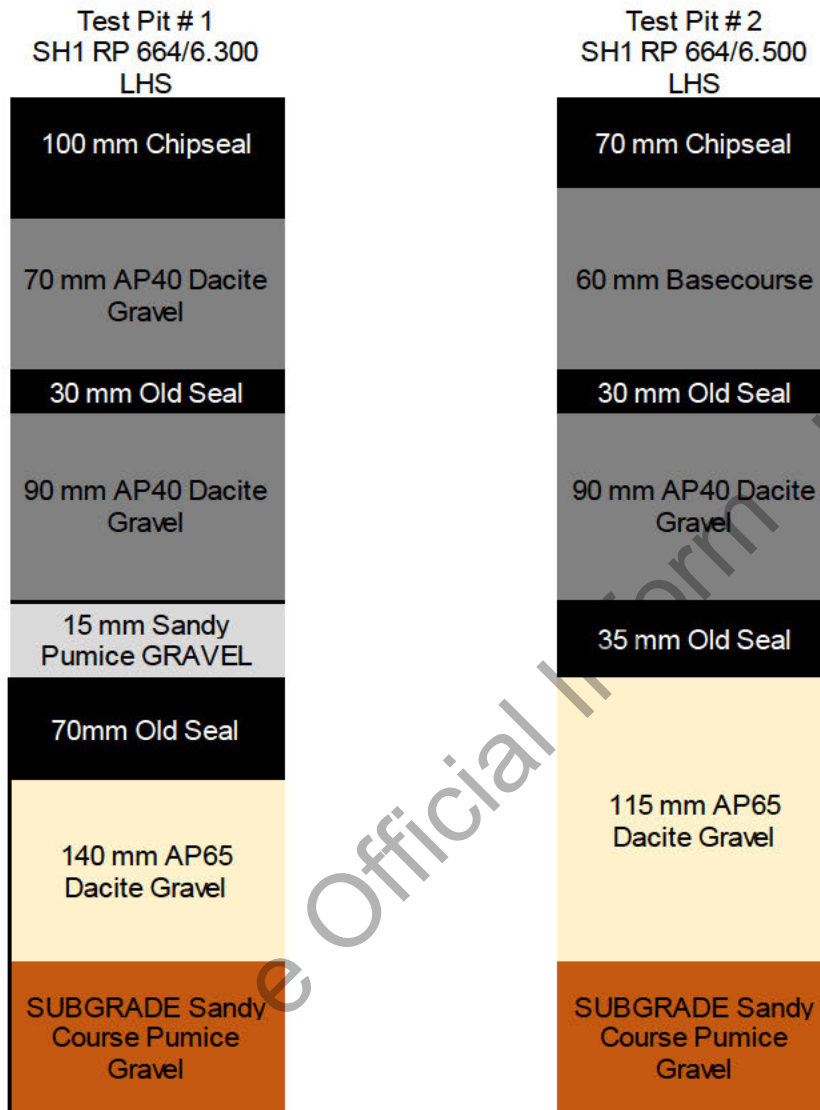
Test pits (see Figure below) show 550mm cover to a pumice subgrade where the top 100mm is existing unstable seal layers. The insitu aggregate is Dacite AP40 and the RLT test found to have very poor rut resistance. This poor rut resistance of the insitu Dacite aggregate at 6.6% moisture content (considered dry) governed the design resulting in thick granular overlays to prevent the Dacite from rutting.

There is evidence of water trapped between the seal layers and a preference is given to removing the seal layers.

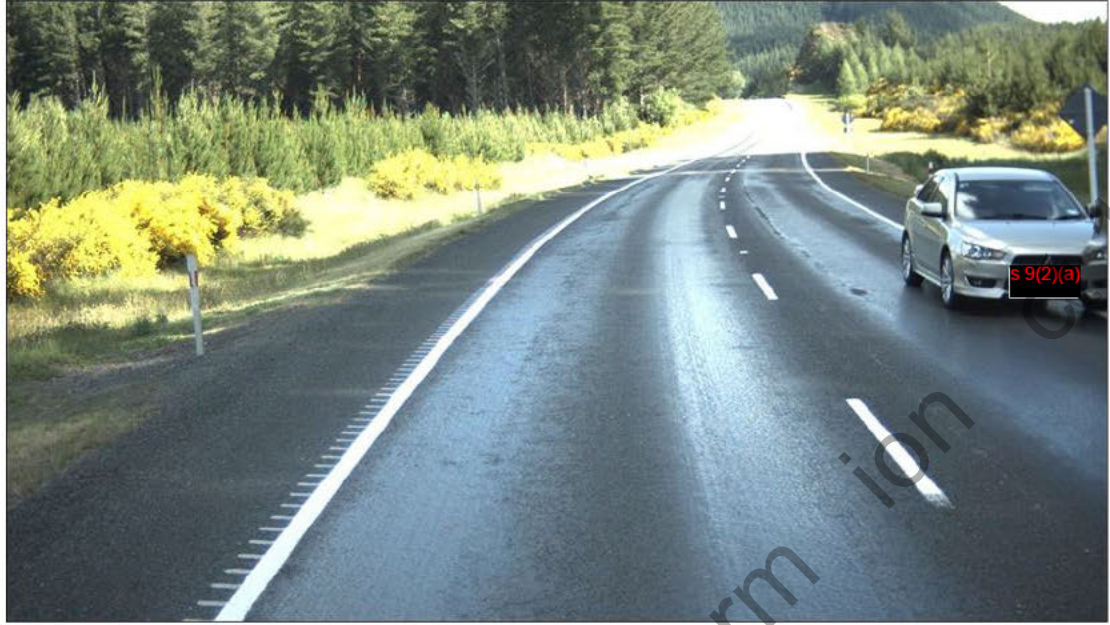
Figure 2a: Photo showing Thorpe Rd Site on SH1 (looking north)

- The surface comprises of multiple chipseal layers that soften in warm weather.
- Flushing is in all four wheel tracks (Figure 2).
- In some areas the flushed chipseal has stuck to tyres and strips removed from the wheel tracks (Figure 3).
- The geometric alignment is straight (relatively horizontal) with a large radius curve.
- The posted speed limit is 100 km/hr.
- This site has had multiple seals due to short lives obtained caused by flushing. Latest sandwich seal applied in December 2015 flushed within a month.
- Recent multiple fatality crash site combined with short seal life due to multiple soft seal layers prompted this pavement renewal design to ensure the applied chipseal surface will have sufficient texture depth to maintain skid resistance.

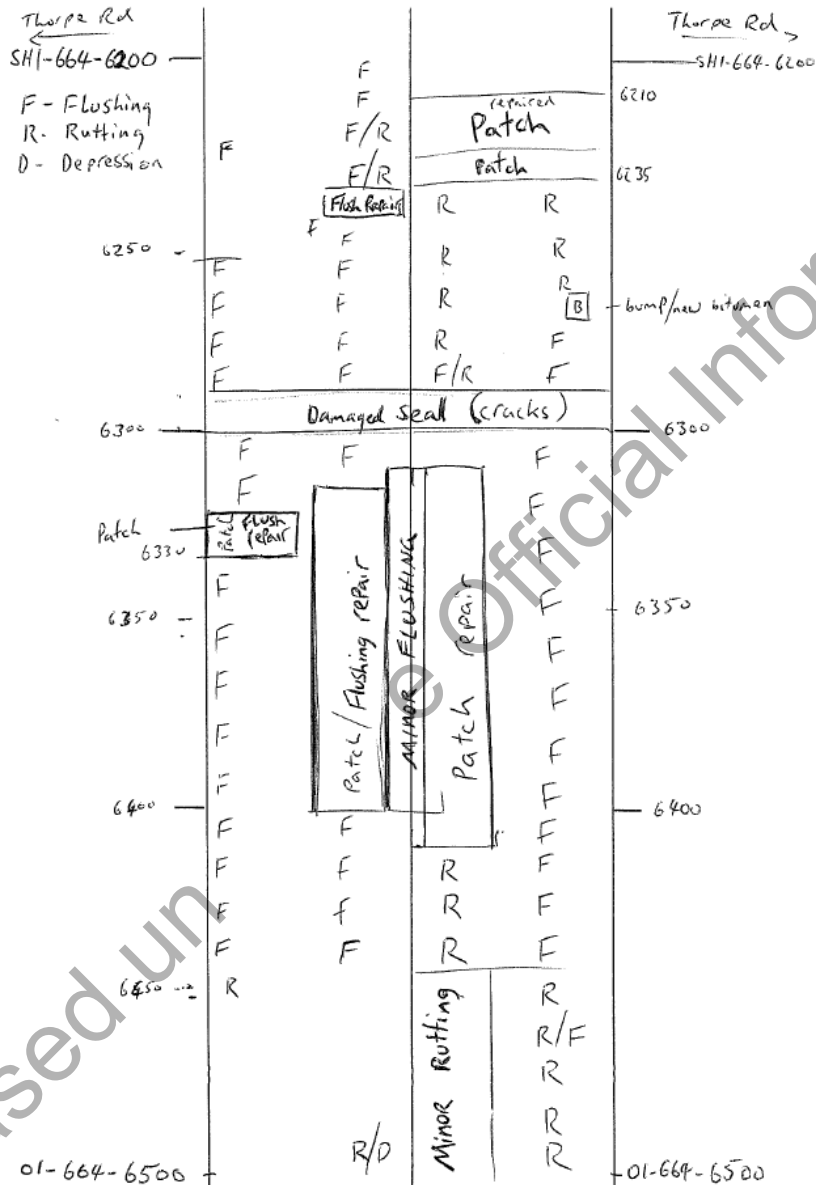
A walk-over on the site was carried out, defects were continuous wheel track flushing and some seal loss due to the seal sticking to the tyres.

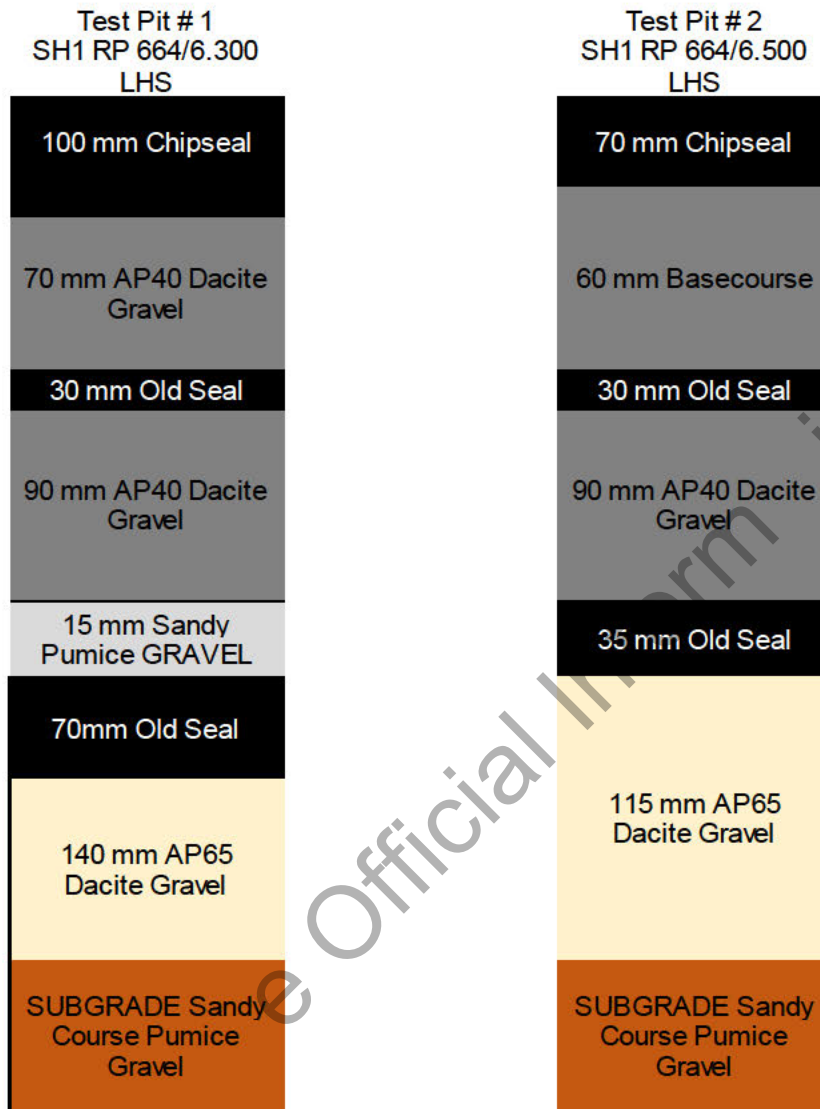
Figure 6 Test pit Summary

- 70 to 100 mm flushed and soft chipseal surfacing layers
- 70 mm of AP40 basecourse aggregates (Dacite)
- 30 mm of old seal
- 90 mm of AP40 basecourse aggregates (Dacite)
- 35 to 75 mm of old seal
- 115 mm to 140 mm AP65 subbase aggregate (Dacite)
- Subgrade (Pumice).
- Total pavement thickness (includes seal layers) of 550mm with a scala measured subgrade CBR >13% (*note as the subgrade is pumice it is likely the modulus based on back calculated Falling Weight Deflectometer testing is 30 to 50 MPa*)

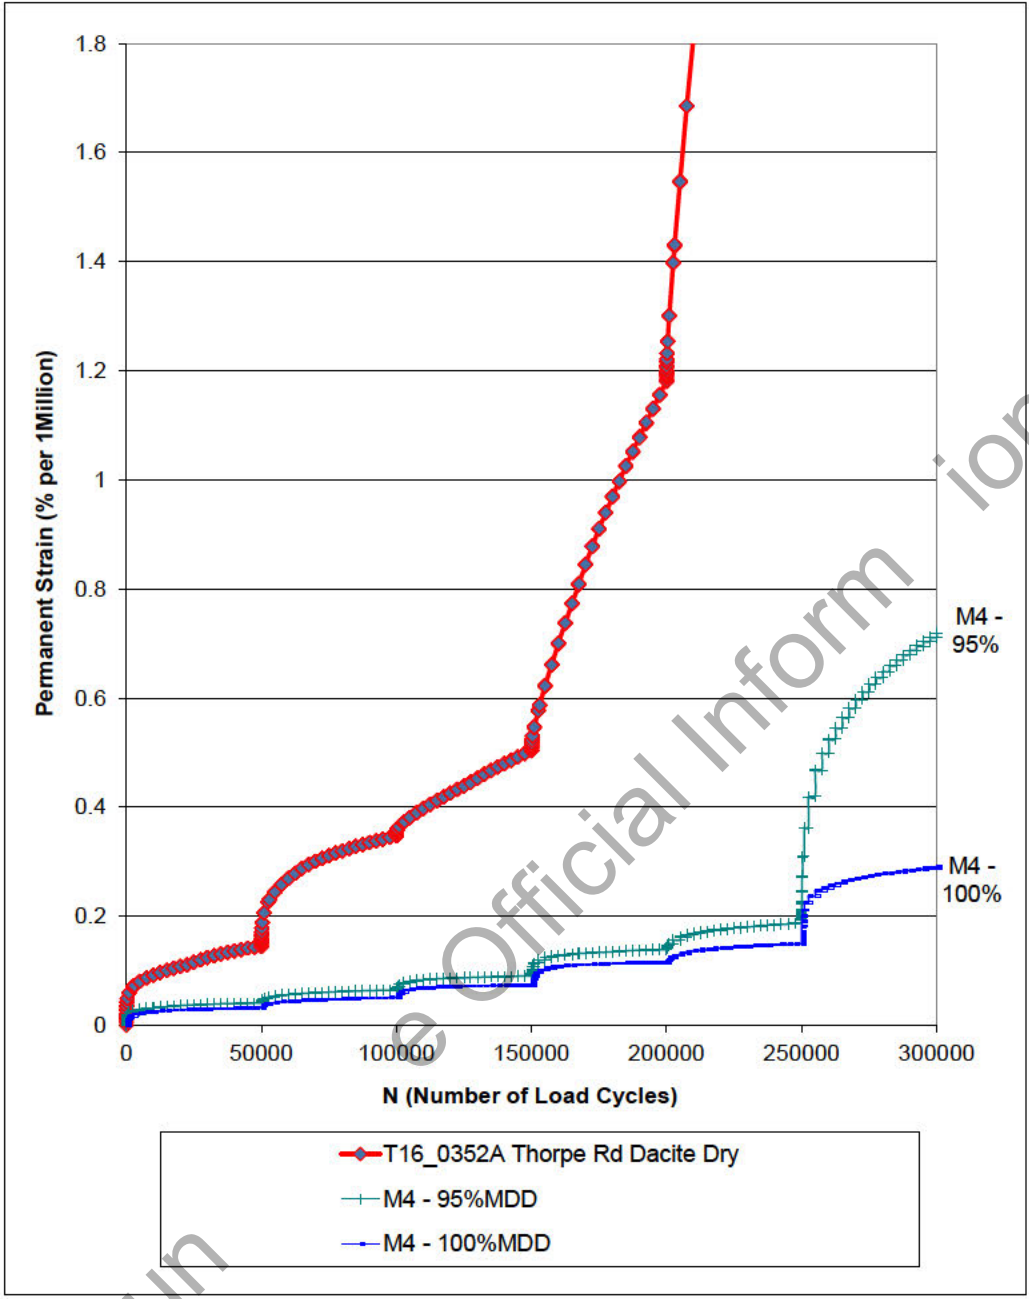
Figure 7 Raw RLT Test Result for Insitu Dacite Basecourse

The raw RLT result when tested in dry conditions of the AP40 Dacite Gravel sampled from the road is shown in Figure 7. As can be seen this is a very poor result and rutting failure of this aggregate is highly likely if the 100mm seal layer is removed.

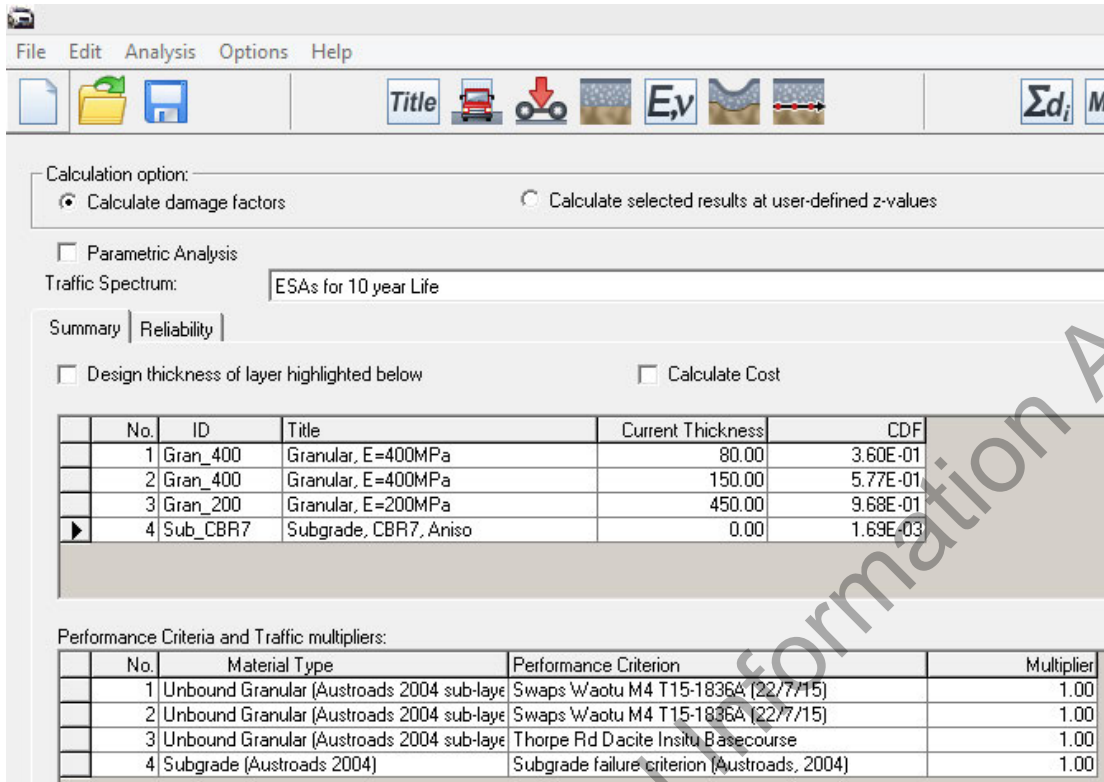
Figure – CIRCLY analysis 10 year life

Results of this CIRCLY analysis for a 10 and a 25 year life are detailed below. The analysis shows that 230mm is needed for a 10 year life before the underlying Dacite aggregate ruts based on a CDF of 1. A 25 year life requires 320mm to ensure the underlying Dacite and pavement will last for 25 years. It should be noted that over a 25 year life the imported NZTA M4 AP40 aggregate from Waotu quarry will have rutted (CDF around 1.2).

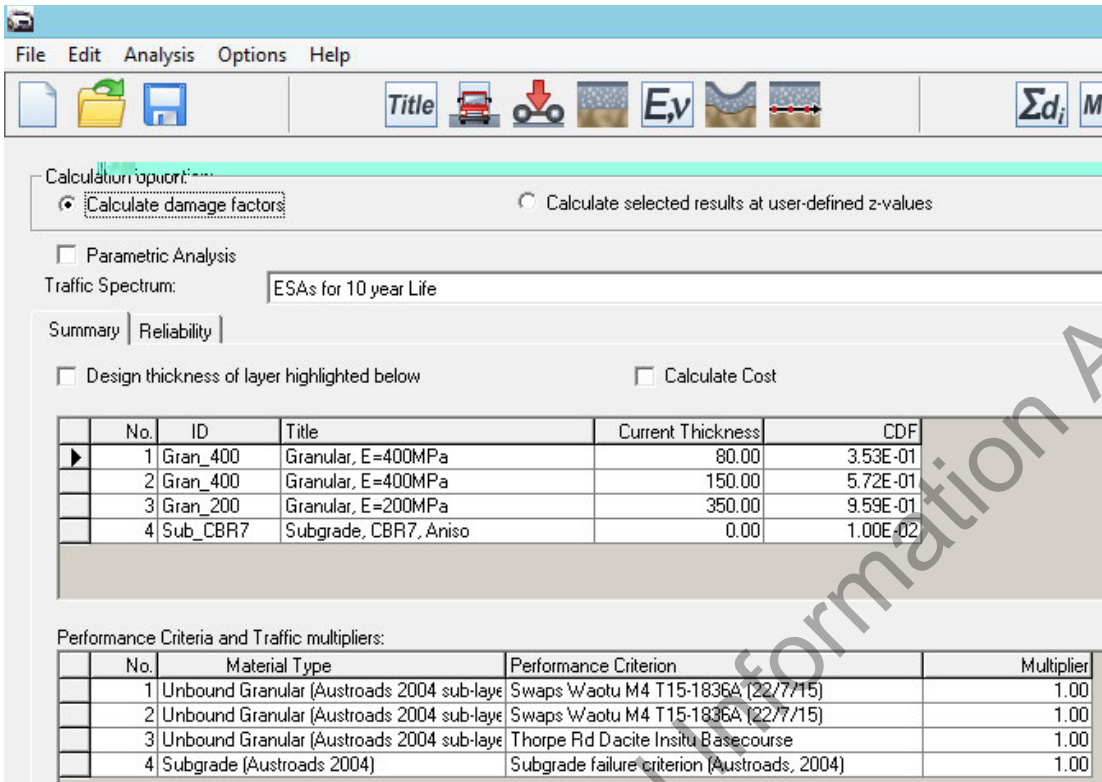
Figure – CIRCLY analysis for 10 year life

Results of this CIRCLY analysis for a 10 and a 25 year life are detailed below. The analysis shows that 230mm is needed for a 10 year life before the underlying Dacite aggregate ruts based on a CDF of 1. A 25 year life requires 320mm to ensure the underlying Dacite and pavement will last for 25 years. It should be noted that over a 25 year life the imported NZTA M4 AP40 aggregate from Waotu quarry will have rutted (CDF around 1.2).
