Asbestos Management Survey Report

**WHANGANUI HOSPITAL
OLD LAUNDRY**

OLD LAUNDRY-EXTERIOR & INTERNAL

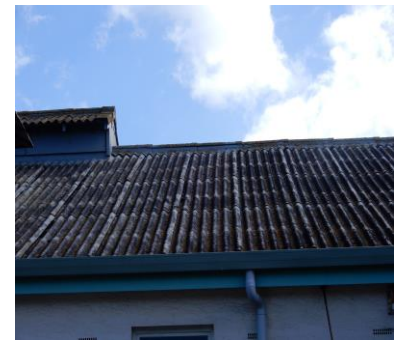
ID: CARD NO:001

Photograph No.	1
Location/Area	Exterior: Roof
Suspected Material Identified	ACM Roofing Material
Condition of Material Identified	Weathered
Categories: (Assessment type). 1: ACM common characteristics or 2: Presumed ACM or 3: Sample collected for analysis	1: ACM common characteristics
Sample No.	Sample Not Taken
Laboratory Analysis Findings	Analysis Not Conducted
Quantity of Material Identified	936.0m2

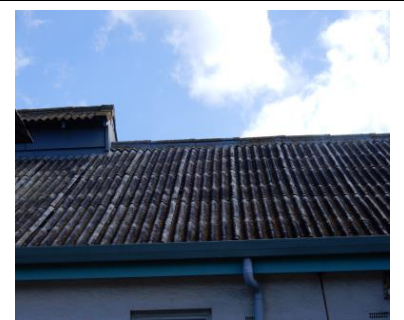
ID: CARD NO:002

Photograph No.	2
Location/Area	Exterior: Gable Ends
Suspected Material Identified	ACM Board
Condition of Material Identified	Weathered
Categories: (Assessment type). 1: ACM common characteristics or 2: Presumed ACM or 3: Sample collected for analysis	2: Presumed ACM
Sample No.	Sample Not Taken
Laboratory Analysis Findings	Analysis Not Conducted
Quantity of Material Identified	16.0m2

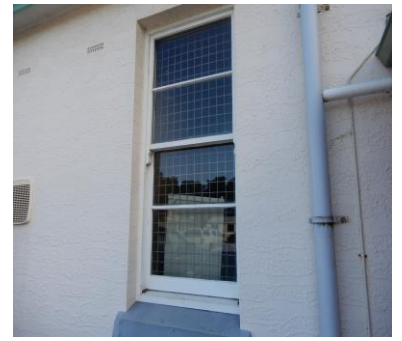
ID: CARD NO:003

Photograph No.	3
Location/Area	Exterior: Windows Frame
Suspected Material Identified	Putty Compound
Condition of Material Identified	Weathered
Categories: (Assessment type). 1: ACM common characteristics or 2: Presumed ACM or 3: Sample collected for analysis	2: Presumed ACM
Sample No.	Sample Not Taken
Laboratory Analysis Findings	Analysis Not Conducted
Quantity of Material Identified	224.0L/M

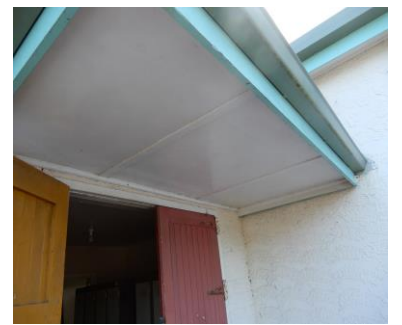
ID: CARD NO:004

Photograph No.	4
Location/Area	Exterior: Entry (Walls)
Suspected Material Identified	ACM Board
Condition of Material Identified	Good
Categories: (Assessment type). 1: ACM common characteristics or 2: Presumed ACM or 3: Sample collected for analysis	2: Presumed ACM
Sample No.	Sample Not Taken
Laboratory Analysis Findings	Analysis Not Conducted
Quantity of Material Identified	3.0m2

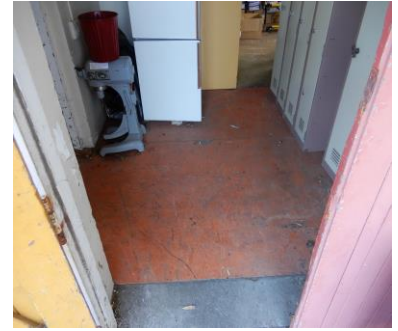
ID: CARD NO:005

Photograph No.	5
Location/Area	Internal: Entry
Suspected Material Identified	Vinyl Flooring
Condition of Material Identified	Good
Categories: (Assessment type). 1: ACM common characteristics or 2: Presumed ACM or 3: Sample collected for analysis	2: Presumed ACM
Sample No.	Sample Not Taken
Laboratory Analysis Findings	Analysis Not Conducted
Quantity of Material Identified	8.75m2

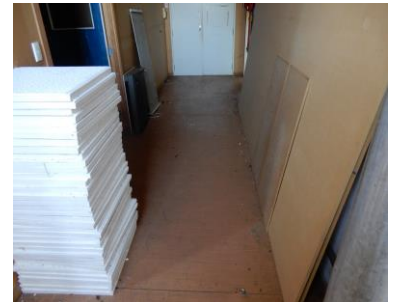
ID: CARD NO:006

Photograph No.	6
Location/Area	Internal: Hallway
Suspected Material Identified	Vinyl Flooring
Condition of Material Identified	Good
Categories: (Assessment type). 1: ACM common characteristics or 2: Presumed ACM or 3: Sample collected for analysis	2: Presumed ACM
Sample No.	Sample Not Taken
Laboratory Analysis Findings	Analysis Not Conducted
Quantity of Material Identified	18.0m2

006		Internal: Hallway (Floor)	2	18.0m2	Vinyl Flooring	Vinyl/Backing resin	1	0	0	1	0	0	0	0	0	0	0	Very low risk	Complete a Risk Assessment.
007		Internal: Hallway 2 (Floor)	2	6.0m2	Vinyl Flooring	Vinyl/Backing resin	1	0	0	1	0	0	0	0	0	0	0	Very low risk	Complete a Risk Assessment.
008		Internal: Bathroom (Floor)	2	18.0m2	Vinyl Flooring	Vinyl/Backing resin	1	0	0	1	0	0	0	0	0	0	0	Very low risk	Complete a Risk Assessment.
009		Internal: Storage Room (Floor)	2	12.0m2	Vinyl Flooring	Vinyl/Backing resin	1	0	0	1	0	0	0	0	0	0	0	Very low risk	Complete a Risk Assessment.
010		Internal: Storage Room (Floor)	2	9.0m2	Vinyl Flooring	Vinyl/Backing resin	1	0	0	1	0	0	0	0	0	0	0	Very low risk	Complete a Risk Assessment.

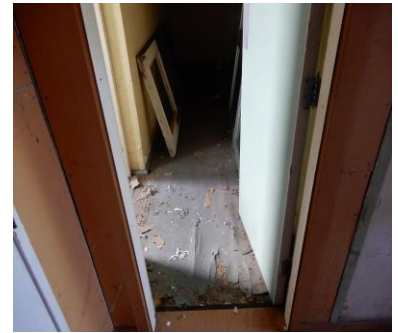
ID: CARD NO:007

Photograph No.	7
Location/Area	Internal: Hallway 2
Suspected Material Identified	Vinyl Flooring
Condition of Material Identified	Good
Categories: (Assessment type). 1: ACM common characteristics or 2: Presumed ACM or 3: Sample collected for analysis	2: Presumed ACM
Sample No.	Sample Not Taken
Laboratory Analysis Findings	Analysis Not Conducted
Quantity of Material Identified	6.0m2

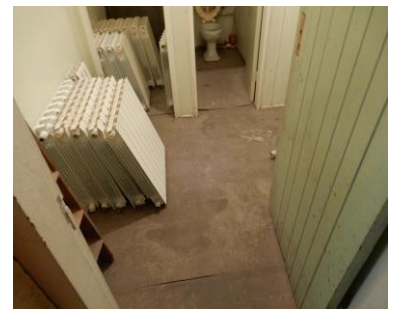
ID: CARD NO:008

Photograph No.	8
Location/Area	Internal: Bathroom
Suspected Material Identified	Vinyl Flooring
Condition of Material Identified	Damaged
Categories: (Assessment type). 1: ACM common characteristics or 2: Presumed ACM or 3: Sample collected for analysis	2: Presumed ACM
Sample No.	Sample Not Taken
Laboratory Analysis Findings	Analysis Not Conducted
Quantity of Material Identified	18.0m2

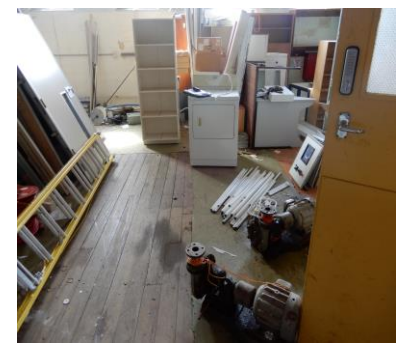
ID: CARD NO:009

Photograph No.	9
Location/Area	Internal: Storage Room
Suspected Material Identified	Vinyl Flooring
Condition of Material Identified	Damaged
Categories: (Assessment type). 1: ACM common characteristics or 2: Presumed ACM or 3: Sample collected for analysis	2: Presumed ACM
Sample No.	Sample Not Taken
Laboratory Analysis Findings	Analysis Not Conducted
Quantity of Material Identified	12.0m2

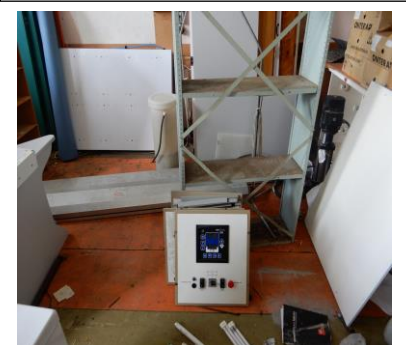
ID: CARD NO:010

Photograph No.	10
Location/Area	Internal: Storage Room
Suspected Material Identified	Vinyl Flooring
Condition of Material Identified	Good
Categories: (Assessment type). 1: ACM common characteristics or 2: Presumed ACM or 3: Sample collected for analysis	2: Presumed ACM
Sample No.	Sample Not Taken
Laboratory Analysis Findings	Analysis Not Conducted
Quantity of Material Identified	9.0m2

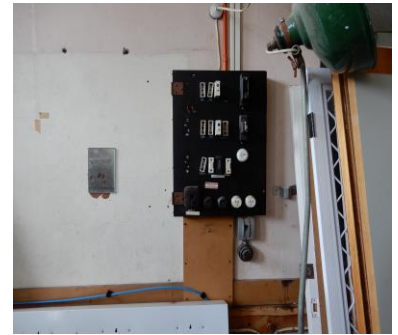
ID: CARD NO:011

Photograph No.	11
Location/Area	Internal: Storage Room
Suspected Material Identified	Fuse Board
Condition of Material Identified	Good
Categories: (Assessment type). 1: ACM common characteristics or 2: Presumed ACM or 3: Sample collected for analysis	2: Presumed ACM
Sample No.	Sample Not Taken
Laboratory Analysis Findings	Analysis Not Conducted
Quantity of Material Identified	.800m2

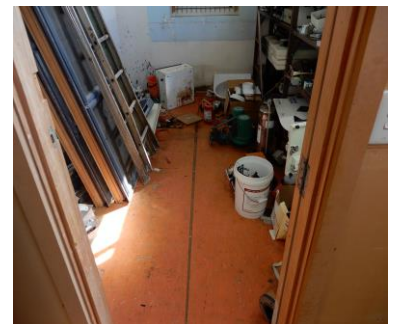
ID: CARD NO:012

Photograph No.	12
Location/Area	Internal: Storage Room- Cupboard
Suspected Material Identified	Vinyl Flooring
Condition of Material Identified	Good
Categories: (Assessment type). 1: ACM common characteristics or 2: Presumed ACM or 3: Sample collected for analysis	2: Presumed ACM
Sample No.	Sample Not Taken
Laboratory Analysis Findings	Analysis Not Conducted
Quantity of Material Identified	8.0m2

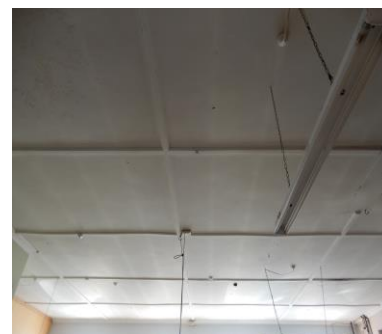
ID: CARD NO:013

Photograph No.	13
Location/Area	Internal: Storage Room (Ceiling)
Suspected Material Identified	Lath & Plaster
Condition of Material Identified	Good
Categories: (Assessment type). 1: ACM common characteristics or 2: Presumed ACM or 3: Sample collected for analysis	2: Presumed ACM
Sample No.	Sample Not Taken
Laboratory Analysis Findings	Analysis Not Conducted
Quantity of Material Identified	39.0m2

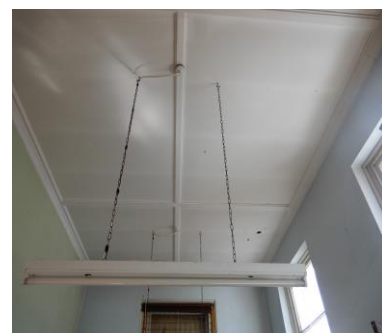
ID: CARD NO:014

Photograph No.	14
Location/Area	Storage Room-Cupboard
Suspected Material Identified	Lath & Plaster
Condition of Material Identified	Good
Categories: (Assessment type). 1: ACM common characteristics or 2: Presumed ACM or 3: Sample collected for analysis	2: Presumed ACM
Sample No.	Sample Not Taken
Laboratory Analysis Findings	Analysis Not Conducted
Quantity of Material Identified	10.0m2

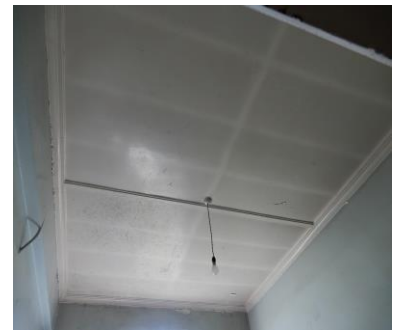
ID: CARD NO:015

Photograph No.	15
Location/Area	Internal: Kitchen (Ceiling)
Suspected Material Identified	Lath & Plaster
Condition of Material Identified	Good
Categories: (Assessment type). 1: ACM common characteristics or 2: Presumed ACM or 3: Sample collected for analysis	2: Presumed ACM
Sample No.	Sample Not Taken
Laboratory Analysis Findings	Analysis Not Conducted
Quantity of Material Identified	12.0m ²

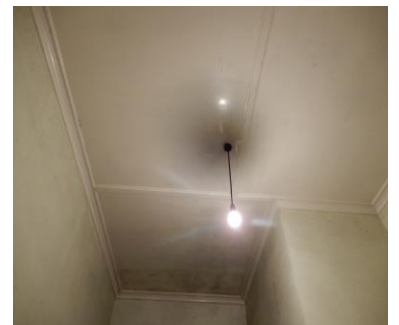
ID: CARD NO:016

Photograph No.	16
Location/Area	Internal: Bathroom (Ceiling)
Suspected Material Identified	Lath & Plaster
Condition of Material Identified	Good
Categories: (Assessment type). 1: ACM common characteristics or 2: Presumed ACM or 3: Sample collected for analysis	2: Presumed ACM
Sample No.	Sample Not Taken
Laboratory Analysis Findings	Analysis Not Conducted
Quantity of Material Identified	15.5m ²

016		Internal: Bathroom (Ceiling)	2	15.5m2	Ceiling Panels	Lath & Plaster	1	0	0	1	0	0	0	0	0	0	0	Very low risk	Complete a Risk Assessment.
017		Internal: Hallway (Ceiling)	2	22.0m2	Ceiling Panels	Lath & Plaster	1	0	0	1	0	0	0	0	0	0	0	Very low risk	Complete a Risk Assessment.
018																			
019																			
020

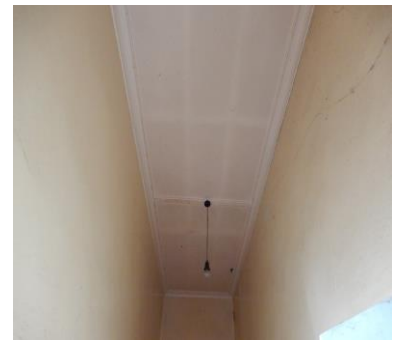
ID: CARD NO:017

Photograph No.	17
Location/Area	Internal: Hallway (Ceiling)
Suspected Material Identified	Lath & Plaster
Condition of Material Identified	Good
Categories: (Assessment type). 1: ACM common characteristics or 2: Presumed ACM or 3: Sample collected for analysis	2: Presumed ACM
Sample No.	Sample Not Taken
Laboratory Analysis Findings	Analysis Not Conducted
Quantity of Material Identified	24.0m2
