## Asbestos Management Survey Report

Whanganui Hospital,  
Horticulture Services

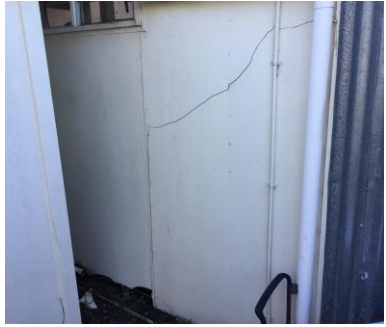
Photograph No.	1

Location/Area	Exterior: Walls	
Suspected Material Identified	ACM Board	
Condition of Material Identified	Damaged	
<b>Categories: (Assessment type).</b> 1: ACM common characteristics or 2: Presumed ACM or 3: Sample collected for analysis	2: Presumed ACM	
Sample No.	Sample Not Taken	
Laboratory Analysis Findings	Analysis Not Conducted	
Quantity of Material Identified	70.0m2

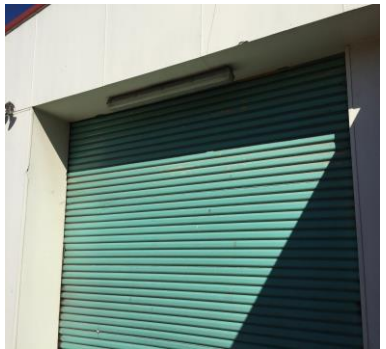
Photograph No.	2

Location/Area	Exterior: Roller Door (Entry)	
Suspected Material Identified	ACM Board	
Condition of Material Identified	Good	
<b>Categories: (Assessment type).</b> 1: ACM common characteristics or 2: Presumed ACM or 3: Sample collected for analysis	2: Presumed ACM	
Sample No.	Sample Not Taken	
Laboratory Analysis Findings	Analysis Not Conducted	
Quantity of Material Identified	12.0m2

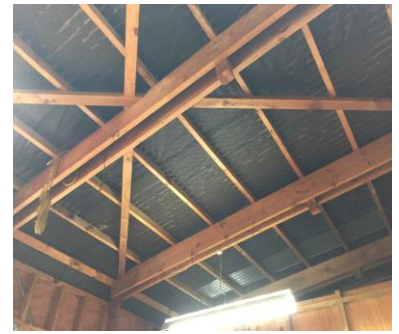
Photograph No.	3
Location/Area	Internal: Roof
Suspected Material Identified	Waterproofing Material
Condition of Material Identified	Good
<b>Categories: (Assessment type).</b> 1: ACM common characteristics or 2: Presumed ACM or 3: Sample collected for analysis	2: Presumed ACM
Sample No.	Sample Not Taken
Laboratory Analysis Findings	Analysis Not Conducted
Quantity of Material Identified	120.0m2

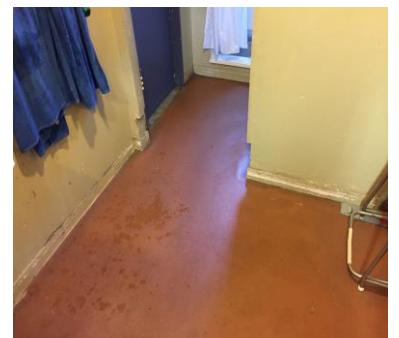
Photograph No.	4
Location/Area	Internal: Bathroom
Suspected Material Identified	Vinyl Flooring
Condition of Material Identified	Good
<b>Categories: (Assessment type).</b> 1: ACM common characteristics or 2: Presumed ACM or 3: Sample collected for analysis	2: Presumed ACM
Sample No.	Sample Not Taken
Laboratory Analysis Findings	Analysis Not Conducted
Quantity of Material Identified	9.0m2

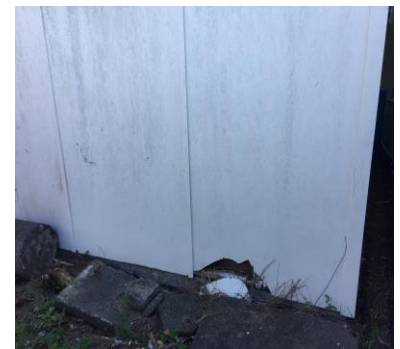
Photograph No.	5
Location/Area	Exterior: Rear Shed (Walls)
Suspected Material Identified	ACM Board
Condition of Material Identified	Good
<b>Categories: (Assessment type).</b> 1: ACM common characteristics or 2: Presumed ACM or 3: Sample collected for analysis	2: Presumed ACM
Sample No.	Sample Not Taken
Laboratory Analysis Findings	Analysis Not Conducted
Quantity of Material Identified	75.0m2

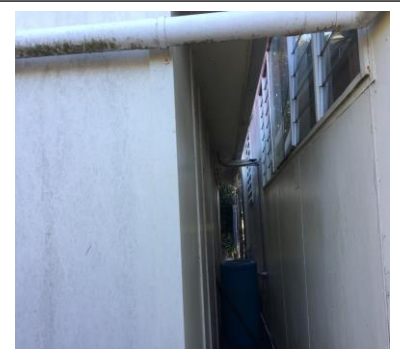
Photograph No.	6
Location/Area	Exterior: Rear Shed (Soffits)
Suspected Material Identified	ACM Board
Condition of Material Identified	Good
<b>Categories: (Assessment type).</b> 1: ACM common characteristics or 2: Presumed ACM or 3: Sample collected for analysis	2: Presumed ACM
Sample No.	Sample Not Taken
Laboratory Analysis Findings	Analysis Not Conducted
Quantity of Material Identified	11.0m2

006	6	Exterior: Rear Shed (Soffits)	2	11.0m2	Soffit Lining	Compressed Board	1	0	0	1	0	0	0	0	0	0	0	Very low risk	Complete a Risk Assessment.
007																			
008																			
009																			
010
