Asbestos Management Survey Report

***WHANGANUI HOSPITAL
SURGICAL BOARD
ASBESTOS MANAGEMENT SURVEY***

WHANGANUI HOSPITAL – SURGICAL WARD

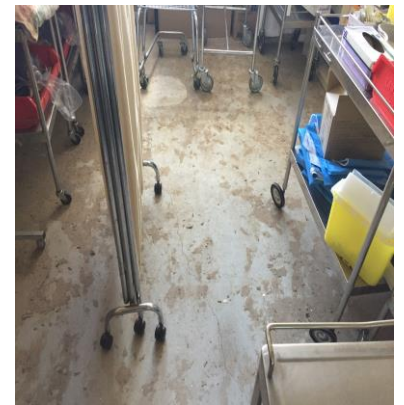
ID: CARD NO:001

Photograph No.	001
Location/Area	Ground Floor-Storage Rooms
Suspected Material Identified	Vinyl Floor Backing
Condition of Material Identified	Damaged
Categories: (Assessment type). 1: ACM common characteristics or 2: Presumed ACM or 3: Sample collected for analysis	Presumed ACM
Sample No.	N/A
Laboratory Analysis Findings	N/A
Quantity of Material Identified	120m ²

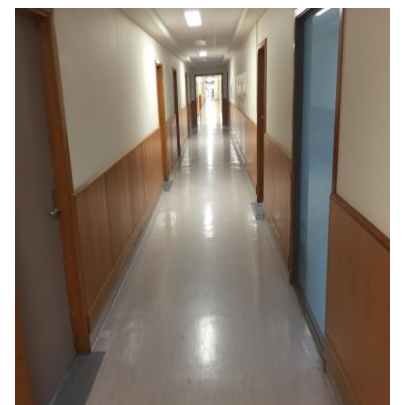
ID: CARD NO:002

Photograph No.	002
Location/Area	Ground Floor-Corridor
Suspected Material Identified	Vinyl Floor
Condition of Material Identified	Good
Categories: (Assessment type). 1: ACM common characteristics or 2: Presumed ACM or 3: Sample collected for analysis	Presumed ACM
Sample No.	N/A
Laboratory Analysis Findings	N/A
Quantity of Material Identified	132.5m ²

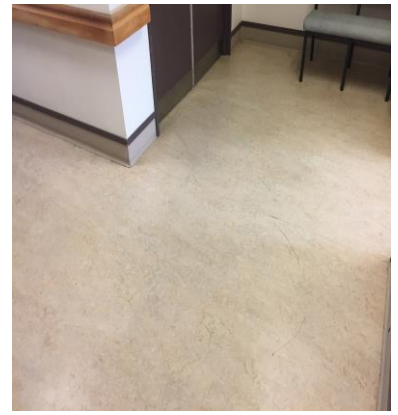
ID: CARD NO:003

Photograph No.	003
Location/Area	Ground Floor-Elevator Lobby
Suspected Material Identified	Vinyl Floor
Condition of Material Identified	Good
Categories: (Assessment type). 1: ACM common characteristics or 2: Presumed ACM or 3: Sample collected for analysis	Presumed ACM
Sample No.	N/A
Laboratory Analysis Findings	N/A
Quantity of Material Identified	84m ²

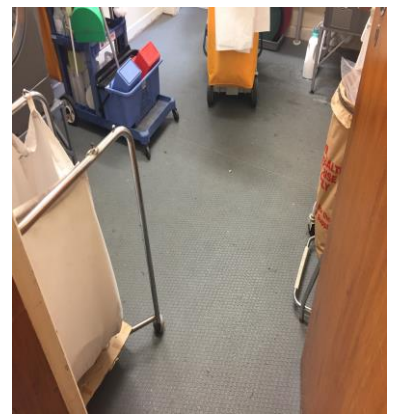
ID: CARD NO:004

Photograph No.	004
Location/Area	Ground Floor-Laundry
Suspected Material Identified	Vinyl Floor
Condition of Material Identified	Good
Categories: (Assessment type). 1: ACM common characteristics or 2: Presumed ACM or 3: Sample collected for analysis	Presumed ACM
Sample No.	N/A
Laboratory Analysis Findings	N/A
Quantity of Material Identified	12m ²

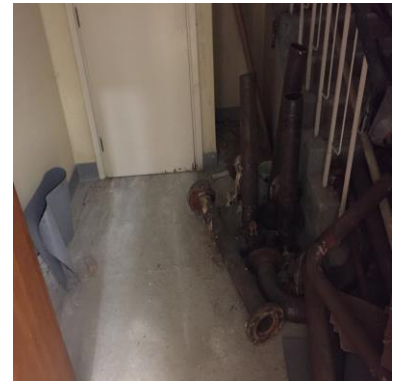
ID: CARD NO:005

Photograph No.	005
Location/Area	Ground Floor-Old Stairwell
Suspected Material Identified	Vinyl Floor Backing
Condition of Material Identified	Damaged
Categories: (Assessment type). 1: ACM common characteristics or 2: Presumed ACM or 3: Sample collected for analysis	Presumed ACM
Sample No.	N/A
Laboratory Analysis Findings	N/A
Quantity of Material Identified	9m ²

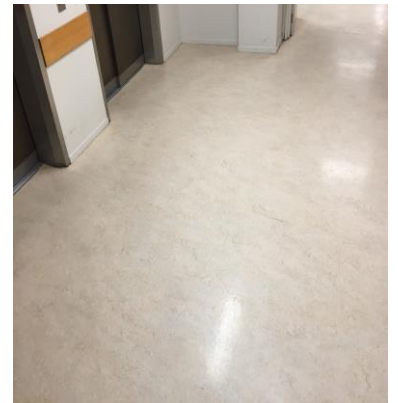
ID: CARD NO:006

Photograph No.	006
Location/Area	1 st Floor-Elevator Lobby
Suspected Material Identified	Vinyl Floor
Condition of Material Identified	Good
Categories: (Assessment type). 1: ACM common characteristics or 2: Presumed ACM or 3: Sample collected for analysis	Presumed ACM
Sample No.	N/A
Laboratory Analysis Findings	N/A
Quantity of Material Identified	84m ²

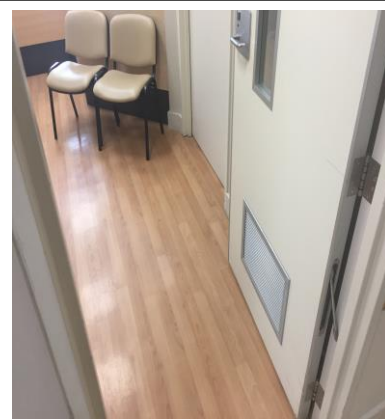
ID: CARD NO:007

Photograph No.	007
Location/Area	1 st Floor-Discharge Lounge Foyer
Suspected Material Identified	Vinyl Floor
Condition of Material Identified	Good
Categories: (Assessment type). 1: ACM common characteristics or 2: Presumed ACM or 3: Sample collected for analysis	Presumed ACM
Sample No.	N/A
Laboratory Analysis Findings	N/A
Quantity of Material Identified	17m ²

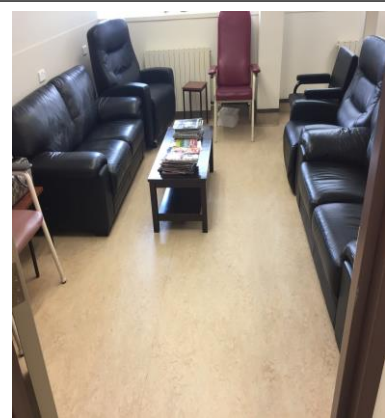
ID: CARD NO:008

Photograph No.	008
Location/Area	1 st Floor-Discharge Lounge Waiting Room
Suspected Material Identified	Vinyl Floor
Condition of Material Identified	Good
Categories: (Assessment type). 1: ACM common characteristics or 2: Presumed ACM or 3: Sample collected for analysis	Presumed ACM
Sample No.	N/A
Laboratory Analysis Findings	N/A
Quantity of Material Identified	30m ²

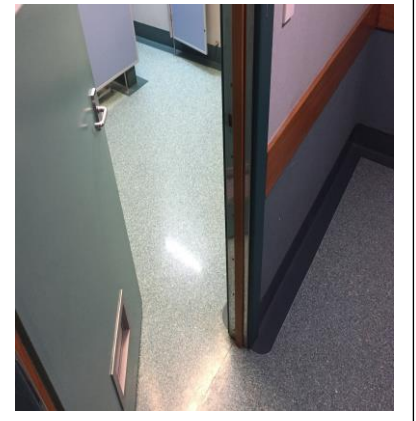
ID: CARD NO:009

Photograph No.	009
Location/Area	1 st Floor-Discharge Lounge Women Toilet
Suspected Material Identified	Vinyl Floor
Condition of Material Identified	Good
Categories: (Assessment type). 1: ACM common characteristics or 2: Presumed ACM or 3: Sample collected for analysis	Presumed ACM
Sample No.	N/A
Laboratory Analysis Findings	N/A
Quantity of Material Identified	3m ²

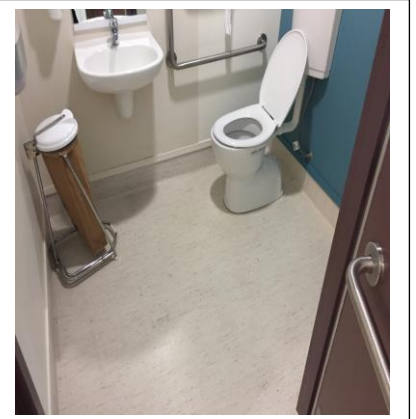
ID: CARD NO:010

Photograph No.	010
Location/Area	1 st Floor-Discharge Lounge Disabled Toilet
Suspected Material Identified	Vinyl Floor
Condition of Material Identified	Good
Categories: (Assessment type). 1: ACM common characteristics or 2: Presumed ACM or 3: Sample collected for analysis	Presumed ACM
Sample No.	N/A
Laboratory Analysis Findings	N/A
Quantity of Material Identified	4m ²

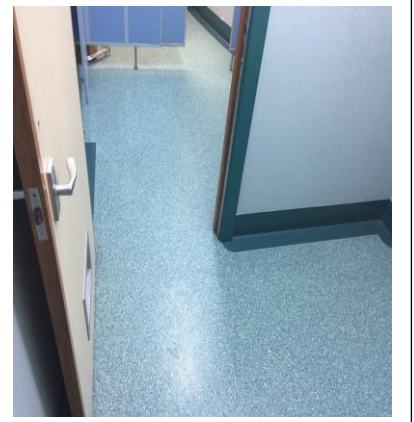
ID: CARD NO:011

Photograph No.	011
Location/Area	1 st Floor-Discharge Lounge Male Toilet
Suspected Material Identified	Vinyl Floor
Condition of Material Identified	Good
Categories: (Assessment type). 1: ACM common characteristics or 2: Presumed ACM or 3: Sample collected for analysis	Presumed ACM
Sample No.	N/A
Laboratory Analysis Findings	N/A
Quantity of Material Identified	3m ²

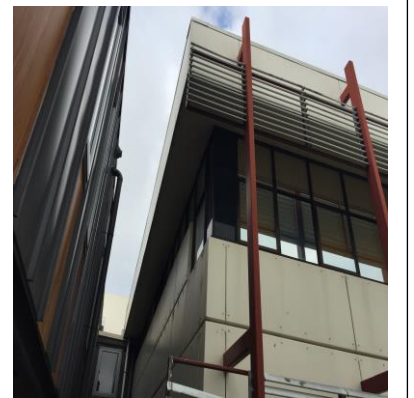
ID: CARD NO:012

Photograph No.	012
Location/Area	External-Soffits Lining
Suspected Material Identified	ACM Board
Condition of Material Identified	Good
Categories: (Assessment type). 1: ACM common characteristics or 2: Presumed ACM or 3: Sample collected for analysis	Presumed ACM
Sample No.	N/A
Laboratory Analysis Findings	N/A
Quantity of Material Identified	125m ²
