Statement of Claim Checklist

Date: 24/11/10Author: GEORGE ALEXANDERS BATES
39 MARRIOTT'S ROAD
NORTH NEW BRIGHTON
CHRISTCHURCH 8083

1257554 2011 CHCH EQ - LAND ENGINEERING REPORT

22 FEB 2011 - EARTHQUAKE
NORTH NEW BRIGHTON, CHRISTCHURCH
(C120-091841) - 39 Marriotts Road

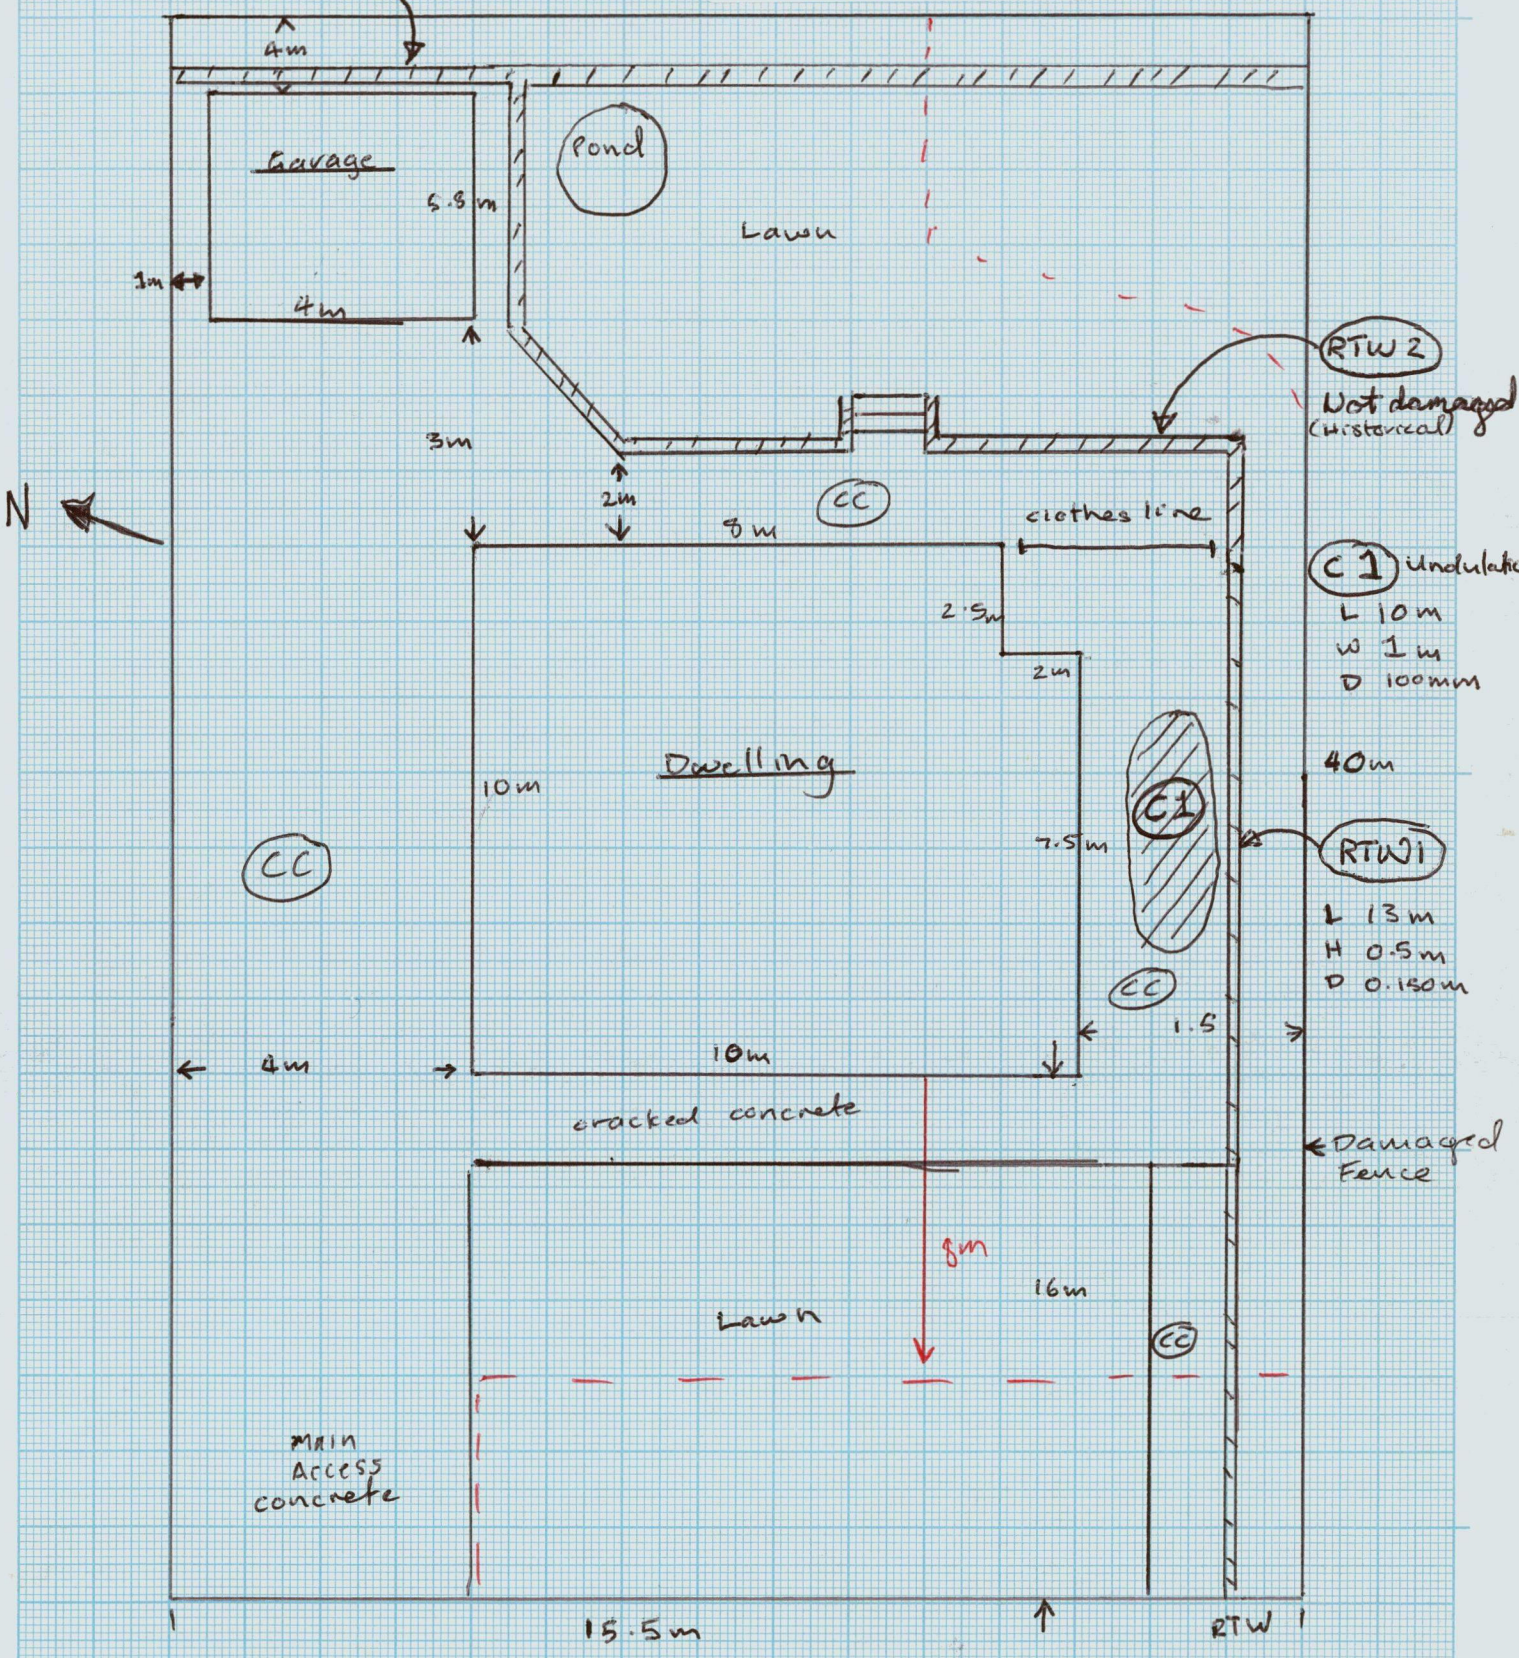
RTW 3
L 6m
H 0.7m
W 0.2m

CC = cracked concrete

Item N°	Description/Construction	Length	Height/Width	Depth	Damage	Damaged Area	Evacuated m ²	Inundated m ²	Debris m ³	Access	
										E	D
C1	Concrete Path	10	1	0.1	undulation	10m ²	10	—	—	E	
RTW 1	Painted Insitu Concrete	13	0.5		Cracked & rotated	DFA 6.5					
RTW 3	Insitu Concrete	6	0.7		Cracked & rotated	DFA 4.2

NEW WALL	Units	Length	Breadth	DFA	Rate Table(includes GST, margin and P&G)	
					Rate	Cost
Structure dimensions	m ²	6	0.7	4.2	\$715	\$ 3003
Total						\$ 4729.87

Earth ramp required to access wall.

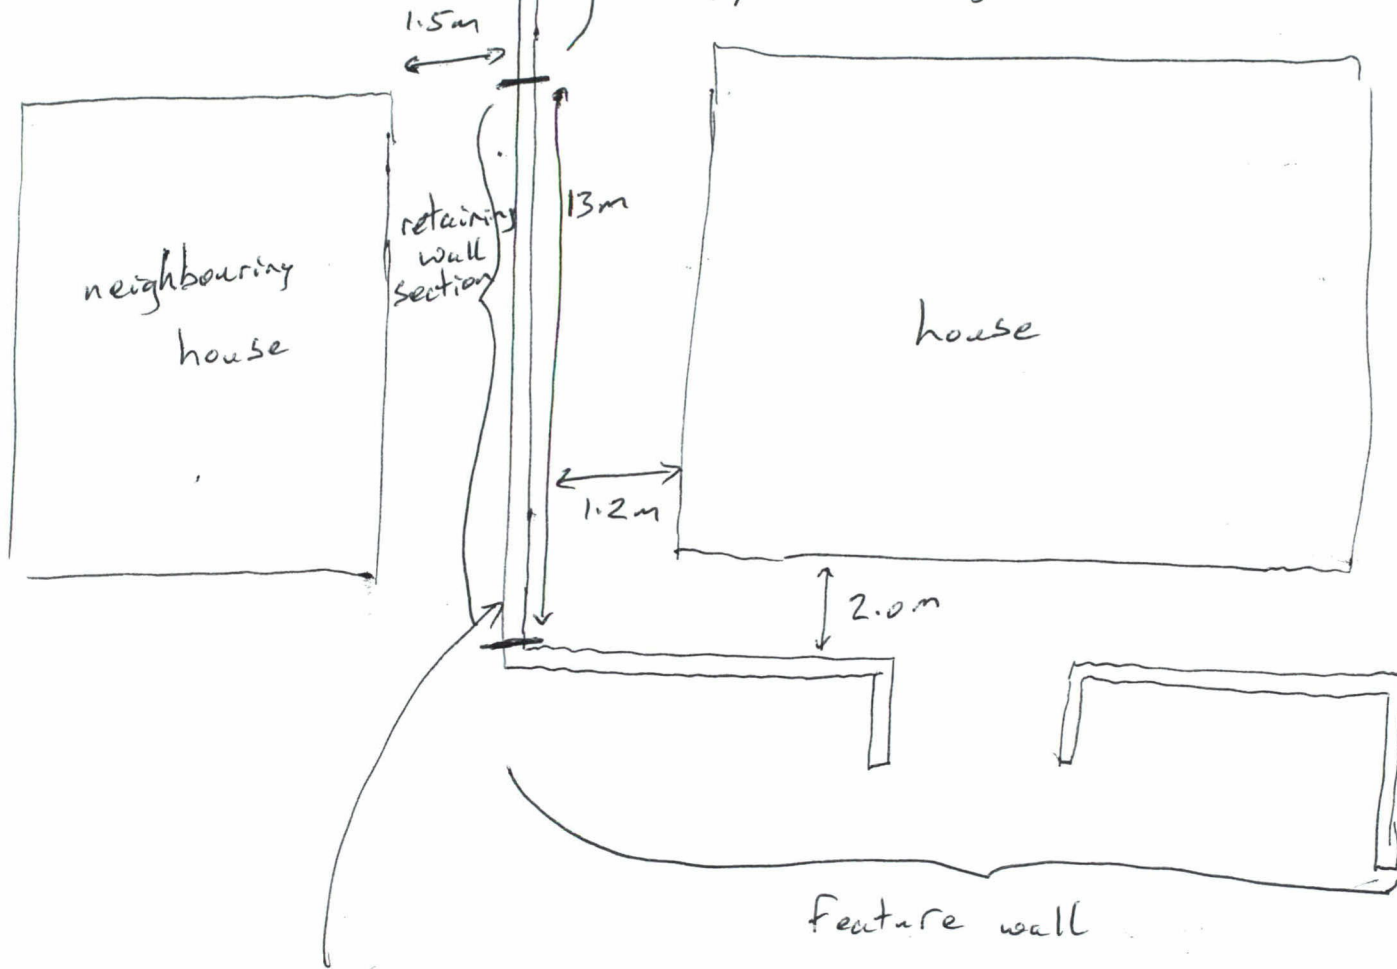
Retaining wall plan

Comments:
 SE boarder slopes from 500mm high to 200mm high, 13m long, from this point onwards it turns into a feature wall & is not support anything.
 Behind garage wall - concrete wall 200mm high & 6m long (cracked only)

Feature wall < 200mm high & not supporting anything

- ① remove ejected sand or silt
- ② locally repair undulations by trimming top of undulations or filling depressions.
- ③ replace both retaining walls with Type 1, 140mm block retaining walls (without surcharge), 1000mm max height, Footing width = 450mm, Key depth = 100mm. (See attached)

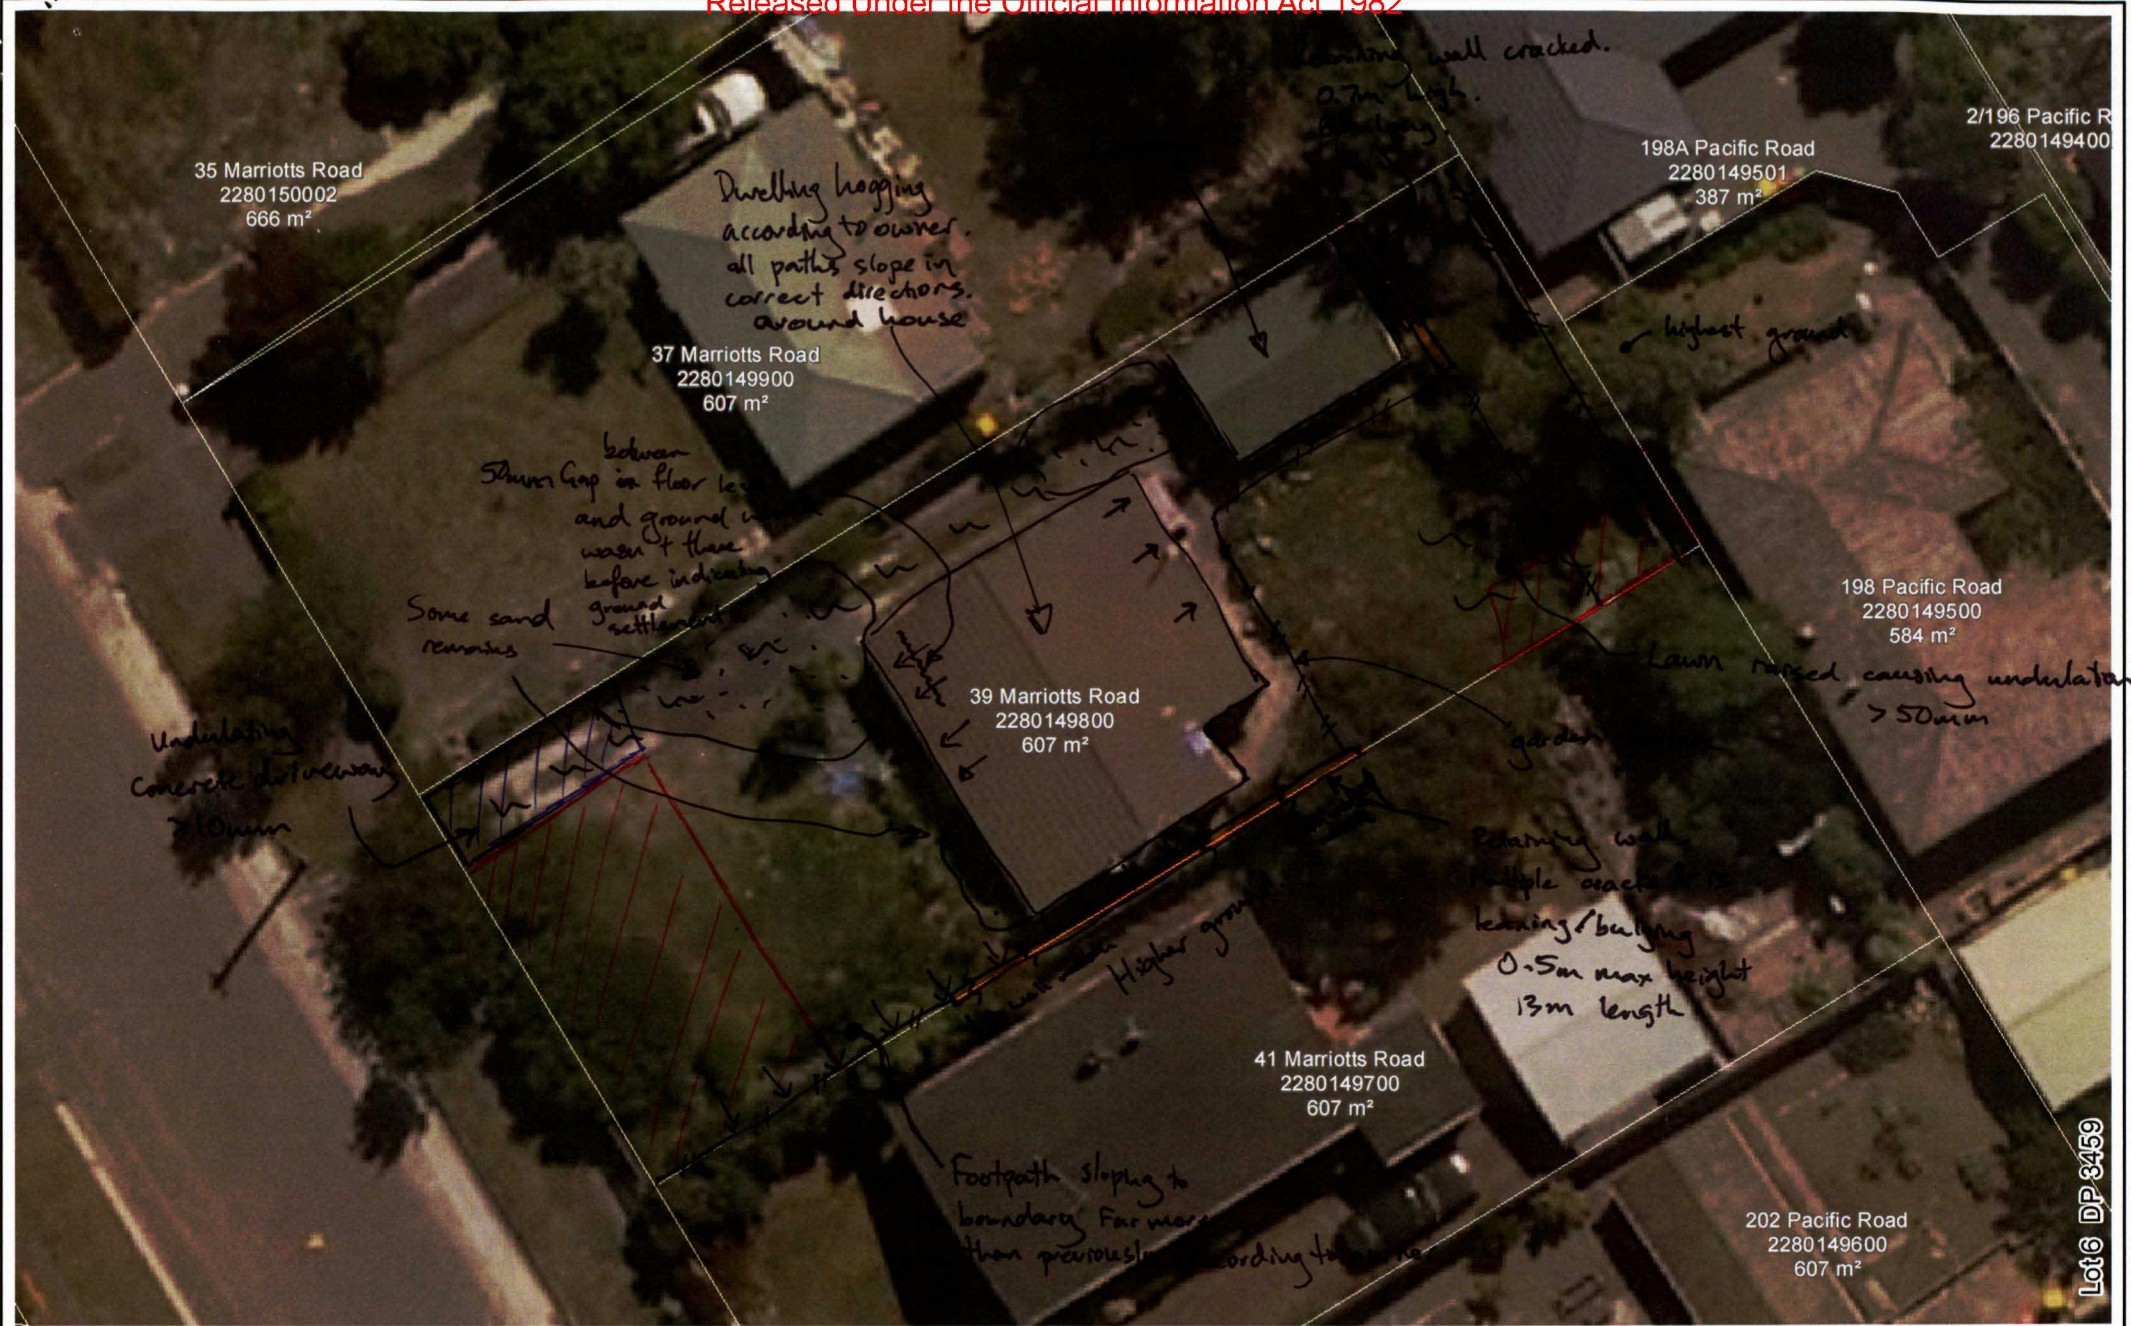
LIQUEFACTION/Flat land damage comments: Sand/silt observed, undulating lawn > 50mm, undulating paths > 10mm, undulating accessways.
 ↗ rear lawn (front ok)

- = sand
- = garden feature wall
- = undulations
- = Damaged retaining wall
- = No EQC Area = 102m²
- = Damaged Accessway = 21m²
