# Totara & Kawaka Streets

## Scheme design stage safety audit

Report prepared for  
Tauranga City Council  
September 2017

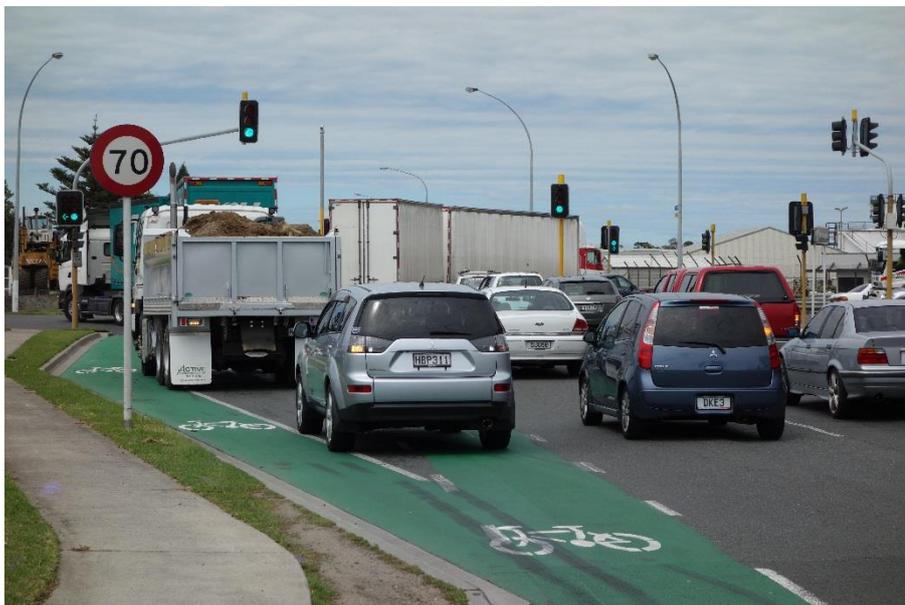
*Figure 38 from the 2013 report*

*The north approach is laid out in a confusing and counterintuitive manner. When traffic queues back, there is no indication for cyclists which lane to choose, as can be seen in Figure 38. For motorists, further sets of right turn arrow are provided before the diverge, but cyclists do not receive this guidance. Intuitively, cyclists intending to go straight through the intersection would proceed straight ahead at the diverge shown in Figure 38, but this is not where they are supposed to go, and there is no way for them to know other than to read road markings in adjacent vehicle lanes (which more often than not are obscured by traffic queues) and then draw the right conclusions from this. This is a highly hazardous layout and lane use arrows need to be marked with urgency so that straight through cyclists know that they have to choose the kerbside lane. The current layout results in unsuspecting straight through cyclists choosing a position where they are to the right of other straight through traffic. Upon entering the intersection, this can result in serious harm.*

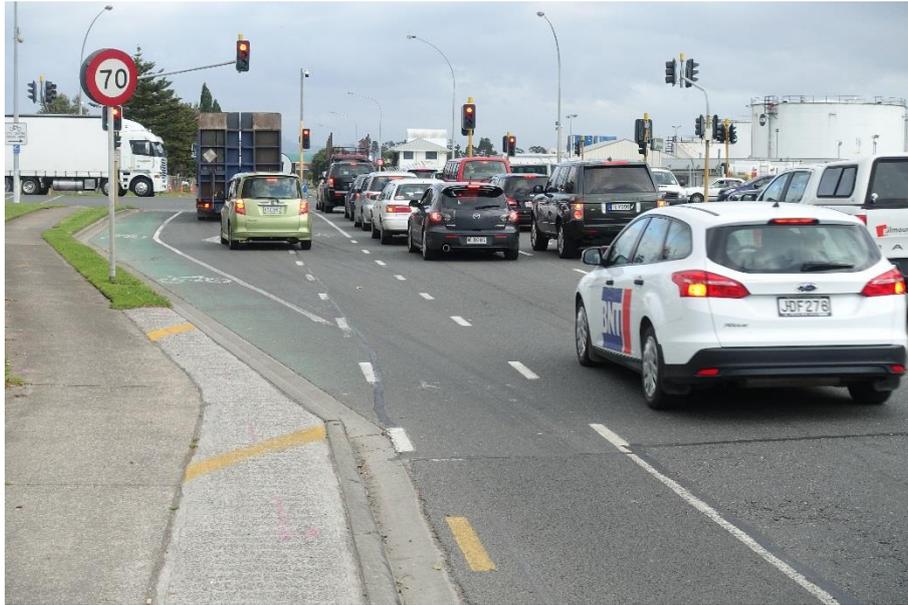
Figure 2: Totara approach to Hewletts in September 2017

It is of deep concern that almost four years later, the risk has not been addressed, as can be seen in Figure 2.

The SAT appreciates that under the proposal, the existing cycle lanes are to be removed. The December 2013 recommendation remains, however. It is suggested that the concern be addressed with urgency, i.e. within days.

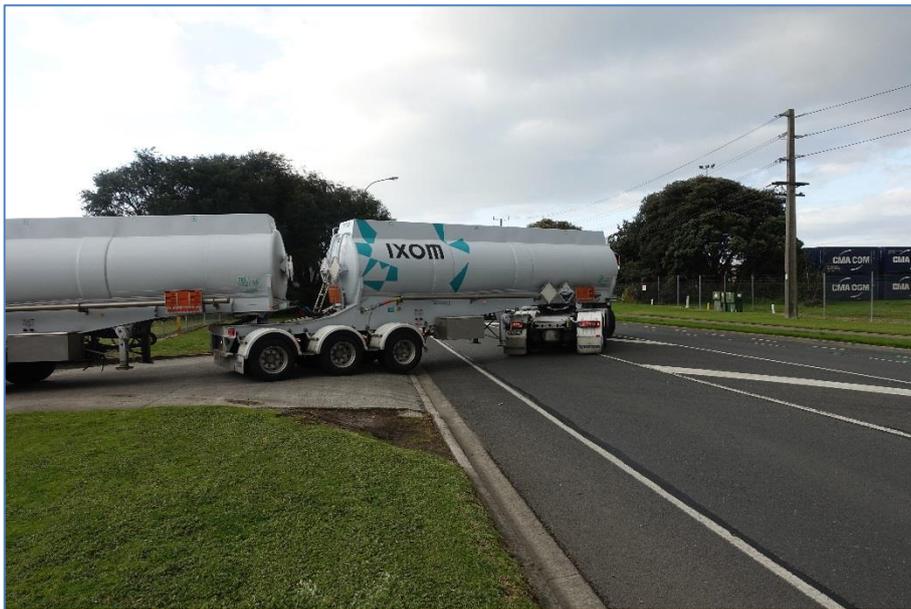
Figure 3: B-train leaving Ixom site – this is much less of a problem than entering by left turn

The problem is that truck drivers turning left have a large blind spot, and will not be able to see people cycling in the same direction. Given the large number of trucks turning left at the various driveways, this is expected to result in a crash occasionally. Crashes that do occur are very likely to result in death or serious injury. Therefore, the overall safety rating is significant.

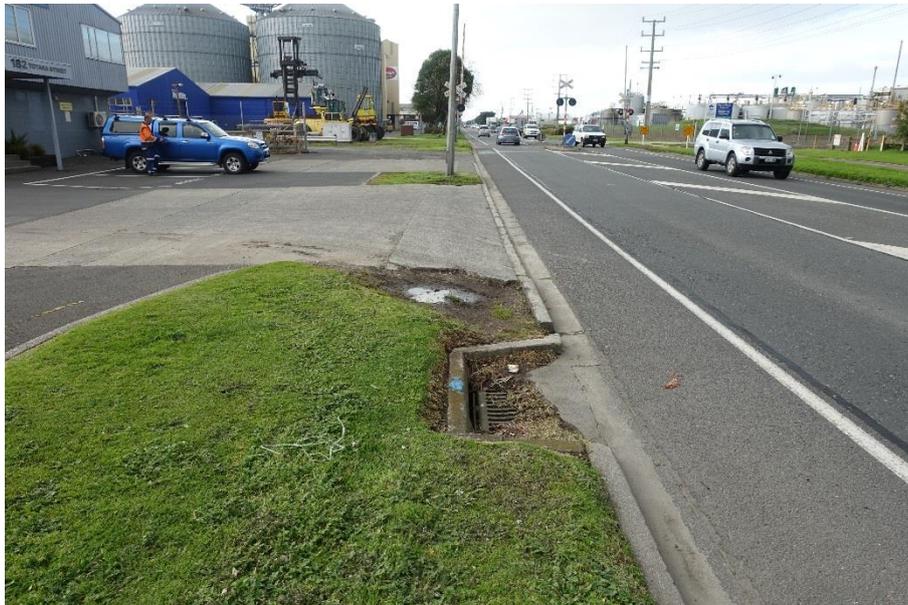
Although most of the commercial driveways are reasonably wide, many have corner splays where the grass berm is commonly run over by trucks. Such splays have been observed at driveways 8, 9, 11, 15, 17, 21, 22, and 23 (refer to section 1.13 for a key). Figure 4 shows the northern commercial driveway of Bulk Storage Terminals Ltd as an example.

Figure 4: Chamfer created by truck overrun (driveway 9; Bulk Storage Terminals Ltd)

The problem is that the geometric design of the driveways appears to be based on the assumption that truck drivers will turn into the driveway without running over the berm like at present, and that larger trucks swing wide onto the flush median, as no swept path allowance appears to have been made. This will not work like that in practice, but it is likely that truck drivers will overrun the proposed separators, just as they currently mount the kerb.

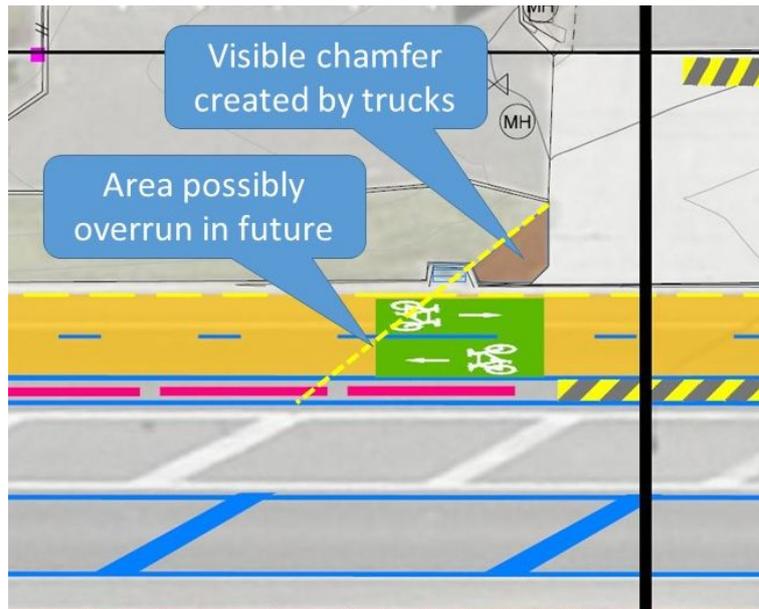
Figure 5: Simple graphic indicating the possible extent of the overrun at driveway 9  
 This could create an ongoing maintenance problem. It is also possible that this will create a hazard, with bits of broken separator obstructing the cycleway.

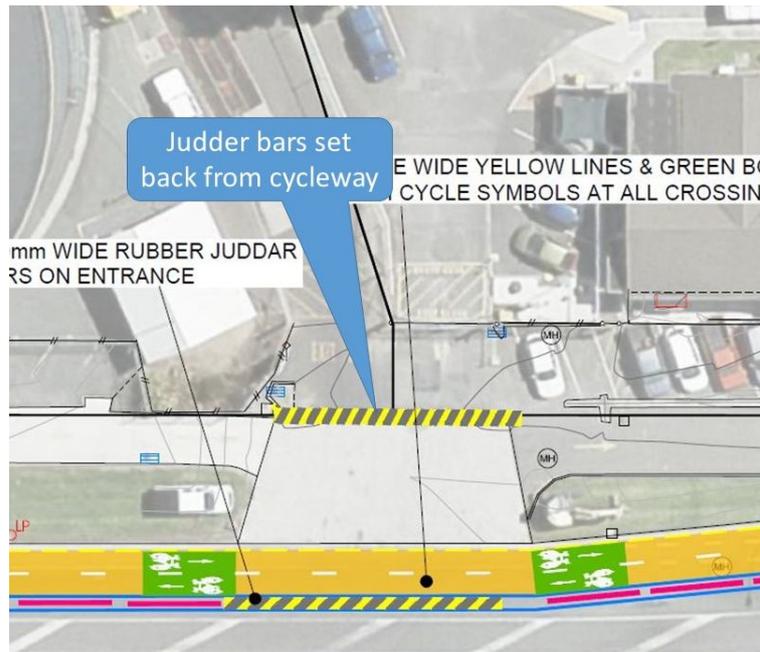
At all driveways, the proposed judder bars encountered by drivers leaving a site are placed at the legal boundary. In most cases, this is 8 m clear of the proposed cycleway. An example is shown in Figure 6.

Figure 6: Judder bar setback at driveway 6

The problem is that drivers ought to be reminded that they are about to cross a cycleway in immediate proximity to the conflict point. With such a large offset, some drivers may not even make the connection between the judder bars and the cycleway. Numerous studies from around the world have shown that people cycling in a contra-flow direction are much more at risk from being overlooked than those travelling in the with-flow direction. For New Zealand guidance on this, please refer to the SCOT documentation.<sup>6</sup> Drivers need to receive the reminder where visibility of the facility is optimal. It is suggested that the calming devices be placed so that a design vehicle (be that a truck for commercial driveways, or otherwise cars) does not obstruct the cycleway just before mounting the judder bars.

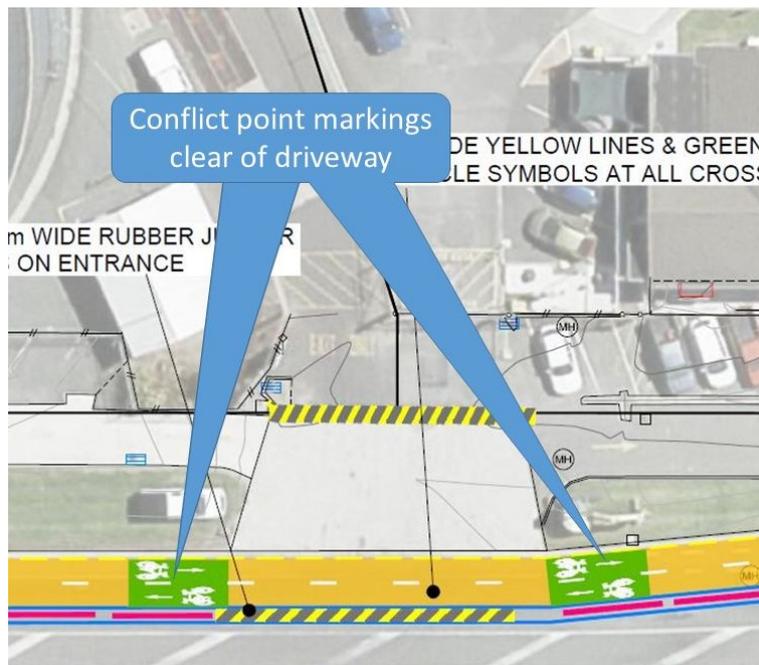
The scheme proposes white cycle logos and directional arrows on top of green coloured boxes at driveways. These markings are proposed to be placed just clear of driveways, presumably to minimise maintenance costs (see Figure 7). Convention is to place these markings directly at the conflict point so that their safety impact (i.e. reminding drivers that they are crossing a cycle facility) is maximised.

Figure 7: Placement of markings at driveways

Placing the markings away from the conflict point will make them less conspicuous to drivers and therefore increase the risk of collision between vehicles and people on bikes, especially those in the contra-flow (unexpected) direction. This is expected to result in occasional crashes. Such crashes that do occur are likely to result in death or serious injury. Therefore, the overall safety rating is moderate.

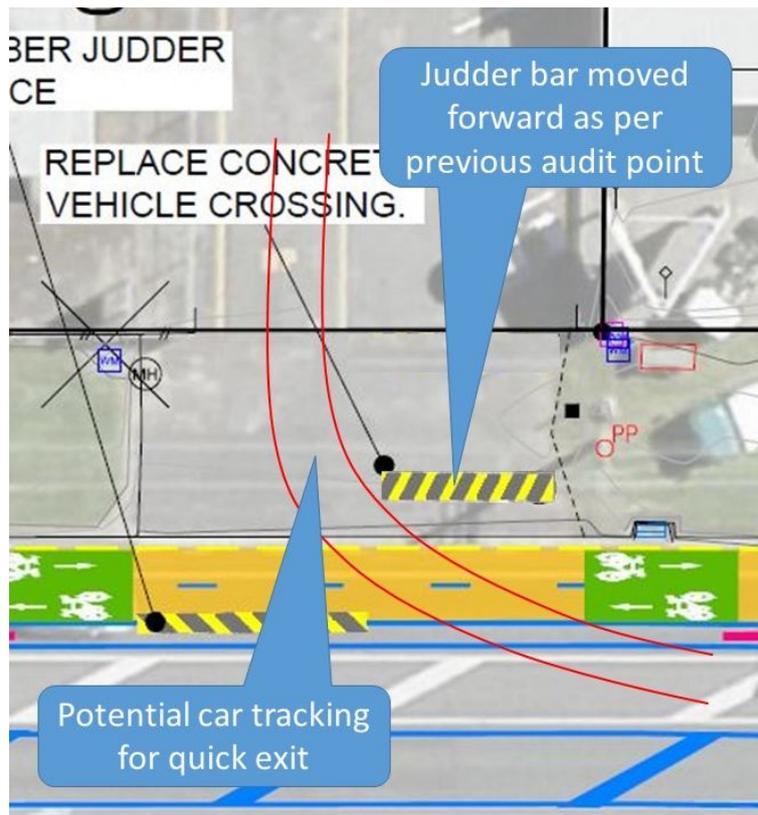
At some of the driveways, the judder bars are placed in a way that drivers exiting to their left, or driving entering to their right, could avoid the vertical deflection. This is conceptually shown in Figure 8, which uses driveway 21 as the example location (note that the judder bar for exiting vehicles has been shifted closer to the cycleway as per section 2.1.6.1 – the problem still exists even then).

Exiting drivers, for example, may concentrate on whether other drivers are turning into the driveway, and if their way is clear and they can see a gap to turn into, they may adopt a tracking path that completely avoids the judder bars, as shown in the figure. When drivers are making these decisions in quick succession, they may well have forgotten that they should also check for cycleway users. Once again, those users travelling in a contra-flow direction are most at risk of getting overlooked, as the exiting driver would have glanced the other way to identify a suitable gap in the northbound traffic.

Figure 8: Potential vehicle tracking that avoids the chicane for a ‘quick exit’

Crashes resulting from this behaviour can be expected to occur occasionally. Given the speed involved, such crashes are very likely to result in death or serious injury. Therefore, the overall safety rating is significant.

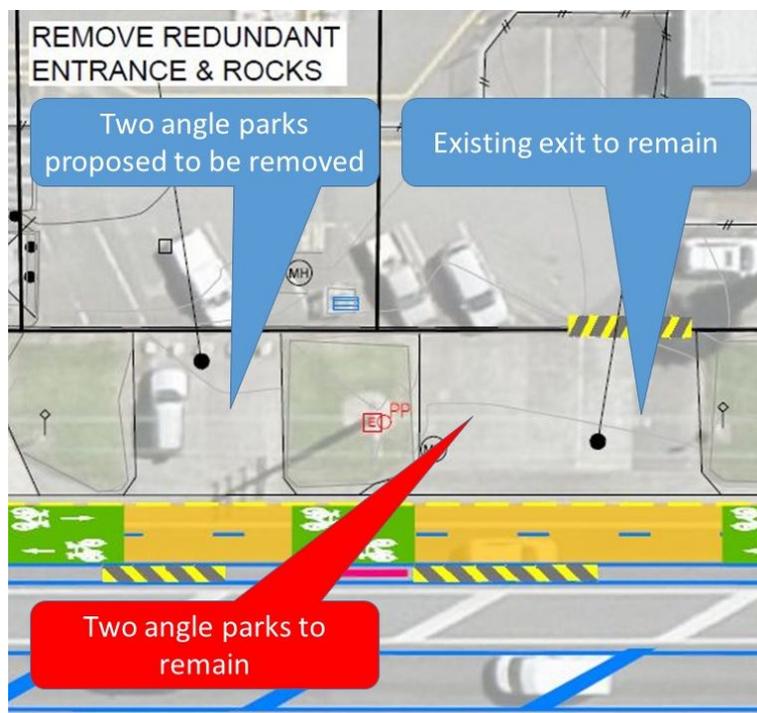
There are two locations outside Ixom that are used for angle parking; driveways 18 and 19 as per section 1.13. Both appear to be previous driveways, with driveway 18 no longer in use, and driveway 19 previously being combined with the adjacent driveway 20 providing one generously-dimensioned facility. The scheme design proposes the removal of driveway 18, while the two angle parks at driveway 19 are to remain. The situation is shown in Figure 9.

It is inappropriate to require drivers to reverse into a busy arterial road like Totara Street. It is even more inappropriate to require them to back across a two-way cycleway while doing so. This puts people cycling at risk, and is hazardous for the reversing drivers, too.

Figure 9: Angle parking (driveway 19) is set to remain

Crashes resulting from reversing may be infrequent. Crashes that do occur are unlikely to result in death or serious injury. Therefore, the overall safety rating is minor.

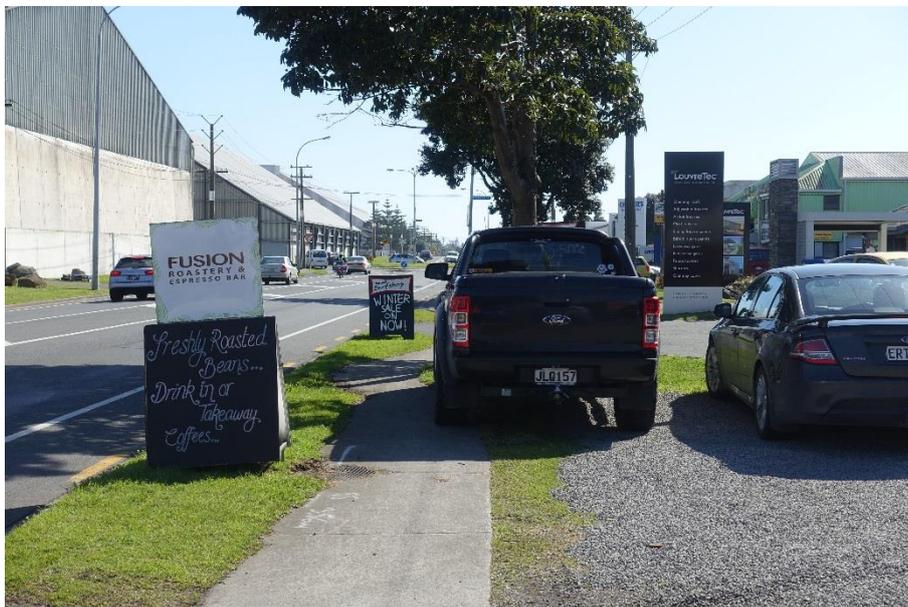
During the site visits, there was low parking demand along Totara Street, and very high parking demand along Kawaka Street (more than 100% occupancy). Despite the low demand along Totara Street, illegal parking could still be observed (see Figure 10).

Figure 10: Illegal parking outside Fusion Coffee Roastery

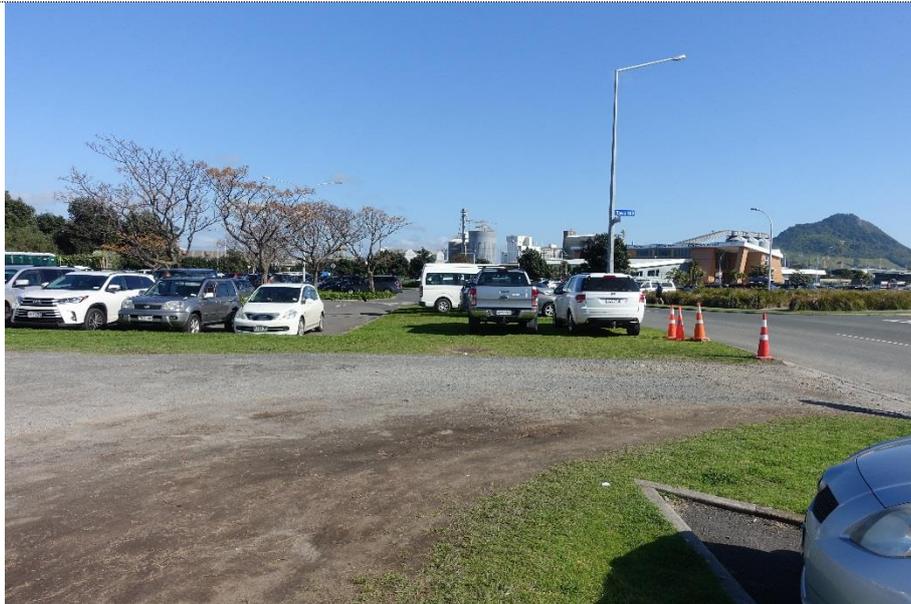
Along Kawaka Street, all formed car parks were occupied, plus much of the grass berms which are supposed to cater for the proposed cycleway (see Figure 11). The footpath shown in Figure 12 was fully parked out (and thus unusable for pedestrians) on Thursday afternoon (the following photo was taken on Friday morning).

Figure 11: Drivers park on the berm that is supposed to become a cycleway as all formed parks are full

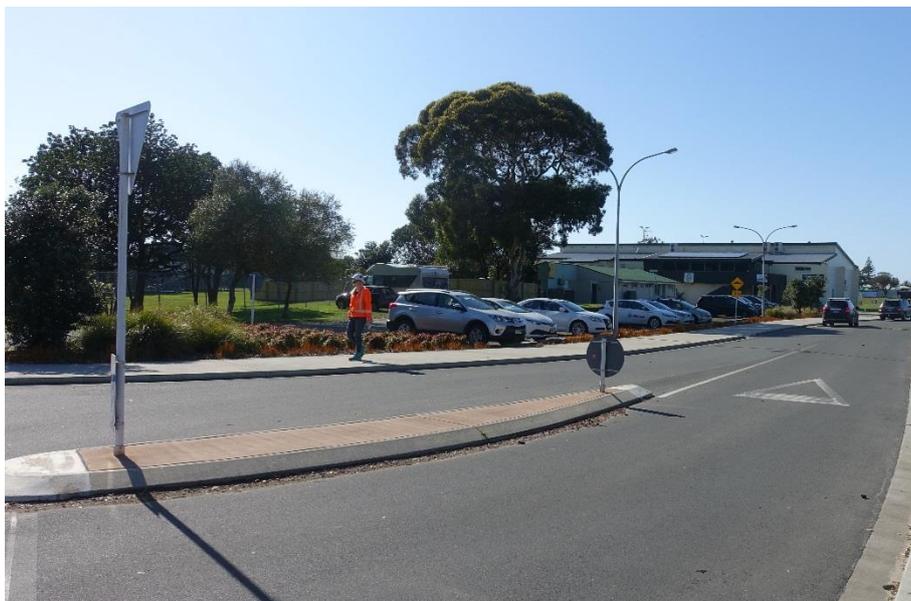
Figure 12: During Thursday afternoon, this footpath was fully parked out<sup>7</sup>

From these observations, it appears that current parking enforcement is insufficient to regulate driver behaviour. Installing the cycleway in this location will generate significant push back from motorists who wish to park there – thus it will be necessary to have strong political support to keep the facility available.

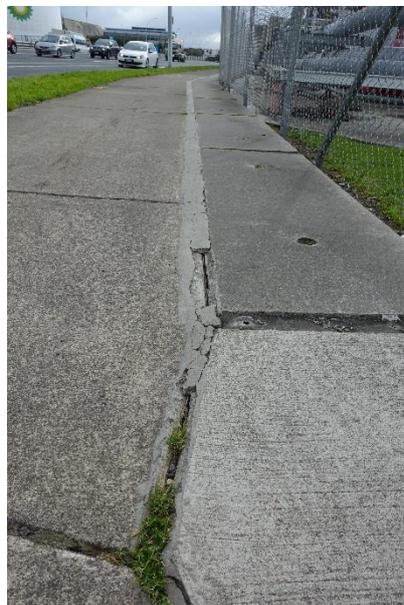
There is a service cover along the shared pathway on Hewletts Road. At its intersection with Totara Street, the fill between the footpath and this service cover is broken, leaving a groove deep enough that can catch a narrow road bike wheel. Visibility around this corner is poor, meaning that riders may take evasive action and they could be trapped by this deficiency even if they are aware of it.

Figure 13: Broken service cover seal (Hewletts / Totara n-w quadrant)

Instances of riders losing control may happen infrequently, and this is unlikely to result in death or serious injury. Therefore, the overall safety rating is minor.

| <b>2.2.1.1.</b> | Replace the broken crack fill on the shared pathway in the north-west quadrant of the Hewletts / Totara intersection. |

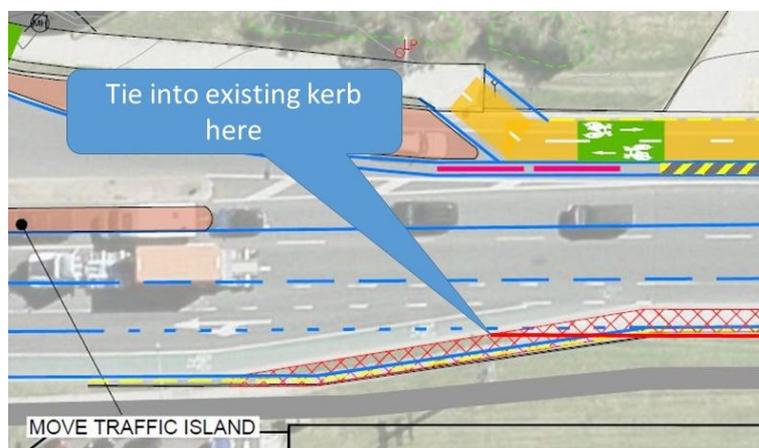
The proposed lengthening of the kerbside lane on the approach to Hewletts Road shown in Figure 14 is an expensive change for which the reason for doing so is not evident. During most of the day, long queues can be observed on this approach and the kerbside lane becomes available only after the Totara Street approach has a green light; making the lane slightly longer will make no difference to intersection performance.

Figure 14: Unnecessary widening on the approach to Hewletts Road

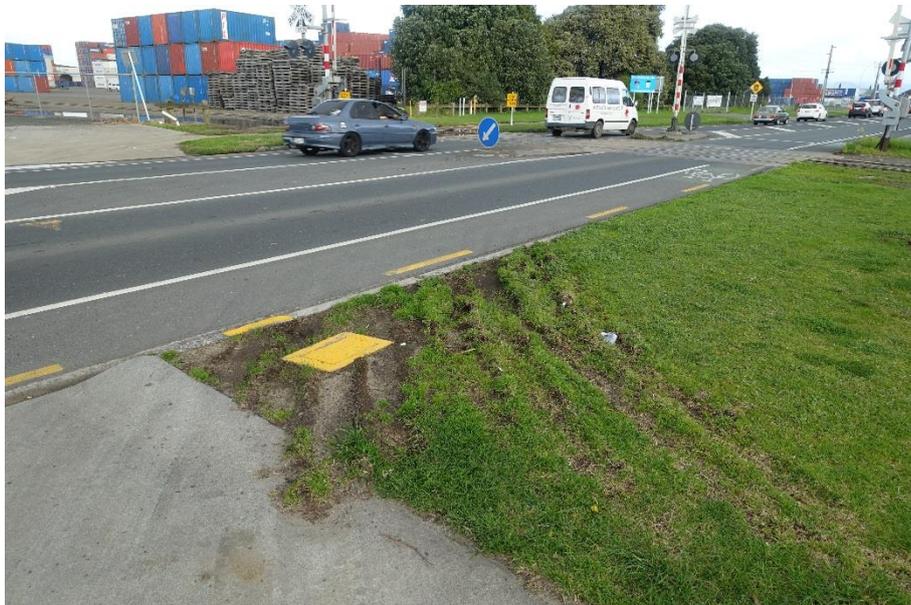
Driveway 11 on sheet C05 has insufficient corner splays (see Figure 15), much like many other driveways as discussed in section 2.1.5. The scheme design does as yet not make any provision for relocated splitter islands at the railway crossing. Hence, this driveway may require a different treatment to the eventual design concept to be developed for driveways in general.

Figure 15: Splitter island geometrically constraining driveway 11

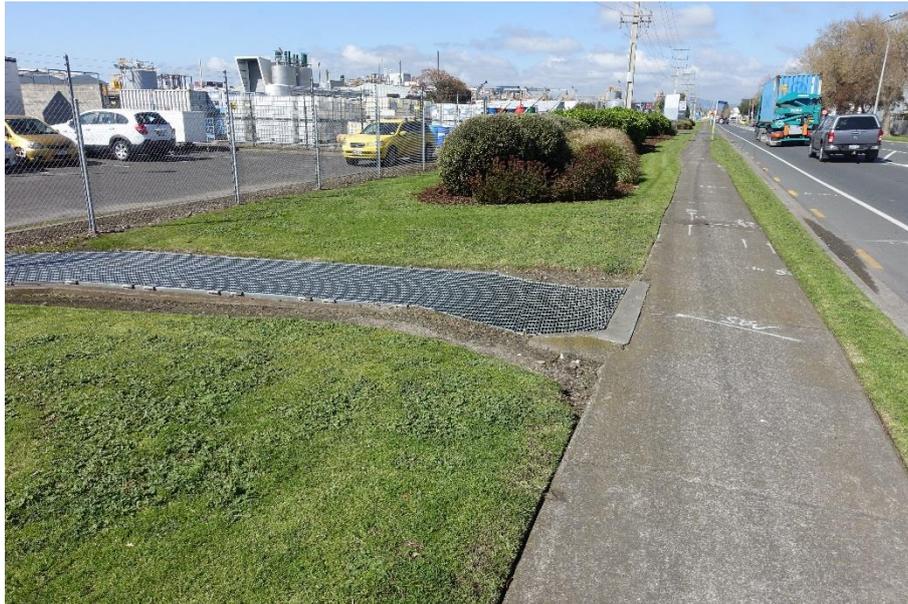
Sheet C06 shows a design note for a vehicle crossing to be reinstated. The feature visible on the aerial photo is not a driveway; it appears to be a drainage structure. This may be a drafting error.

Figure 16: Drainage structure outside 2 Triton Avenue

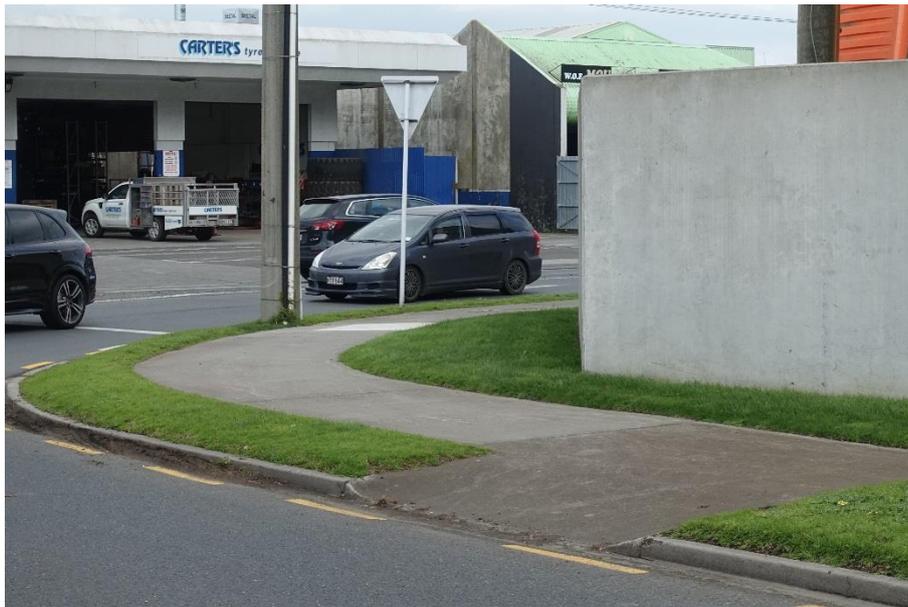
There is a surprising lack of provision for pedestrians at the Hull Road roundabout. There are no formal facilities to cross Totara Street, and the existing crossing point on the west arm has very poor intervisibility (see Figure 17). The auditors don't know whether it is within the brief of the consultant to address these issues, but there is as yet nothing shown on the scheme plan (sheet C08). There will be some pedestrian demand as service businesses (coffee, lunch, etc.) are on the east side of the road or further east along Hull Road, whilst the Port of Tauranga is a major employer.

Figure 17: Poor intervisibility from the western crossing point at Hull Road roundabout

The problem is that pedestrians either have no refuge (crossing east-west), or have very poor intervisibility from the southern side of the western crossing point. Given that drivers (including truck drivers) turn left into the port entrance at quite some speed due to excellent visibility to the east, this is expected to result in infrequent crashes. Such crashes that do occur are likely to result in death or serious injury. Therefore, the overall safety rating is moderate.

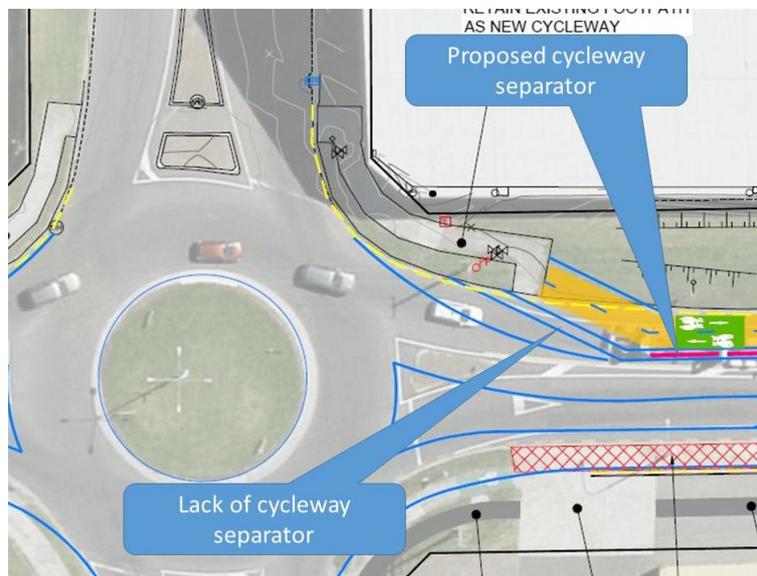
North of the roundabout with Hull Road, the proposed cycleway continues on the west side of the carriageway, separated from motor traffic with a proposed separator. As is shown in Figure 18, there is no separator where the cycleway transitions from the berm onto the carriageway. The alignment for drivers is such that they may inadvertently drive into the cycleway, instead of remaining on the carriageway.

Figure 18: Missing cycleway separator

This may result in occasional crashes between people cycling and motor vehicles. Such crashes are likely to result in death or serious injury. Therefore, the overall safety rating is moderate.

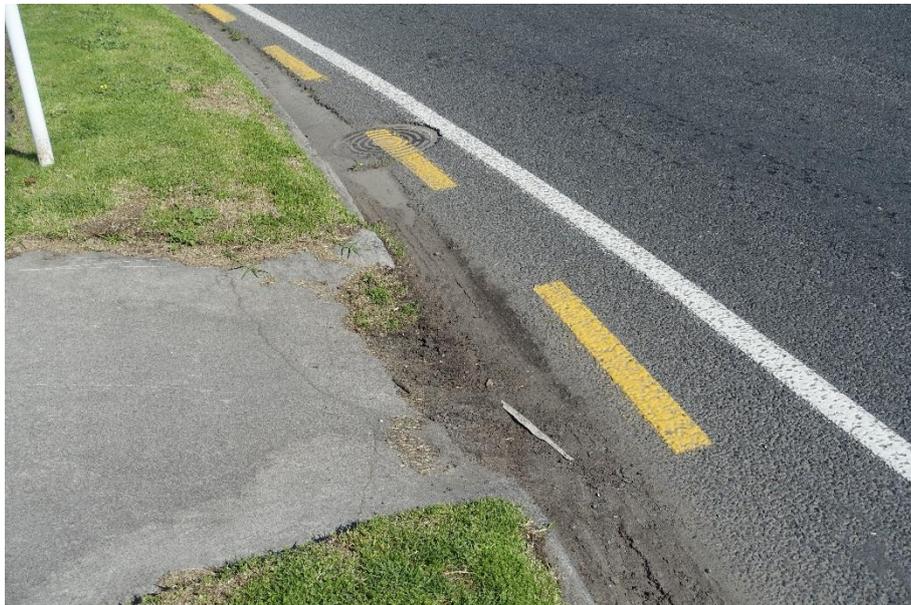
On Hull Road outside Carters Tyre Service, a low point has formed in the drainage channel right at the pedestrian crossing point. Consequently, mud accumulates here that forms a slip hazard when it rains.

Figure 19: Mud accumulates at the pedestrian crossing point outside Carters Tyre Service

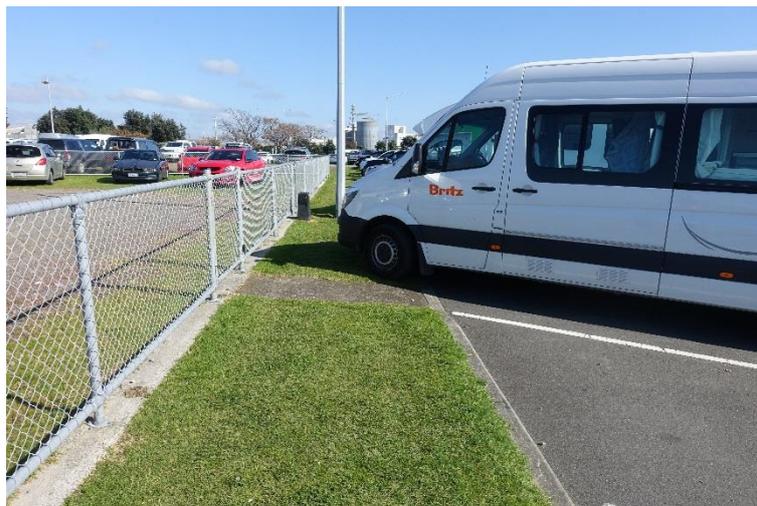
It is proposed to establish a shared pathway along what is now a grass berm adjacent to some angle parking. The concept design does not prevent for car bonnets to overhang onto the cycleway. Drivers of very long vehicles are even inclined to mounting the berm so that the rear of their vehicle does not overhang into the carriageway (see Figure 20). It is important to capture these issues during concept design, as this may determine whether parking on the opposite side of the road can be maintained or will have to be removed. Wheel stops may work, but they generally become a maintenance headache. To prevent intrusion onto the proposed facility, the kerb should be relocated, with a buffer strip between the angle parking and the cycleway, and a higher kerb provided so that mounting it is discouraged.

Figure 20: Overhang onto the grass berm

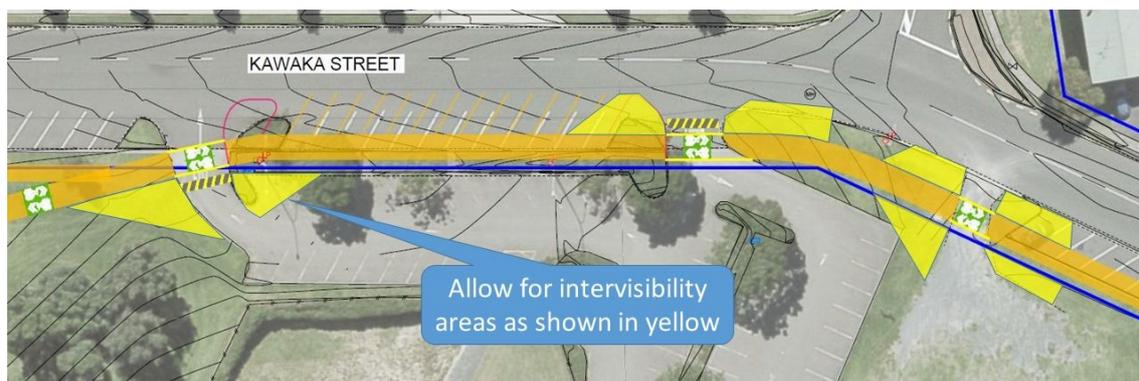
Given the parking demand at Blake Park observed during the site visits, it is clear that the driveways into and out of the Blake Park car parks will be busy. As explained elsewhere in this report, the most at-risk people are those cycling in a contraflow direction, i.e. in this case in an eastbound direction. That said, it is necessary to provide good intervisibility at and before the crossing points for cycle travel in both directions. It will be challenging to keep visibility splays unobstructed from informal parking, and it will be necessary to employ passive means like low landscaping, link and chain fences, or high kerbs. The yellow areas in Figure 21 may be those that need further consideration. This is based on our observations that the two western driveways operate as one-way, whilst the eastern one (shown in Figure 11) operates in both directions.

Consideration should also be given as to whether a judder bar is a sufficient calming measure, or whether a raised platform with reasonably short ramps could be more effective. We note that the eastern driveway does not appear to have received any treatment. The western exit, for example, could be squared up as part of this project, to further slow down drivers.

Figure 21: Intervisibility should be ensured for yellow areas

The interaction between people driving and cycling at driveways is often the primary safety issue for pathway projects. Crashes of this nature can be expected to be common, but they are unlikely to result in death or serious injury. Therefore, the overall safety rating is moderate.

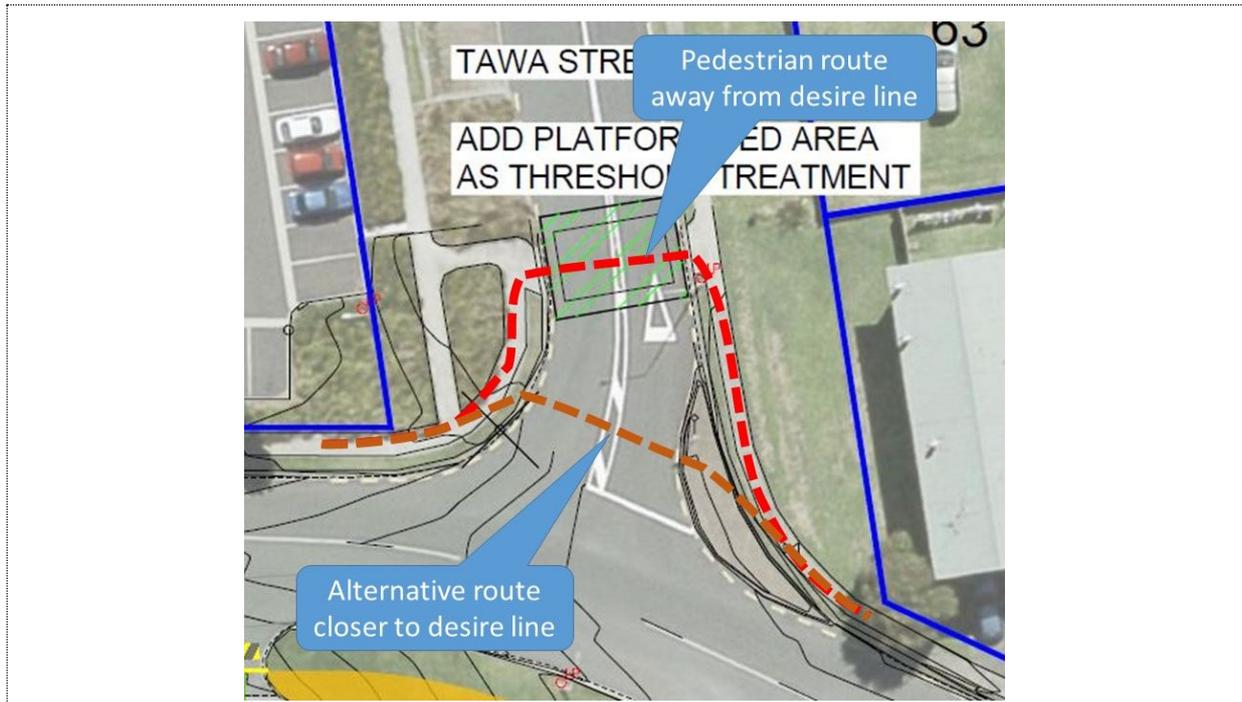
| The platform proposed for Tawa Street creates a circuitous route for pedestrians who want to walk along Kawaka Street. Figure 22 below shows a more logical route that should be allowed for as an alternative to the proposed detour. |

Figure 22: Tawa Street platform should support pedestrian desire line
