25 June 2021

Land Information New Zealand  
Private Bag 4721  
Christchurch 8140

**RE: Level 5-10 Foyer Assessment - RNZ House, 155 The Terrace, Wellington**  
**(Our Reference: 18960.000.001\_01)**

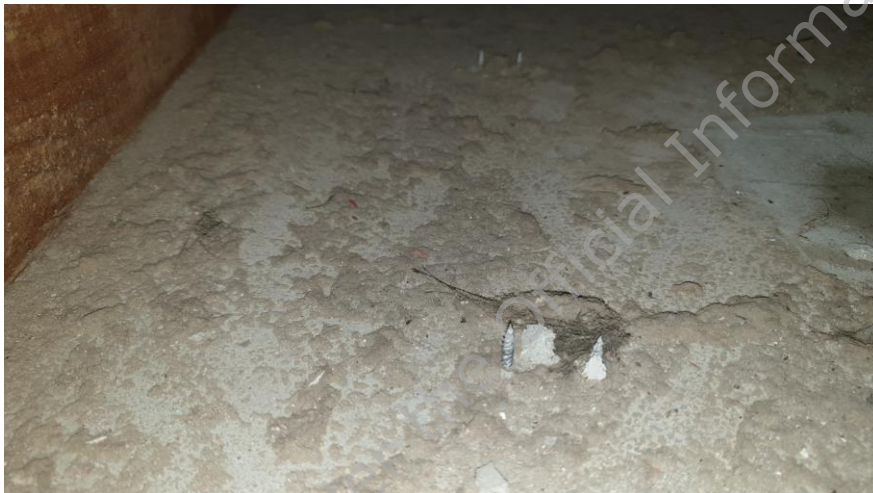
On level 10, the assessor was able to view the ceiling space through the access hatch and visually identified a potential asbestos containing material lining the top side of the plasterboard ceiling. This is presumed to be the original ceiling which has had plasterboard installed over at some point. The dust levels present is typical of what would be expected in a building of that age for an area which cannot be accessed and cleaned routinely.

A sample of the material was collected for analysis. The material appeared solid in nature and the chisel used to sample did not enter easily indicating the product was cement based rather than an insulation board. In addition the previous sample results indicated crocidolite, which is typically not present in AIB.

Photo 1: Cement based sheeting above level 10 ceiling.

Asbestos fibres were found to be present in the fibre cement sheet from the level 10 ceiling. The fibre cement sheet is located behind modern plasterboard lining on the ceiling. All other swab and bulk samples returned negative results when analysed for asbestos fibres (Certificates of analysis attached as Appendix 1).

As required by the Asbestos Regulations, the Asbestos Management Plan should be updated to reflect this additional information. The material should be routinely inspected (every two years is recommended), and its presence should be made known to site occupants or sub-contractors who may be required to work on the material or near to it.

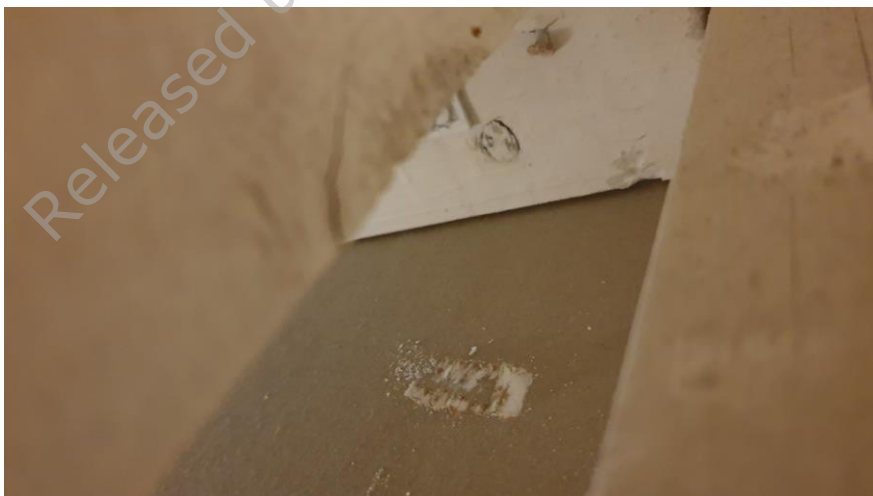
Though hard to access, the surveyor was able to assess the material from the lobby. The sampling tool was inserted into the underside of the ceiling to assess what type of material was present. On levels 6-9 the chisel easily entered a material and white powder came out on the chisel, consistent with plasterboard dust. On level 5, the chisel was met with a hard surface and the sound was consistent with what would be expected from a cement based sheeting. A camera was also inserted through the gap to collect photographs of the material to assist with identification. The damage caused by the sampling chisel is again visually similar to that expected for plasterboard.

Photo 2: Example of plasterboard ceiling levels 6 – 9.

No potential ACM was observed on levels 6 – 9 in the areas previously identified as containing high-risk asbestos insulation material. Based on our visual assessment it appears modern plasterboard is present and attached directly to timber framing.

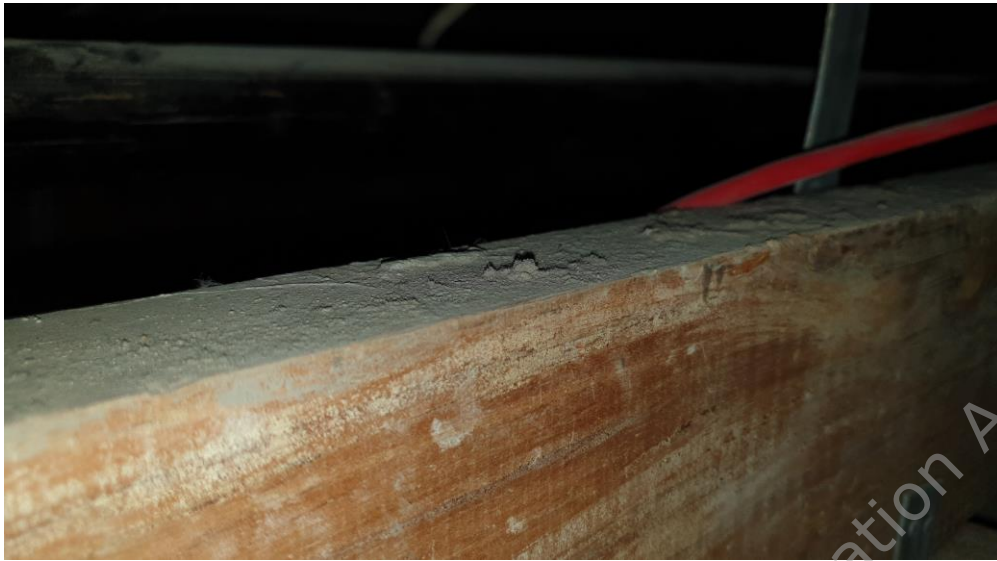
A sample of dust from surfaces in the area (not the cement sheet) was also collected for analysis. One air monitor was placed in the ceiling space within Level 10.

Photo 3: Example of dust loading on surfaces within ceiling space above level 10 lobby to access hatch.

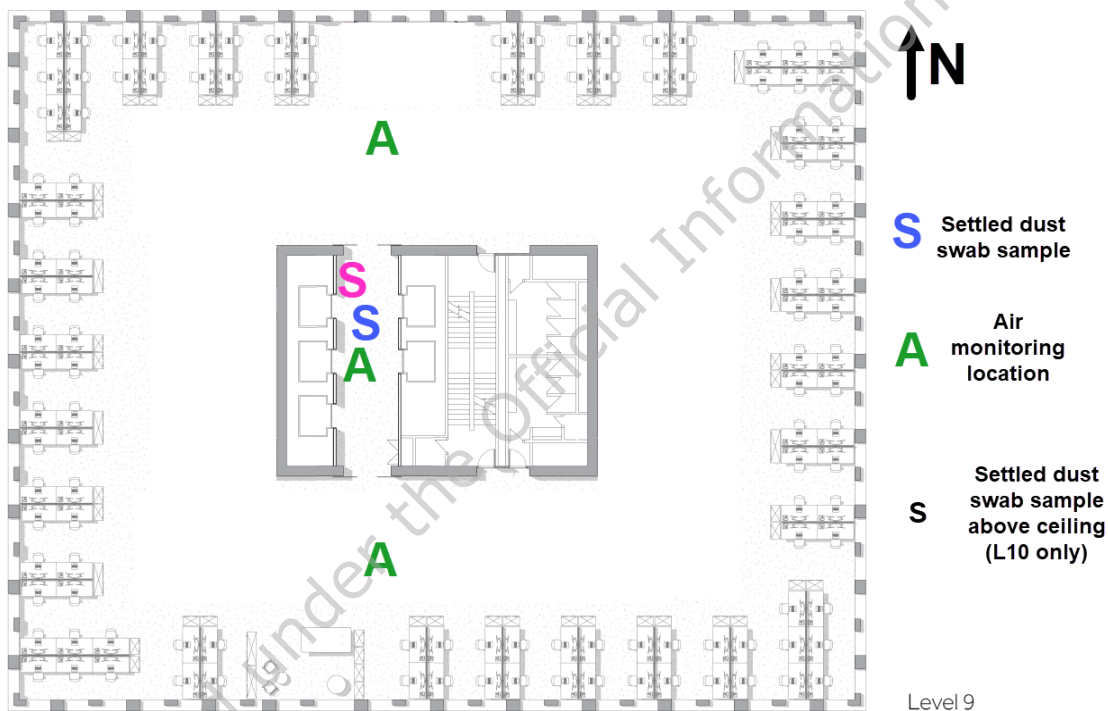
Figure 3: Sampling Locations Levels 5 – 10

To assess the air within each work space, one air monitor was set up within the lobby area, a second air monitor was set up to the north of the elevator lobby entrance and a third monitor on each floor was placed to the south of the lobby entrance (Refer to Figure 3). The sampling locations were chosen to be directly beneath the identified ACM in the AMP and also located in the likely pathway between the ACM and the closest workspaces. The sampling locations are sufficient to assess the air in those workspaces from the identified ACM in the lobby.

All air monitors were reported by the laboratory to have an asbestos concentration of <0.01 airborne asbestos fibres per millilitre (f/ml) of air sampled (Certificate of Analysis 21-26574). The laboratory limit of detection for this method, or the minimum concentration that can be detected with this method using Phase Contrast Microscopy (PCM) is at 0.01 f/ml. This concentration, 0.01 f/ml is also equal to the 'trace level' set within the Asbestos Regulations, which is defined as the amount of respirable asbestos fibres in the air that is permitted before action needs to be taken to prevent exposure to asbestos in an asbestos removal area.

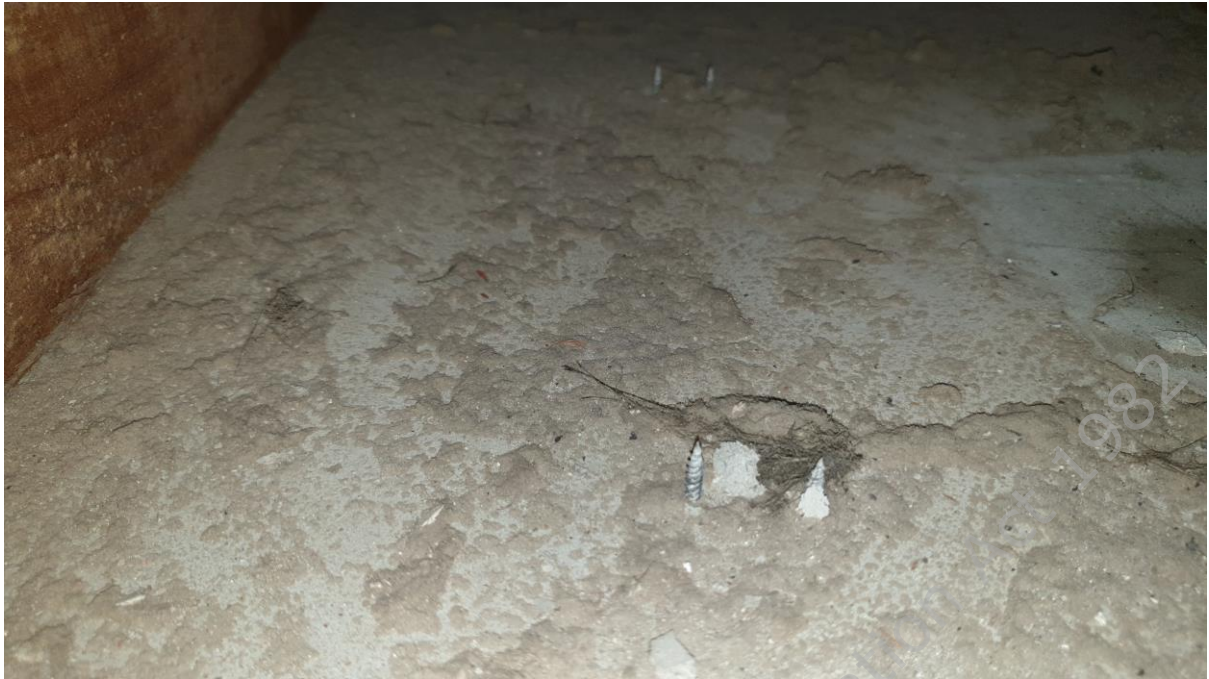
Level 10 cement sheet

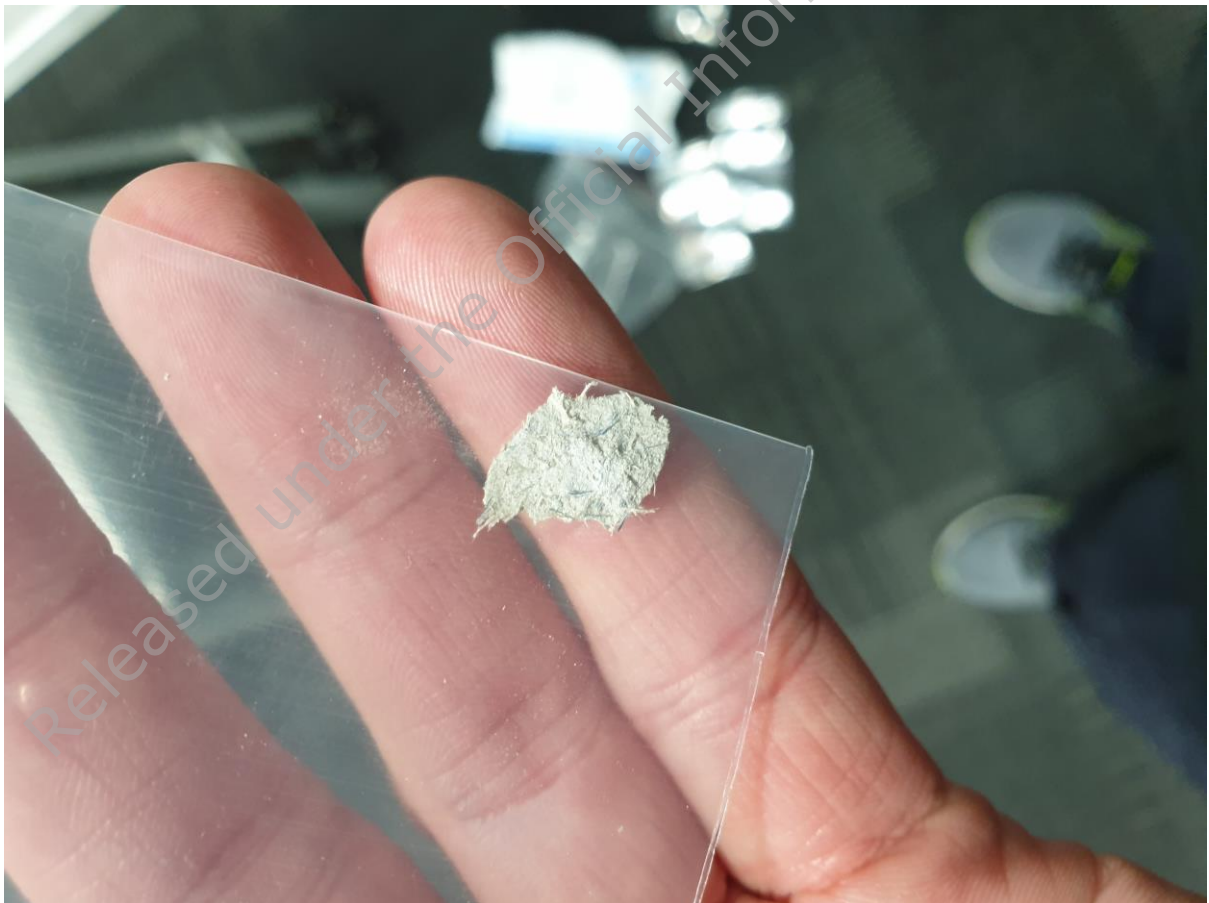
Cement sheet sample

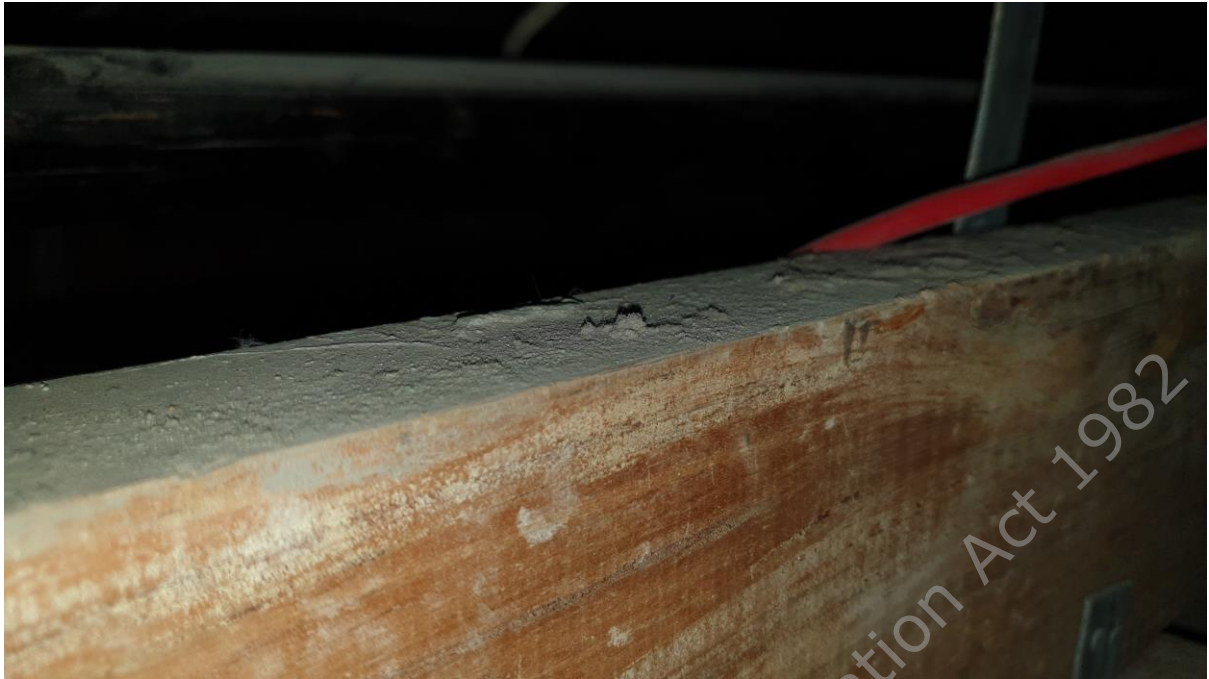
Example of dust in level 10 ceiling.

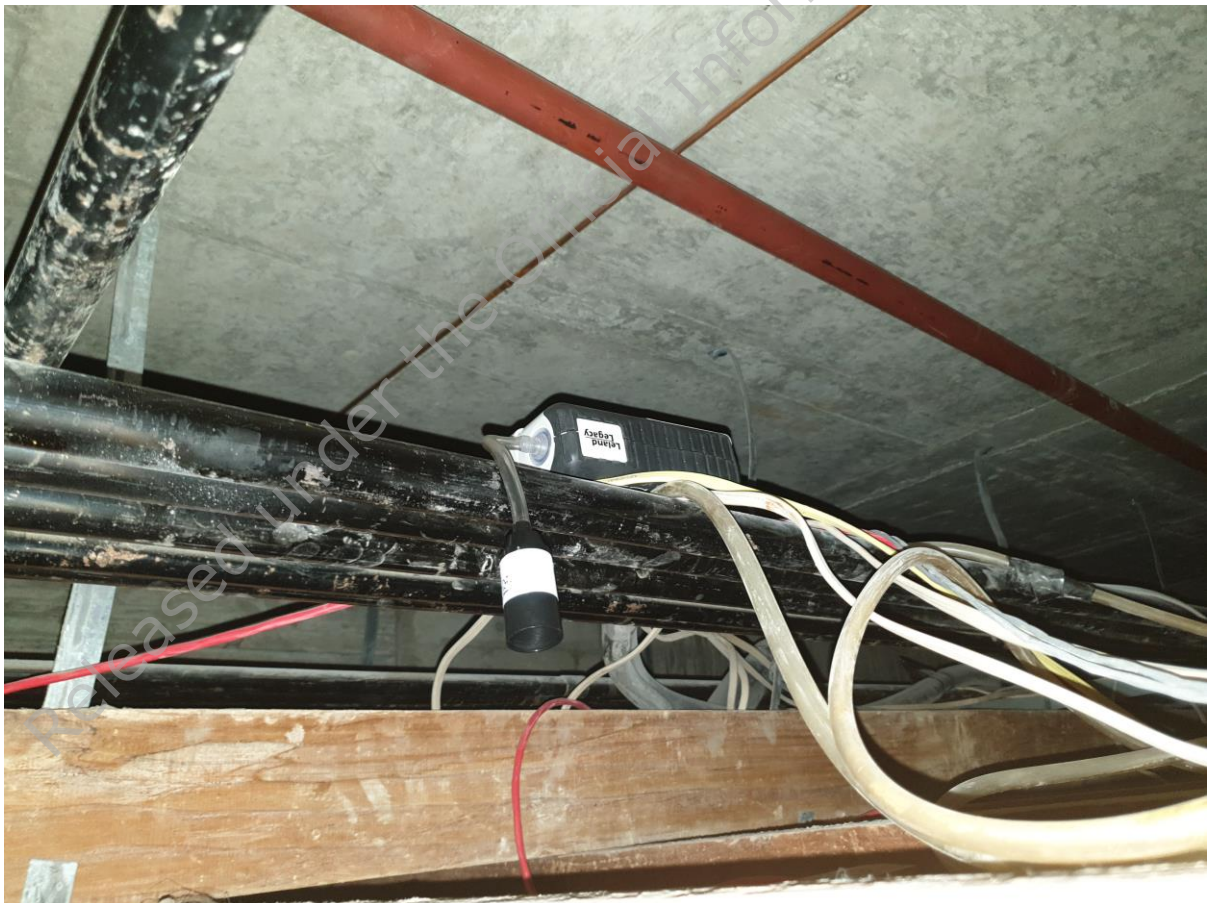
Air monitor in level 10

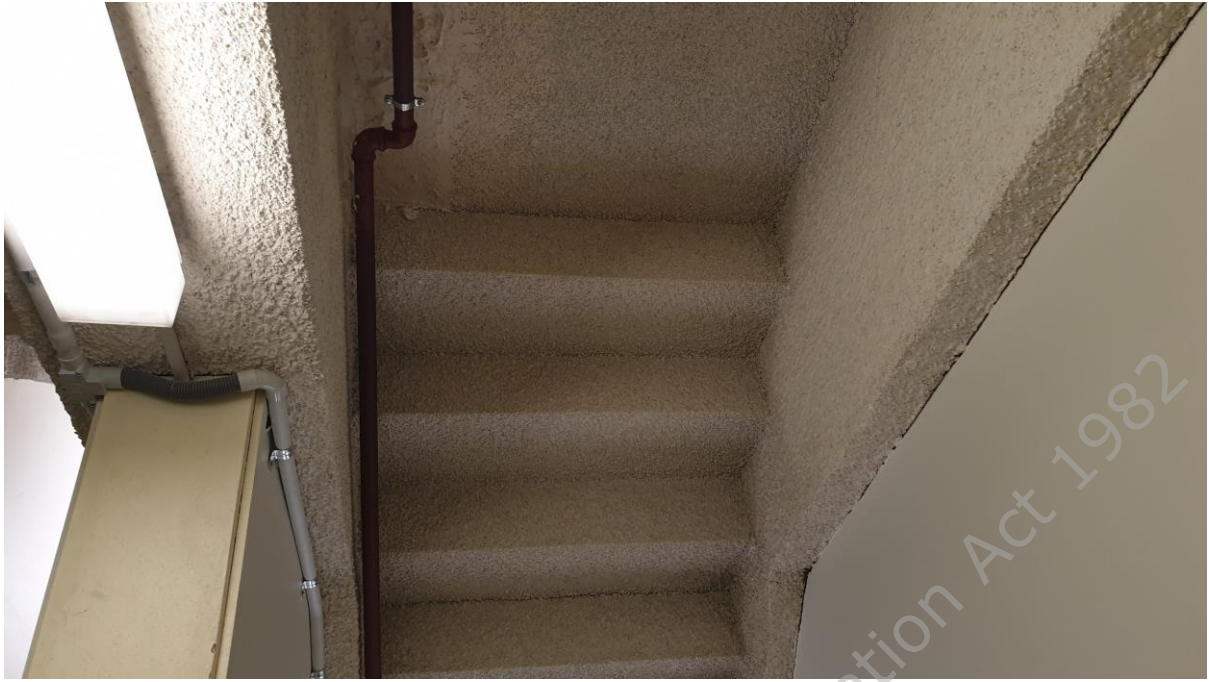
Stairwell spraycoat
