Final report AO-2013-010: Aérospatiale AS350B2 'Squirrel', ZK-IMJ,  
collision with parked helicopter, near Mount Tyndall, Otago, 28 October 2013

Aviation inquiry AO-2013-010

Aérospatiale AS350B2 'Squirrel', ZK-IMJ,  
collision with parked helicopter  
near Mount Tyndall, Otago  
28 October 2013

Approved for publication: June 2017

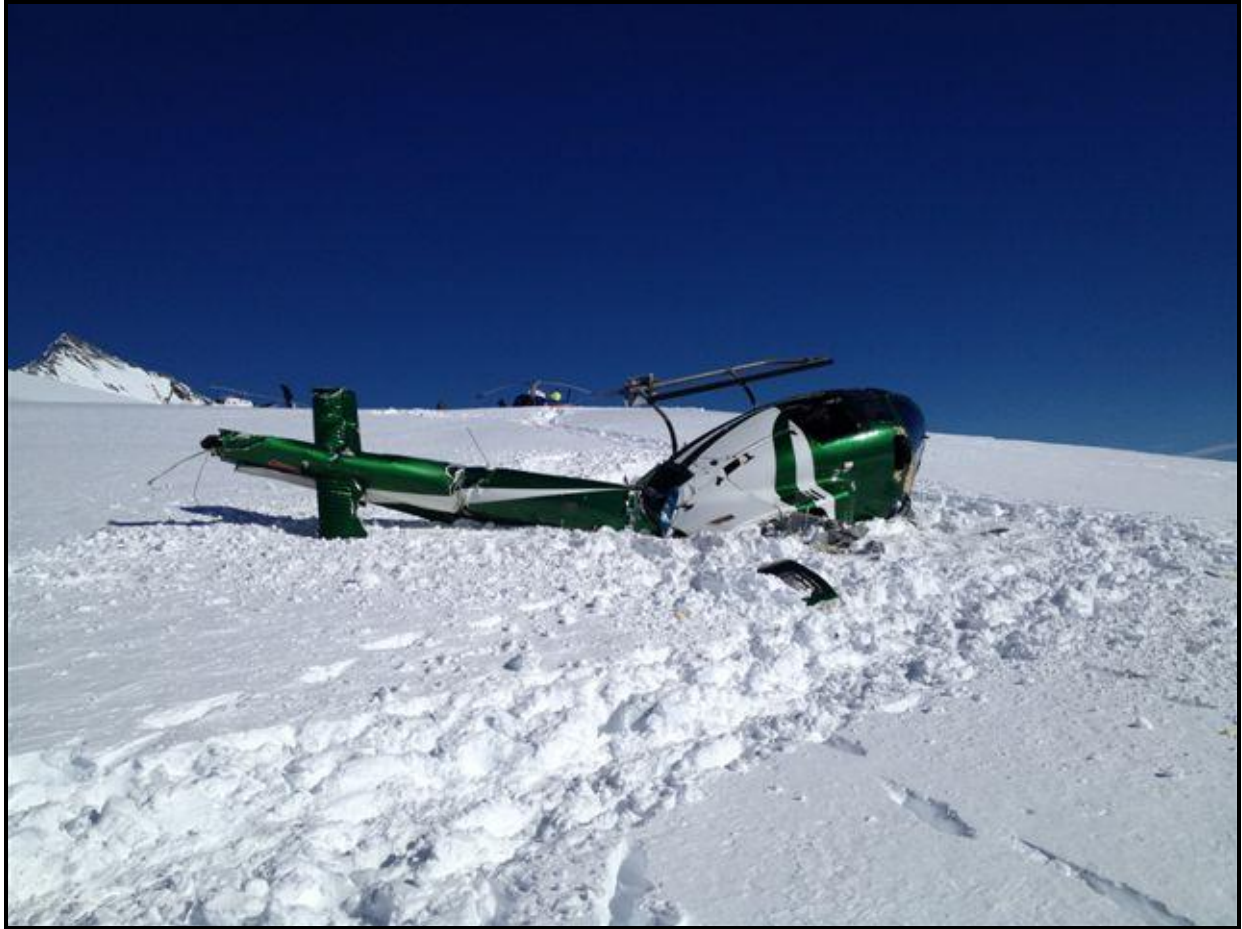
The accident scene, with ZK-IMJ in the foreground and ZK-HAE in the background

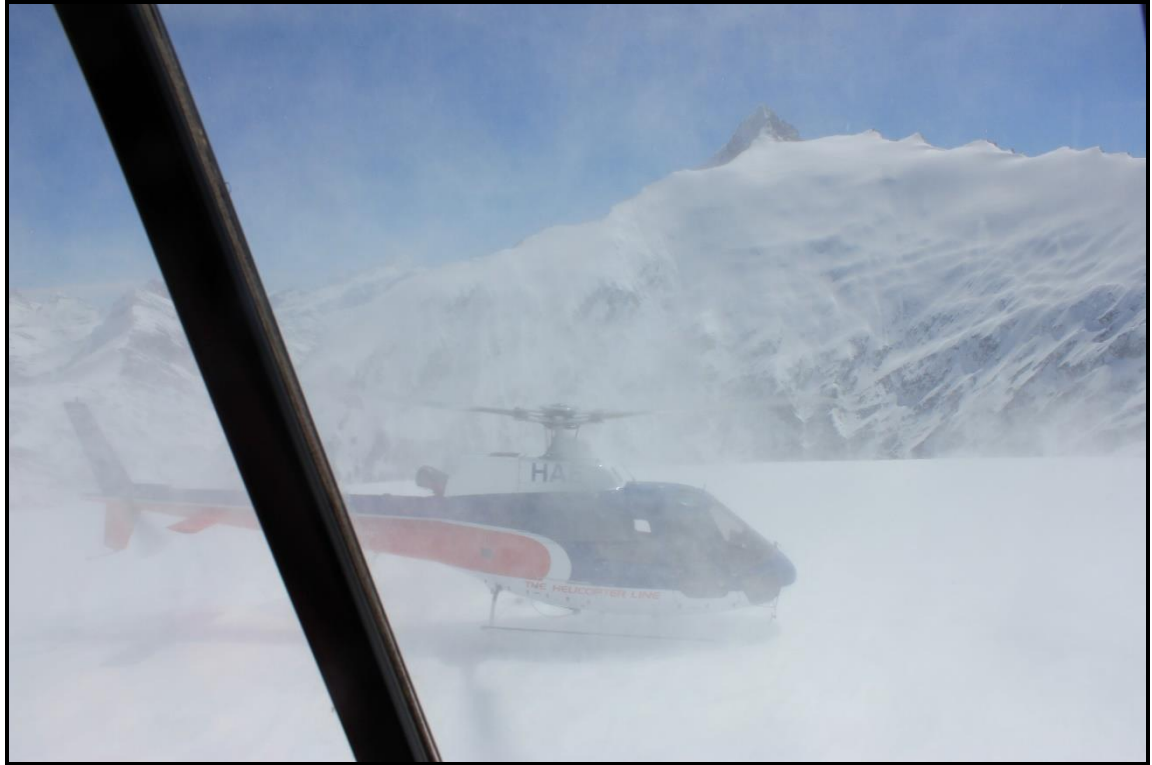
**Figure 1**  
**The parked helicopter as seen on the go-around from first approach**

- 3.1.9. The helicopter continued to move towards the parked helicopter until its lower vertical stabiliser and tail rotor hit the main rotor blades of the parked helicopter. The tail rotor assembly and vertical fin separated from the helicopter and fell in front of and to the right of the parked helicopter.

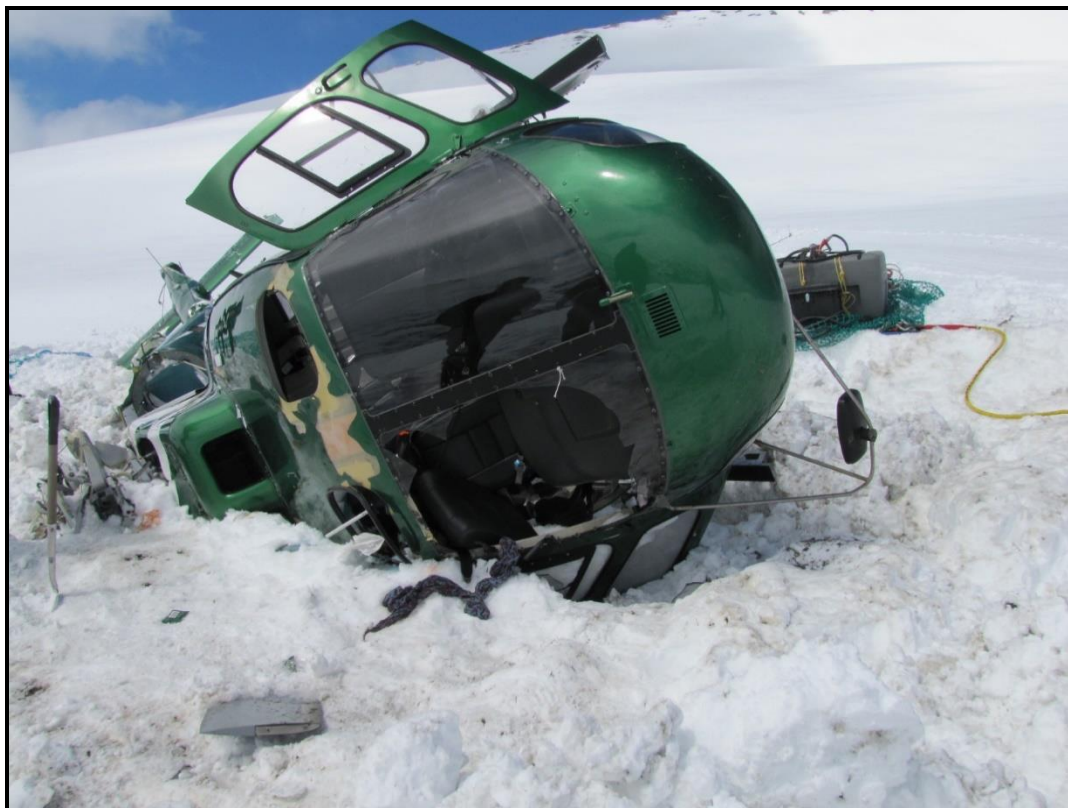
**Figure 2**  
The helicopter after the accident (with de-fuelling kit alongside)

3.3.1. The helicopter came to rest on its right side (see Figure 2). The main rotor blades were attached but had shattered from striking the snow while under power. The tail assembly had fallen about 15 m in front of and to the right of the parked helicopter. The severed lower vertical stabiliser was located, but the removed section of tail rotor blade was not found. The front-left cabin door was detached in the ground impact.

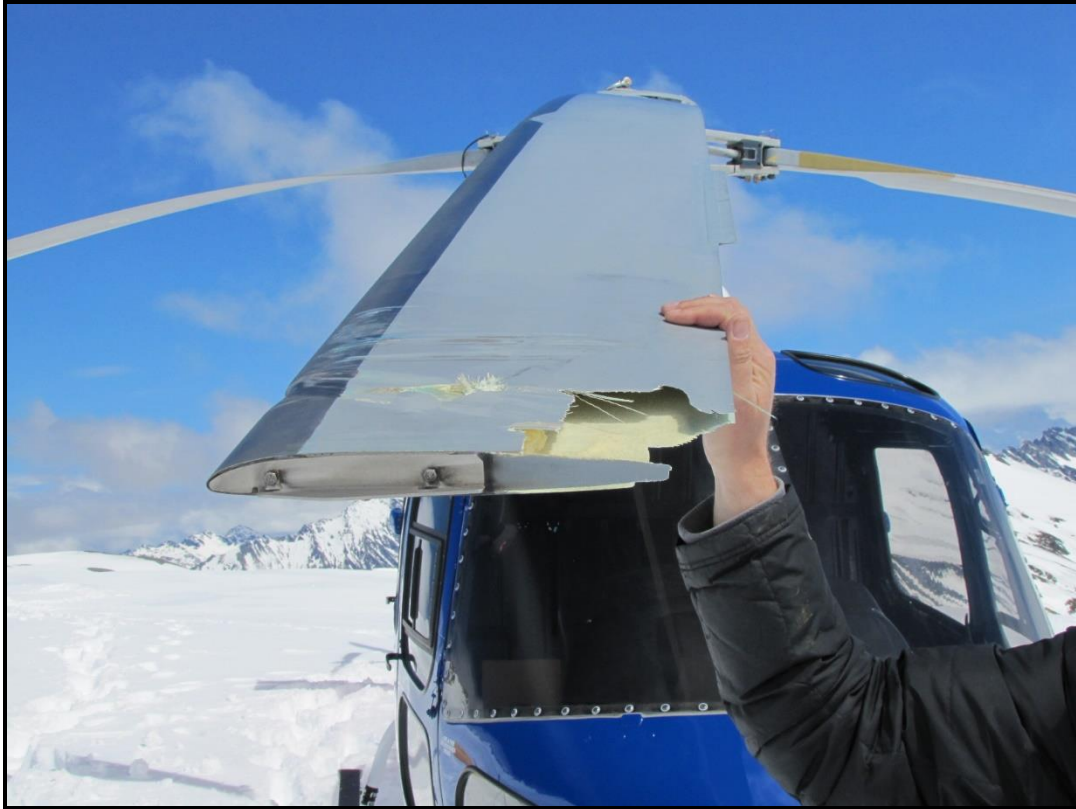
**Figure 3**  
Typical damage to the main rotor blades of the parked helicopter

3.3.2. The visible damage to the parked helicopter was confined to the outermost half-metre of each of the three main rotor blades (see Figure 3). The main rotor head and main transmission were subjected to shock loading when the main rotor struck the airborne helicopter, and had to be replaced.

3.7.13. The visible damage to the parked helicopter was confined to the outermost half-metre of each main rotor blade. However, later examination determined that the main transmission and mast needed replacement.
