Transport Accident  
Investigation  
Commission

# Final report

***Aviation inquiry A0-2019-003  
Diamond DA42 aeroplane, ZK-EAP  
Controlled flight into terrain  
Kaimanawa Range, near Taupō  
23 March 2019***

November 2021

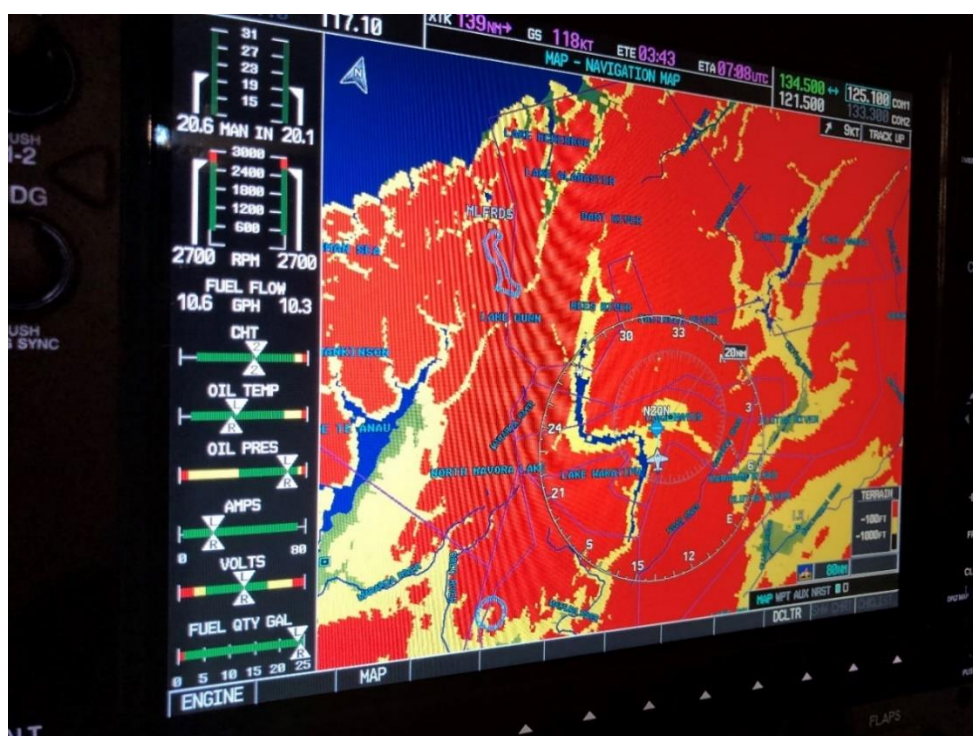
- 2.31. The G1000 system manufacturer offered an optional augmentation to the terrain-conflict-proximity functionality. The augmentation consisted of a secure digital card<sup>19</sup> that unlocked the Class-B Terrain Avoidance and Warning System.<sup>20</sup> The operator had not purchased this augmentation for its DA42 aeroplane fleet.

**Figure 5: The G1000 multifunctional display moving map, showing a graphical presentation of the terrain-conflict-proximity function (not representative of the flightpath of the accident aircraft)**

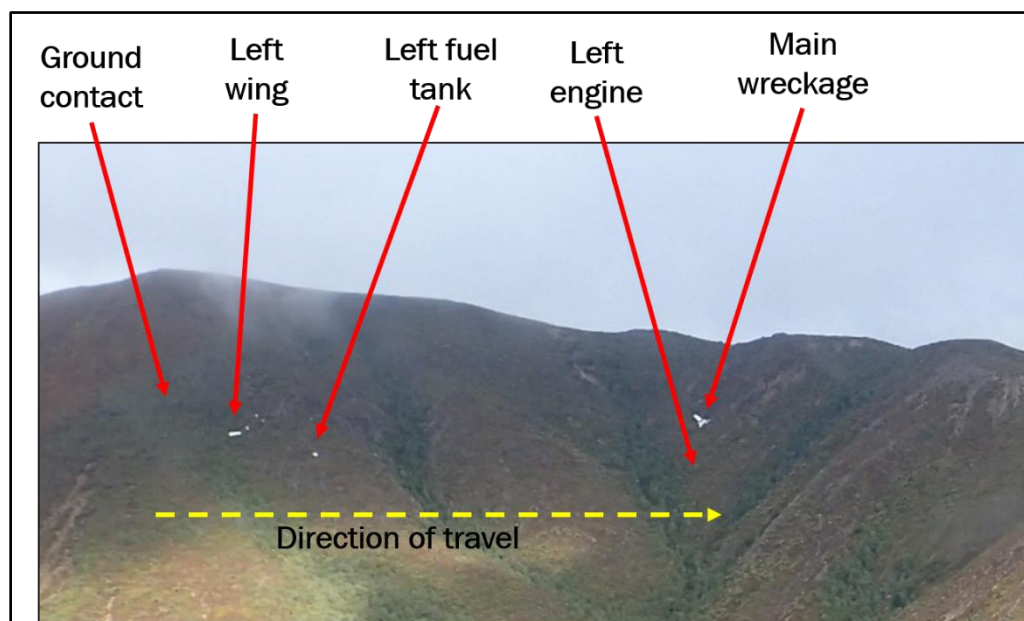
**Figure 8: Accident site**

- 2.36. The accident scene was situated at 4,500 feet (1,371 m) on sloping ground in the Kaimanawa Range, approximately 38 km south of Taupō Aerodrome (see Figure 2).
- 2.37. The aeroplane had first hit the ground with the left wing tip. The left wing had separated as a result. With the terrain sloping away, the remainder of the aeroplane had continued in the general direction of the original flightpath for a further approximately 250 m before striking the northern face of a gully. The initial ground scar made by the left wing tip and the location of the wreckage showed that the aeroplane had been in about a straight and level attitude when the ground strike occurred (see Figure 8).

- 2.38. The blades on the left and right propellers had shattered, and shards of wood had been dispersed widely throughout the first 100 m of the accident scene. The main portion of the aeroplane comprising the fuselage, right wing and right engine indicated the end of the wreckage trail. The right engine had separated structurally from the wing but remained attached to the wing by electrical cables. The left engine was found embedded in the ground nearby. There was no evidence of a fire having occurred.

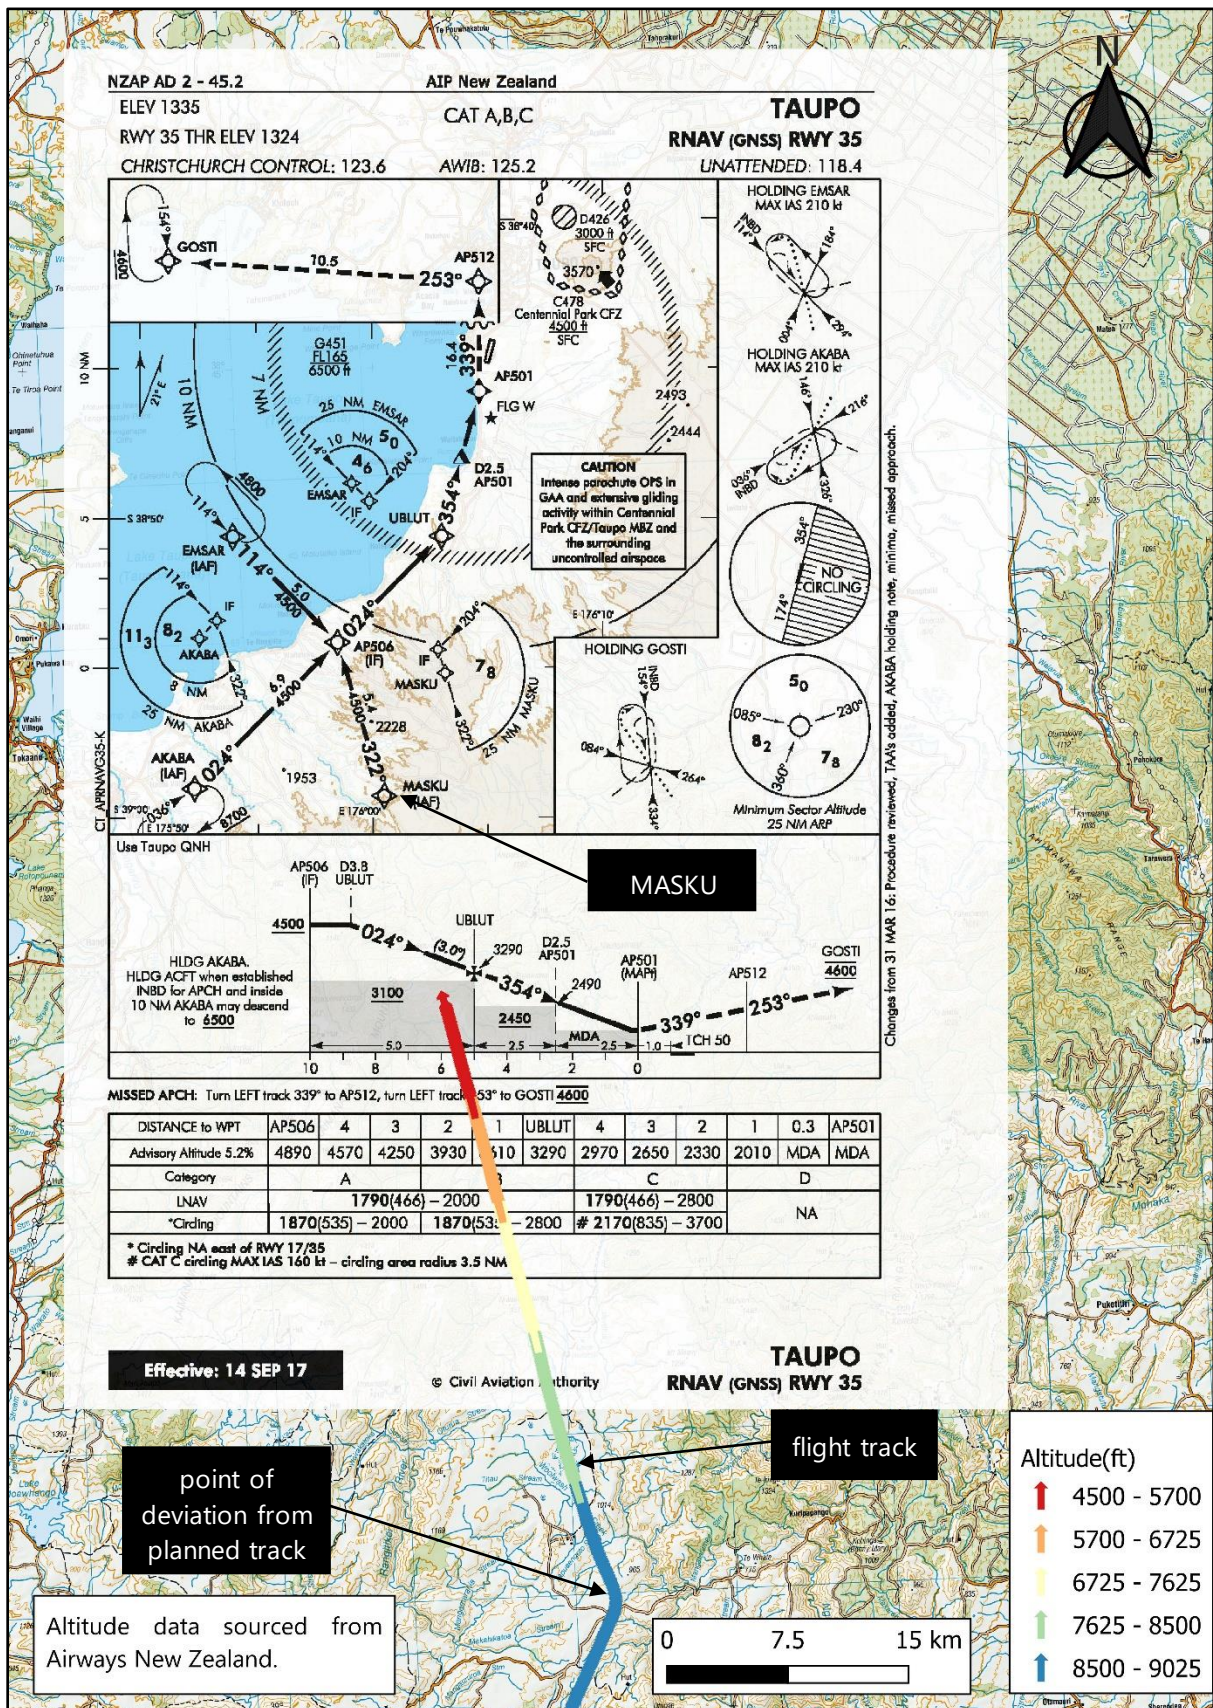
**Figure 9: Taupo RWY 35 RNAV Aeronautical Information Publication Approach Plate scaled, georeferenced and superimposed on LINZ Topo250 map, with surveillance data showing deviation and track direct to reporting point MASKU**

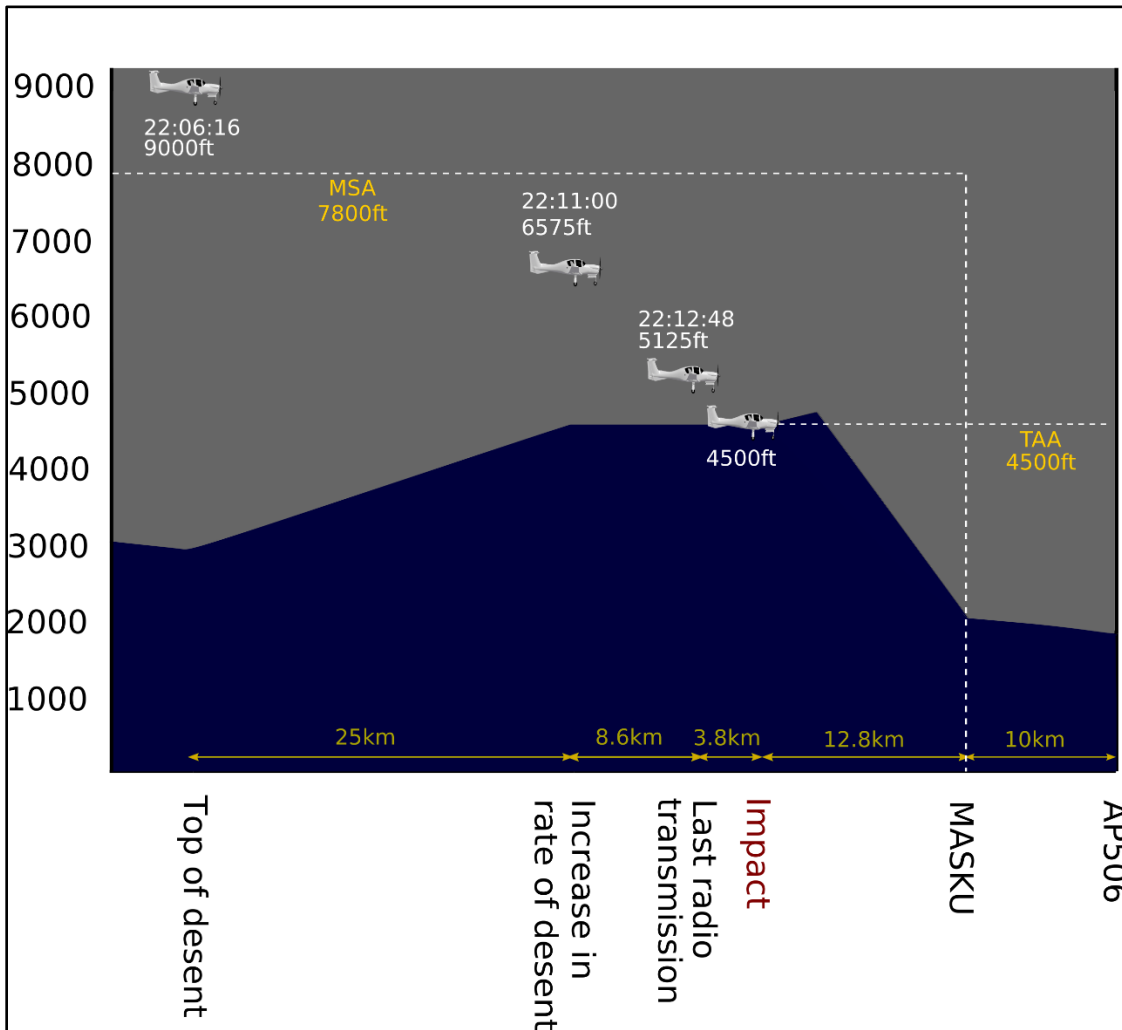
Figure 10: Relationship between flight profile and MSA/terminal arrival altitude

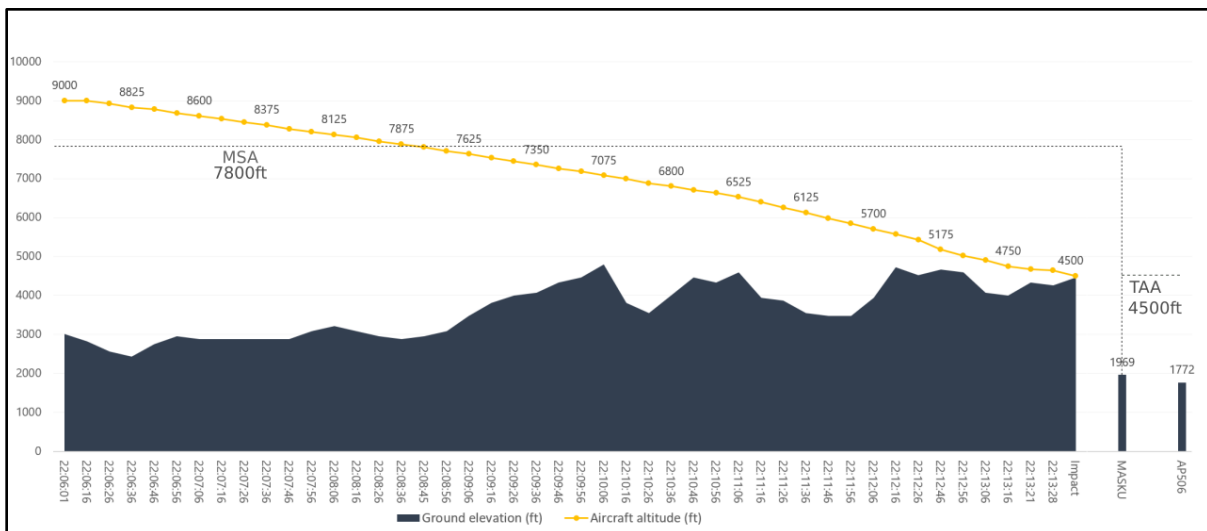
Figure 11: Flight profile from top of descent to ground impact
