Waitomo District Council

Queen St, Te Kuiti, Waikato

Detailed Seismic Assessment 2019

August 2019

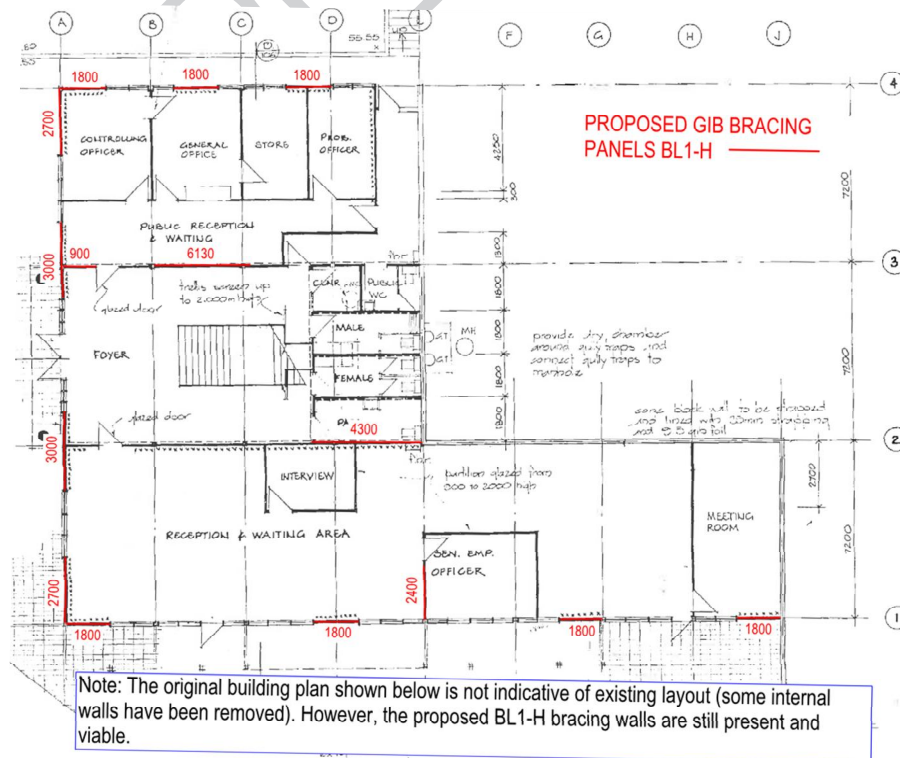
Figure 5: Ground Floor GIB Strengthening Plan

The main structural weakness of this building is considered to be the type and number of bracing panels in the upper and lower floor of the double-storey portion of the building. The panels are 9

mm Plywood (Grade D) fixed at 300 mm centres with 3.15 mm diameter nails. The bracing capacity of these panels does not satisfy the seismic demand imposed upon the building at both the upper and lower floor, in both the longitudinal and transverse directions.

To strengthen the structure in both the along and across directions, GHD recommends replacing all existing Plywood bracing panels with GIB Bracing Panels (type BL1-H). The proposed installation locations for the ground floor and upper floor are shown in Figure 5 and Figure 6 respectively.

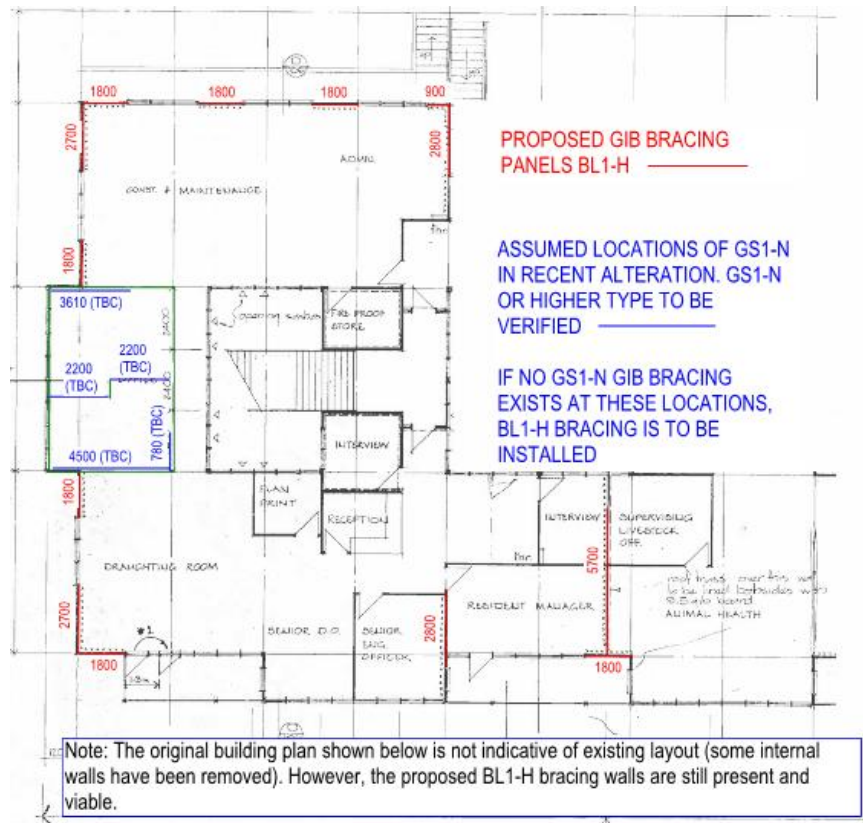
Figure 6: Upper Floor GIB Strengthening Plan

The upper floor obtains %NBS scores of 41% and 40% in the longitudinal and transverse directions respectively. The lower floor %NBS scores are improved from 22% and 12% to 100% in the longitudinal and transverse directions respectively. The increase to 100% NBS is due to the blockwall retaining wall which runs along the perimeter of the lower floor. This blockwall contributes significant bracing capacity in both directions. In the absence of this blockwall, the bracing panels alone would not satisfy the seismic demands on the building to a degree of obtaining a 'very high risk' score.

If there are no bracing panels along these walls, it is recommended that BL1-H GIB panels are installed as shown in blue above in Figure 6.

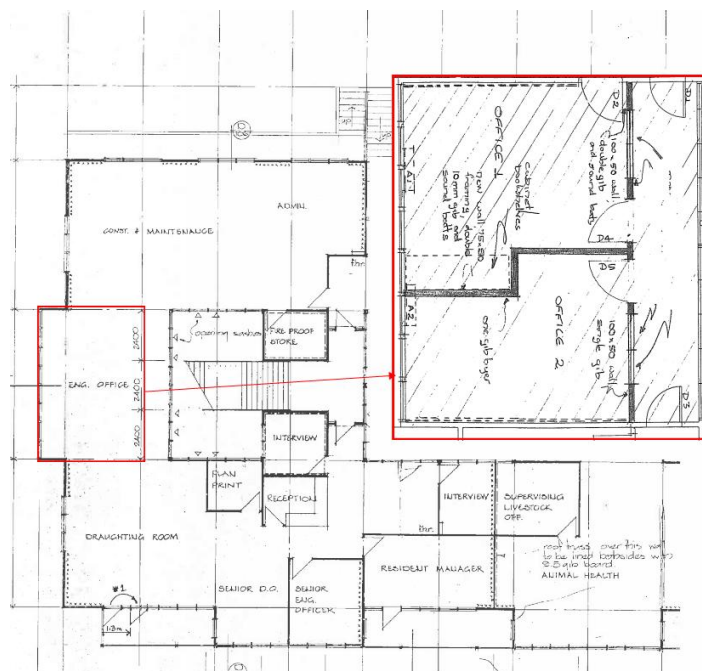
Figure 7: Undated office wall alterations

Note: The image outlined in red above was provided to GHD by WDA. It an undated alteration plan and did not appear to belong to a larger drawing set. The additional walls shown in this alteration plan were visibly verified to exist on site. The dimensions will need to be verified on site to confirm those dimensions shown in blue scaled by GHD in Figure 6.

In addition to replacing all existing panels with BL1-H as shown above, it is recommended that the upper floor office walls constructed in the most recent alterations are verified to have GS1-N bracing panels (or higher capacity type). See Figure 7 for locational context.

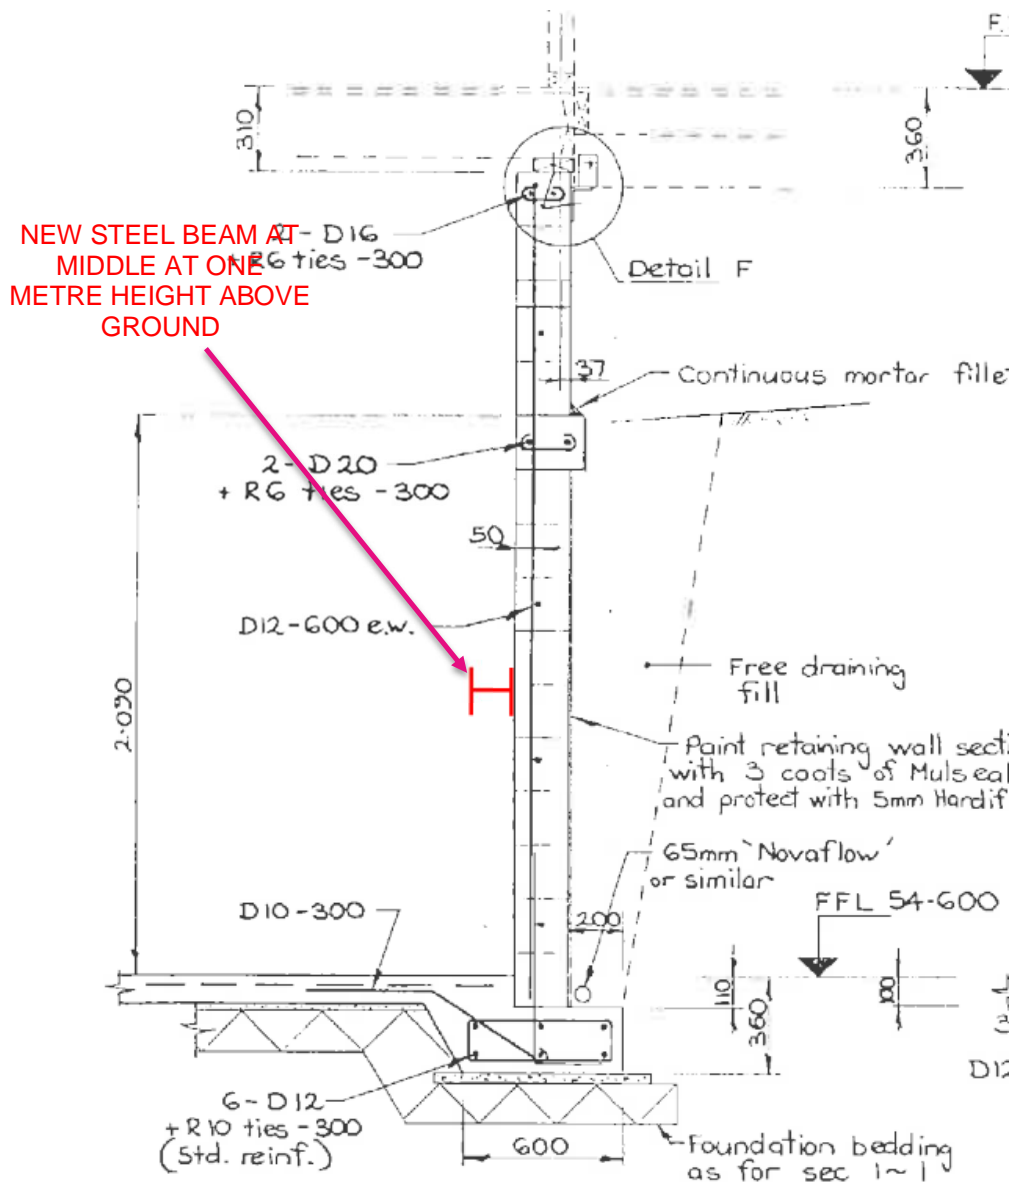
Another structural weakness of the building is the blockwall retaining wall that runs along the rear perimeter of the ground floor. The wall obtained a score of 59% NBS for flexure and the bond beam scored 52% for shear. In the event of a seismic event, it is likely the wall will fail in flexure and the bond beam in shear.

To strengthen the blockwall retaining wall elements, installation of a 150 UC steel member along the wall at mid-height between the bond beam and the wall foundation can be done. See Figure 8 below. The effect of providing an additional steel support along the wall will bring the %NBS score to above 67% for both wall element shear and flexural capacity.
