Project Number: 5-C4006.00

# Petone to Melling Cycleway

## Pre-Opening Road Safety Audit

28 May 2024

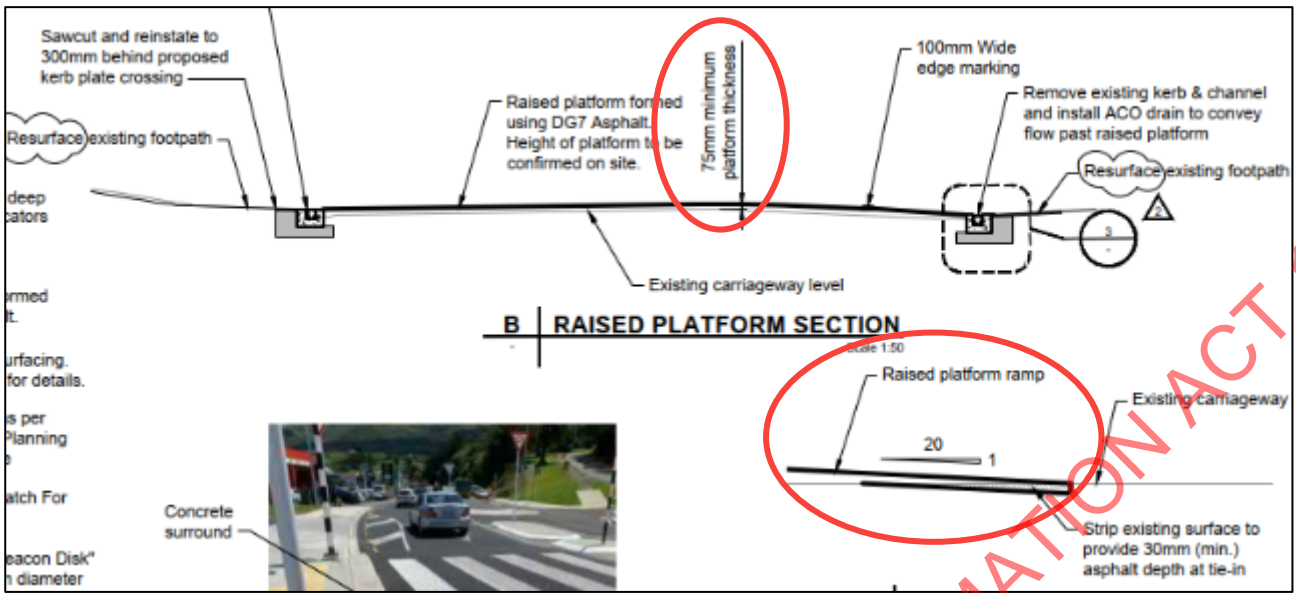
Figure 2: Raised crossing details from detailed designs.

From the designs, the ramp gradient is shown to be 1:20 and the minimum platform height is shown as 75mm as shown below. From Waka Kotahi's Pedestrian Network Guidance<sup>2</sup>, it is recommended that a 1:15 ramp gradient is selected for a 30km/h speed at the platforms, and that a 1:20 ramp gradient is selected for a 40km/h speed. Additionally, a 100mm high platform is recommended and a 75mm high platform minimum is only to be used if there are a high volume of trucks anticipated. As shown below, the risk of death for a pedestrian/cyclist vs. vehicle collision at 30km/h is around 10%, but at 40km/h is around 45%. The speeds to avoid serious injury are lower again.

- 1 Confirm the in-situ platform height and ramp geometry in comparison to the Pedestrian Network Guidance standards, and survey vehicle speeds at the crossing.
- 2 If required, reconstruct the platform to achieve a speed reduction to at or below 30km/h.
- 3 Consider speed humps/cushions in advance of ramp.
- 4 Replace the '15' hump advisory speed supplementary plates with a more realistic speed closer to the platform geometry, i.e. '35'.

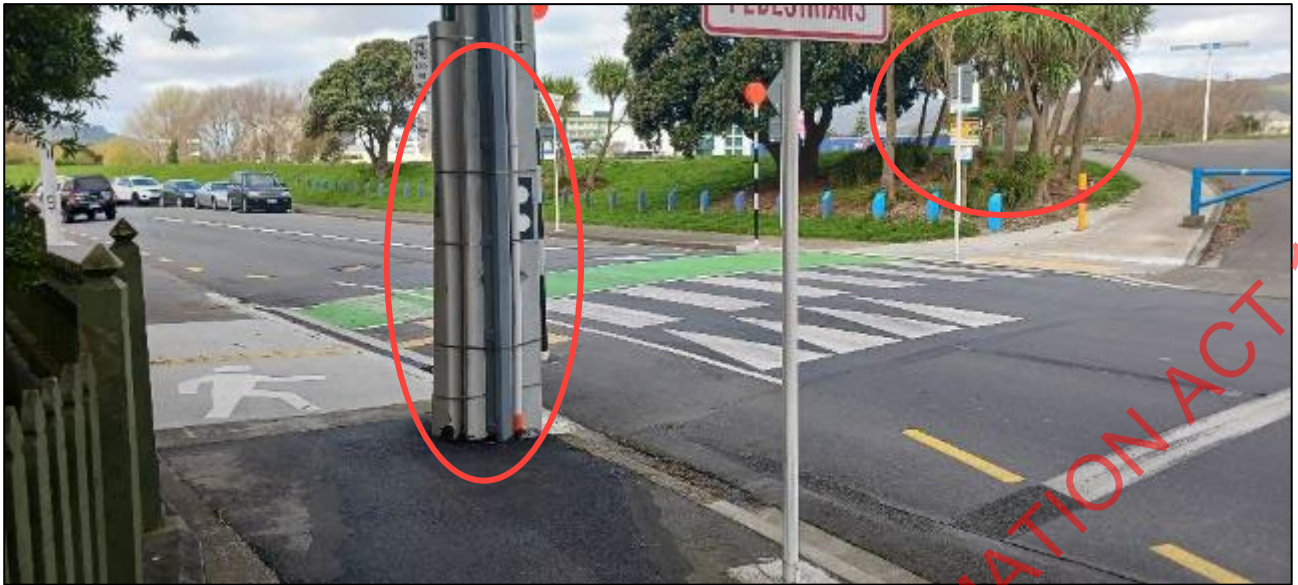
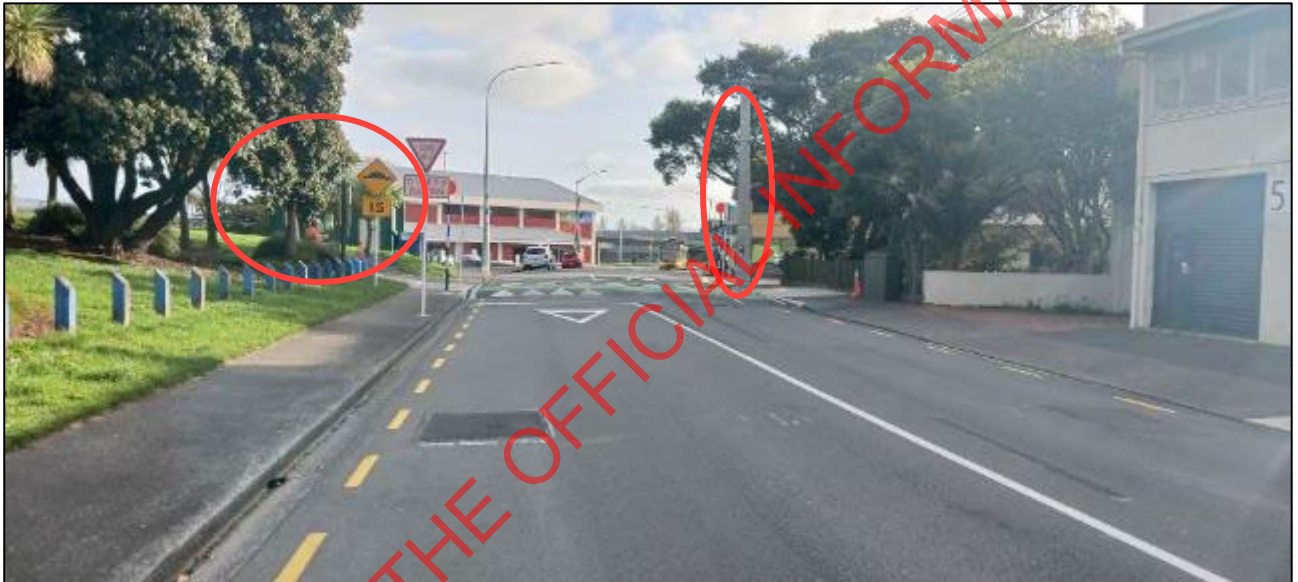
Figure 4: Intervisibility issues at Marsden Street raised crossing.

One other possible way where intervisibility may be obscured between drivers and crossing users is in the morning, when there is a risk of sunstrike due to the north-south alignment of Marsden Street aligning with the sun's position near the horizon at certain times of year. This is likely to be more of an issue in Winter when the sun rises further north and when the morning peak period coincides with sunrise. See Figure 5 below, from Google Street view in June 2021.

<p><b>Safety Engineer:</b></p>	<p>Discuss vegetation removal with GWRC. Consider a pair of safe hit post or cycle separator to accentuate edge of roadway                  HCC: in principal would support improved kerb delineation.                  Approval subject to reviewing site and final treatment proposal.                  Signage should be reviewed when road realigned.</p>
<p><b>Client Decision:</b></p>	<p><b>Hazard is significant and should be addressed. Undertake early removal of vegetation to improve sightlines (to be removed anyway as part of future stop bank works).</b>                  Improve kerb delineation at northbound approach through installation of cycle separators.                  The crossing and eastern approach will be redesigned by Te Awa Kairangi project in 12-24 months as part of the road reconfiguration.</p>
<p><b>Action Taken:</b></p>	<p>Included in package of works to contractor – confirm cycle separator placement with HCC and approval for tree pruning from GWRC first.</p>

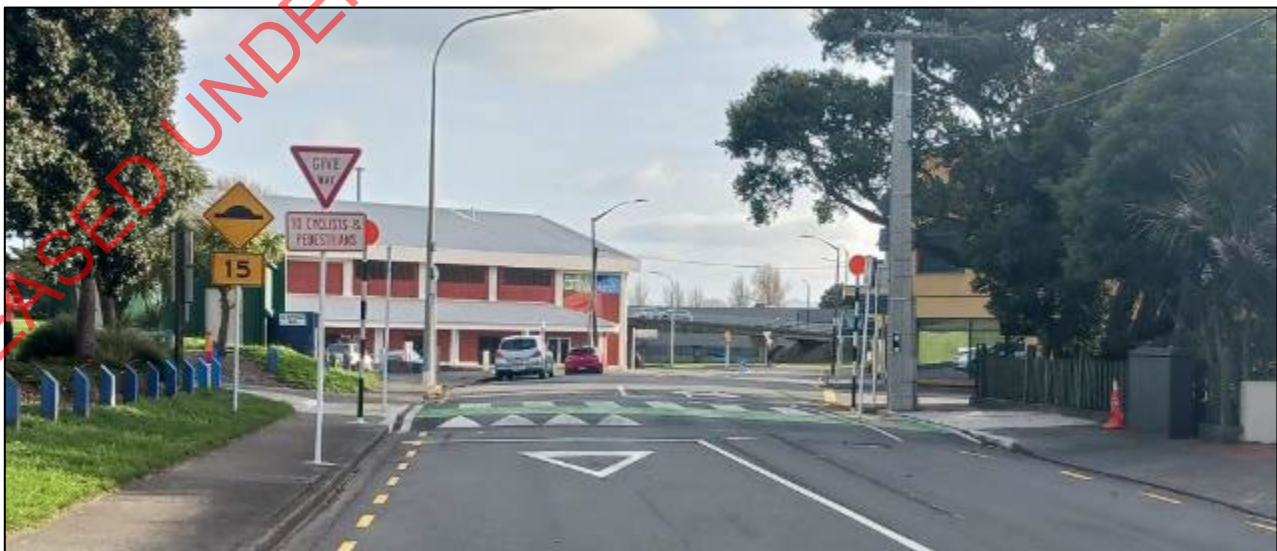
Figure 6: Marsden Street raised crossing.

Cycle priority crossings are a relatively new feature in New Zealand which some drivers may not be aware of, so particularly for cyclists there is a risk approaching drivers do not recognise they need to yield.

Frequency:	Severity:	Rating:
<i>Crashes are likely to be Infrequent</i>	<i>Death or serious injury is Likely</i>	<i>The safety concern is Moderate</i>
<b>Designer Response:</b>	The Designer recommends installing cushions (to the locations shown on Dwg LS-0030 Rev 5) on the approaches to the crossing will help slow speeds for those drivers not aware of recent changes to the TCD manual and minimise crash severity. WRT monitoring the crossing, the Designer is unsure what is to be recorded if monitoring was to occur and suggests the Client seek further clarification from the Safety Auditors.	
<b>Safety Engineer:</b>	This is a standard intervention working well nationwide. No action.	
<b>Client Decision:</b>	No action.	
<b>Action Taken:</b>	nil

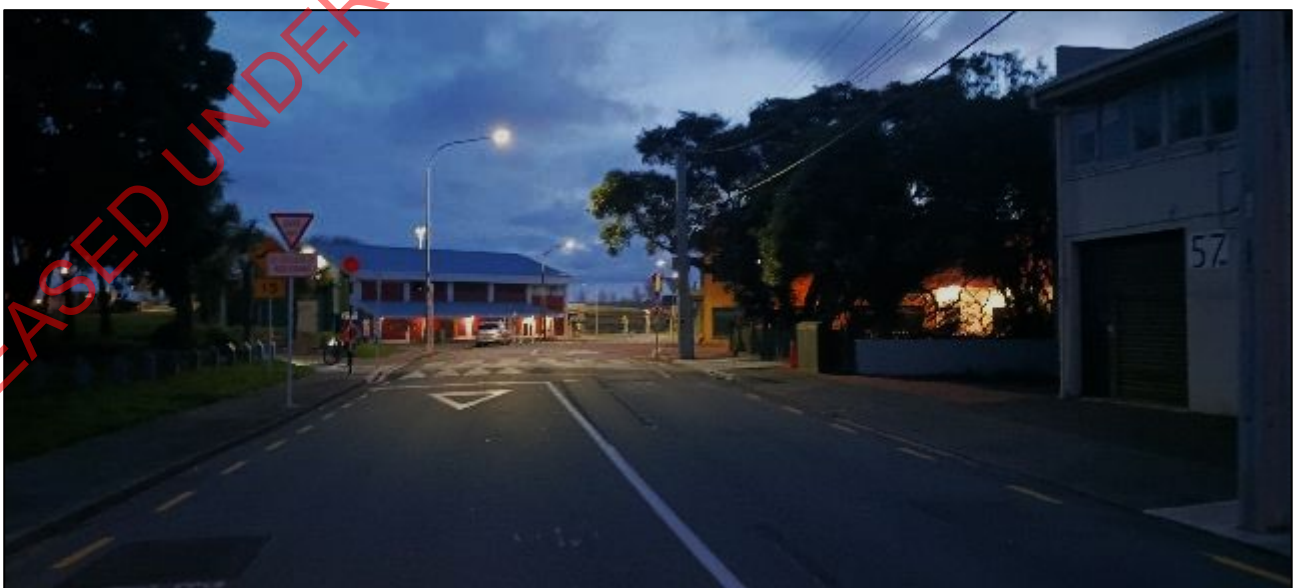
Figure 7: Marsden Street crossing at night.

The Marsden Street crossing has no specific street lighting at the crossing and relies on existing streetlighting in the area so drivers can see pedestrians and cyclists on the crossing. While zebra crossings are allowed to be unlit in New Zealand if the road controlling authority does not think they require lighting, the SAT is not supportive of this stance as the Petone to Melling Cycle Path would be used by commuters in winter when it's dark, such that there would be many cyclists and possibly pedestrians using this crossing in dark natural lighting conditions.

The SAT had some difficulty seeing pedestrians and cyclists using the crossing in our night inspections as pictured below.

<b>Frequency:</b> <i>Crashes are likely to be Occasional</i>	<b>Severity:</b> <i>Death or serious injury is Likely</i>	<b>Rating:</b> <i>The safety concern is Moderate</i>
<b>Designer Response:</b>	The Designer agrees with the Safety Auditors recommendation	
<b>Safety Engineer:</b>	Agree with the recommendation regarding surveying light levels. Belisha disks should stand out well when viewed by vehicle lights. If a street light is needed, perhaps utilise existing power pole HCC: flashing belisha should be considered. Support surveying lighting level and additional lighting on existing power pole if necessary.	
<b>Client Decision:</b>	Support additional lighting as needed. The crossing is temporary until Marsden St is realigned in 12-24 months, therefore attach temp light to power pole rather than replacing belisha infrastrucutre.	
<b>Action Taken:</b>	Included in package of works to contractor – first confirm existing lighting level against minimum requirements with lux survey.

- 10 Use a luxmeter to survey the level of lighting from the existing streetlighting on the crossing. If the minimum lux levels for a zebra crossing aren't met, replace the existing Belisha Poles with combined poles including streetlights and Belisha Discs.

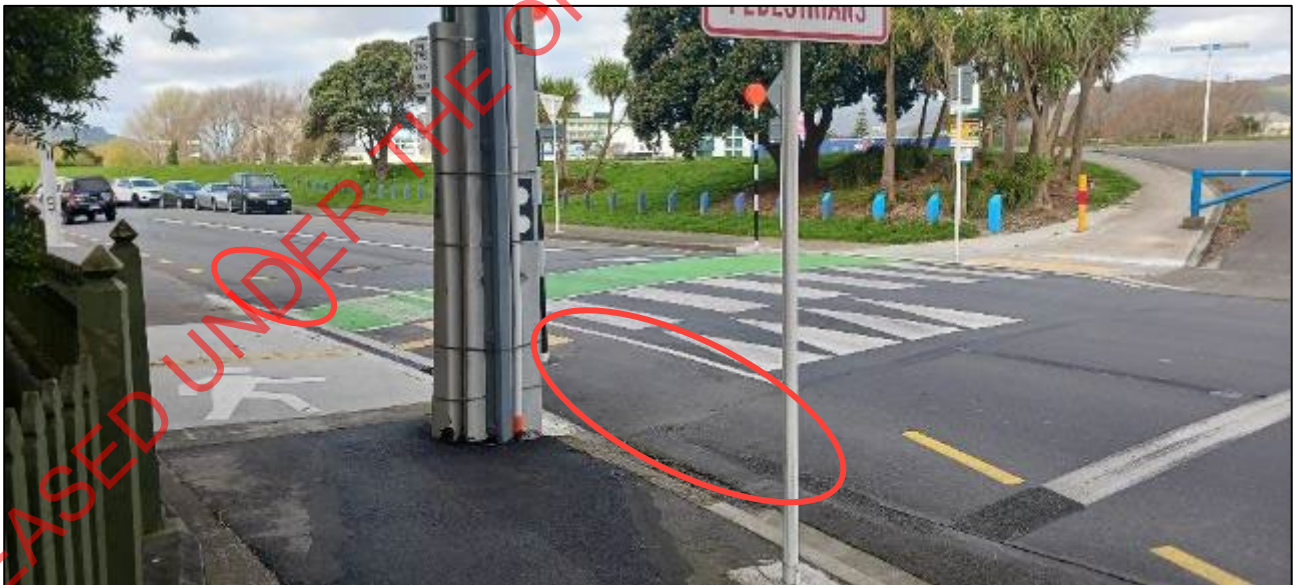
Figure 8: Western side of Marsden Street crossing without kerb build-outs.

On the western side of the crossing, the crossing length appears to start part way out into the road, and kerb built-out islands have not been provided to protect pedestrians and cyclists waiting to cross on the tactiles. It's likely that some northbound drivers on Marsden Street would perceive the area with tactiles as part of the carriageway, and drive into it.

<i>Designer Response:</i>	WRT the northbound approach, a kerb build-out was not installed after consultation with Waka Kotahi correlated to cost. Originally, a flush kerb, as the hold point for pedestrians and cyclists, together with signage in-between the existing kerb and the flush nib kerb was designed to be installed which gave visibility to approaching drivers (refer to Dwg TR-0021 Rev 1). The flush nib kerb, or signage in the designed position has not been installed and the Designers response to Section 3.2 above is recommended.
<i>Safety Engineer:</i>	Consider a pair of safe hit post or cycle separator to accentuate edge of roadway HCC: don't support hit post (maintenance issue), prefer kerb extension. Consider planter boxes (with reflectors).
<i>Client Decision:</i>	As per 3.2, improve kerb delineation at northbound approach through installation of cycle separators. TR-0021 Rev 2 was the final IFC, with removal of nib kerb and confirmed built as specified

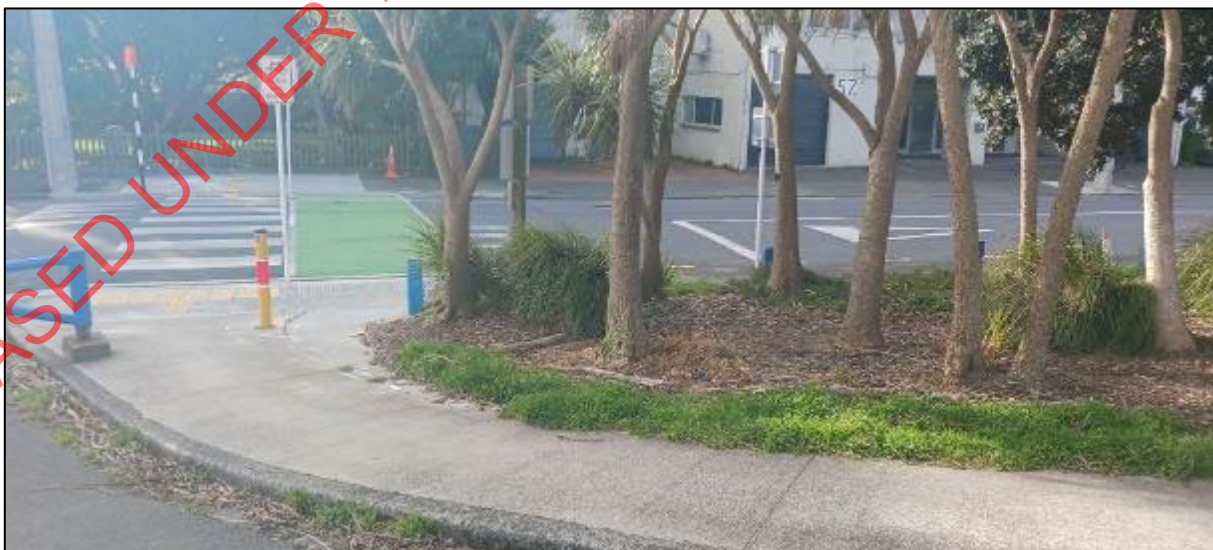
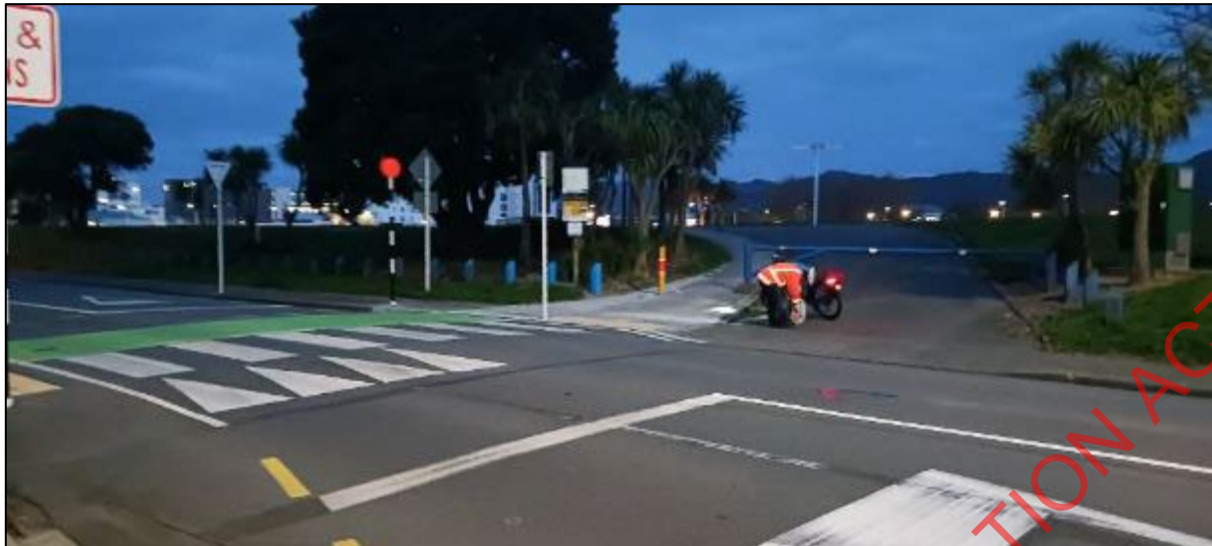
Figure 9: Views of approach to Marsden Street raised crossing.

One other risk is that given the approach to the path is difficult to negotiate, cyclists will be focused on avoiding the bollard and negotiating the curve on, so may be less likely to carefully check any approaching vehicles on Marsden Street have seen them and will give way, i.e. lazy looking. This is exacerbated by the steep geometry of the path which may encourage faster approach speeds to the crossing for some cyclists.

Frequency:	Severity:	Rating:
Crashes are likely to be Occasional	Death or serious injury is Unlikely	The safety concern is Minor
Designer Response:	The bollard was installed to prevent unauthorised vehicle accessing the stopbank area. The Designer does not recommend making more space as this will lead to unauthorised vehicular access to the stopbank,. The Designer agrees with Recommendations 13 and 14. WRT recommendation 15, a site visit shows that hazard markings have been installed on the approach to the bollard from the stopbank. WRT Recommendation 15, the Designer agrees with installing line markings but the words are too long and suggests that symbols be used instead.	
Safety Engineer:	Noting that recommendation 13 has been completed. Agree with recommendation 14 but a couple of red blocks should be sufficient.	
Client Decision:	<b>The existing approach to the crossing from the stop bank was utilised as an interim measure until the crossing and it's approach are redesigned by Te Awa Kairangi. As the impact rating is minor defer improvements until the Te Awa Kairangi project.</b>

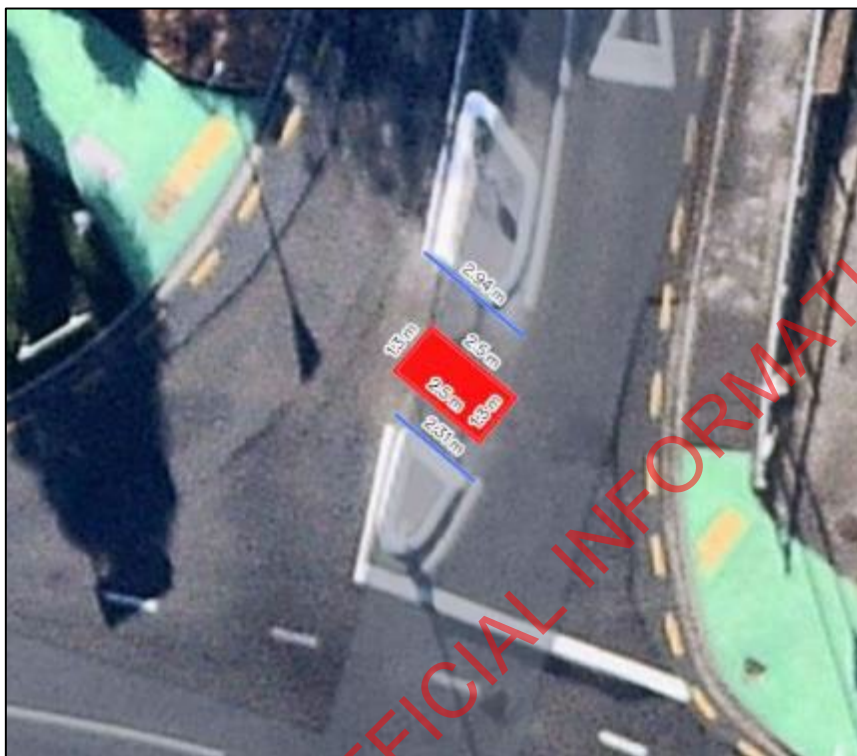
Figure 11: Median refuge depth dimensions shown with dimensions of a cargo box (represented by red box).

The refuge allows path users to cross Normandale Road in two movements. However, the depth of the refuge is only just enough for bikes, particularly on the southern side. The depth is insufficient for cargo bikes or other forms of longer bikes. Waka Kotahi's Cycle Network Guidance suggests that median refuges should have a depth of at least 2.5m to accommodate longer bikes. The shallow depth of the refuge means that front and/or back wheels protrude into the traffic lane.

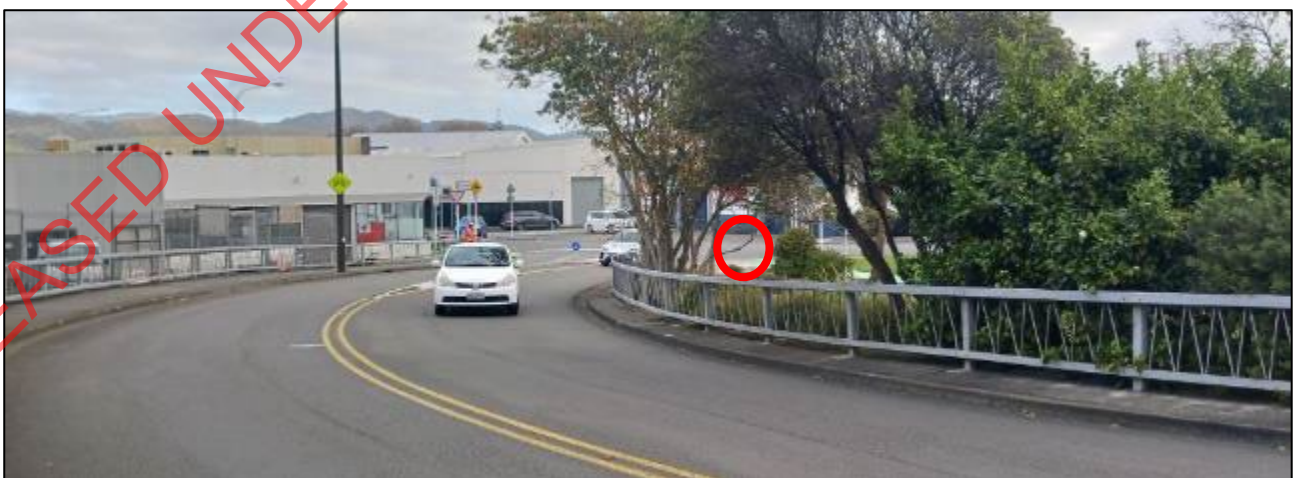
Figure 13: Intervisibility of path between southbound vehicles approaching intersection and shared path on western side of crossing (circled in red).

However, due to the limitations of the median refuge described above, many path users, particularly those on bikes, are likely to prefer to cross in one movement. In which case, visibility from each end is much more important. There are numerous conflict points to check (including looking back over shoulder) before crossing. The sight distance between a southbound vehicle on Normandale Road and a path user on the western side of the crossing is about 45m through a gap in the vegetation.

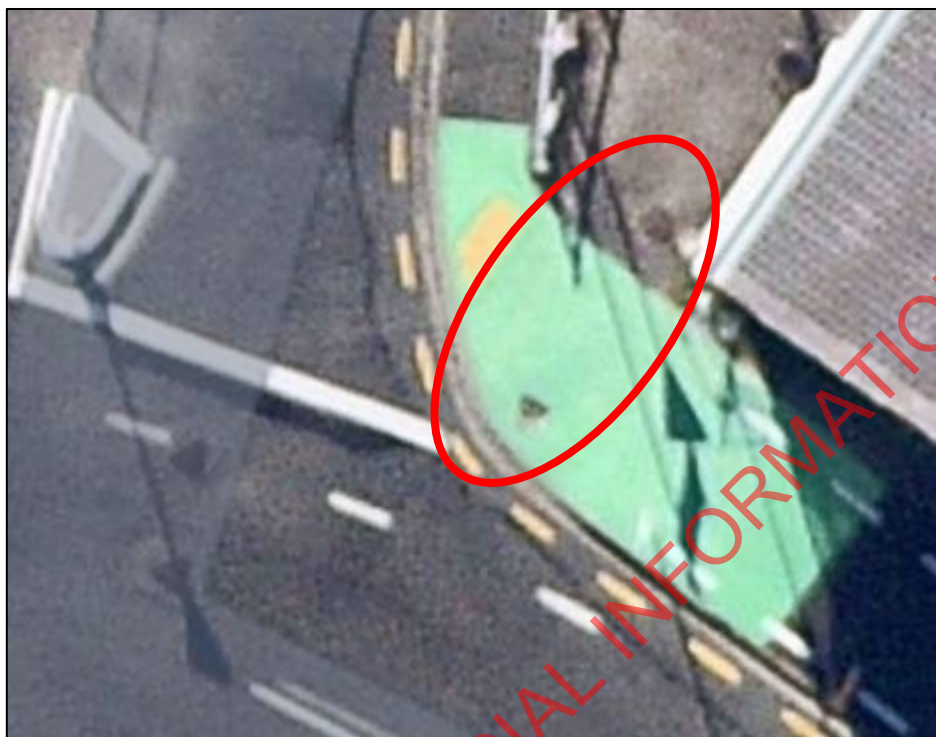
Figure 14: Driveway onto Normandale Road / Bridge Street intersection.

There is a driveway on the corner of the intersection as pictured in Figure 13. This is an unfortunate location for a driveway, which is beyond the control of the project to change. The driveway is located where path users will stop to give way to traffic.

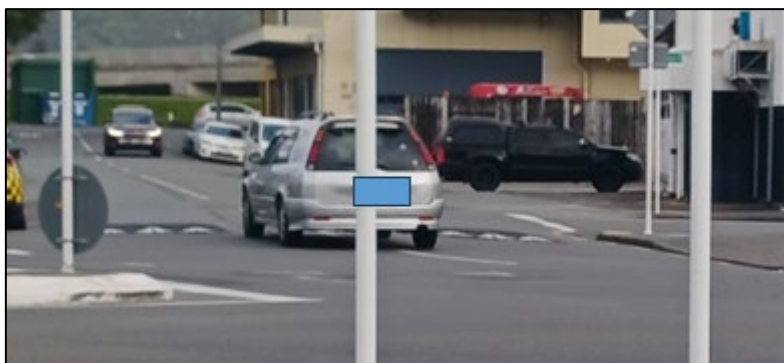
Figure 15: Example of vehicle crossing centre line to bypass speed cushions on Bridge Street.

Vehicles bypassing the speed cushions and straddling the centre line on Bridge Street was observed by the SAT. This increases the risk of a head-on crash. This is enhanced by the presence of nearby side roads (Aglionby Street and Herbert Street). For example, a left-turning vehicle from Aglionby Street onto Bridge Street may encounter a westbound vehicle who has crossed the centre line to avoid the speed cushions.

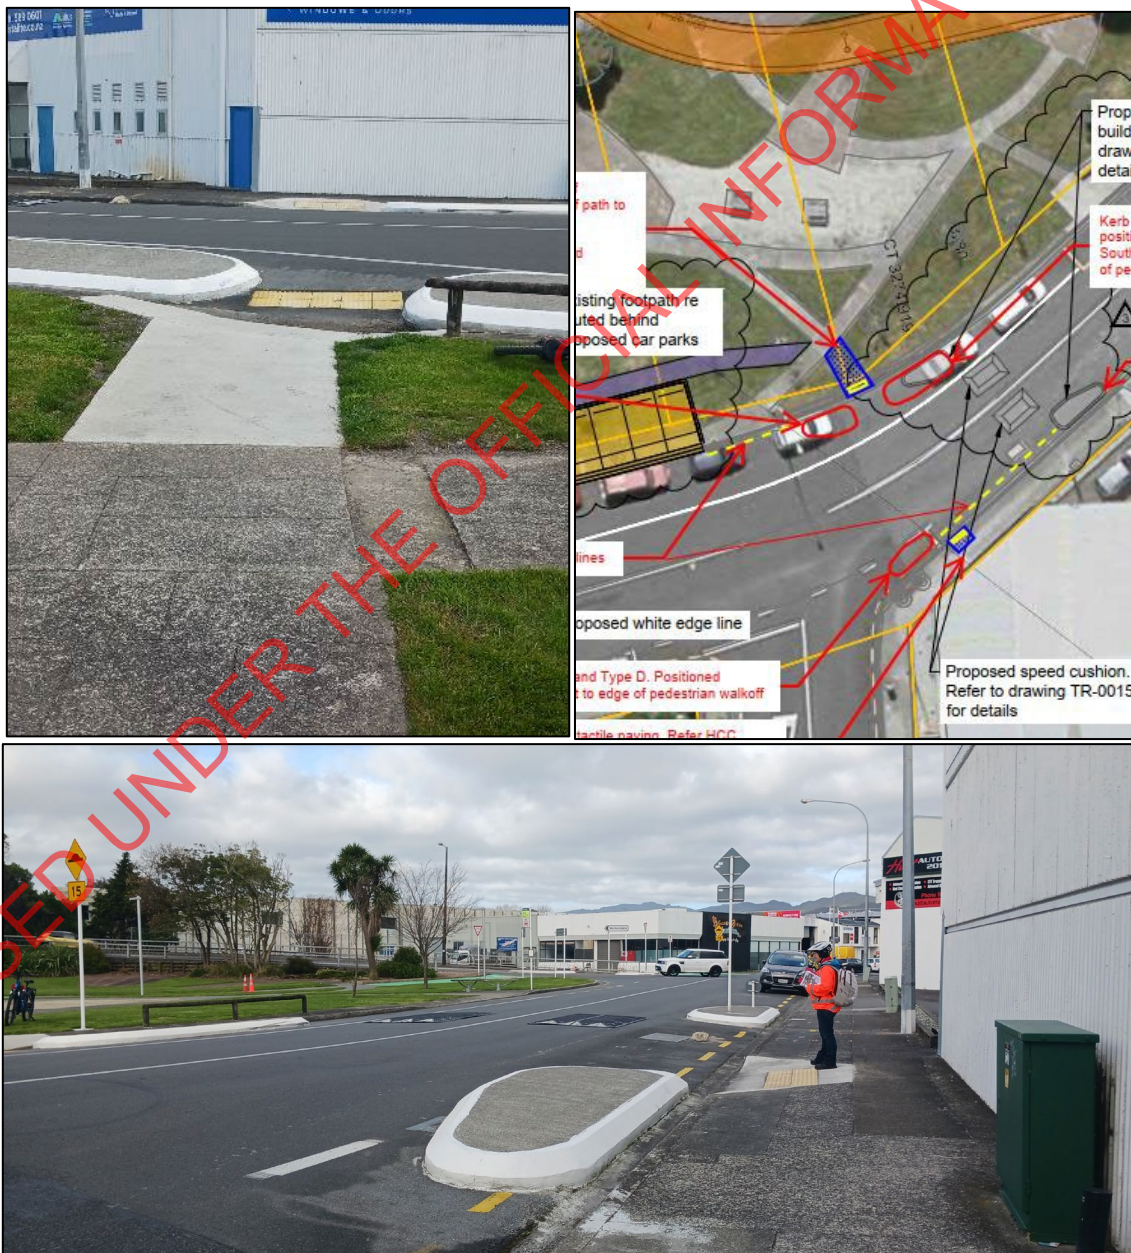
Figure 16: Bridge Street crossing, images from site visit and designs.

This difficulty of choosing a gap is also exacerbated by the long crossing distance and the ability of pedestrians to accurately judge both a vehicle's approach speed and predict how long it will take them to walk across the full length of the crossing.

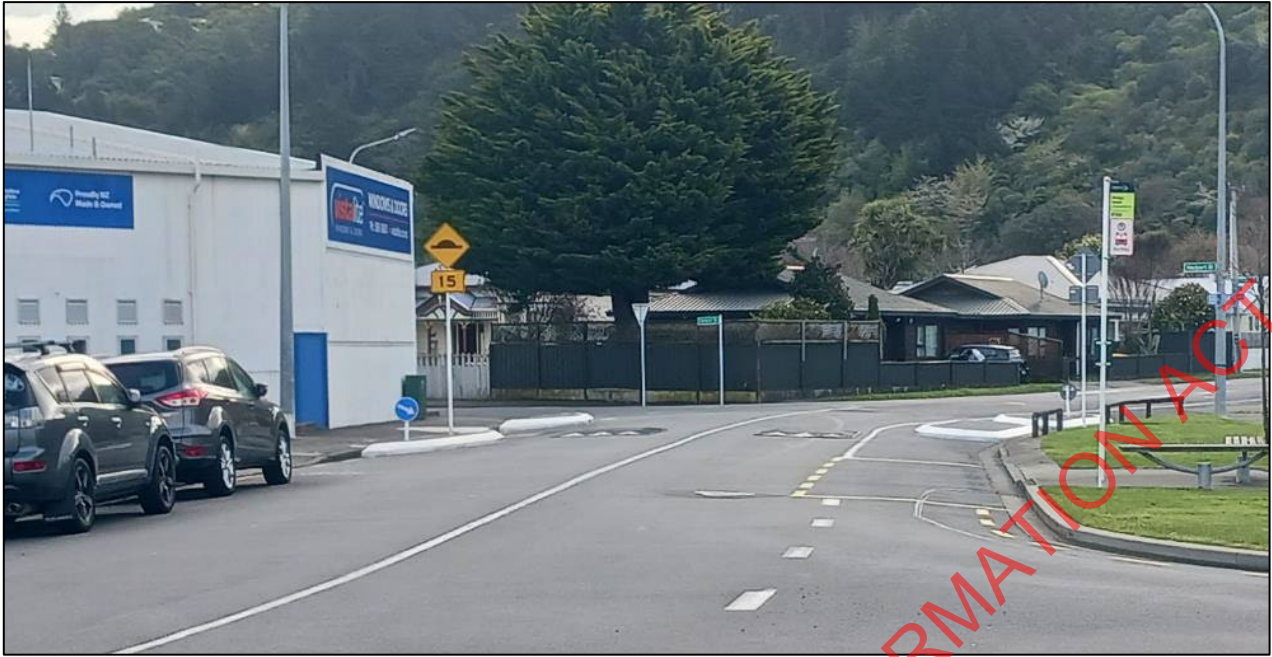
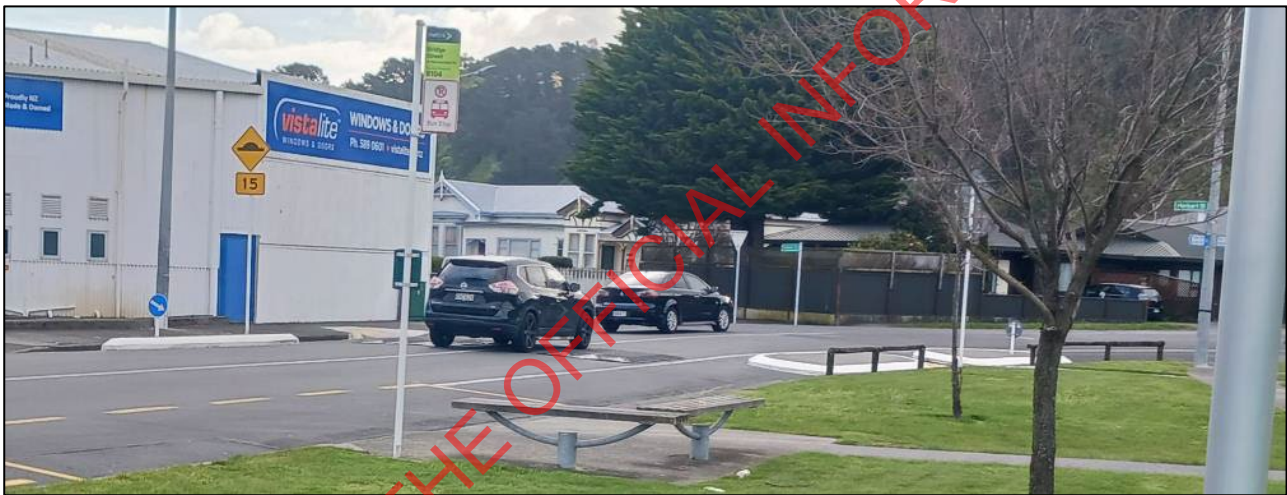
Figure 17: Speed cushions near Bridge Street crossing with vehicles driving along centre line to avoid.

The speed cushions placed in the vicinity of the crossing to reduce vehicle speeds are effective when drivers align their vehicle correctly in the traffic lane; however, the cushions are placed far enough apart such that a driver can drive over the centreline between the cushions, so they don't need to slow down. We observed more than 10 drivers doing this in a period of around five minutes during our inspection.

The path vehicles take between the speed cushions increases the risk of a head-on crash rated in this section, and also affects vehicle speed and the severity ratings for the crossing in the previous section. Speed cushion placement close to the Normandale Road intersection is covered in Chapter 4.

<b>Frequency:</b> Crashes are likely to be Common	<b>Severity:</b> Death or serious injury is Very Unlikely	<b>Rating:</b> The safety concern is Minor
<b>Designer Response:</b>	The Designer agrees with Recommendation 24. Raised platforms on Bridge Street are not supported by HCC. WRT monitoring, the Designer recommends that the Client discusses with the Safety Auditors the items to be recorded if monitoring is to be undertaken.	
<b>Safety Engineer:</b>	Agree to consider a refuge island, this may negate the need for a central cushion. HCC: consider that the crossing ultimately needs to be redesigned and possibly relocated in future. Not supportive of refuge island option.

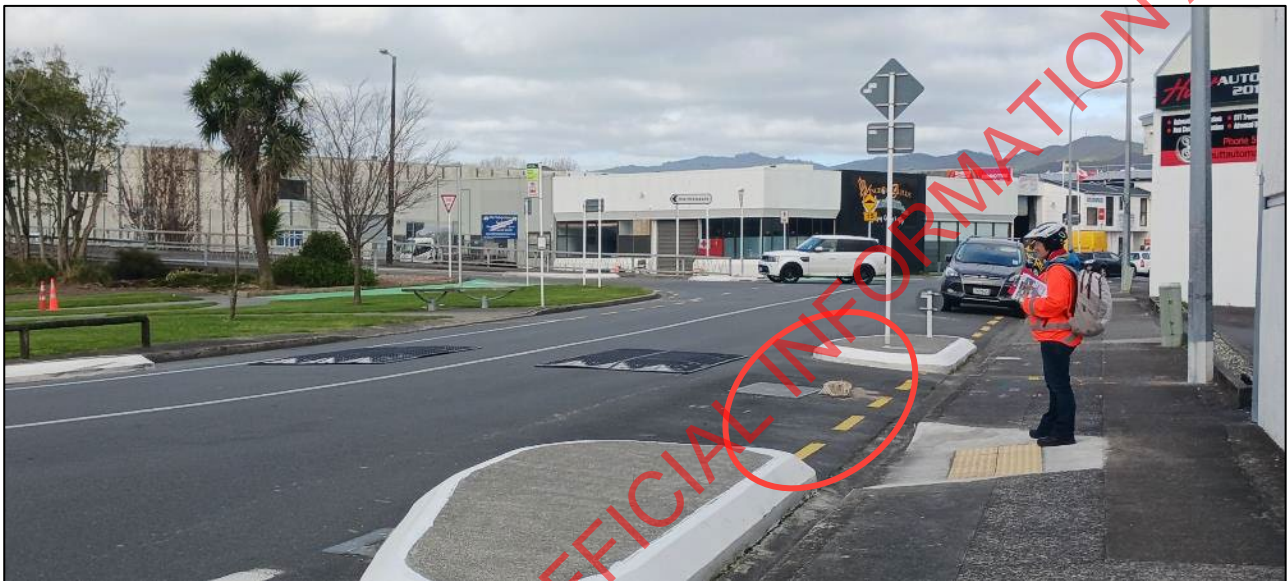
Figure 18: Bridge Street crossing indicating placement of kerb build-outs.

Similar to the issue at the Marsden Street crossing, the placement of the kerb buildouts in relation to the crossing location on Bridge Street would not prevent drivers from driving into the area of carriageway where pedestrians may be waiting to cross. Pedestrians may also be discouraged from waiting on the carriageway due to the discomfort of not being protected by kerb buildouts, meaning they are further from the driver’s field of vision and approaching drivers may be less likely to see them.

<b>Client Decision:</b>	Kerb build-out not simple as would require drain relocation. Hazard is minor and can be considered as part of future crossing upgrade/relocation. Do nothing.
<b>Action Taken:</b>	nil

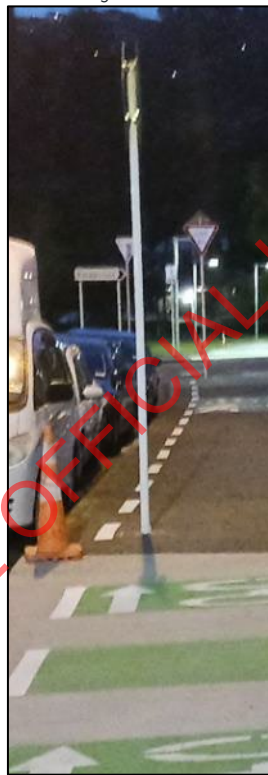
Figure 20: Example of WU61 sign pole located within shared path.

The WU61 signage poles should be located clear of the cycle path or shared path, and pointing in a direction that faces an oncoming driver. The placement of the poles on Bridge Street are within the shared path which increases the risk of a cyclist crash if they hit the pole with their handlebars.

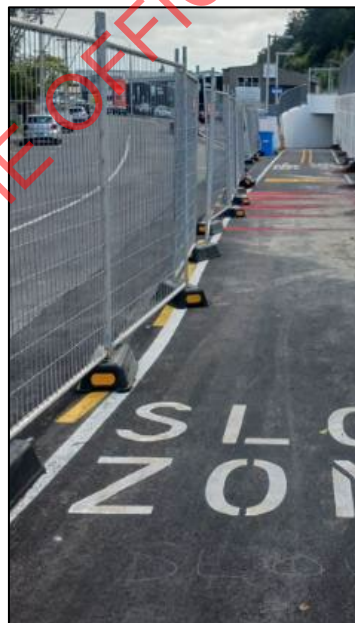
Figure 21: No permanent physical separation between cycle path and traffic lane.

The lack of separation also means that there is no physical barrier to stop vehicles from parking on the cycle path, blocking access for cyclists. Cyclists may have to use the road to get around parked vehicles, reducing accessibility.

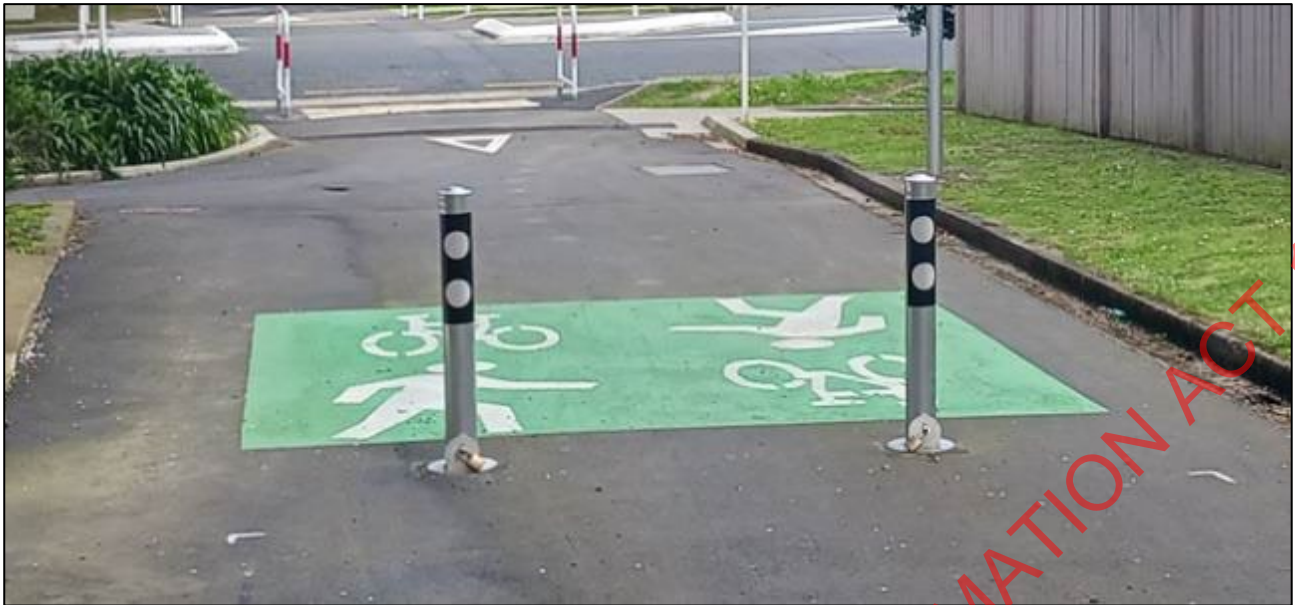
Figure 23: Bollards on shared path west of Pharazyn Street.

About 25m west of the Pharazyn Street crossing, there are two bollards to prevent vehicle access to the path (beyond the pump station). There are no hazard delineation markings around the bollards, which increases the risk of a cyclist crash with the bollards.

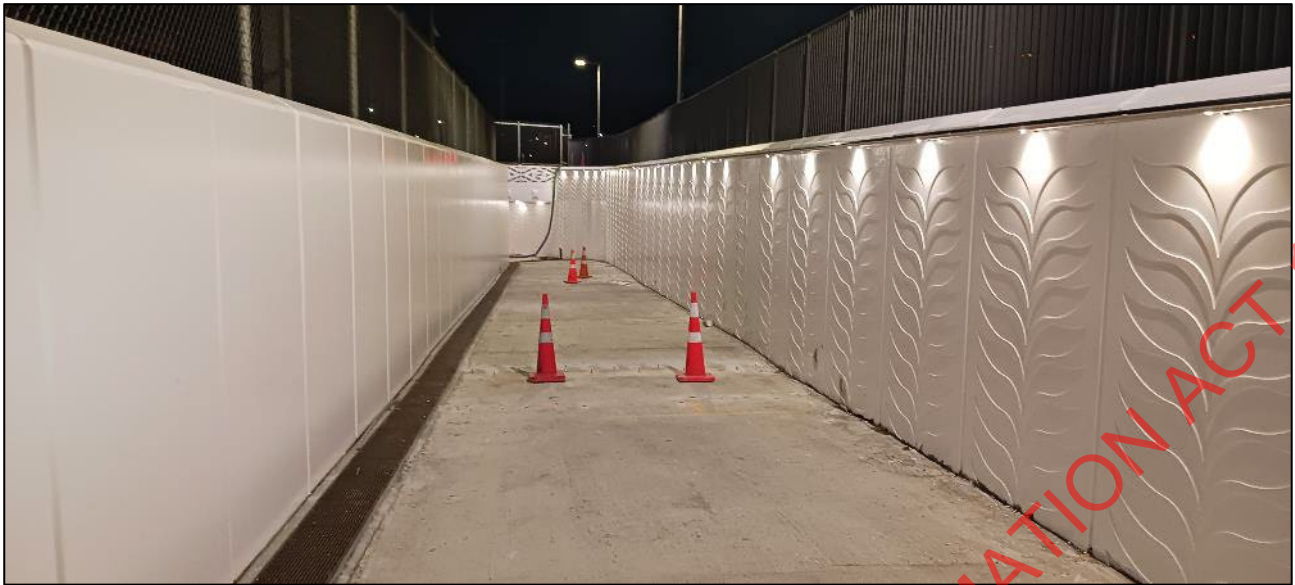
Figure 25: Entrance to Petone underpass at either end.

One potential issue which may also lead to inappropriate entry speeds to the underpass is cyclists' ability to judge their speed in the lower sections of the underpass, especially as the grade of the ramps means cyclists roll faster as they ride further into the underpass. In *Austroads Research Report 557-18: Measures to Reduce Crashes Adjacent to and within Tunnels*<sup>8</sup>, tunnels create an enclosed environment where people are less able to judge speed because there is less information from the environment about how fast they're travelling, and that providing stripes along the tunnel wall can assist to both reduce travel speeds and reduce speed differential between tunnel users. This would fulfil a similar role to how edge marker posts function for drivers at night when there is no visual information from the landscape surrounding the road to provide depth perception, which is essential for judging travel speed.

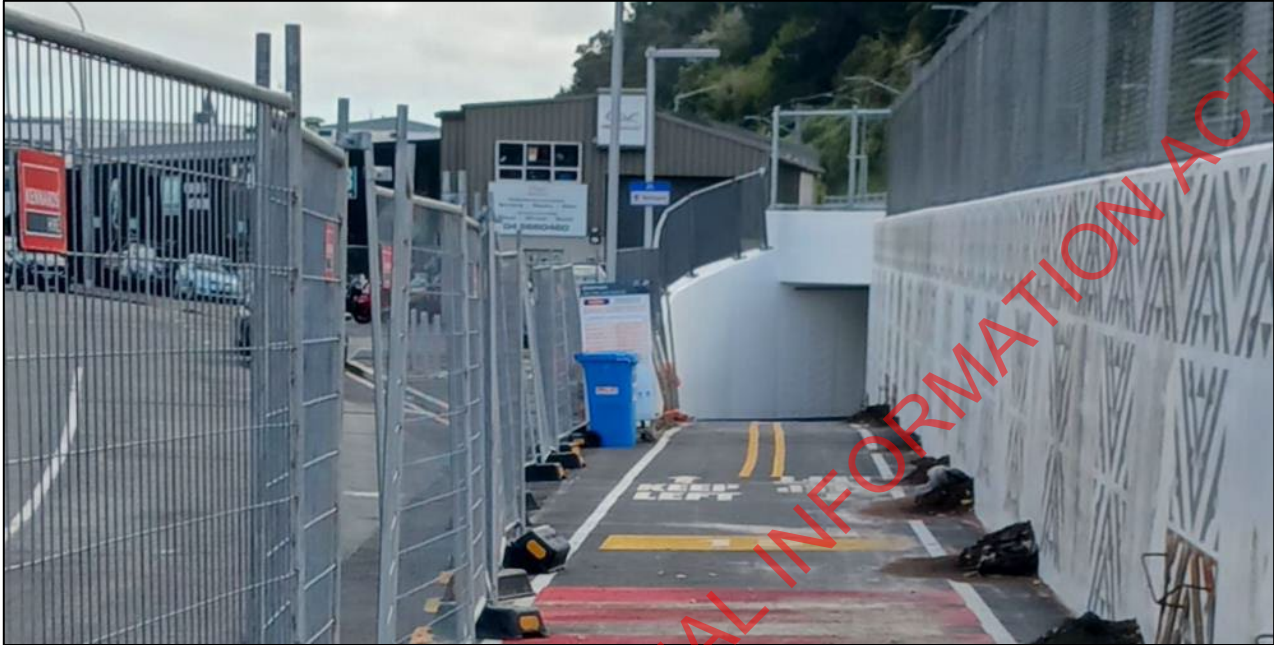
Figure 26: Normandale underpass.

The Normandale underpass already has 'keep left' path behaviour markings and a double-yellow no-overtaking centreline to prevent this; however these are again linemarkings rather than physical measures.

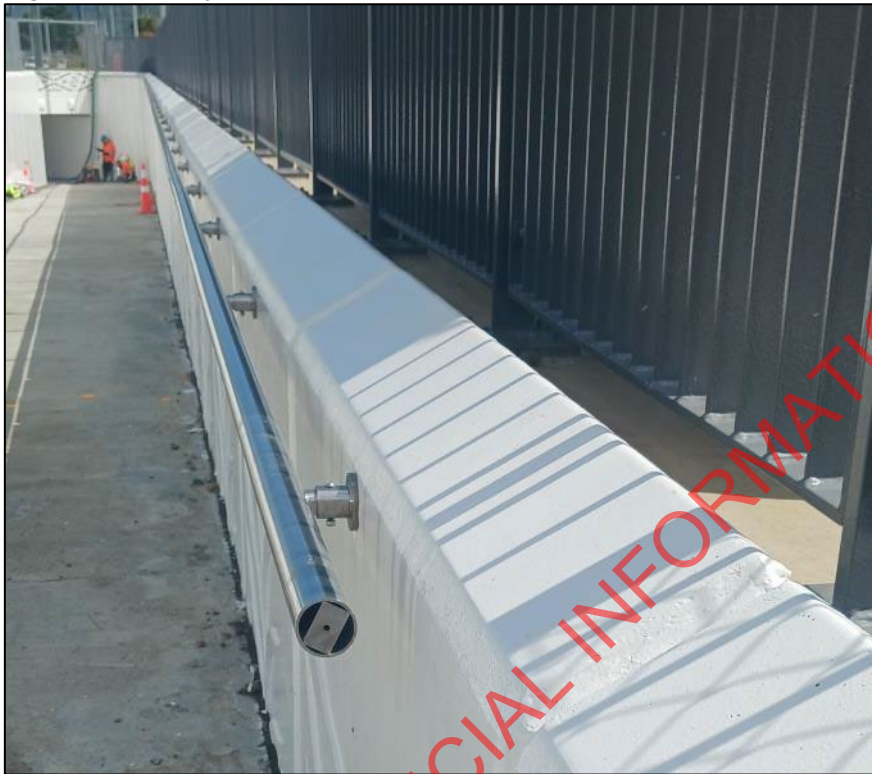
Figure 27: Service duct with no cover.

When the SAT travelled through the underpass, the service duct ends were not covered, and could act as an impaling hazard for cyclists.

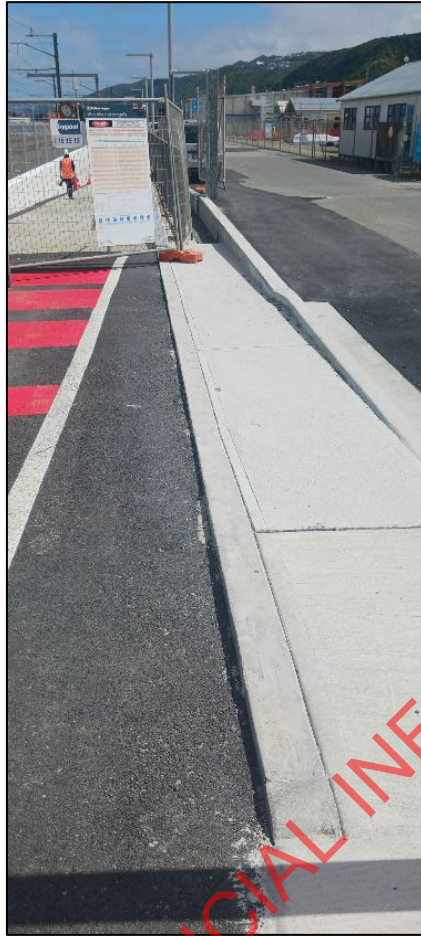
Figure 28: Possible hazard at northern end of Petone underpass.

There are several areas in the vicinity of the underpasses where minor differences in the height between the footpath, carriageway and underpass ramp could trip pedestrians, as the height difference is not sufficiently large (e.g. a kerb is 100mm high) that pedestrians may notice the difference in levels.

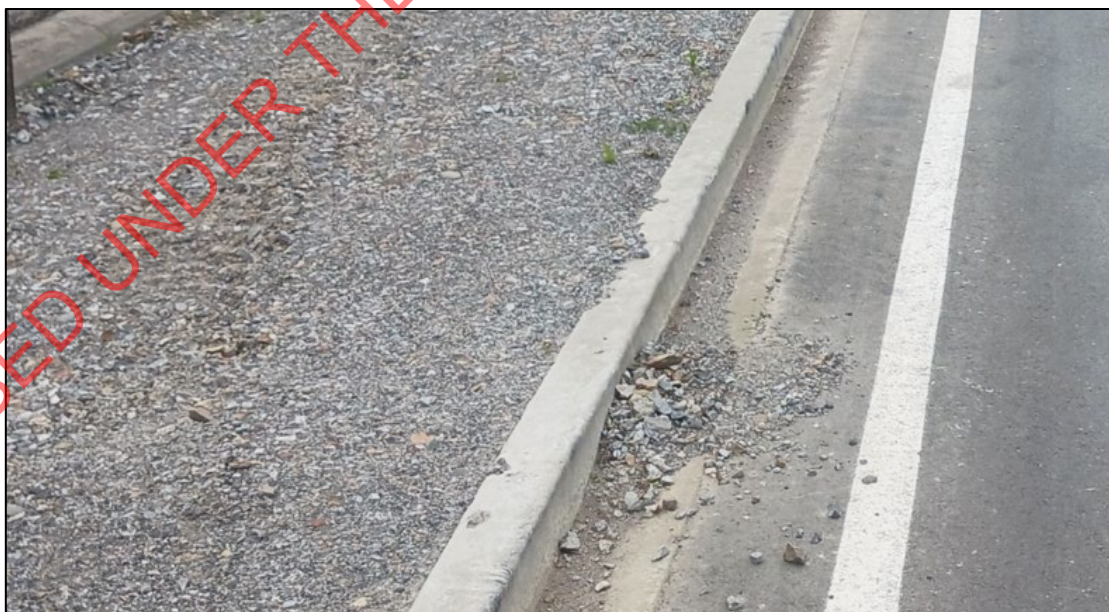
Figure 29: Example of debris build-up on path adjacent to gravel berm

The cycle path is between the rail corridor and the state highway. On both sides, there are gravel berms. This gravel is likely to migrate onto the cycle path on a frequent basis due to rainfall events and tracking by maintenance vehicles using the corridor and berm. If left unmaintained, the build-up of debris may lead to cycle loss-of-control crashes.

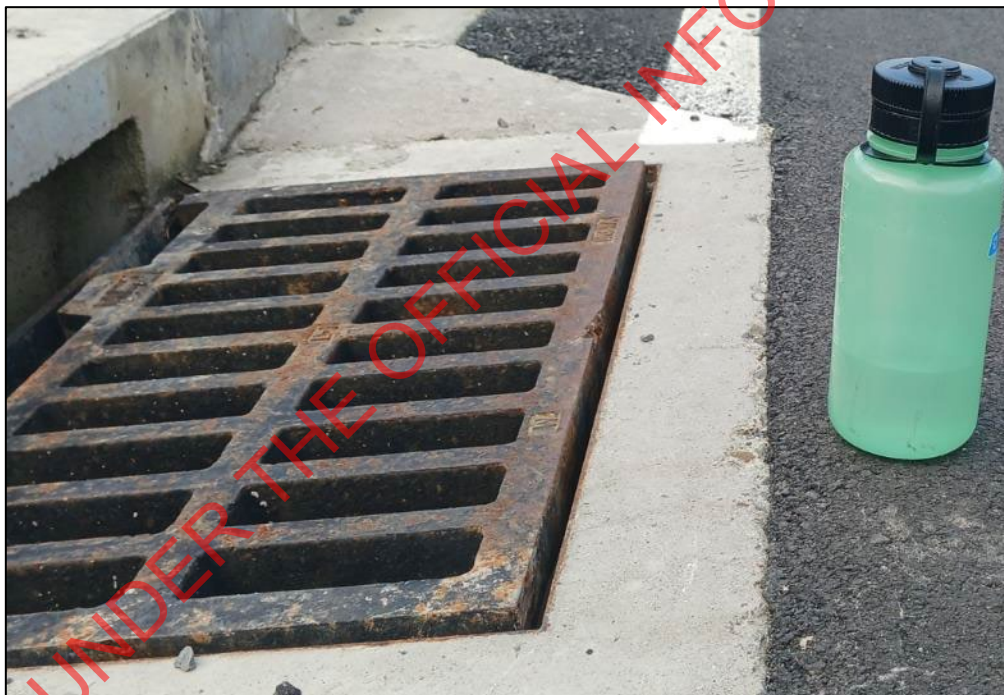
Figure 30: Example of stormwater grate protruding slightly at edge of path.

The SAT observed that some stormwater grates were protruding slightly in some locations on the main cycle path. Stormwater grates are beyond the edgelines, and thus out of the main route of travel of cyclists. However, they could cause a loss-of-control crash for some cyclists that adjust their line of travel for some reason.

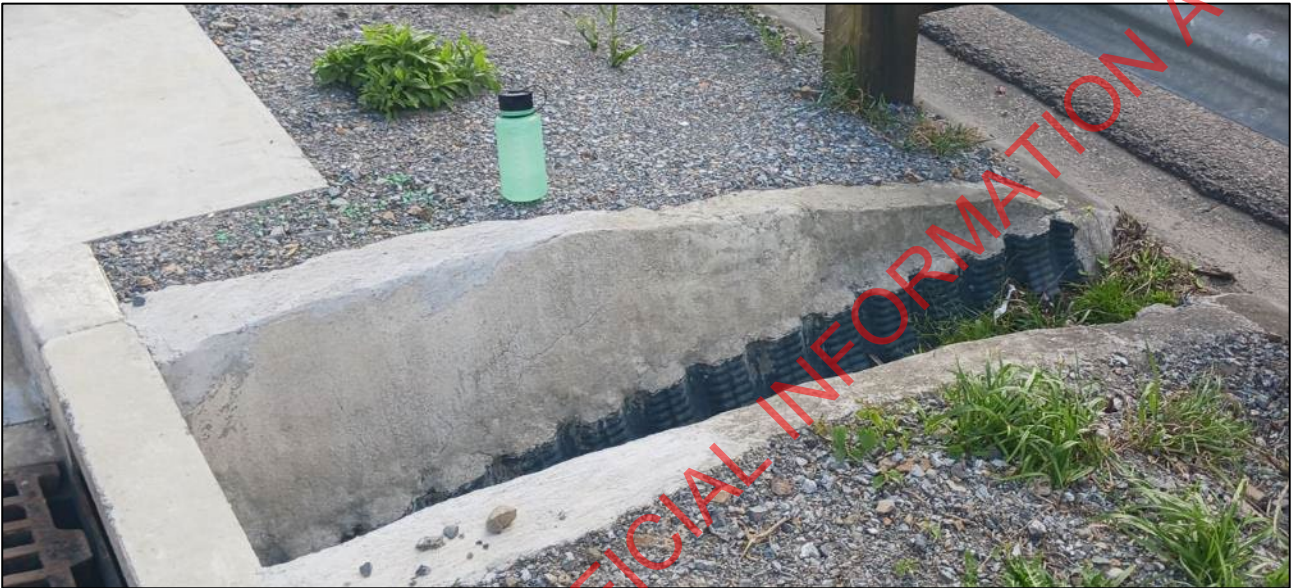
Figure 31: Example of deep, uncovered stormwater culvert adjacent to cycle path.

If a vehicle on SH2 strikes the barrier, there is also a low risk of the wheel from that vehicle getting caught in the culvert.
