Project Number: 5-C4006.00

# Petone to Melling Cycleway

## Pre-Opening Road Safety Audit

28 May 2024

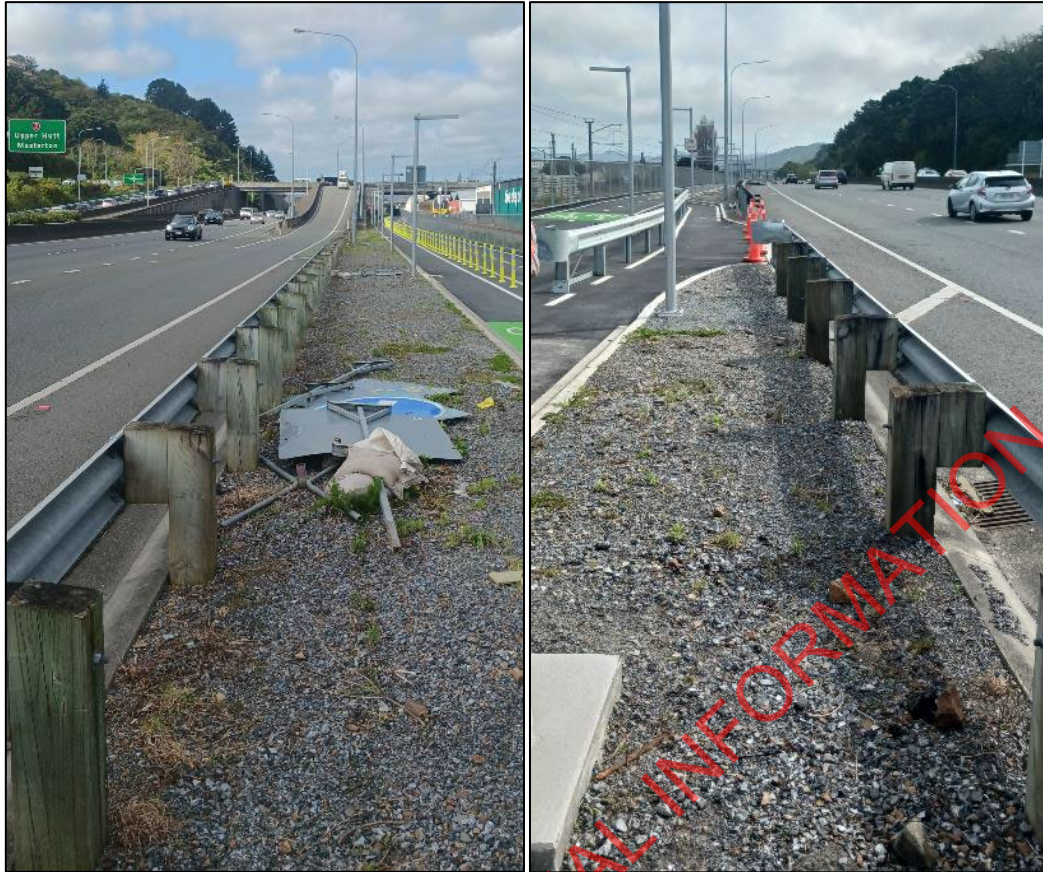
Figure 32: SH2 shoulder adjacent to Dowse bypass.

On the SH2 Dowse southbound onramp, there is a risk that drivers on the ramp are not aware that a cyclist using the Dowse Bypass southbound are about to enter the shoulder. Measures to prevent drivers on the ramp from entering the shoulder are required.

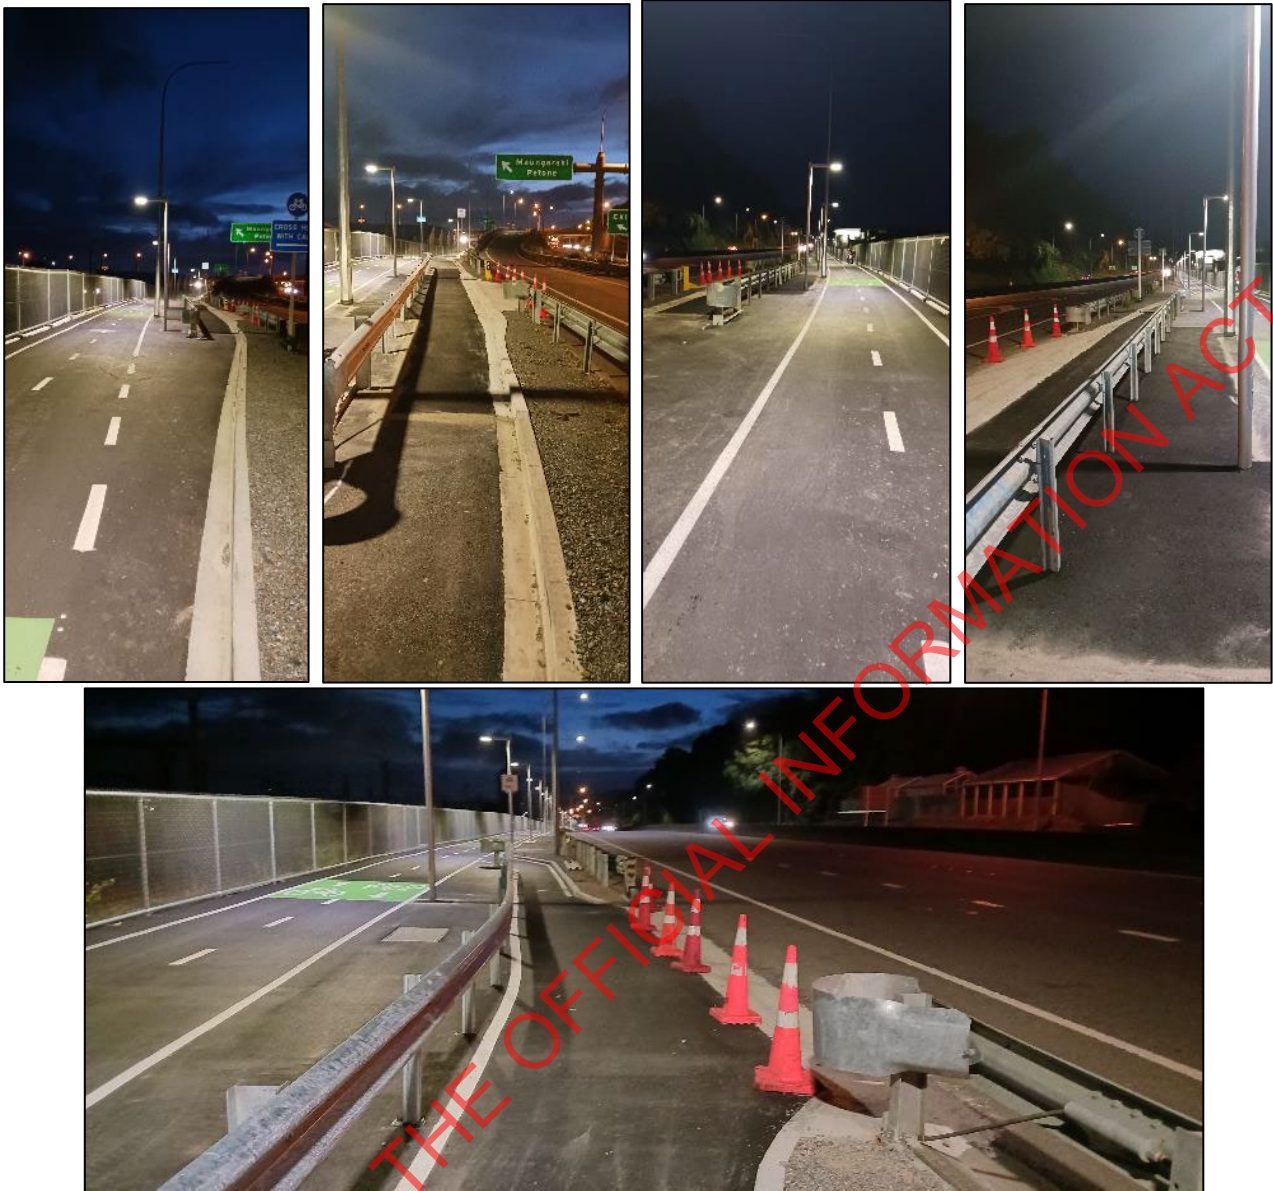
Figure 33: Dowse bypass at night.

The bypass area at night was well lit. However, we anticipate that some additional guidance would be beneficial to assist cyclists in snagging on the edges of fixed objects in the area such as barriers, as these were difficult to see at night. The northern end of the bypass also did not have linemarking when we passed through, which would have facilitated in cyclists positioning their bikes to avoid snagging on the barriers.

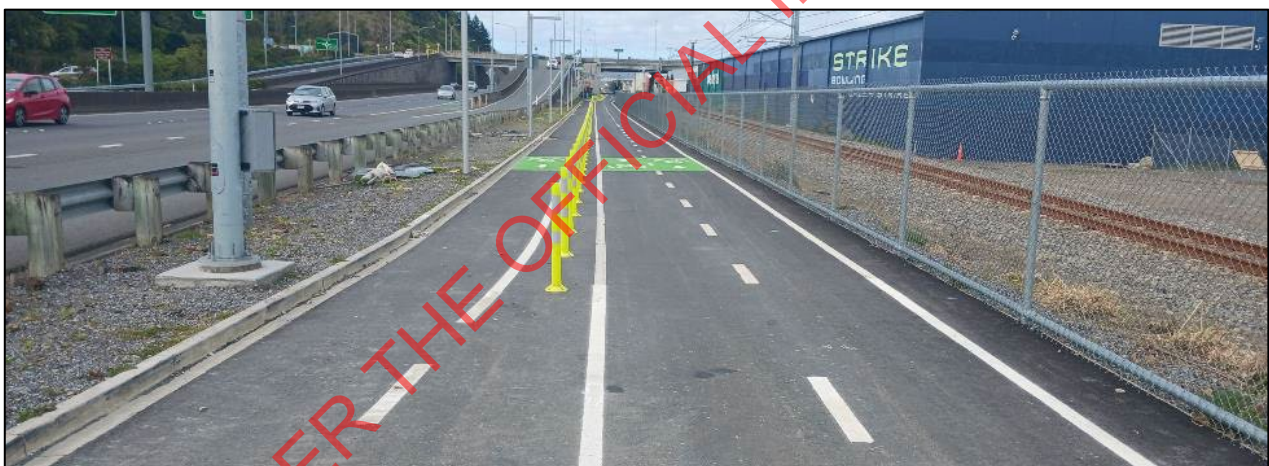
Figure 34: Southern end of Dowse bypass.

The SAT anticipate confusion of how the cycle path layout works in this area would be more of a useability issue than a safety issue, as there are good sightlines for oncoming cyclists so riders would moderate their speeds and behaviour.

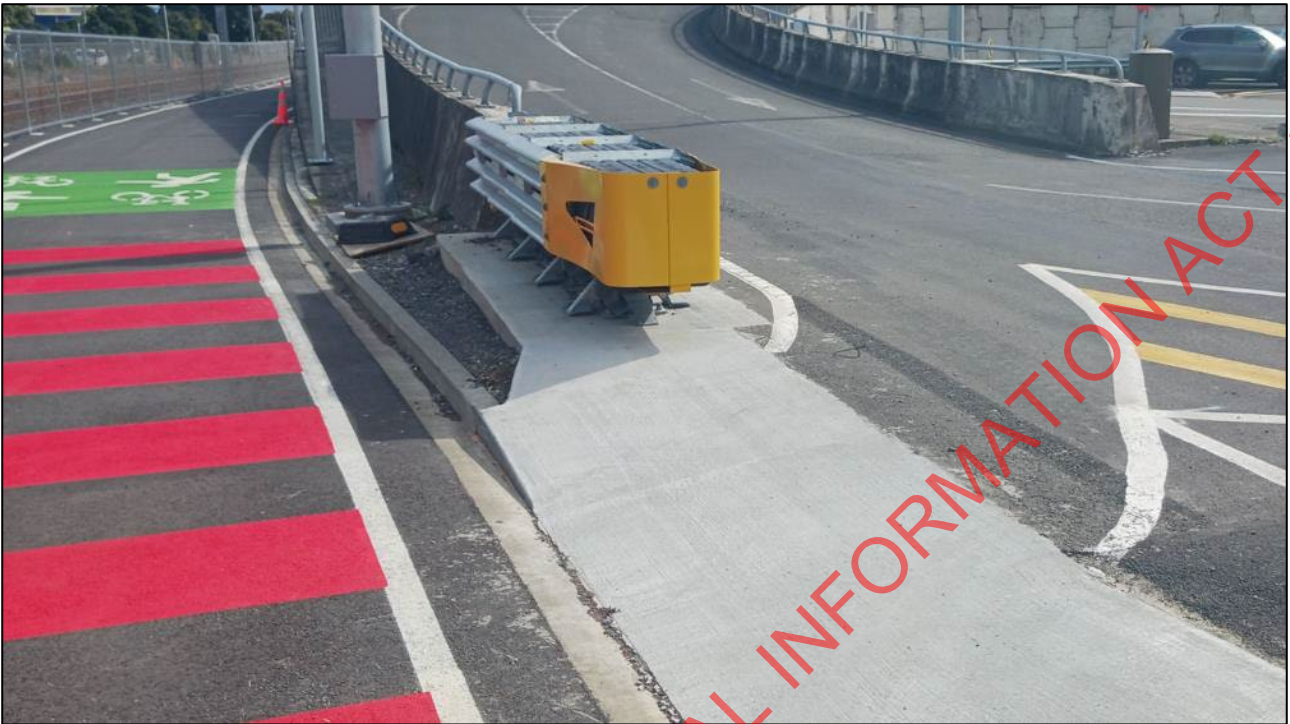
Figure 37: Cycle accessway between McKenzie Avenue and P2M cycle path.

there were no markings to highlight this as a cycle access or to advise cyclists to give way to other path users. The access is only 1.6m wide which is not wide enough to allow for an exiting cyclist and an entering cyclist at the same time.

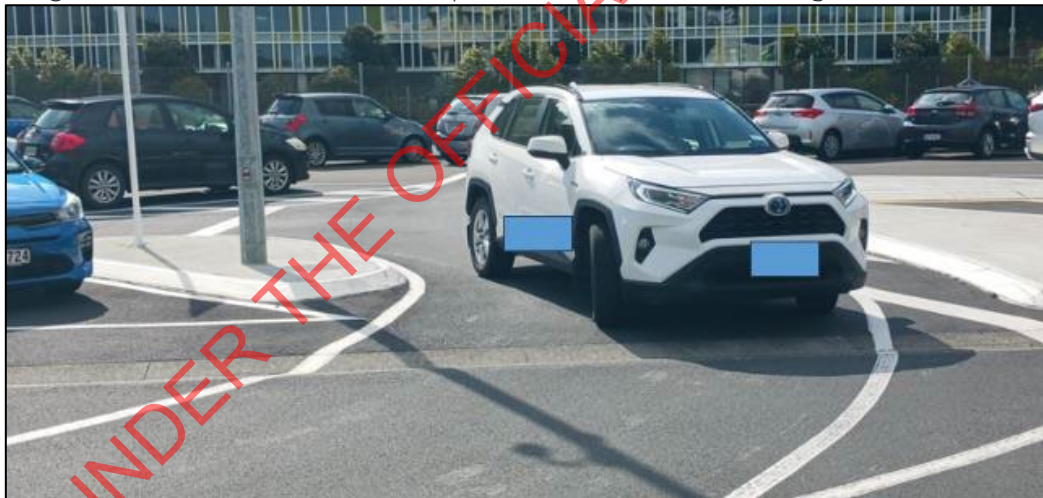
Figure 38: Example of vehicle exiting out of Park and Ride car park the wrong way.

Given that sightlines are reasonable and expected low speeds of exiting vehicles, the risk is low.

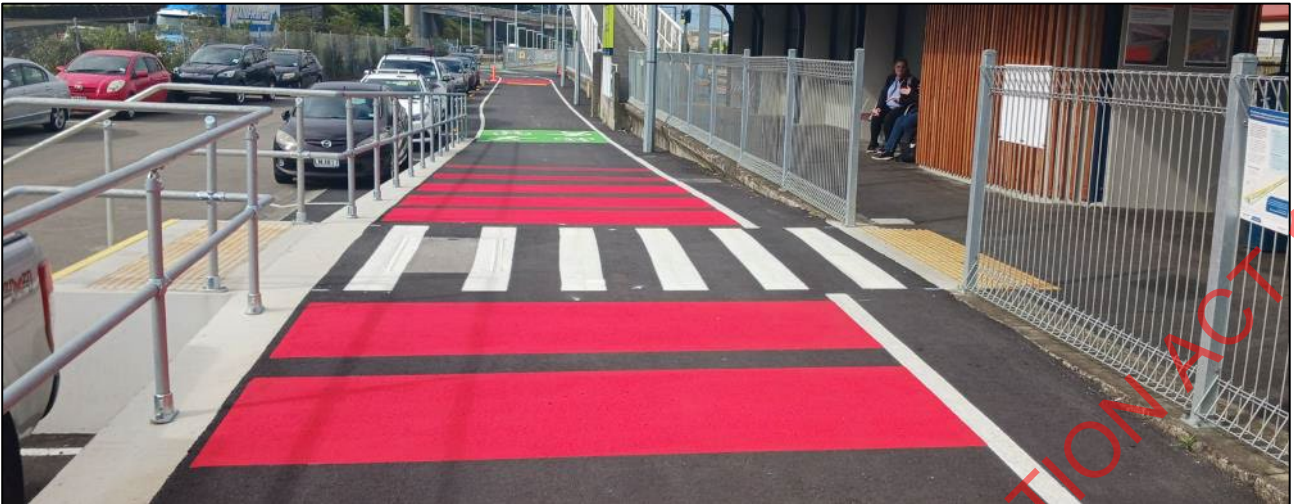
Figure 40: Pedestrian zebra crossing and conflict marking adjacent to Petone Station.

The P2M passes adjacent to Petone Station, which is one of the busiest stations on the Wairarapa Line and Melling Branch. Cyclists must stop and give way to train passengers walking between the Park and Ride car park and the platform. This is indicated by zebra crossing markings on the path. This is supported by striped, red markings which is intended to highlight an area of possible conflict, and 15km/h speed advisory markings.

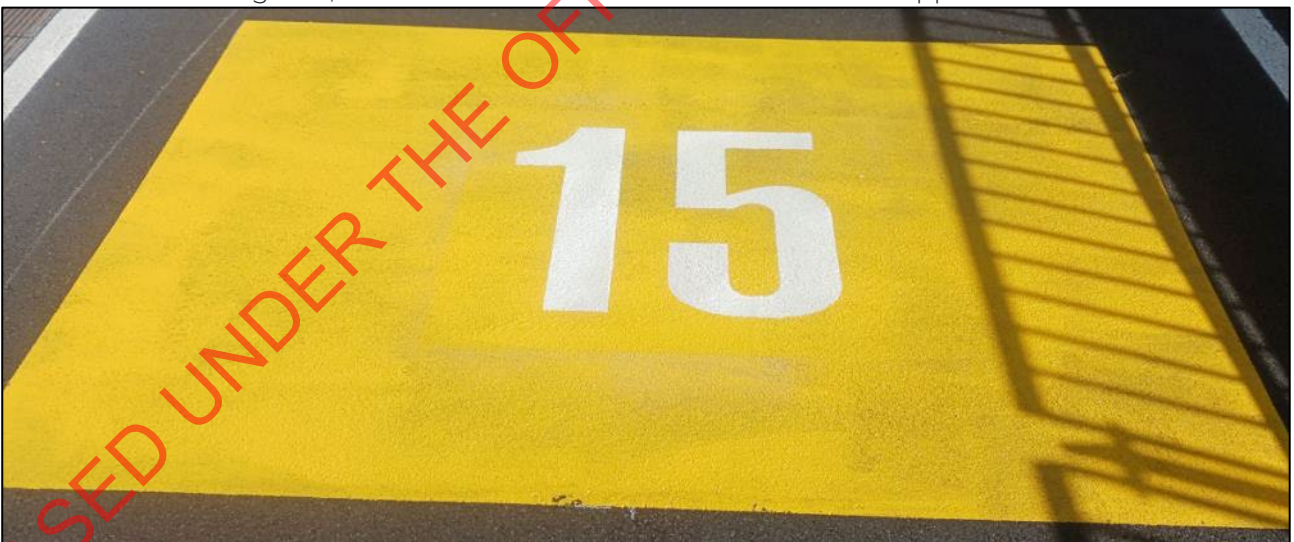
Figure 41: Advisory speed marking on approach to Petone Station.

The 15km/h speed advisory marking pictured in Figure 40 are ineffective. They are intended to represent advisory signs but are missing the black text and border. They are low-contrast, white text-on-yellow background, which means that they cannot be read until the cyclist is almost on top of them. By this point, a cyclist should be looking ahead rather than down at the ground. The text is also not elongated, which also makes them harder to read on approach.

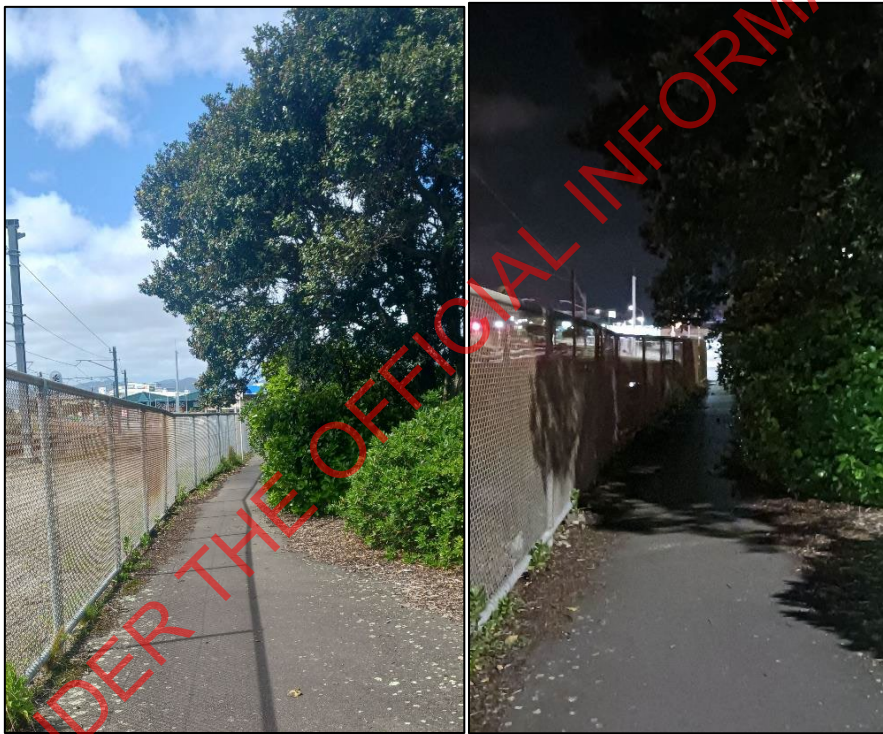
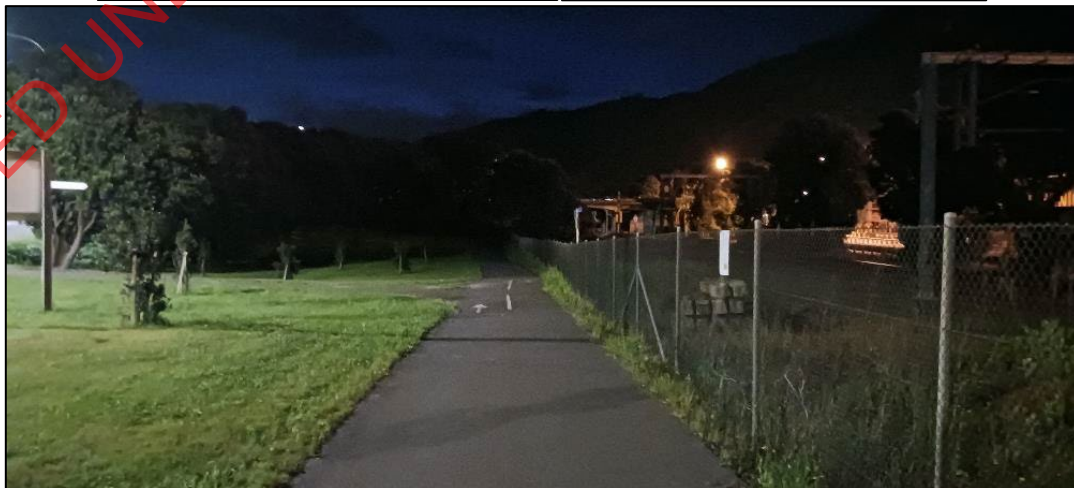
Figure 44: Existing shared path south of Petone to Melling path.

One other issue is there is a gap in the path at the south end between the Petone to Melling and Te Ara Tupua project extents which is not planned to be upgraded.

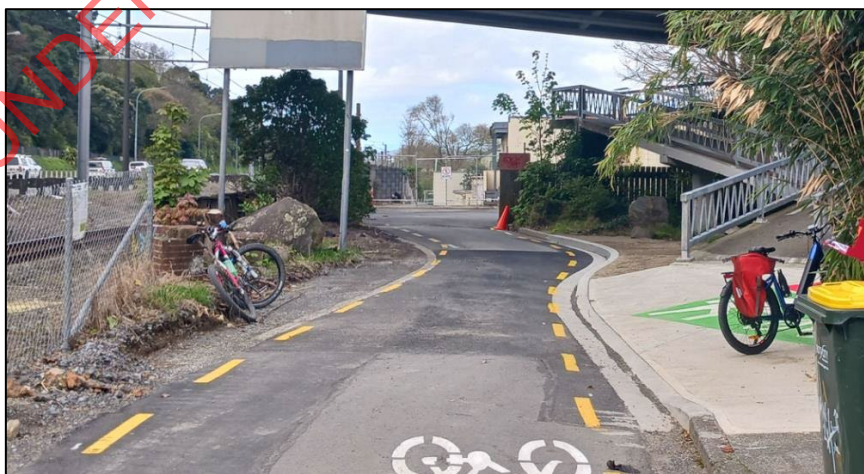
Figure 45: Intersection of Parliament Street and shared path with no wayfinding.

The shared path begins off Parliament Street. During the site visit, there were no wayfinding signs to indicate which way to go. The designs don't show wayfinding signs being included here. Wayfinding at this intersection, including the pedestrian path up to Normandale Road, would help prevent path users from missing the turn-off, which is partially hidden by a large bamboo plant.
