Feederlines

Confined Space Rescues and Firefighting

Operational Assurance Case Study

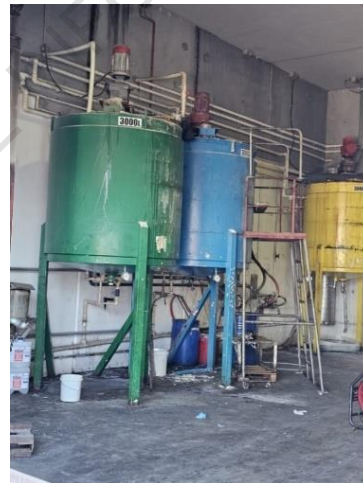
The incident was at an industrial premises. They found a 3000-litre chemical mixing tank with a 600mm diameter top entry hatch, up on a tank stand with limited access. (Fig1) 9(2)(a)

The tank had held chemicals to make paint brush cleaner and was being cleaned. The interior of the tank had a central mixing arm which reduced the internal space to 3 cubic meters. 9(2)(a)

Fig1 – 9(2)(a) in right hand (blue) tank in the pair, a portable ladder/platform provides access
