**Local Government Official Information & Meetings Act 1987 Request:**

1. Trish Wigley – Inspection Report 30 October 2023
2. Draft Report – Climbing Pole 25 January 2024
3. Email chain Playgroundcentre – compliance report 18 August 2024
4. Playsafe Play Report 2024
5. Caroline Bay Flying Fox Inspection Report August 2024

# PLAY REPORT 2024

## Caroline Bay Playground Flying Fox Inspection Report

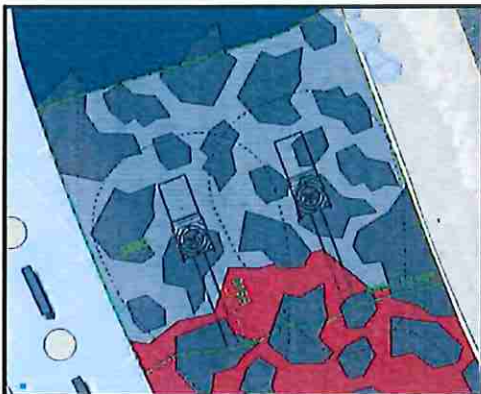
The shock pad thickness is correct in this area. We suspect that the recycled rubber included in the original shock pad is causing the issue. Additional shock pad and another top layer will be applied in grey tones. The area will be slightly raised to accommodate this as discussed onsite.

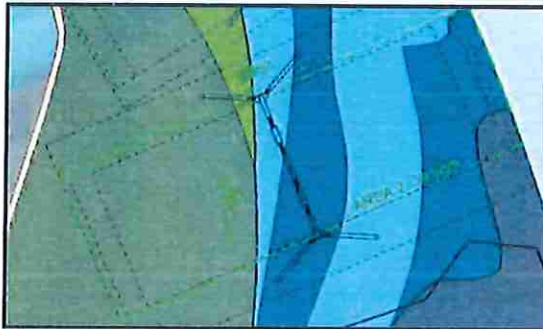
### Area 3 – High Swing

It was found that the drawings were incorrect and that the wrong shock pad thickness was specified for this area. Additional shock pad and another top layer will be applied in a similar design. The area will be slightly raised to accommodate this as discussed onsite.

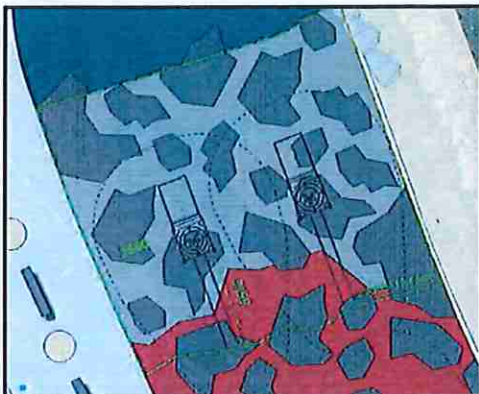
The shock pad thickness is correct in this area. We suspect that the recycled rubber included in the original shock pad is causing the issue. Additional shock pad and another top layer will be applied in grey tones. The area will be slightly raised to accommodate this as discussed onsite.

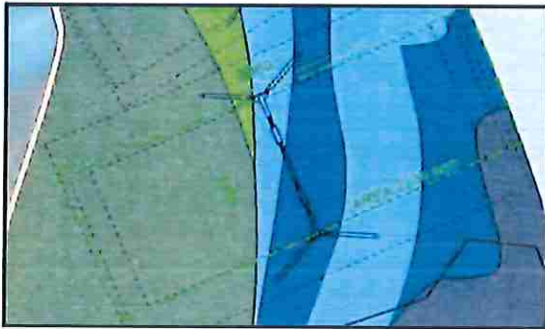
**Area 3 – High Swing**

It was found that the drawings were incorrect and that the wrong shock pad thickness was specified for this area. Additional shock pad and another top layer will be applied in a similar design. The area will be slightly raised to accommodate this as discussed onsite.

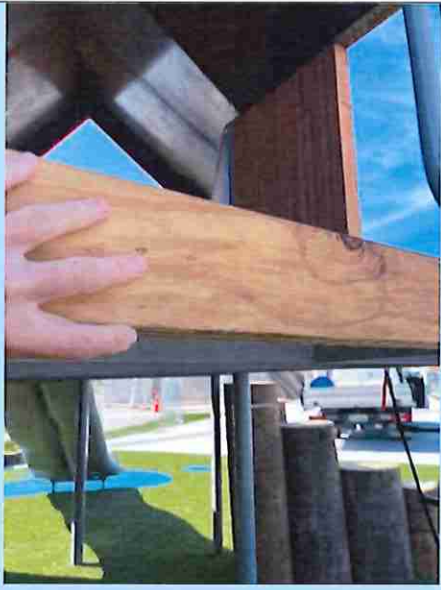
| | Sharp finish on whare | Edges shall have a radius less than 3mm | Very Low | Sand back. |

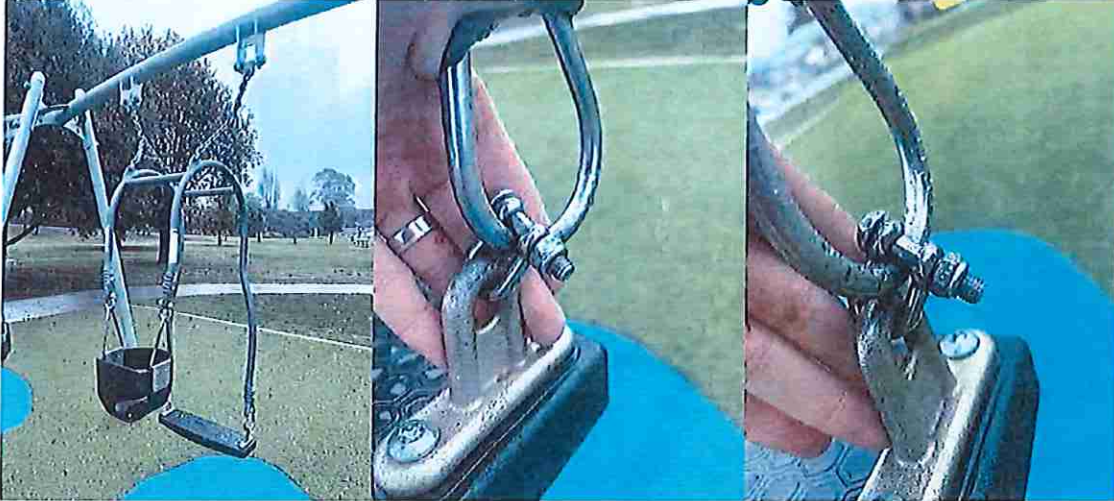
**Disagree - Ref 4.2.5 Finish of equipment “Nuts and bolt heads that project less than 8 mm shall be free from burrs.” EN 1176.1:2008**

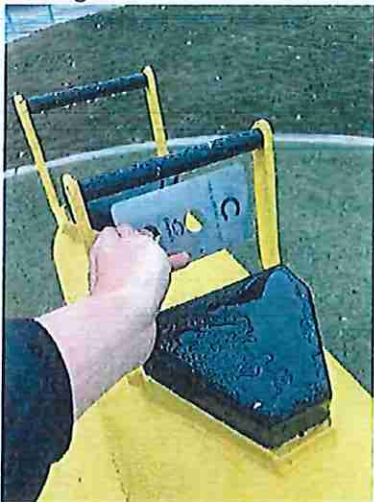
**Finding 3**

**Not a failure shown in photo where there is foot support – due to less than 600mm drop. Yes to failure at back of seat.**

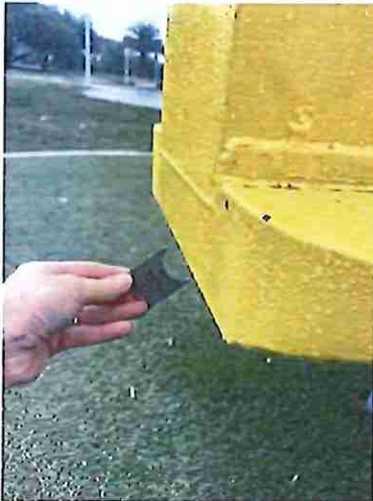
**Finding 4**

Agree with the horse head failing– picked up profile issue on my audit. But don't agree with equipment edging failure.

Disagree with the body of the horse having to meet 20mm radius. 3mm should be sufficient.

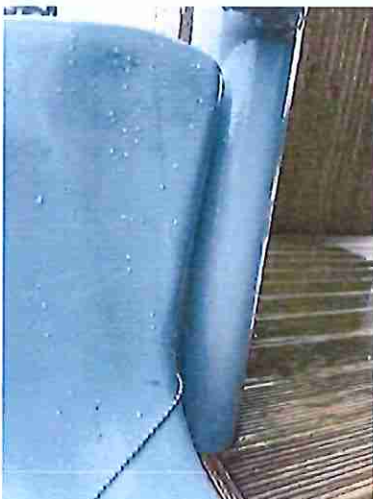
#### Finding 9

Agree –this one was found in my audit.

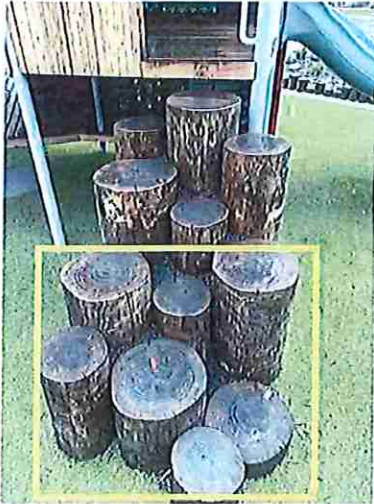
#### Finding 10

Disagree – fall from each step is less than 600mm and no different from stairs or steep play leading to deck.

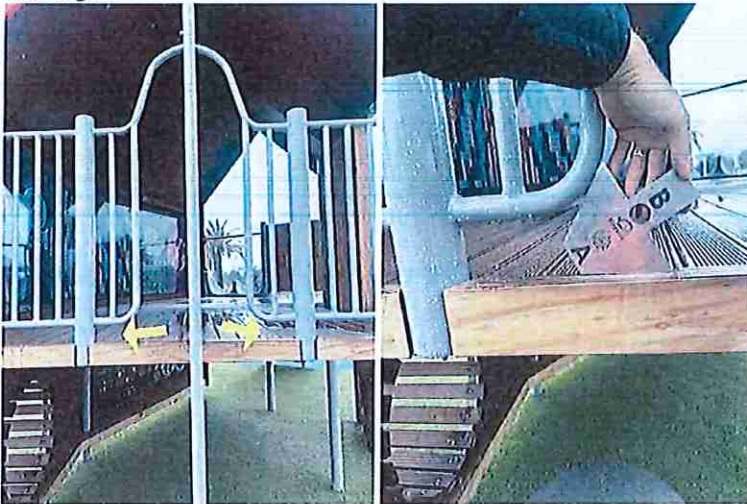
#### Finding 12

Considering Adam's recommendation of closing the gap to 45mm, I feel that Adam has not applied the range 2 rule correctly to this scenario. The depth needs to be 120mm or more to fail. There is no evidence in his report that he tested this

There is no demonstration of this scenario in the standards, common sense prevails. Torso, shoulders and head do not pass through this partial opening. Adam has not shown the depth of the opening - to conform as entrapment it must be deeper than A section (120mm)

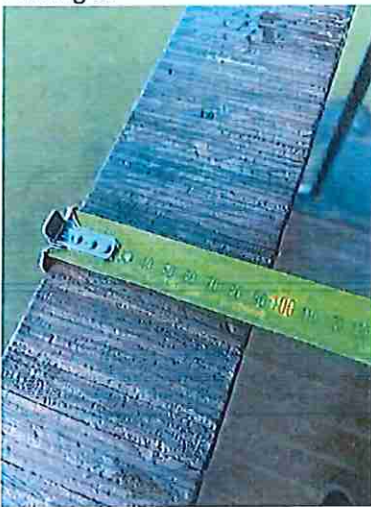
#### Finding 27

Not a failing in the standard. no measurement given on width of barriers. Adams finding is opinion. No horizontal railings to encourage sitting.

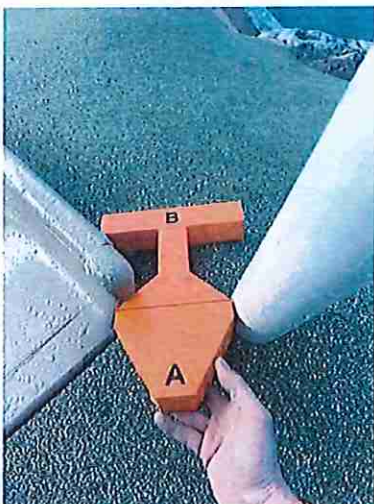
No vertical fall above 600mm. Child can stand up.

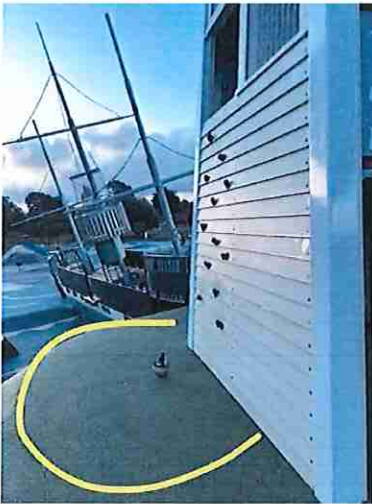
Photo 44

Failed drops from Rockwall 2. Requires 2540 mm critical fall height and is achieving approximately 2400mm.

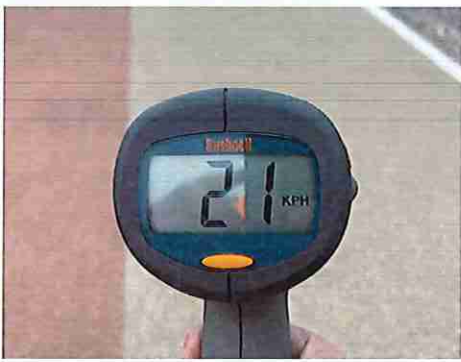
| <b>Additional Items</b> | Green | Orange | Red | Black |
|--|--|---|---|---|
| Notes | <p>Springs replaced to bring stopping under 45 degree angle.</p> <p>Ride height at minimum ground clearance at landing area.</p> <p>Seat height at take off ends quite high (may be hard for smaller users to hop on ride).</p> <p>No signage present.</p> | | | |

During the inspection the brake springs were replaced to bring the angle below 45 degrees at the braking zone, due to the nature of this flying fox and the design there are no other ways to decrease the speed or add additional gravity brake to the system.
