WHAA Detailed Seismic Assessment

16 Glenmore Street

Job Number: Revision: Date of issue:
N0541 A01 13 January 2025

Document Number:
N0541-RBG-WHA-XX-RP-ST-00001

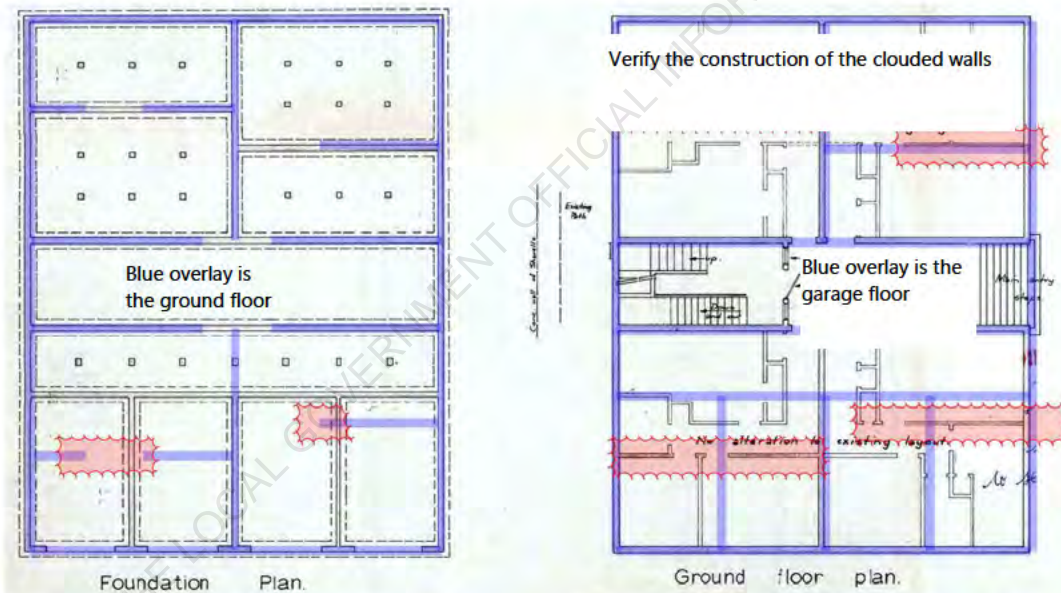
Figure 3: Extent of uncertainty

There are some ambiguities in the 1950 and 1975 drawings about the detailed setting out of the concrete walls inside the units. An overlay of the floor plans from the 1974 set shows unusual small offsets, and some walls with no apparent support. (The garage and first floor are each shown in blue below). For the purposes of this assessment all these walls are assumed to exist. Those walls provide lateral support, so if they are absent the loads will be higher in the remaining elements. A detailed site measure of the interior of the units will be needed to confirm the setting out of these walls.

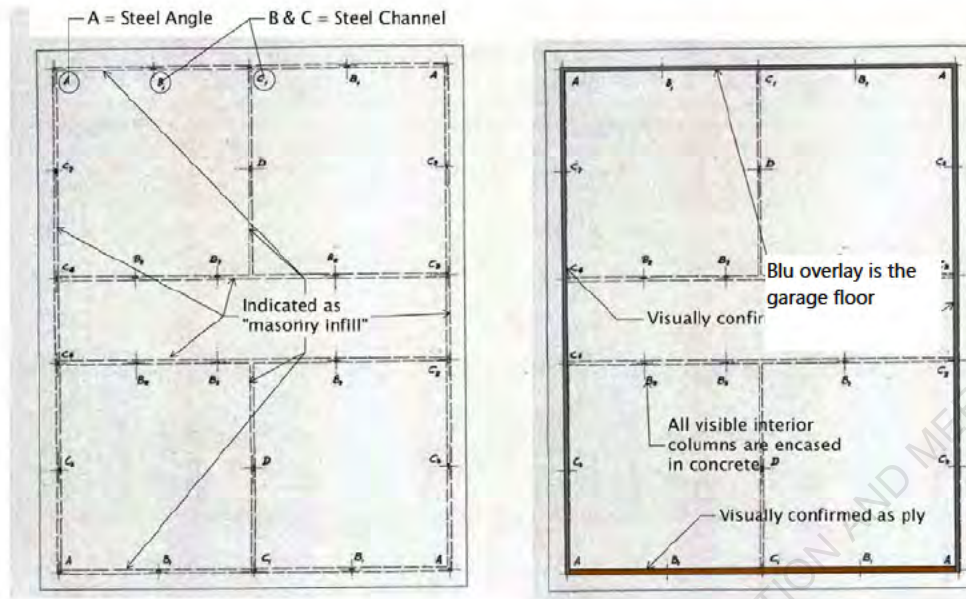
Figure 4: Extent of uncertainty

The construction of the “second floor support structure” is unclear, as conflicting information is shown in different areas of the 1975 drawings, and the 2013 strengthening plan does not show existing structure. The 1975 scheme showed a series of steel posts with masonry infill, but from the accessway into the area a different construction has been observed, as shown below. The detailed construction of the observed concrete elements needs to be confirmed with intrusive investigation. This is shown in more detail in the appendices.

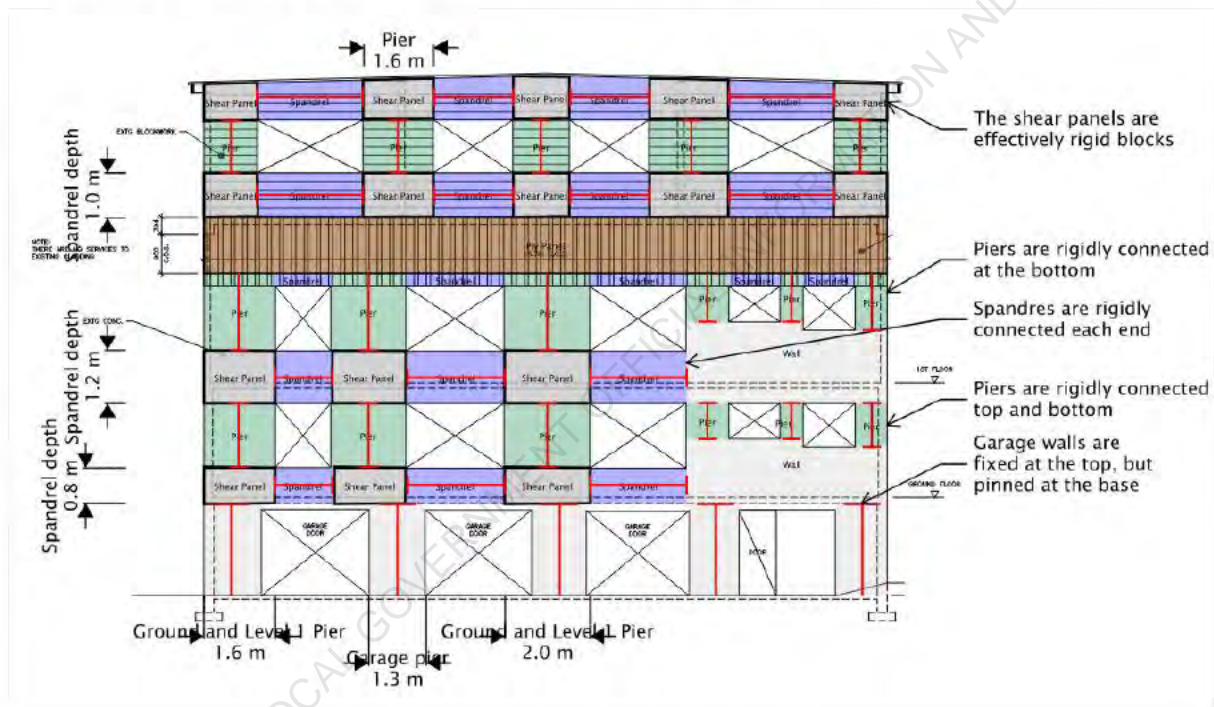
Figure 9: Glenmore Street Elevation Key Features

The analysis shows that the components of the Glenmore Street elevation limit the global capacity of the building. We have summarised the qualitative features of the model in Figure 9 below. The key features of this model are:

- The punched shear walls perform similar to a moment-resisting frame with rigid joints.
- In general the piers are stiffer than the spandrels, which will cause the rotations and damage to be concentrated in the spandrels.
- The shallow foundations don't provide restraint to rotation of the garage walls. They will pivot around the base. Typically free-standing walls cantilever from their base, but in effect these cantilever from the rigid structure above.
- The concrete floors will enforce deflection compatibility between adjacent piers at each level. This means the shorter (vertically) piers will experience relatively higher damage because any deflections will be a greater proportion of their length.

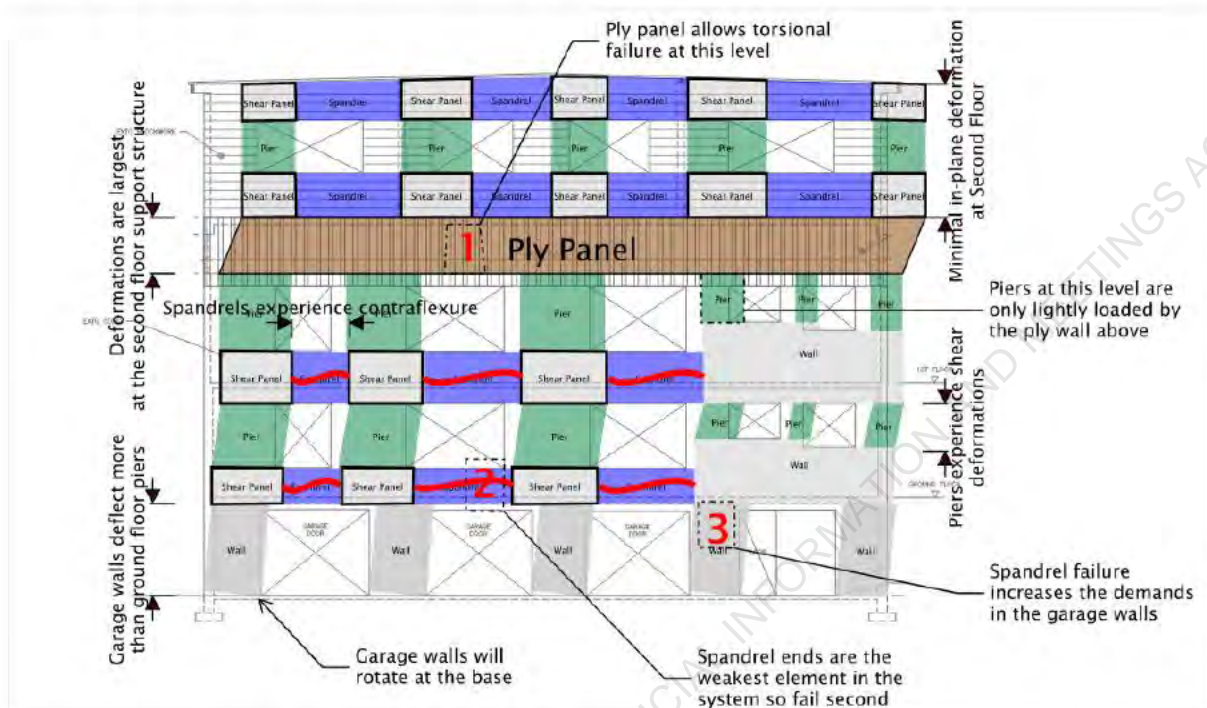
Figure 10: Qualitative results summary

The ETABS modelling shows that the inherently torsional response at the second-floor support structure limits the performance of the system. The plywood allows relatively large displacements at the front of the building, in turn inducing second-order buckling in the wall stitching the 1950 building to the 1975 extension. A failure of this type in this location could be catastrophic, because the kinetic loads from the upper storey landing on the first floor will be very high.

The next-weakest elements in the system are the spandrel panels. These panels experience contraflexure as the structure tries to rotate. The spandrel panels try to restrain the rotation of the joints and the piers. Since there is no fixity in the walls at the bottom of the garage, once the spandrels fail there is nothing to restrain movement in the front wall. In a more typical building, where the base of the cantilever walls were fixed, the failure of a spandrel panel transfers load into those fixed bases, but here that is not possible.

Because they are not fixed against rotation at the base, and because they are shorter than the piers above, the garage walls are far more flexible than the structure above. They are supported against lateral movement

by the concrete floor above the garages, but the garage concrete construction is also a torsional "C" shape. Once the garage walls begin to experience damage or significant rotation, they also begin to lose their ability to carry vertical loads, which would be potentially catastrophic.

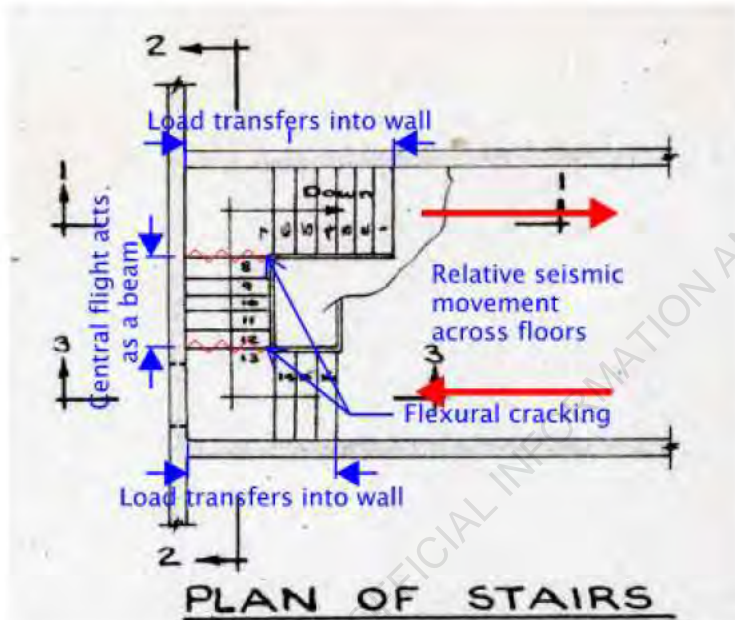
Figure 12: Stair load paths

The internal stairs from Ground to First are formed from in-situ concrete with no apparent seismic detailing for movement, but they also contain a landing at mid height that prevents an efficient strut forming between the storeys. The stairs are built into the walls on one side, and the connection is detailed showing a hooked bar which will allow them to transfer loads into the stairs. This is illustrated in the diagram below:

This flexural cracking could make the stairs inoperable at higher levels of shaking, but is not likely to prevent use of the stairs at the levels of shaking which would cause primary structural damage. Due to the stiff connections to surrounding walls even high levels of shaking are unlikely to lead to the kind of buckling collapse that a direct stair flight could experience.

The concrete stairs represent a hazard to the occupants because once they are damaged it may make it difficult to evacuate the building. However, they are likely to perform adequately above levels of shaking that will cause one of the primary systems to fail, as described elsewhere in this report.

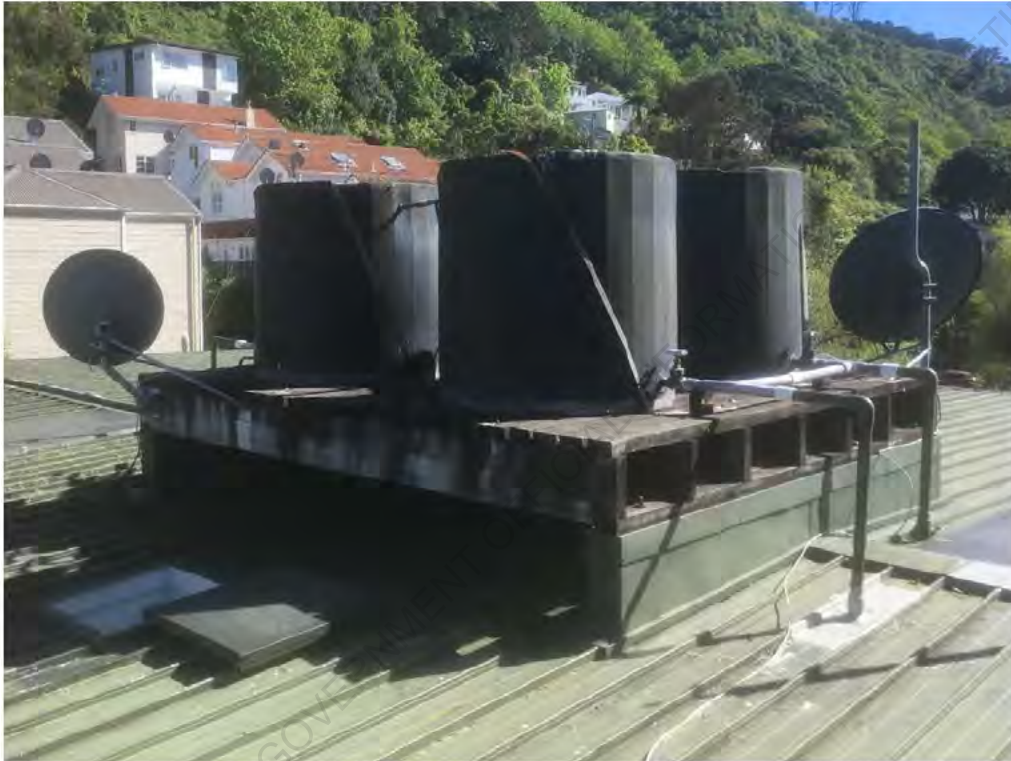
Figure 13: Roof tank support structure

There are four tanks of 750l each. In the 1974 drawings, they were intended to be supported on a substantial platform with an enclosure, but in reality they appear to be supported by two timber walls built above the 1974 block walls supporting a timber platform, refer to the photo below.

From the photos provided, there is a notional seismic restraint to the tanks on top of the platform, but this is likely to be inadequate for all but the lowest of seismic loads. The bolts connecting the platform to the support walls appear nominal, so the platform could become detached, and the joists for the platform appear to be unrestrained from rotation so can suffer rolling shear failures.

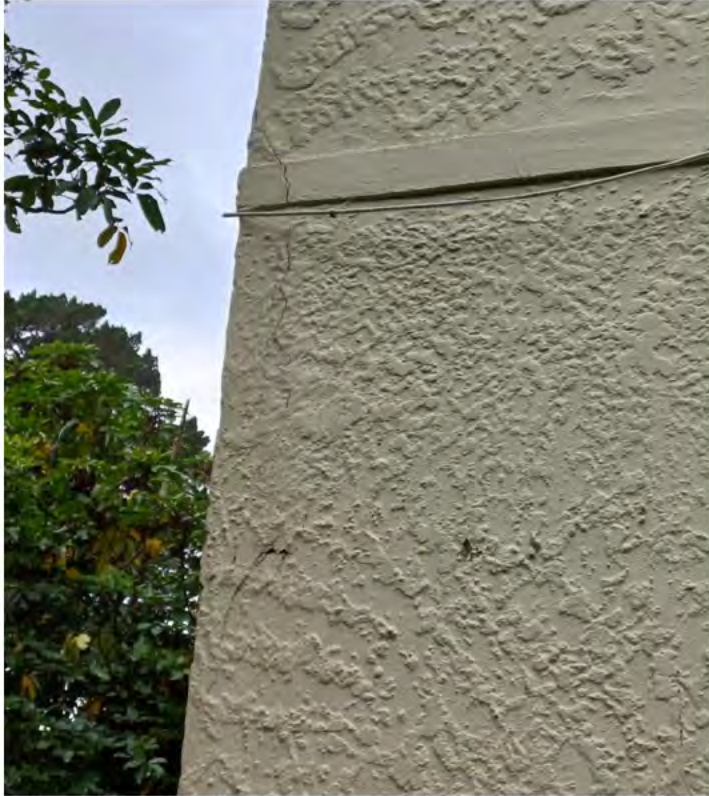
Cracking at Glenmore/Driveway Corner (Grid F/5 intersection)

This may indicate advanced corrosion in the original reinforcing steel.

BREAK OUT CONCRETE AT CRACKS TO DETERMINE REINFORCING CONDITION

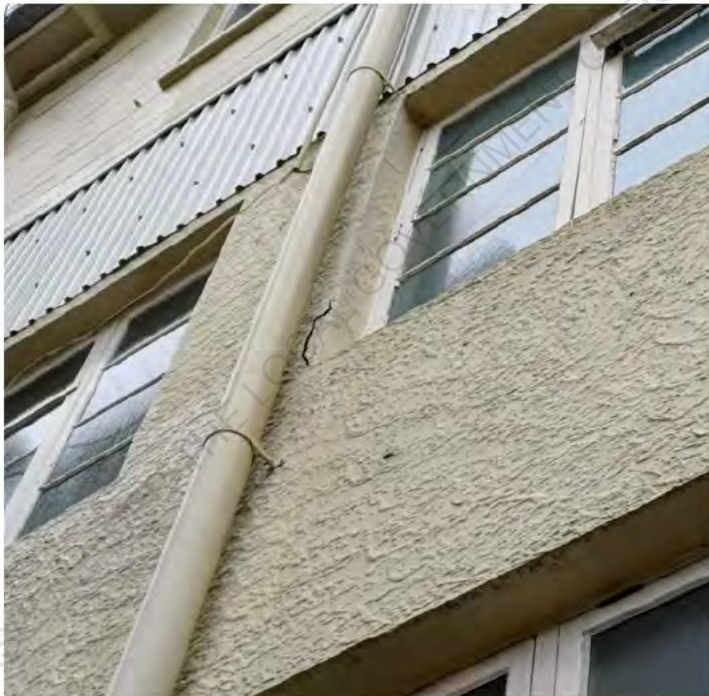
Cracking on Grid 1 pier.

This may indicate advanced corrosion in the original reinforcing steel.

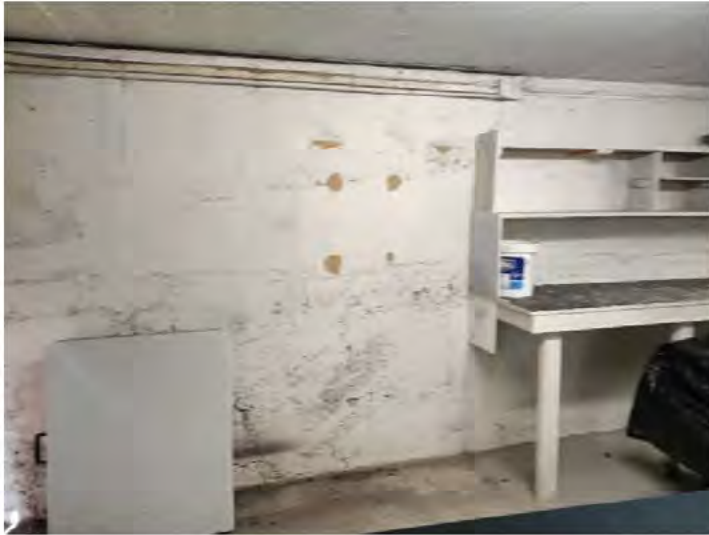
Typical condition of visible interior concrete at garage level.

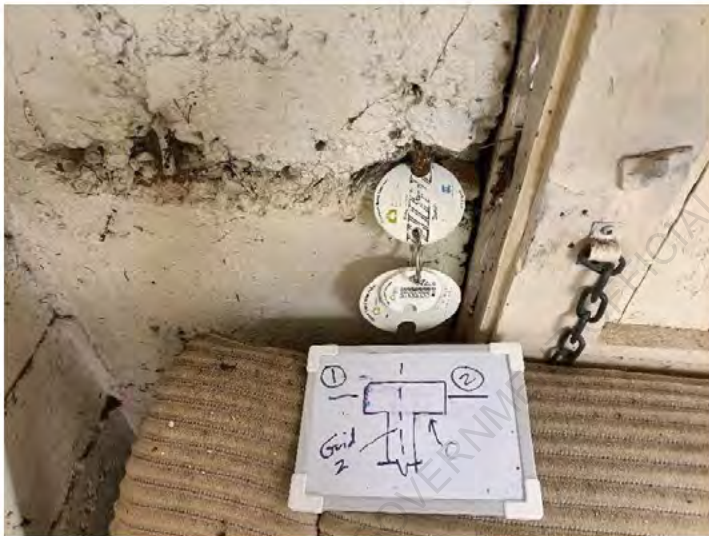
Condition of the garage wall piers

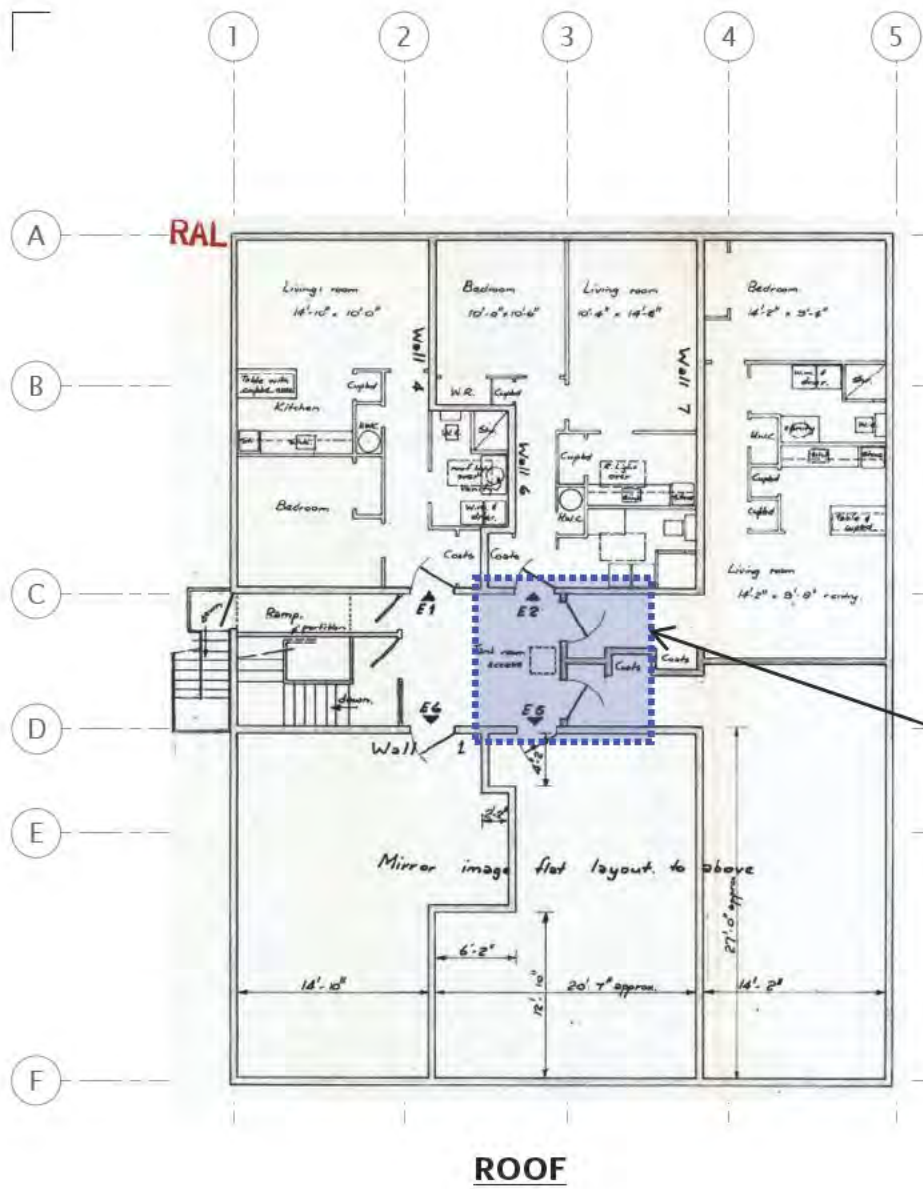
LOCATION OF EXISTING WATER TANK PLATFORM

Notes:
 Sufficient investigation has been conducted to confirm that the existing tanks are inadequately supported and restrained.
 No further investigation is needed at this level.
