**Silverdale Fire Station –  
147 Hibiscus Coast Road, Silverdale:  
Condition Assessment Report  
& Forward Maintenance Plan**

July 2012

## Executive Summary

**Date of Inspection:** 26 June 2012

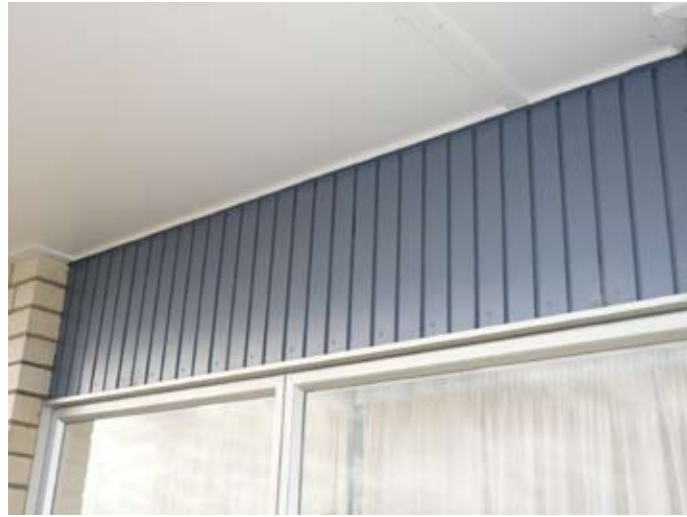
Photo 10

1.2.1	Brick faced walls	Brickwork and pointing in serviceable condition.	4	No work required.	10	-		\$ -														
1.2.2	Smooth finish painted concrete walls to entrance of Appliance Bay	Appears well maintained	4	Re-finish during normal routine maintenance period.	11	3		\$ 2,250

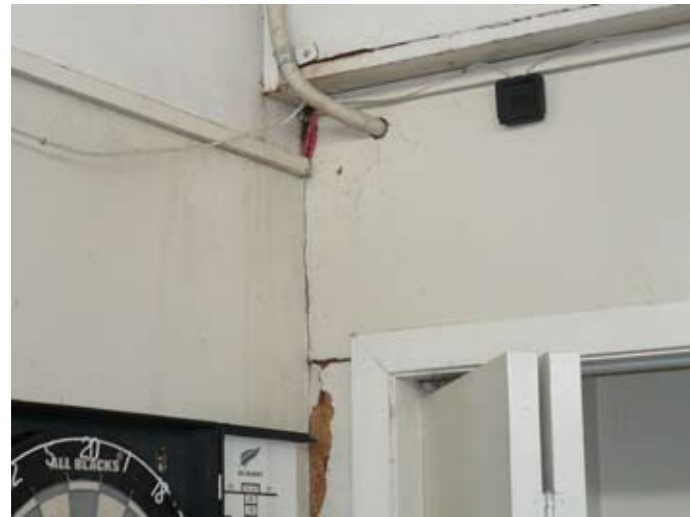
Photo 19

1.4.1	Walls	Painted plasterboard. Generally in serviceable condition however, damage from water egress visible in Southwest corner.	2	Cyclical redecoration and re-line damaged area and decorate to match adjacent.	18, 19	3		\$ 1,650

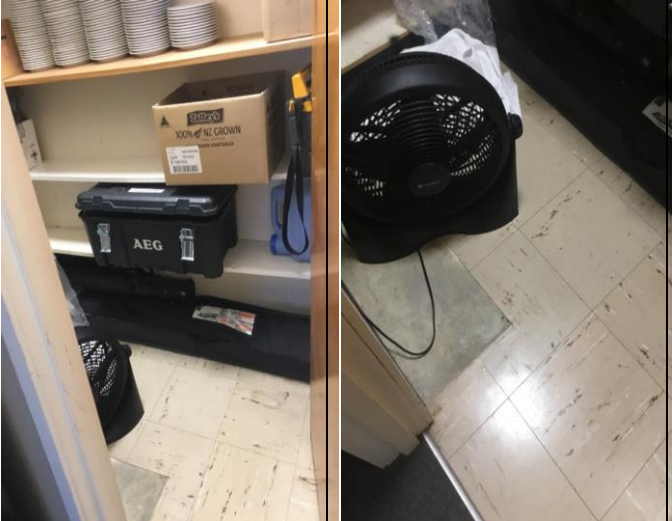
Silverdale Fire Station	Ground floor	Store (adjacent to bedroom/s) – Vinyl Tiles (RV642484)	8 - Low risk ACM	<p><u>Manage &amp; re-inspect periodically</u>                      Leave in place &amp; manage. Condition of material to be monitored and maintained.</p> <ul style="list-style-type: none"> <li>• Never sand, grind or waterblast the vinyl or floor under.</li> <li>• Cutting or drilling of the material must be performed in a controlled way (see the 'Asbestos Regulations', Clause 18) to prevent possible fibre release.</li> <li>• Workers (PCBUs) undertaking work that disturbs this material should do so in accordance with Worksafe's 'ACOP for the Management &amp; Removal of Asbestos'.</li> <li>• Re-inspect condition 3-yearly.</li> </ul>	3 yearly - May 2023.	Low risk ACM. Material has low damage. Floor tiles and linoleum, or lino can contain asbestos. They may also have asbestos backing paper, or be fixed with asbestos containing mastic. Normal cleaning and maintenance such as mopping, waxing and polishing is permitted.

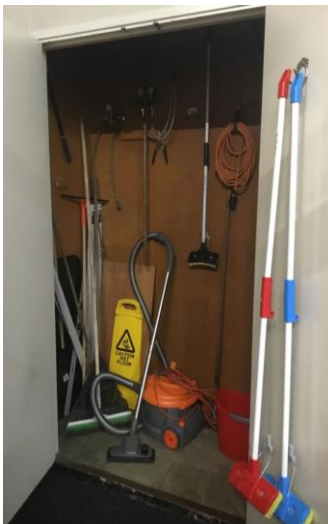
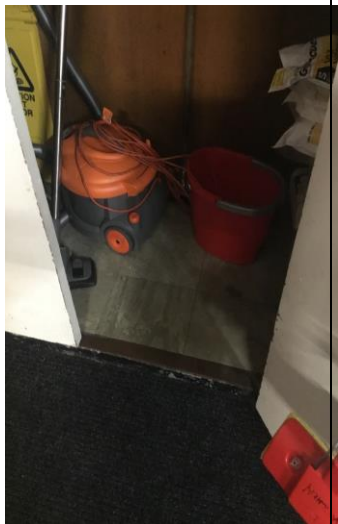
Silverdale Fire Station	Ground floor	Appliance Bay storage closet – Vinyl Tiles (RV642484)	8 - Low risk ACM	<p><u>Manage &amp; re-inspect periodically</u>                      Leave in place &amp; manage. Condition of material to be monitored and maintained.</p> <ul style="list-style-type: none"> <li>• Never sand, grind or waterblast the vinyl or floor under.</li> <li>• Cutting or drilling of the material must be performed in a controlled way (see the 'Asbestos Regulations', Clause 18) to prevent possible fibre release.</li> <li>• Workers (PCBUs) undertaking work that disturbs this material should do so in accordance with Worksafe's 'ACOP for the Management &amp; Removal of Asbestos'.</li> <li>• Re-inspect condition 3-yearly.</li> </ul>	3 yearly - May 2023.	<p>Low risk ACM. Material has low damage. Floor tiles and linoleum, or lino can contain asbestos. They may also have asbestos backing paper, or be fixed with asbestos containing mastic. Normal cleaning and maintenance such as mopping, waxing and polishing is permitted.</p>

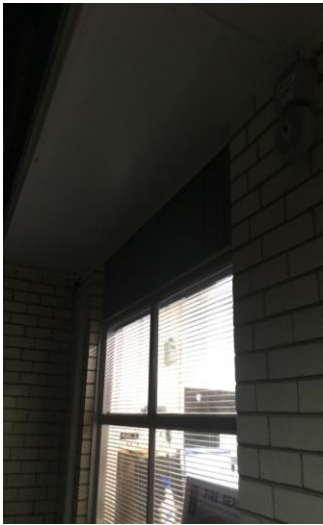
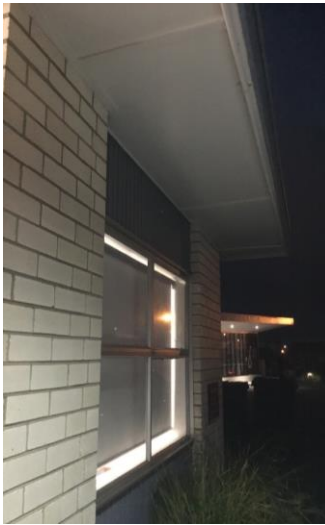
Silverdale Fire Station	Ground floor	Exterior - Soffit linings (RV645271)	10 - Medium risk ACM	<p><u>Manage &amp; re-inspect periodically</u></p> <p>Leave in place &amp; manage. Finish of material to be monitored and maintained.</p> <ul style="list-style-type: none"> <li>• Never sand, grind or waterblast the material.</li> <li>• Cutting or drilling of the material must be performed in a controlled way (see the 'Asbestos Regulations', Clause 18) to prevent possible fibre release.</li> <li>• Workers (PCBUs) undertaking work that disturbs this material should do so in accordance with Worksafe's 'ACOP for the Management &amp; Removal of Asbestos'.</li> <li>• Re-inspect condition 3-yearly.</li> </ul>	3 yearly - May 2023.	Exterior location. Material has low damage, with a very low chance of disturbance. Activities such as light cleaning, or painting are permitted.

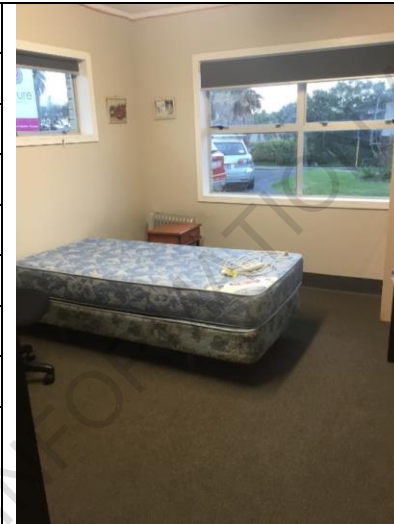
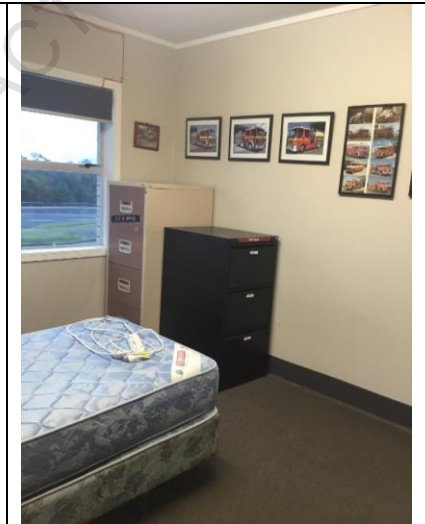
Reference Number	RV642484	Extent	4 m <sup>2</sup>
Date Identified	28 May 2020	Condition	Low damage
How Identified	Sampled	Friability	Non-friable
Surveyor Name	Ronaldo Vollenhoven	Accessibility	Accessible
Survey Address	149-153 Hibiscus Coast Highway, Te Hiku	Surface Treatment	Composite
Building	Silverdale Fire Station	Laboratory	Analytica Laboratories
Room	Bedroom 1 Store	Lab Test ID	RV642484
Floor	Ground floor	Test Result	Confirmed Asbestos RV642484
Item Location	Floor	Asbestos Type	Chrysotile
Product Type	Composite materials	Risk Assessment	8 - Low risk ACM

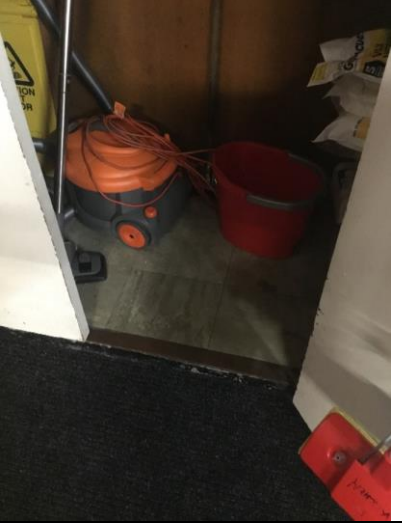
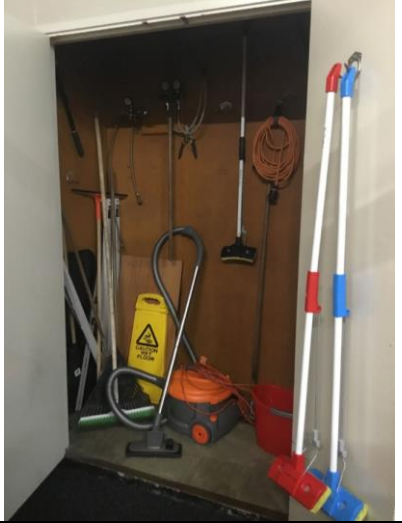
Reference Number	RV642484	Extent	6 m <sup>2</sup>

Date Identified	28 May 2020	Condition	Low damage		
How Identified	Sampled	Friability	Non-friable		
Surveyor Name	Ronaldo Vollenhoven	Accessibility	Accessible		
Survey Address	149-153 Hibiscus Coast Highway, Te Hiku	Surface Treatment	Composite		
Building	Silverdale Fire Station	Laboratory	Analytica Laboratories		
Room	Appliance Bay storage closet	Lab Test ID	RV642484		
Floor	Ground floor	Test Result	Confirmed Asbestos RV642484		
Item Location	Floor	Asbestos Type	Chrysotile		
Product Type	Vinyl floor tiles	Risk Assessment	8 - Low risk ACM

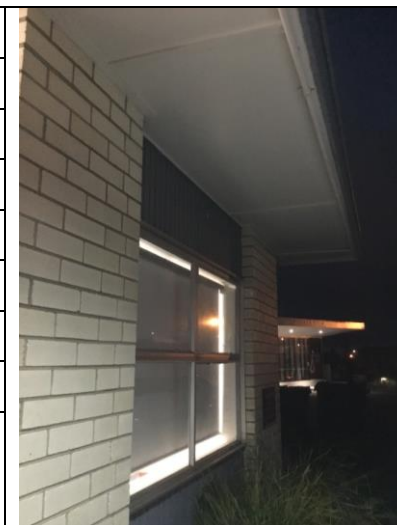
Reference Number	RV645271	Extent	40 m <sup>2</sup>
Date Identified	28 May 2020	Condition	Low damage
How Identified	Sampled	Friability	Non-friable
Surveyor Name	Ronaldo Vollenhoven	Accessibility	Accessible
Survey Address	149-153 Hibiscus Coast Highway, Te Hiku	Surface Treatment	Sealed
Building	Silverdale Fire Station	Laboratory	Analytica Laboratories
Room	Soffit linings	Lab Test ID	RV645271
Floor	Ground floor	Test Result	Confirmed Asbestos RV645271
Item Location	Exterior Sides	Asbestos Type	Chrysotile Crocidolite
Product Type	Cement products	Risk Assessment	10 - Medium risk ACM
